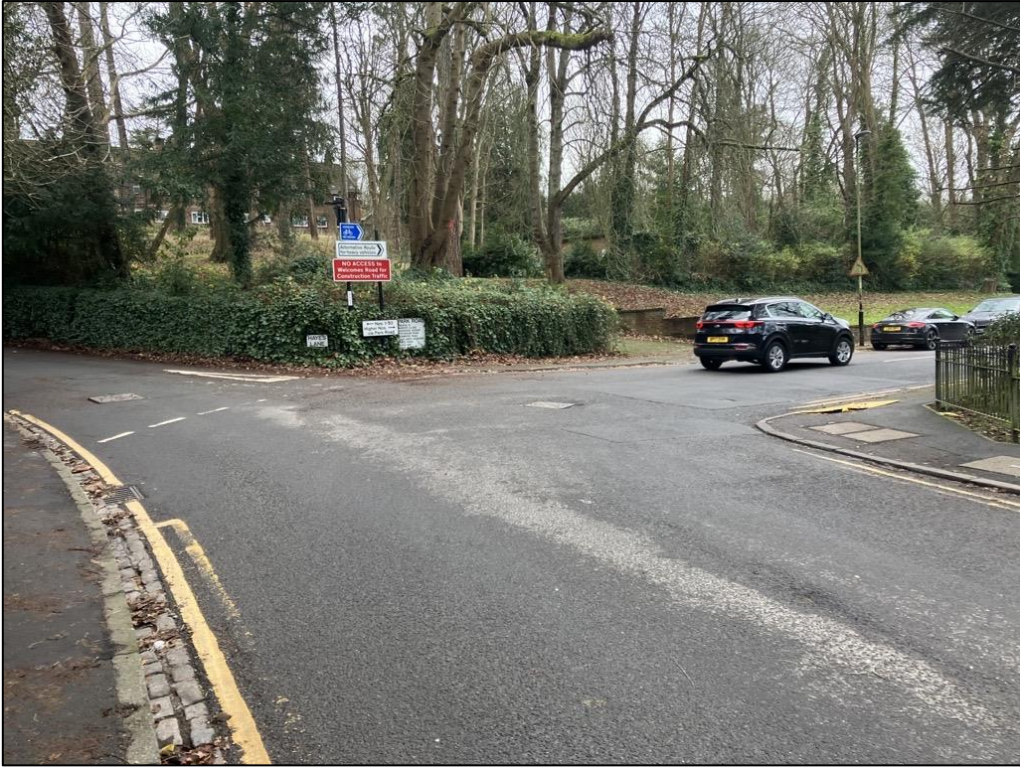
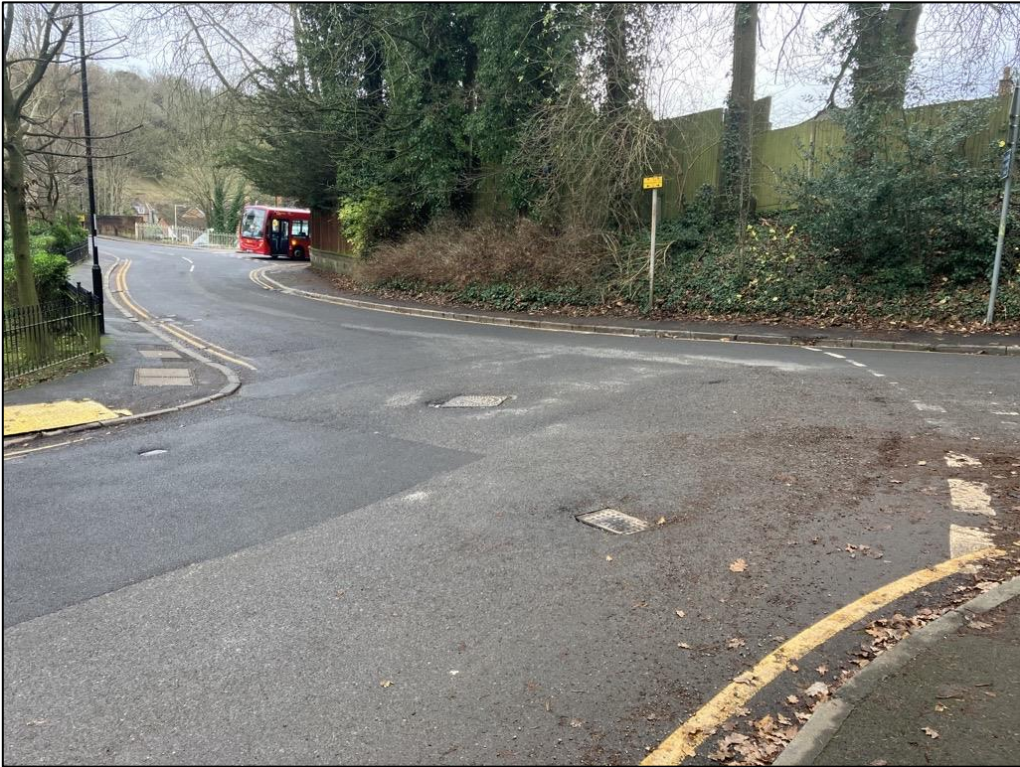
The junction between Park Road and Hayes Lane (on the side closest to Kenley Station) raised concerns. Two vehicles cannot safely pass each other if they meet at this junction; one either has to wait before the junction, or, if they are already traversing the junction, one vehicle must likely reverse to give way. This is an issue especially since, when heading towards Coulsdon, if a 434 bus commits to turning onto Hayes Lane from Kenley Lane (as seen below in Figure 6), it has no choice but to proceed. Drivers cannot see whether there is a bus coming from Park Road until they have proceeded beyond the junction.

*Figure 6: Images of the junction between Hayes Lane and Park Road. The top image is facing Park Road (curving to the right). The bottom image is showing Hayes Lane. The 434 used on the test can be seen turning from Kenley Lane. The driver of this bus cannot see any vehicle that might be approaching from Park Road to the left.*

The Hayes Lane / Park Road junction is currently traversed as part of route 434's normal line of route, so a risk assessment may be necessary, as based on the findings of this test, this junction is not suitable for bus use.

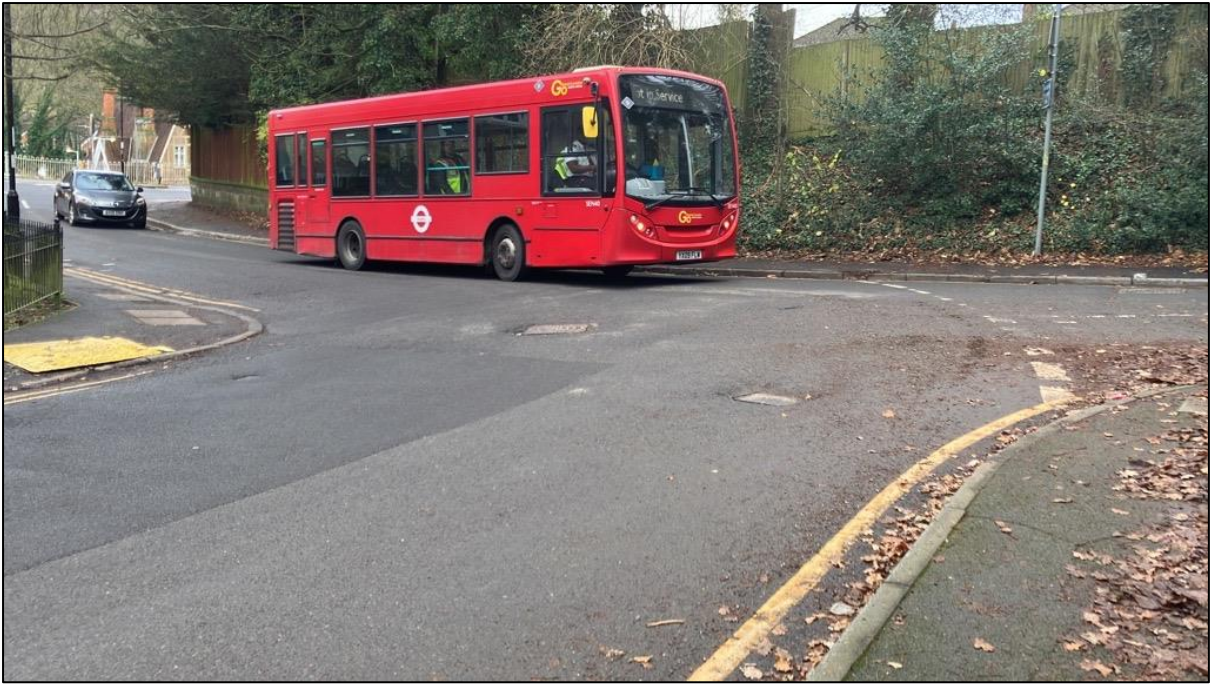
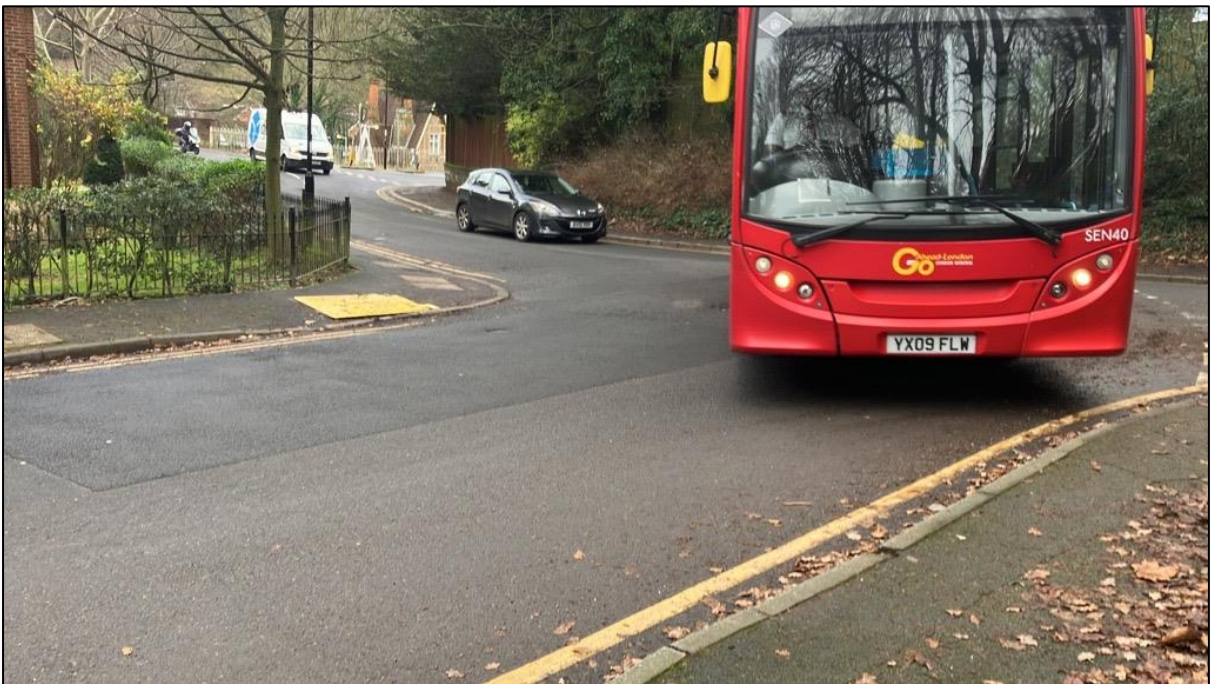
*Figure 7: Image of the bus used on the test, having just made the turn from Hayes Lane onto Park Road (towards Coulsdon). There is more clearance to make this turn without infringing on the opposite lane, in this direction only.*

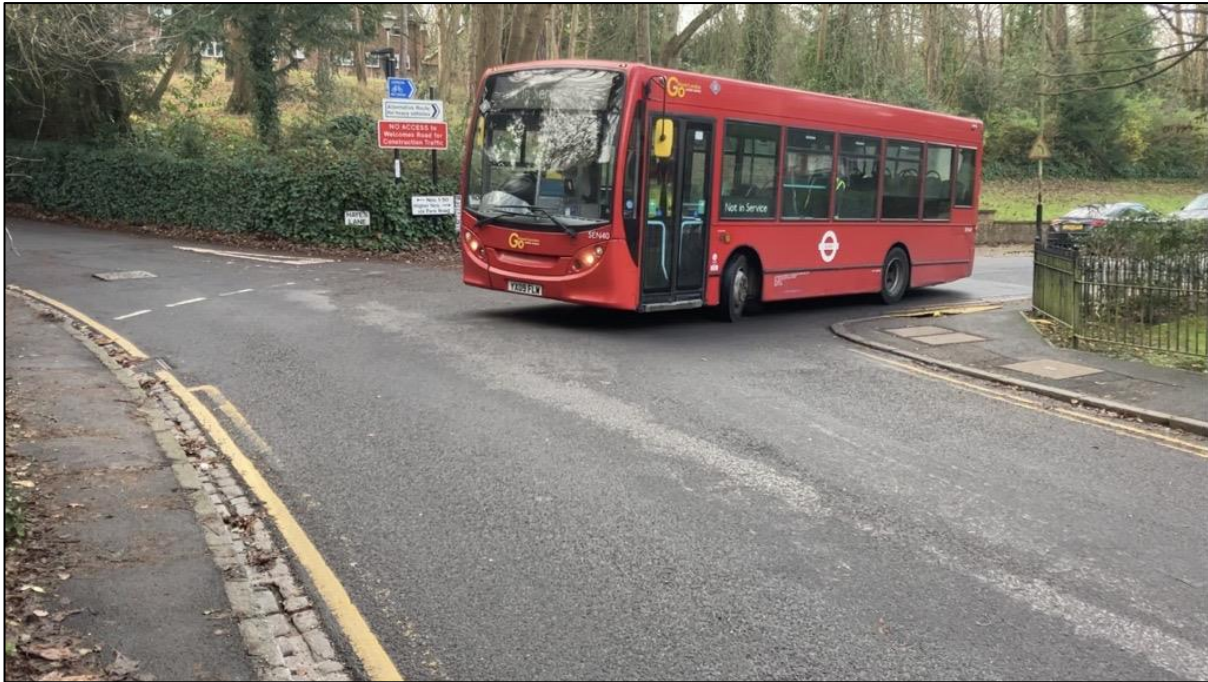
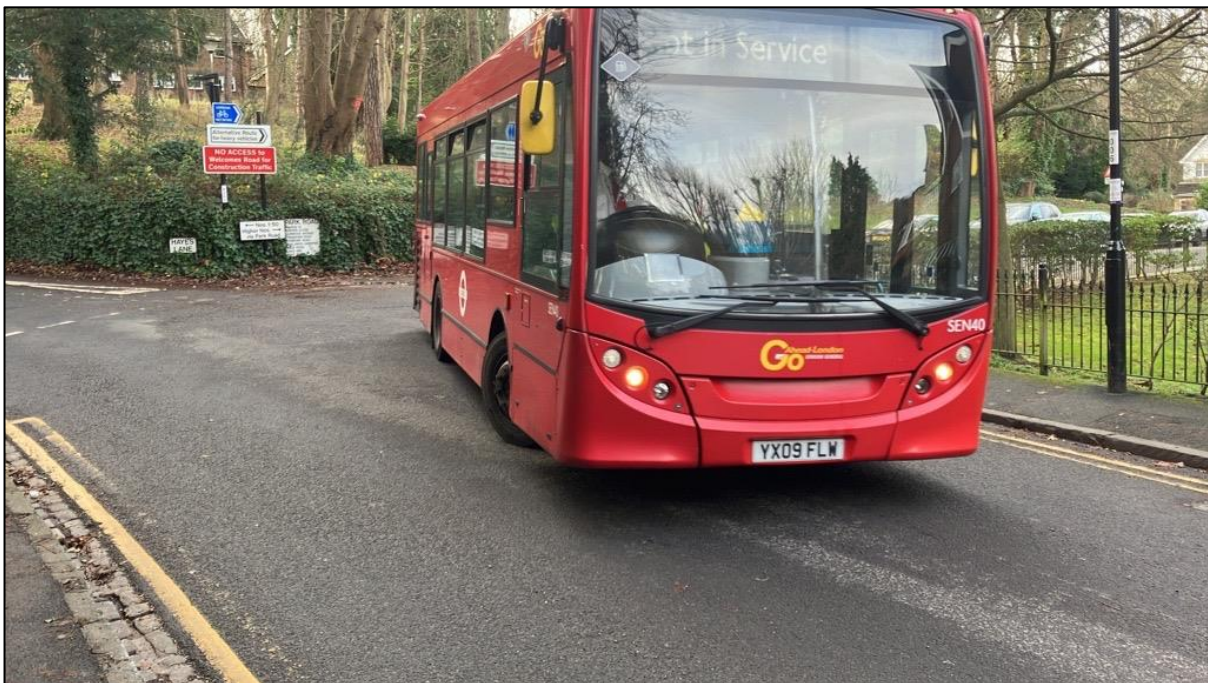
Figure 8: Image of the bus used on the test, having just made the turn from Park Road onto Hayes Lane (towards Whyteleafe). The driver has remained as close to the kerb as possible, but still cannot leave enough room for a vehicle to proceed in the opposite direction.

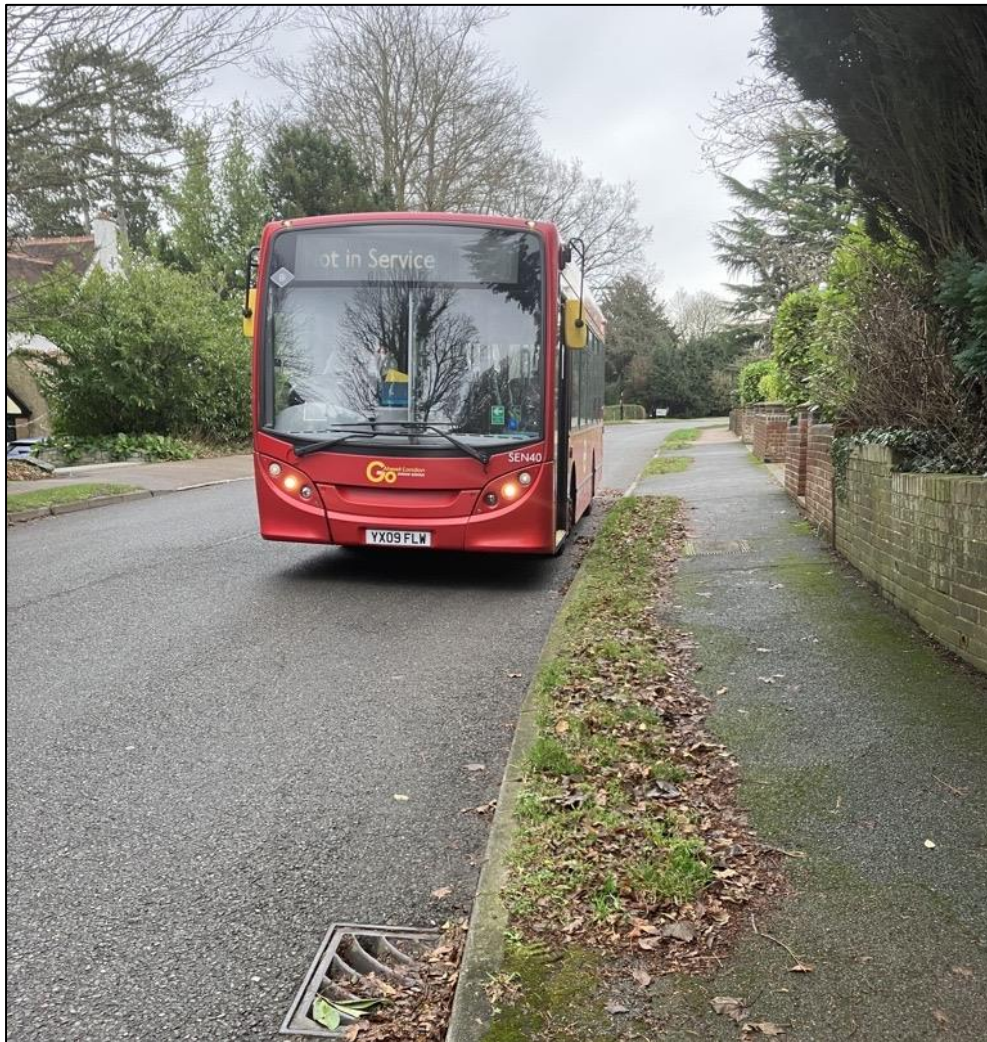
Along various stretches of the proposed new routing, there are fewer dropped kerbs, which raised questions among attendees regarding accessibility. Since a significant portion of the route is Hail & Ride, this is something that may need to be addressed.

*Figure 9: Bus parked on Hayes Lane, which has several green verges, and few dropped kerbs for less able passengers to alight safely.*
