Hazardous Materials - TfL Engineering

Re-inspection Sign-Off for Brixton

Re-inspection Reference: V059/4RS-200403

Station	Brixton
Original Management Survey	R346601
Date of Original Management	31st August 2012
Re-inspection Reference:	V059-4RS-200403
Next Planned Re-inspection	Periodical re-inspection according to HM Management Plan

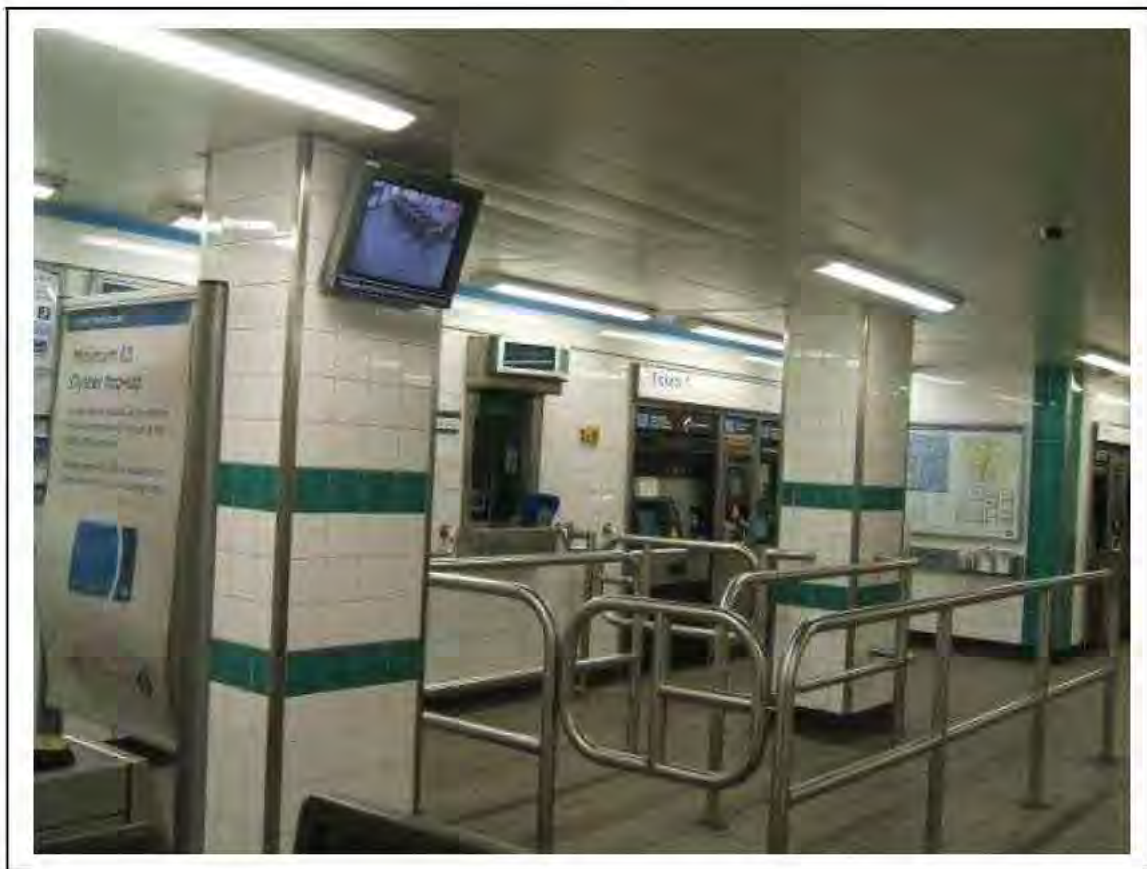
FIGURE 2: PRESUMED ASBESTOS ABOVE FALSE CEILING IN TICKET HALL, 2/001 - DESCRIPTION & RESULT OF ASSESSMENT (SAMPLE REF. P1&2(2))

Sample Number	P1&2(2)
Location	Ticket Hall , 2/001
Material Description	Above false ceiling
Material Comment	Refer to report reference 4RS-BIM-034523-R34777, new ceiling system requires specialist access
Quantity	-
Product Type	-
Current Condition	-
Surface Treatment	-
Asbestos Type	Presumed Amosite and Chrysotile
Material Assessment Rating	-
Accessibility	
Further Comment	Areas within the structure were previously found to contain asbestos residues sealed within. Note: the alcove 2/087 in front of the new lift is also included in the Ticket Hall

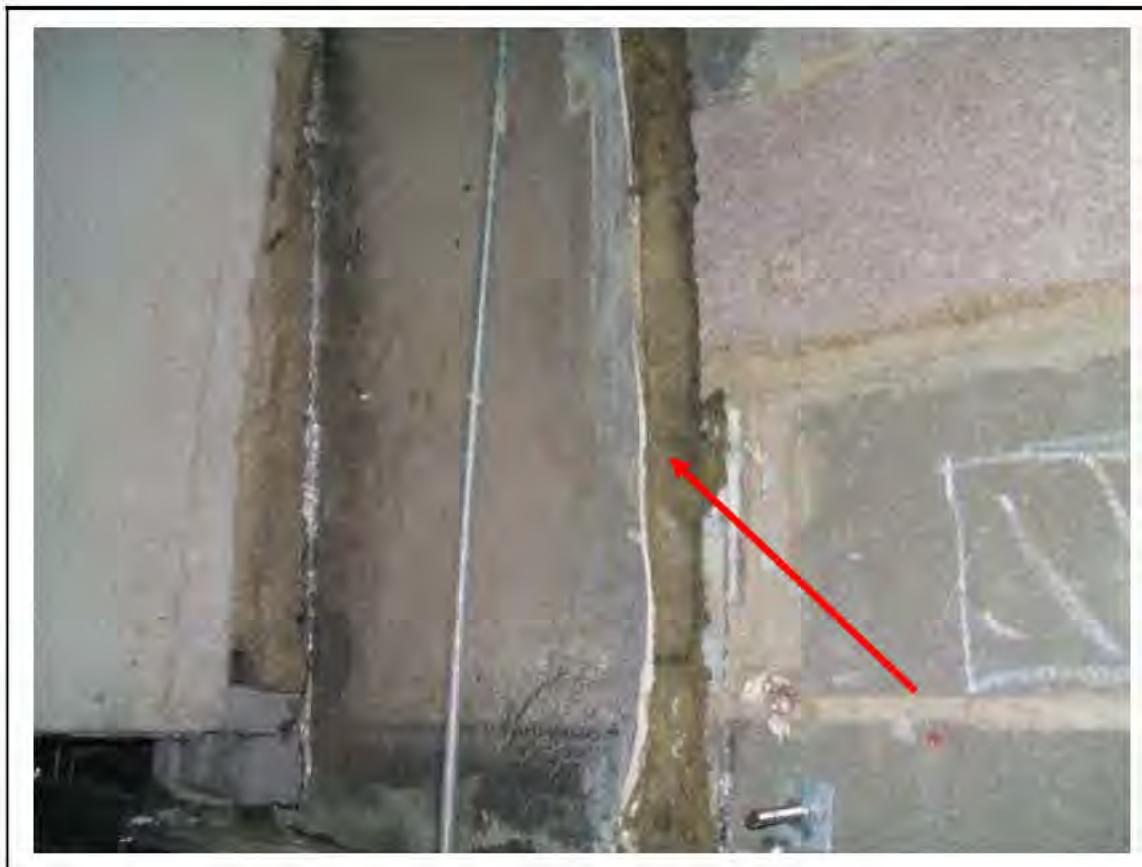
FIGURE 3: PRESUMED ASBESTOS IN RESIDUES BEHIND OLD VERMICULITE CLADDING N TICKET OFFICE CORRIDOR, 2/011 - DESCRIPTION & RESULT OF ASSESSMENT (SAMPLE REF. P1&2(3))

Sample Number	P1&2(3)
Location	Ticket Office Corridor, 2/011
Material Description	Possible residues behind old vermiculite cladding to beam over station supervisors office and also where beam goes into wall
Material Comment	Above false ceiling
Quantity	-
Product Type	-
Current Condition	-
Surface Treatment	-
Asbestos Type	Presumed Amosite and Chrysotile
Material Assessment Rating	-
Accessibility	
Further Comment	Not applicable

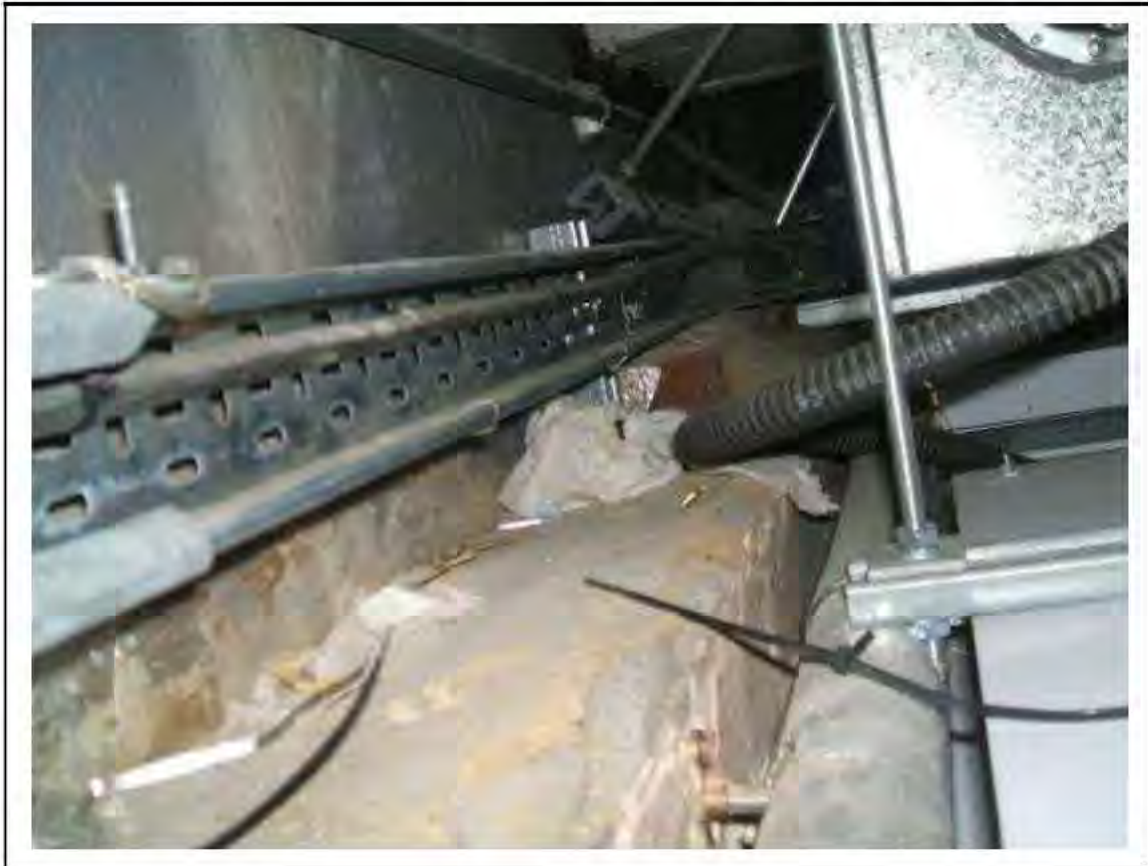
FIGURE 4: PRESUMED ASBESTOS IN EXTERNAL CAVITY WALL LIKELY RESIDUES IN CAVITY BEHIND TICKET OFFICE CORRIDOR, 2/011 - DESCRIPTION & RESULT OF ASSESSMENT (SAMPLE REF. P1&2(4))

Sample Number	P1&2(4)
Location	Ticket Office Corridor, 2/011
Material Description	External cavity wall likely residues in cavity behind ticket office corridor
Material Comment	Above false ceiling
Quantity	-
Product Type	-
Current Condition	-
Surface Treatment	-
Asbestos Type	Presumed Amosite and Chrysotile
Material Assessment Rating	-
Accessibility	
Further Comment	Not applicable

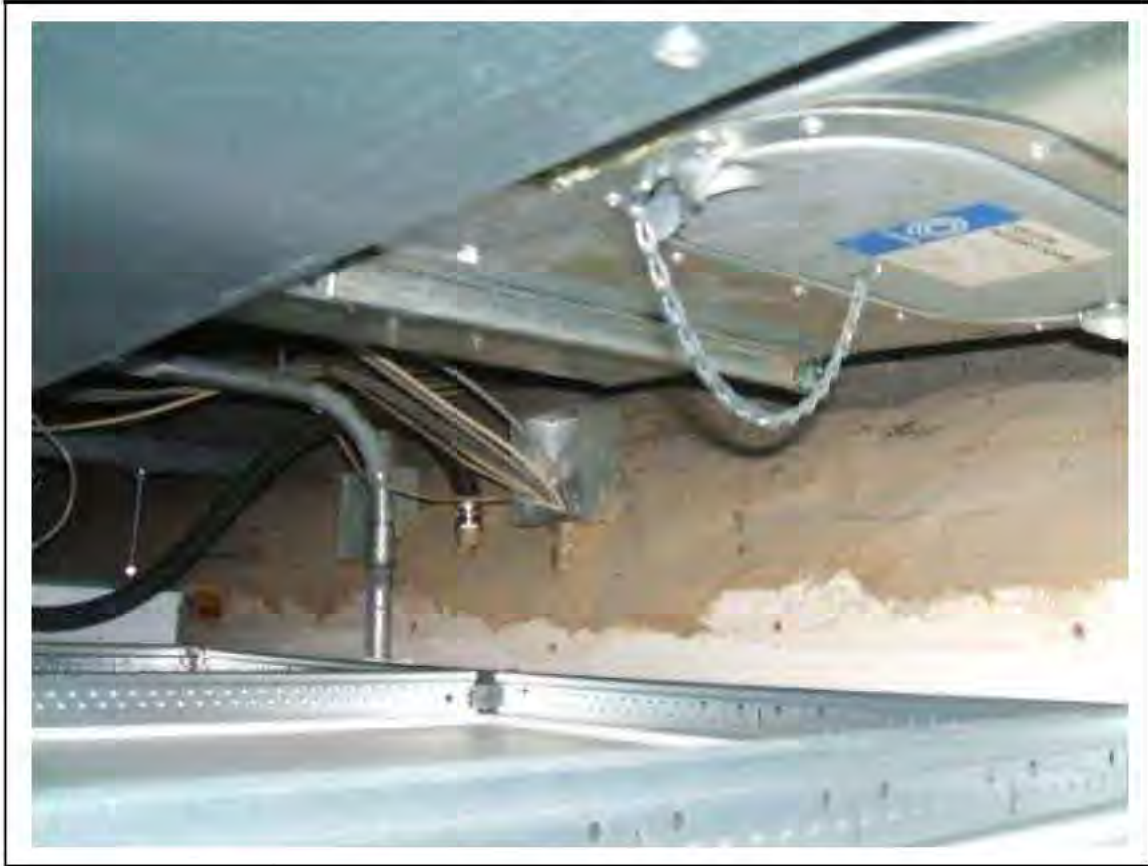
FIGURE 5: PRESUMED ASBESTOS - POSSIBLE RESIDUES BEHIND FALSE WALL TO EXTERNAL SIDE IN TICKET OFFICE, 2/011 - DESCRIPTION & RESULT OF ASSESSMENT (SAMPLE REF. P1&2(5))

Sample Number	P1&2(5)
Location	Ticket Office, 2/011
Material Description	Possible residues behind false wall to external side
Material Comment	Above false ceiling, wall (external)
Quantity	-
Product Type	-
Current Condition	-
Surface Treatment	-
Asbestos Type	Presumed Amosite and Chrysotile
Material Assessment Rating	-
Accessibility	
Further Comment	Not applicable

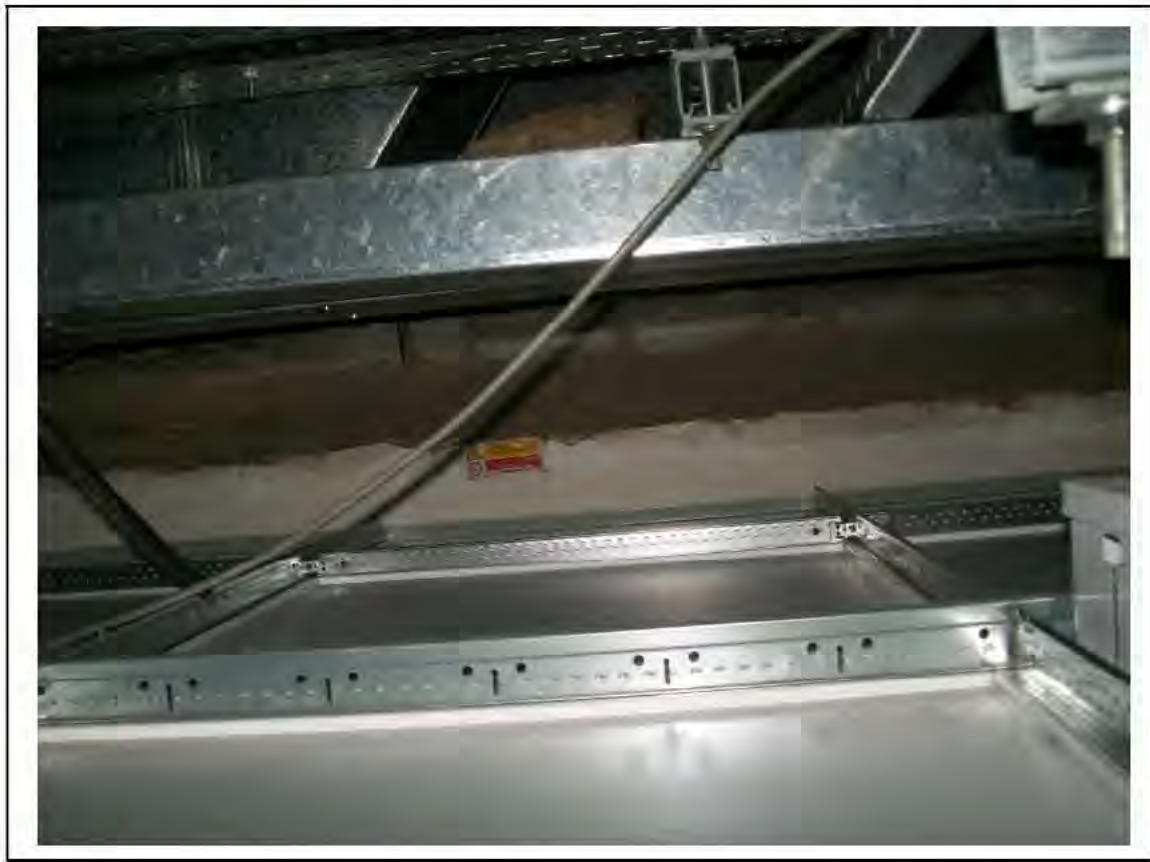
FIGURE 6: PRESUMED ASBESTOS IN RESIDUAL SPRAY INSULATION WITHIN CAVITY IN POM, 2/021 - DESCRIPTION & RESULT OF ASSESSMENT (SAMPLE REF. P1&2(6))

Sample Number	P1&2(6)
Location	POM, 2/021
Material Description	Residual spray insulation within cavity
Material Comment	Wall 3, external wall of station entrance area
Quantity	throughout
Product Type	-
Current Condition	-
Surface Treatment	-
Asbestos Type	Presumed Amosite and Chrysotile
Material Assessment Rating	-
Accessibility	
Further Comment	Not applicable

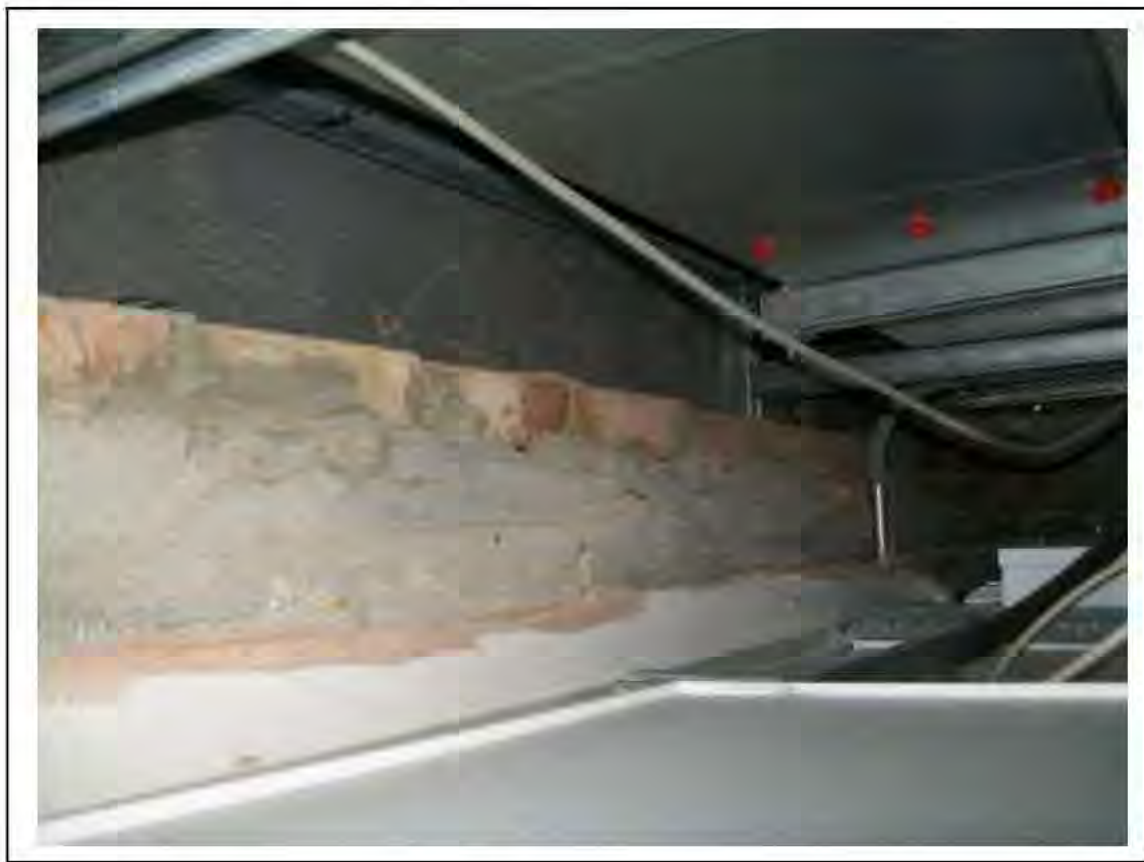
FIGURE 7: PRESUMED ASBESTOS IN RESIDUAL SPRAY INSULATION WITHIN WALL CAVITY IN OFFICE , 2/031 - DESCRIPTION & RESULT OF ASSESSMENT (SAMPLE REF. P1&2(7))

Sample Number	P1&2(7)
Location	Office , 2/031
Material Description	Residual spray insulation within wall cavity
Material Comment	Within wall cavity to external wall (wall 2)
Quantity	-
Product Type	-
Current Condition	-
Surface Treatment	-
Asbestos Type	Presumed Amosite and Chrysotile
Material Assessment Rating	-
Accessibility	
Further Comment	Not applicable

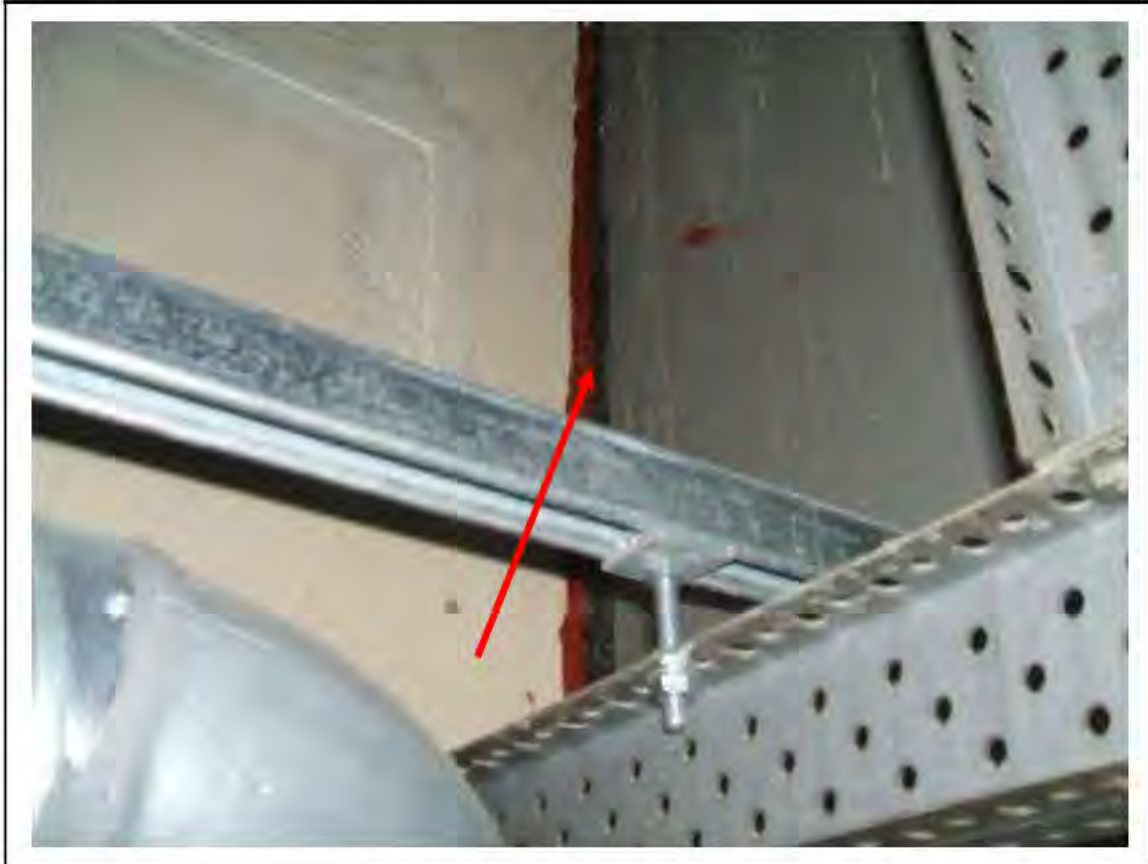
FIGURE 8: PRESUMED ASBESTOS IN SUPALUX BOXING CLADDING POSSIBLE RESIDUES IN WALL AROUND BEAM IN MESS ROOM , 2/032 - DESCRIPTION & RESULT OF ASSESSMENT (SAMPLE REF. P1&2(8))

Supalux boxing cladding, possible residues in wall around beam, presumed to contain Amosite and Chrysotile asbestos, Figure 8

Sample Number	P1&2(8)
Location	Mess Room , 2/032
Material Description	Supalux boxing cladding possible residues in wall around beam
Material Comment	Beams within false ceiling,
Quantity	-
Product Type	-
Current Condition	-
Surface Treatment	-
Asbestos Type	Presumed Amosite and Chrysotile
Material Assessment Rating	-
Accessibility	
Further Comment	Not applicable

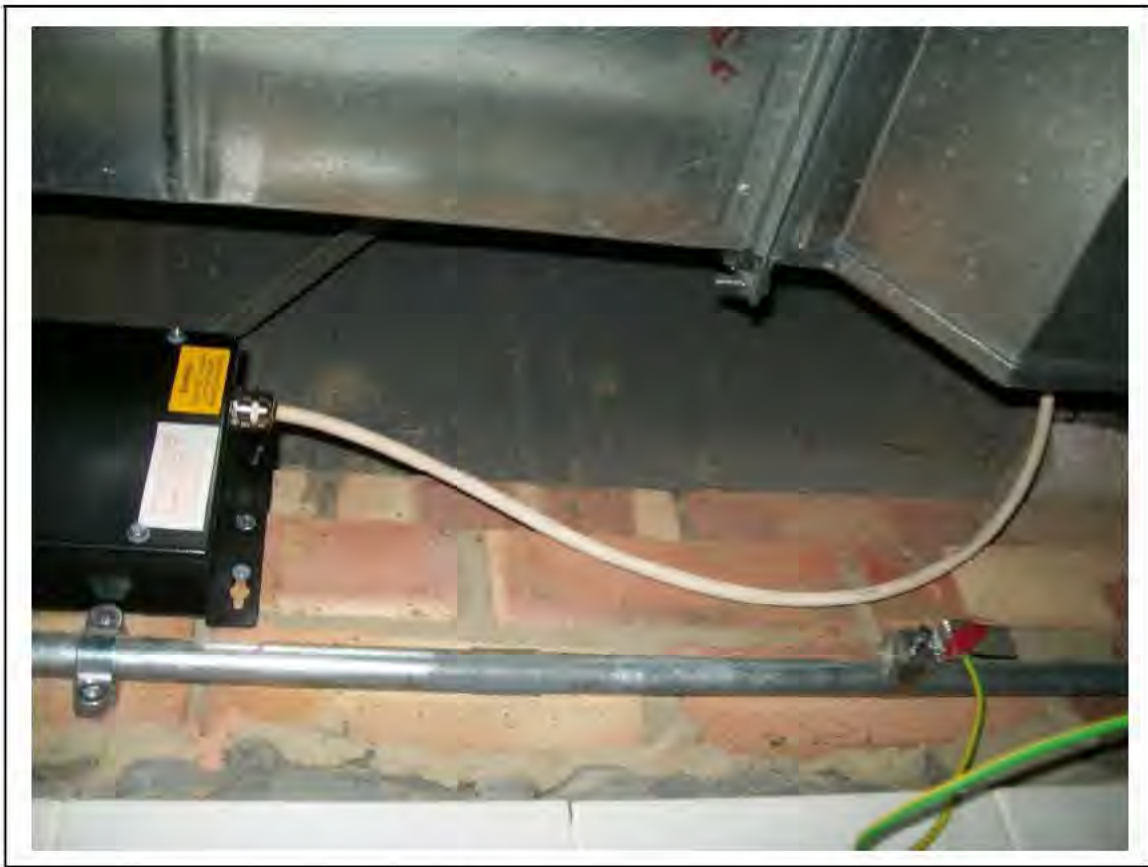
FIGURE 9: PRESUMED ASBESTOS IN RESIDUAL SPRAY INSULATION WITHIN WALL CAVITY IN SHOWER , 2/037 - DESCRIPTION & RESULT OF ASSESSMENT (SAMPLE REF. P1&2(9))

Possible residual spray insulation within wall cavity behind false wall presumed to contain Amosite & Chrysotile asbestos, Figure 9

Sample Number	P1&2(9)
Location	Shower , 2/037
Material Description	Residual spray insulation within wall cavity
Material Comment	Within wall cavity to external wall (wall 2)
Quantity	-
Product Type	-
Current Condition	-
Surface Treatment	-
Asbestos Type	Presumed Amosite & Chrysotile
Material Assessment Rating	-
Accessibility	
Further Comment	Not applicable

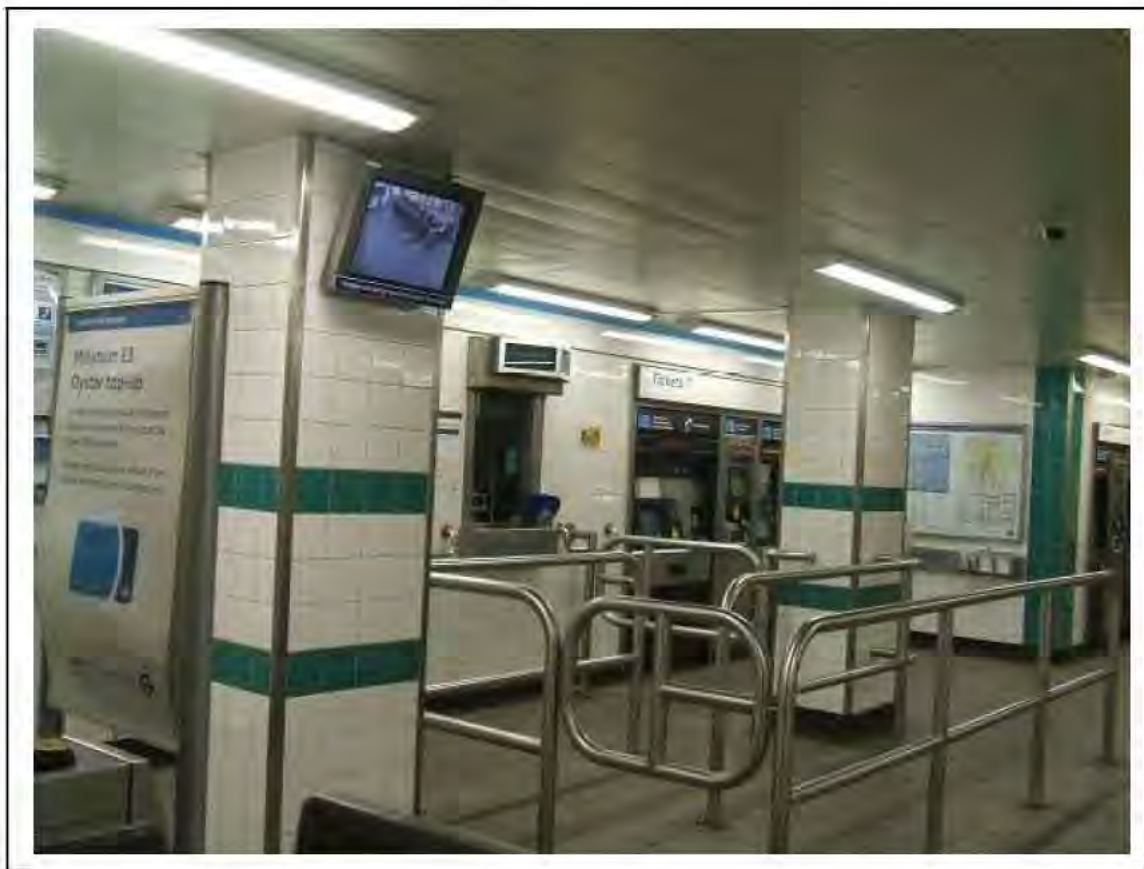
FIGURE 10: PRESUMED ASBESTOS ABOVE FALSE CEILING IN CIRCULATION AREA, 2/071 - DESCRIPTION & RESULT OF ASSESSMENT (SAMPLE REF. P1&2(10))

Above false ceiling not currently accessible, areas presumed to contain Amosite and Chrysotile asbestos within the structure, Figure 10 (see previous report reference 4RS-BIM-034523-R34777)

Sample Number	P1&2(10)
Location	Circulation Area, 2/071
Material Description	Above false ceiling
Material Comment	Refer to report reference 4RS-BIM-034523-R34777
Quantity	-
Product Type	-
Current Condition	-
Surface Treatment	-
Asbestos Type	Presumed Amosite & Chrysotile
Material Assessment Rating	-
Accessibility	
Further Comment	Area above false ceiling known to contain items and areas with asbestos residues sealed within

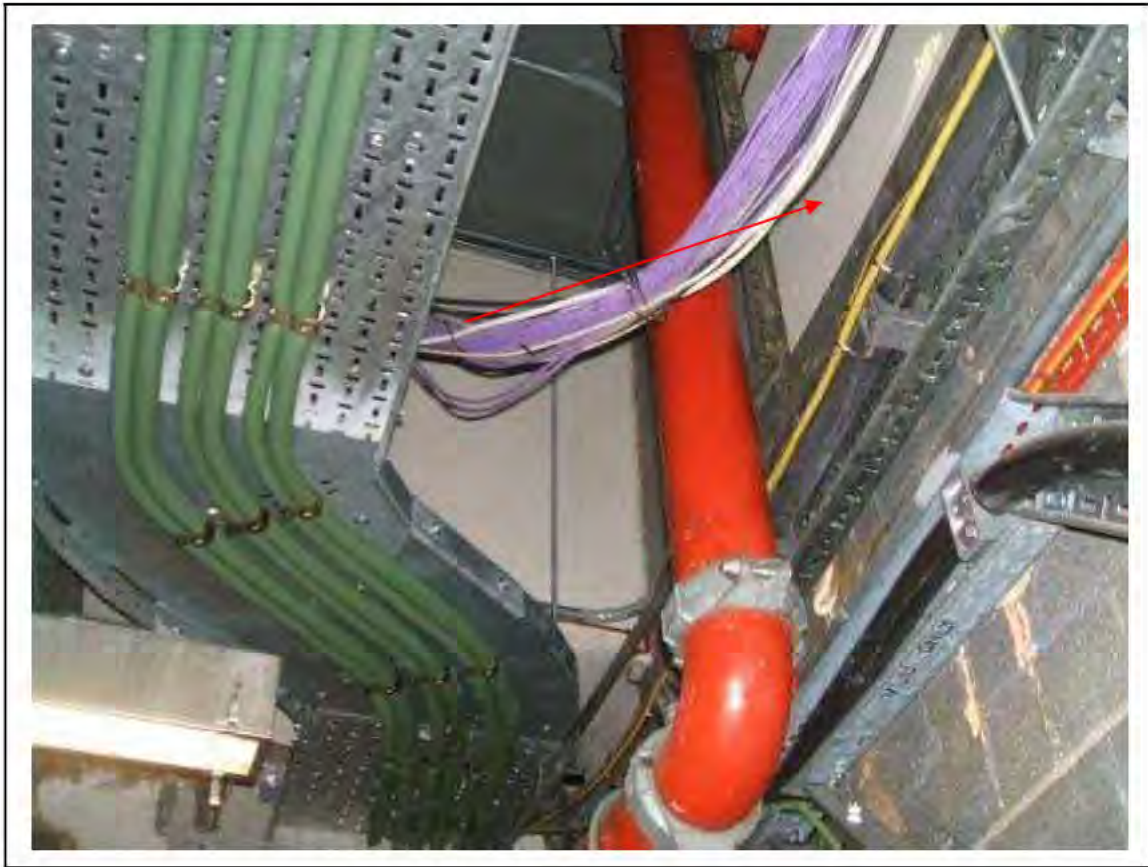
FIGURE 12: PRESUMED ASBESTOS IN SUPALUX PANEL IN UMC ACCESS , 2/151 - DESCRIPTION & RESULT OF ASSESSMENT (SAMPLE REF. P1&2(12))

Supalux panel possible residues behind presumed to contain Amosite & Chrysotile asbestos, Figure 12

Sample Number	P1&2(12)
Location	UMC Access , 2/151
Material Description	Supalux panel
Material Comment	Wall 1 high level possible materials behind
Quantity	-
Product Type	-
Current Condition	-
Surface Treatment	-
Asbestos Type	Presumed Amosite & Chrysotile
Material Assessment Rating	-
Accessibility	
Further Comment	Not applicable

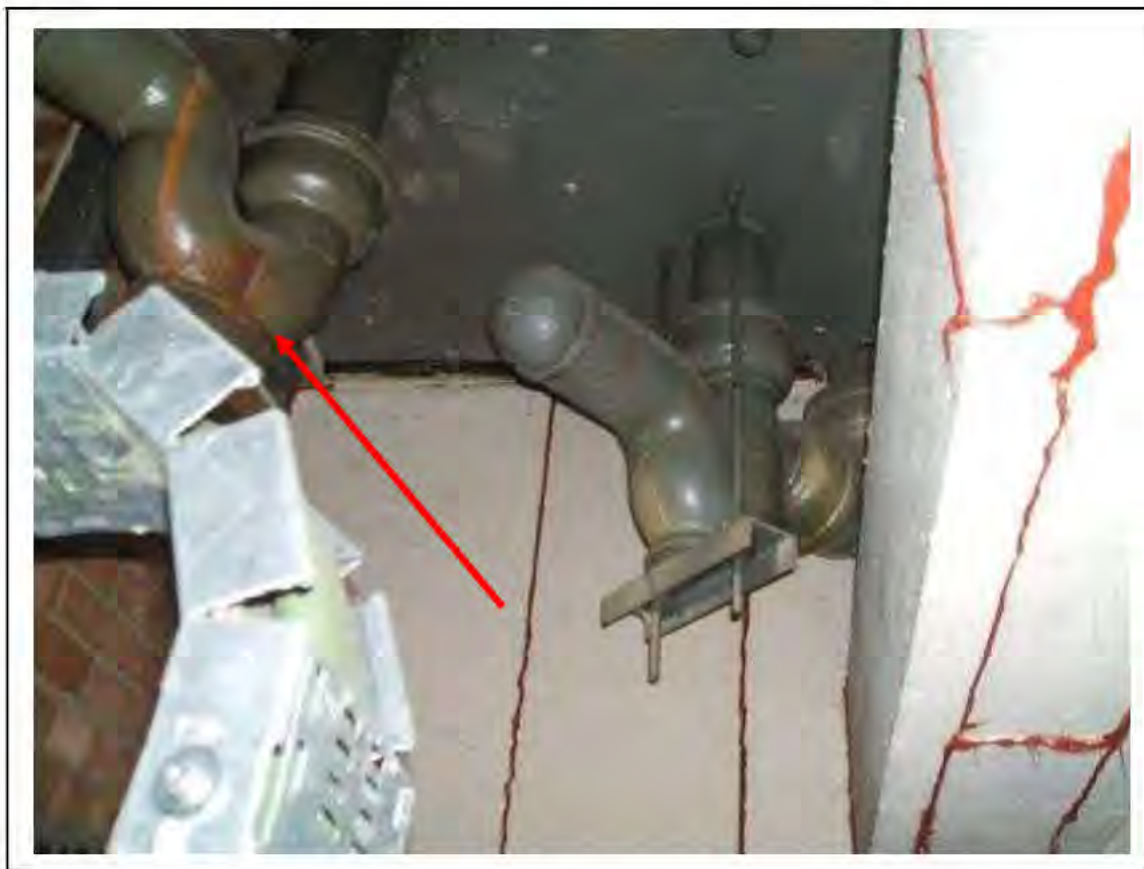
FIGURE 15: PRESUMED ASBESTOS IN RESIDUE AROUND SOIL PIPE IN UMC ACCESS , 2/151 - DESCRIPTION & RESULT OF ASSESSMENT (SAMPLE REF. P1&2(14))

Possible residue around soil pipe within concrete roof. Note: other soil pipe through ceiling included presumed to contain Amosite & Chrysotile asbestos, Figure 15

Sample Number	P1&2(14)
Location	UMC Access , 2/151
Material Description	Possible residue around soil pipe within concrete of roof. Note: other soil pipe through ceiling included
Material Comment	See R34777 page 42, Fig 31
Quantity	-
Product Type	-
Current Condition	-
Surface Treatment	-
Asbestos Type	Presumed Amosite & Chrysotile
Material Assessment Rating	-
Accessibility	
Further Comment	Not applicable

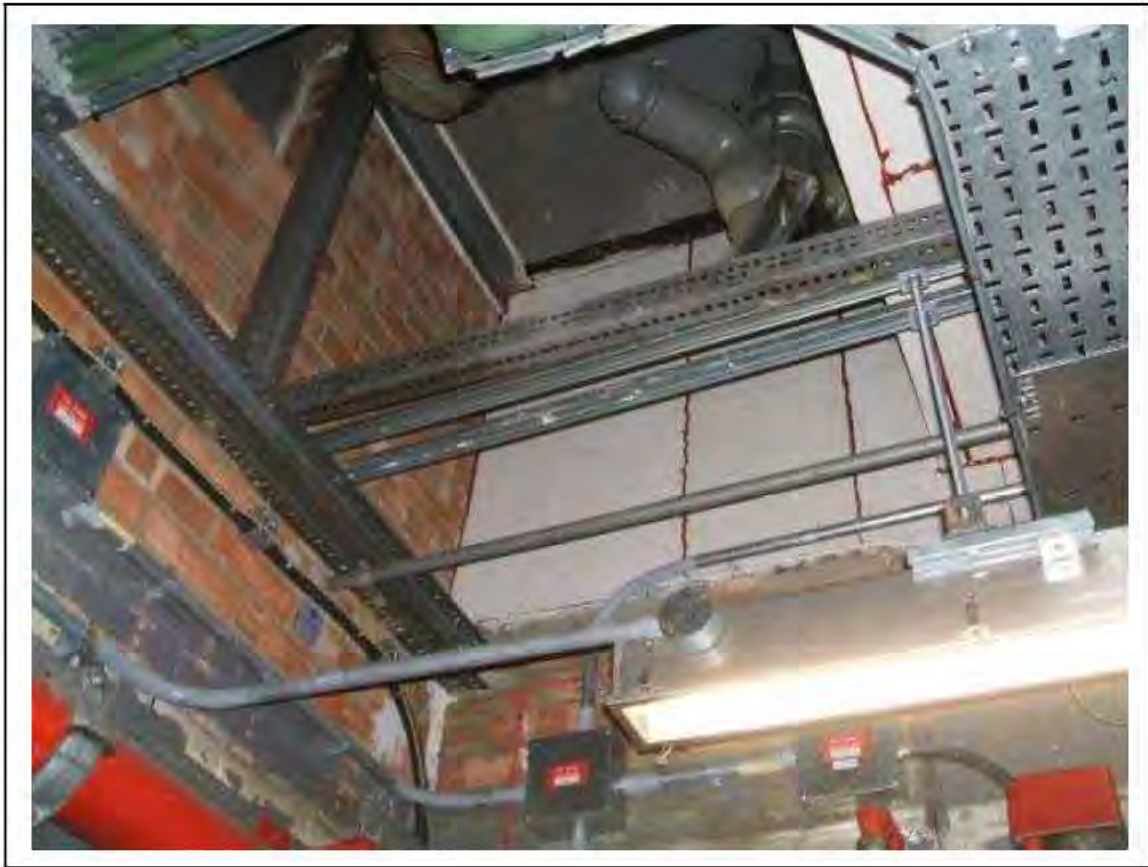
FIGURE 16: PRESUMED ASBESTOS IN RESIDUE WITHIN CAVITY WALL BENEATH BEAM S9 IN UMC ACCESS , 2/151 - DESCRIPTION & RESULT OF ASSESSMENT (SAMPLE REF. P1&2(15))

Possible residue within cavity wall beneath beam S9 presumed to contain Amosite & Chrysotile asbestos, Figure 16

Sample Number	P1&2(15)
Location	UMC Access , 2/151
Material Description	Possible residue within cavity wall beneath beam S9
Material Comment	See R34777 page 41, Fig 41
Quantity	-
Product Type	-
Current Condition	-
Surface Treatment	-
Asbestos Type	Presumed Amosite & Chrysotile
Material Assessment Rating	-
Accessibility	
Further Comment	Not applicable

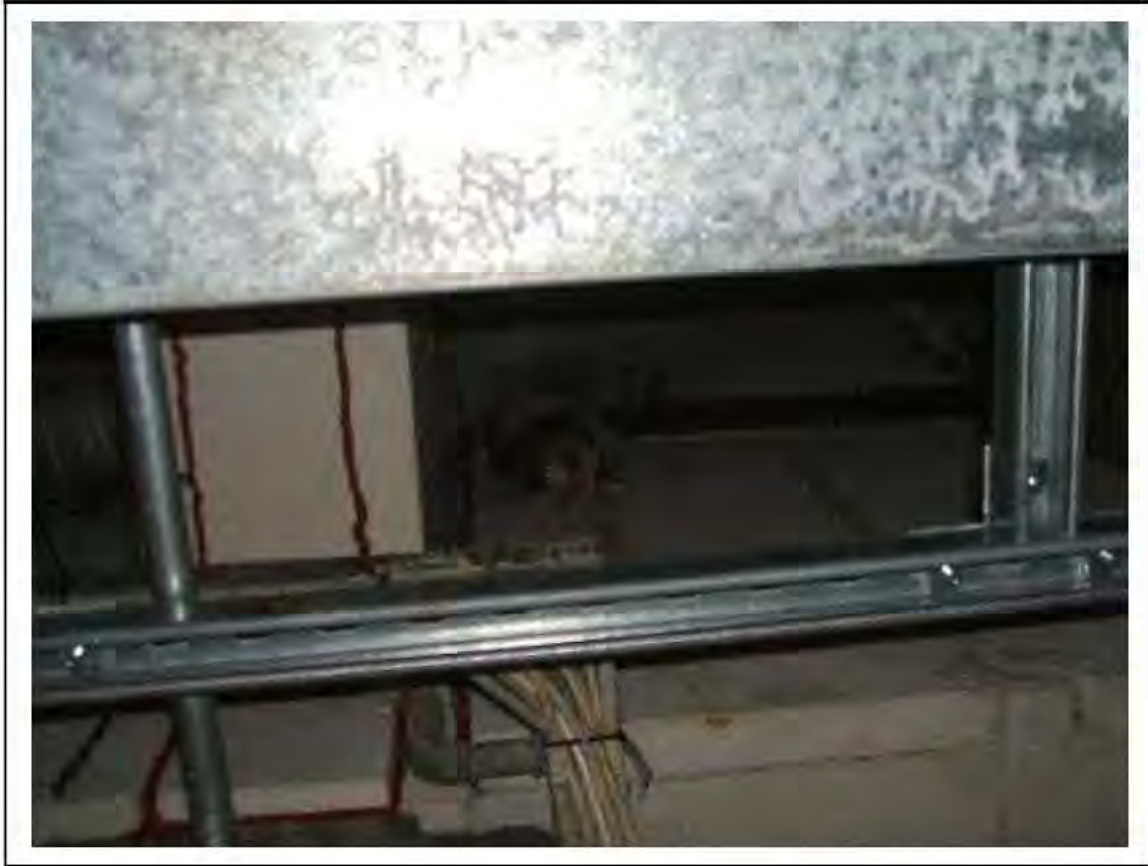
FIGURE 17: PRESUMED ASBESTOS IN RESIDUES WITHIN CONCRETE BY REDUNDANT SOIL PIPE THROUGH CEILING IN UMC ACCESS , 2/151 - DESCRIPTION & RESULT OF ASSESSMENT (SAMPLE REF. P1&2(16))

Possible residues within concrete by redundant soil pipe through ceiling presumed to contain Amosite & Chrysotile asbestos, Figure 17

Sample Number	P1&2(16)
Location	UMC Access , 2/151
Material Description	Possible residues within concrete by redundant soil pipe through ceiling
Material Comment	-
Quantity	-
Product Type	-
Current Condition	-
Surface Treatment	-
Asbestos Type	Presumed Amosite & Chrysotile
Material Assessment Rating	-
Accessibility	-
Further Comment	Not applicable

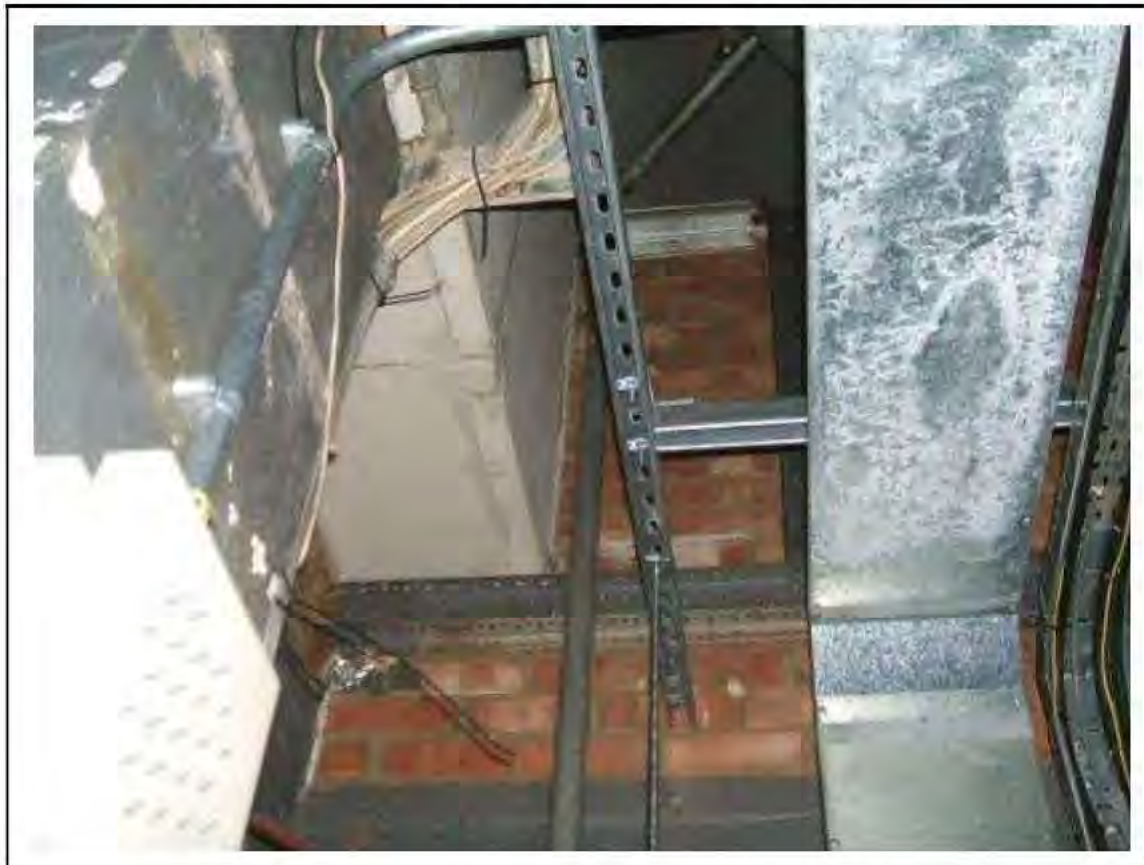
FIGURE 18: PRESUMED ASBESTOS IN RESIDUE BENEATH PAINT WHERE BEAM S10 PASSES INTO WALL IN UMC ACCESS , 2/151 - DESCRIPTION & RESULT OF ASSESSMENT (SAMPLE REF. P1&2(17))

Possible residue beneath paint where beam S10 passes into wall presumed to contain Amosite & Chrysotile asbestos, Figure 18

Sample Number	P1&2(17)
Location	UMC Access , 2/151
Material Description	Possible residue beneath paint where beam S10 (was called SCR) passes into wall now encapsulated
Material Comment	See R34777 Page 46
Quantity	-
Product Type	-
Current Condition	-
Surface Treatment	-
Asbestos Type	Presumed Amosite & Chrysotile
Material Assessment Rating	-
Accessibility	
Further Comment	Not applicable

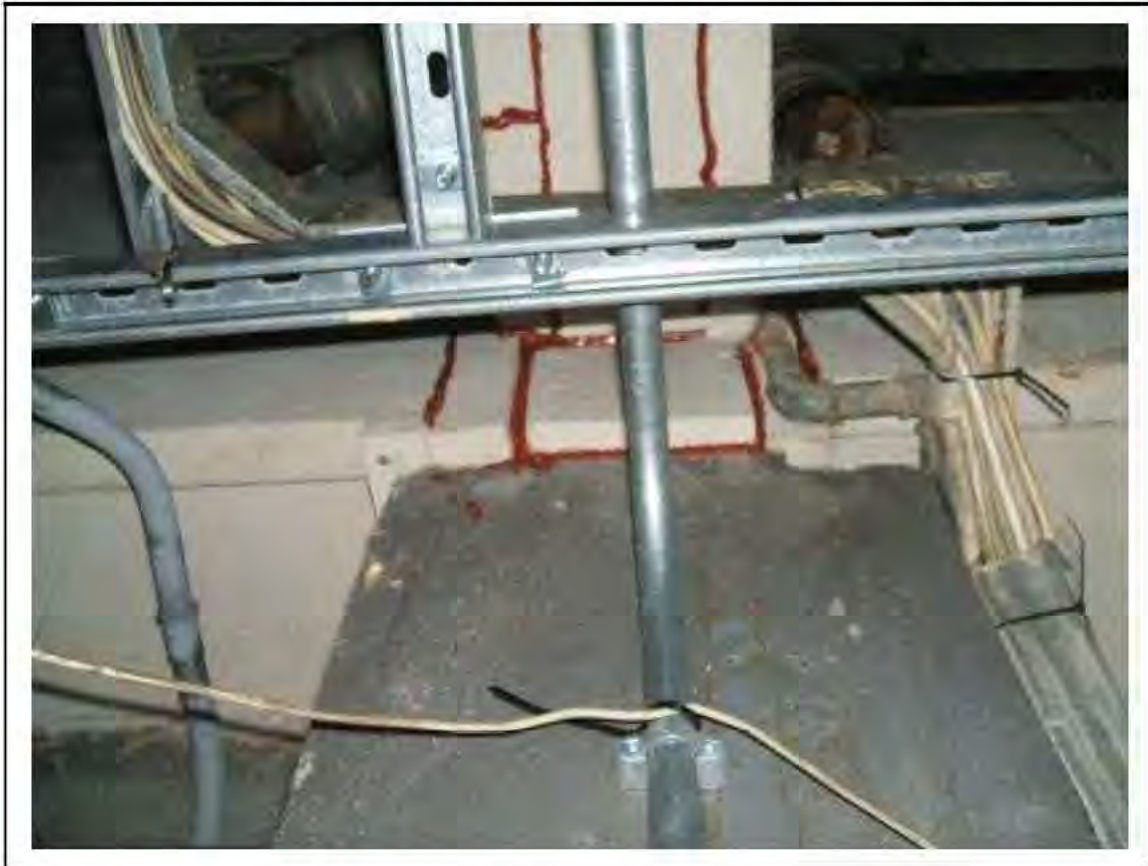
FIGURE 19: PRESUMED ASBESTOS IN RESIDUE REMAINING IN SMALL GAP BETWEEN BEAMS S9 AND S10 AND TOP OF WALL AND VOID OVER ESCALATOR IN UMC ACCESS , 2/151 - DESCRIPTION & RESULT OF ASSESSMENT (SAMPLE REF. P1&2(18))

Possible residue remaining behind cladding in small gap between beams S9 and S10 and top of wall and void over escalator presumed to contain Amosite & Chrysotile asbestos, Figure 19

Sample Number	P1&2(18)
Location	UMC Access , 2/151
Material Description	Possible residue remaining in small gap between beams S9 and S10 and top of wall and void over escalator
Material Comment	See E34777 Page 38
Quantity	-
Product Type	-
Current Condition	-
Surface Treatment	-
Asbestos Type	Presumed Amosite & Chrysotile
Material Assessment Rating	-
Accessibility	
Further Comment	Not applicable

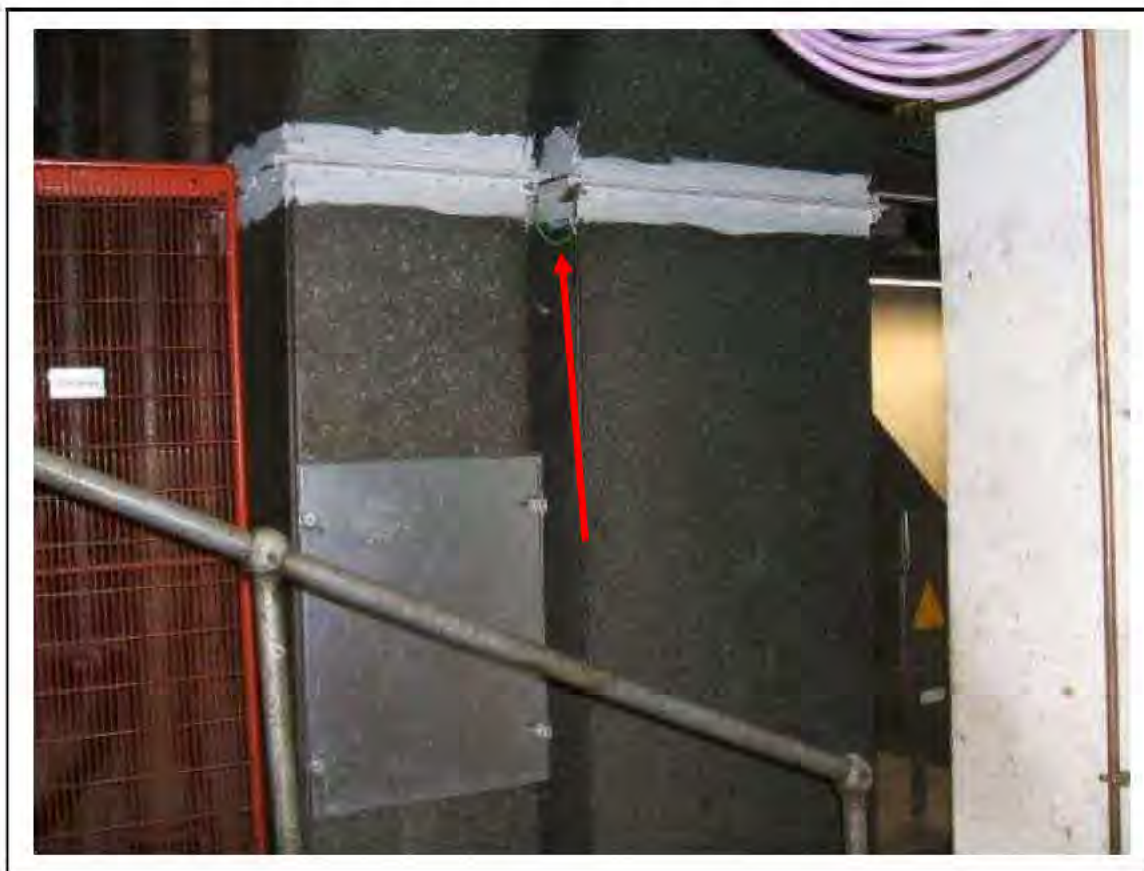
FIGURE 20: KNOWN ASBESTOS IN GASKETS IN UMC, 2/151 - DESCRIPTION & RESULT OF ASSESSMENT (SAMPLE REF. K1(1))

Gaskets known to contain chrysotile asbestos, Figure 20 - Material assessment rating: Low

Sample Number	K1(1)
Location	UMC, 2/151
Material Description	Gaskets
Material Comment	Air conditioning ducts
Quantity	2no 4lm
Product Type	Medium density
Current Condition	Slight damage
Surface Treatment	Encapsulated medium density
Asbestos Type	Known Chrysotile
Material Assessment Rating	Low
Accessibility	Low
Further Comment	Not applicable

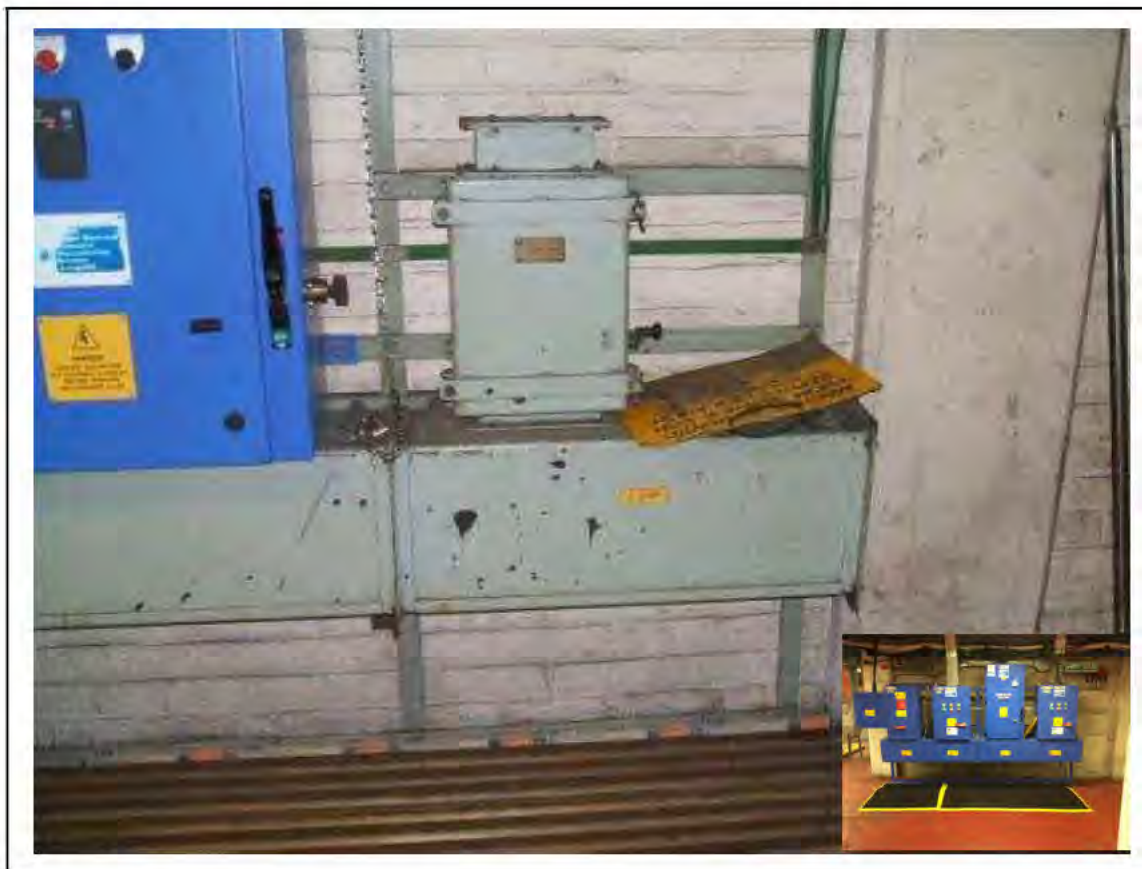
FIGURE 23: PRESUMED ASBESTOS IN AUXILIARY PLANT BOX IN UMC, 2/151 - DESCRIPTION & RESULT OF ASSESSMENT (SAMPLE REF. P1(3))

Auxiliary plant box presumed to contain Chrysotile asbestos, Figure 23

Sample Number	P1(3)
Location	UMC, 2/151
Material Description	Auxiliary plant box
Material Comment	Possible rope, seals and paper within
Quantity	-
Product Type	-
Current Condition	-
Surface Treatment	-
Asbestos Type	Presumed Chrysotile
Material Assessment Rating	-
Accessibility	Low
Further Comment	Not applicable

ACU update
Auxiliary plant box removed

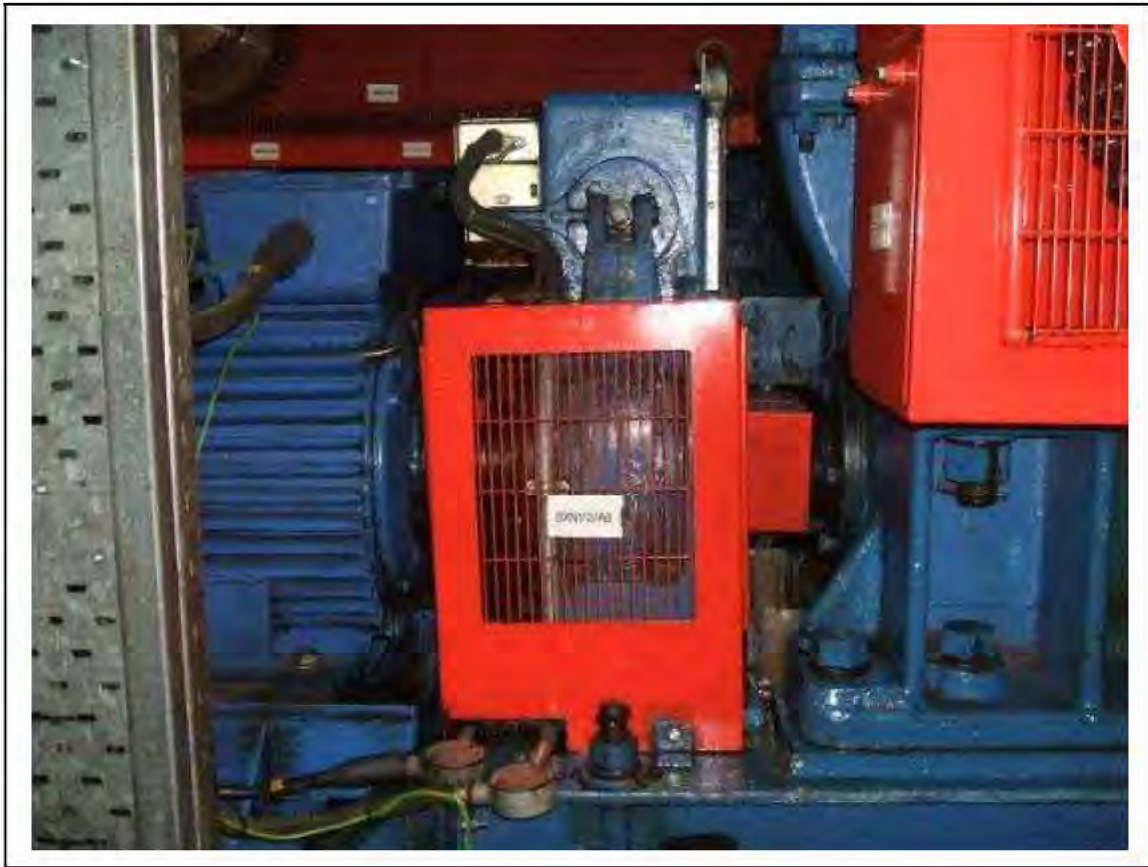
FIGURE 25: PRESUMED ASBESTOS IN BRAKE SHOES NO. 1 & 3 IN UMC, 2/151 - DESCRIPTION & RESULT OF ASSESSMENT (SAMPLE REF. P1(4))

Brake shoes No. 1 & 3 presumed to contain Chrysotile asbestos, Figure 25 - Material assessment rating: Very low

Sample Number	P1(4)
Location	UMC, 2/151
Material Description	Brake shoes No. 1 & 3
Material Comment	Possible asbestos brake shoes
Quantity	2 pairs
Product Type	Composite
Current Condition	Slight damage
Surface Treatment	Composite
Asbestos Type	Presumed Chrysotile
Material Assessment Rating	Very low
Accessibility	Medium
Further Comment	Not applicable

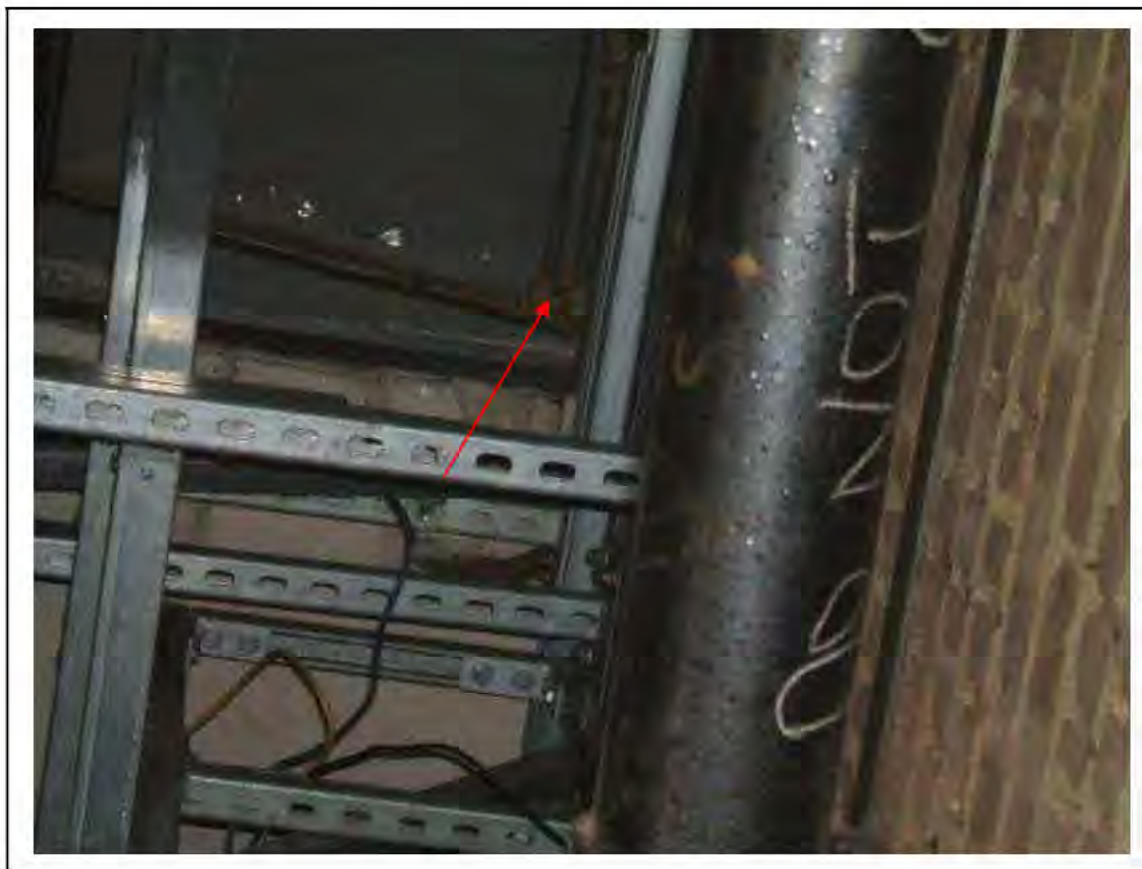
FIGURE 28: PRESUMED ASBESTOS IN RESIDUES BELOW FOAM IN UMC , 2/151 - DESCRIPTION & RESULT OF ASSESSMENT (SAMPLE REF. P1&2(19))

Possible residues below foam presumed to contain Amosite & Chrysotile asbestos, Figure 28

Sample Number	P1&2(19)
Location	UMC , 2/151
Material Description	Possible residues below foam
Material Comment	Foam at high level, near beam, left hand side looking down escalator
Quantity	-
Product Type	-
Current Condition	-
Surface Treatment	-
Asbestos Type	Presumed Amosite and Chrysotile
Material Assessment Rating	-
Accessibility	
Further Comment	Not applicable
