Hazardous Materials - TfL Engineering

Re-inspection Sign-Off for Brixton

Re-inspection Reference: V059/4RS-200403

Station	Brixton
Original Management Survey	R346601
Date of Original Management	31st August 2012
Re-inspection Reference:	V059-4RS-200403
Next Planned Re-inspection	Periodical re-inspection according to HM Management Plan

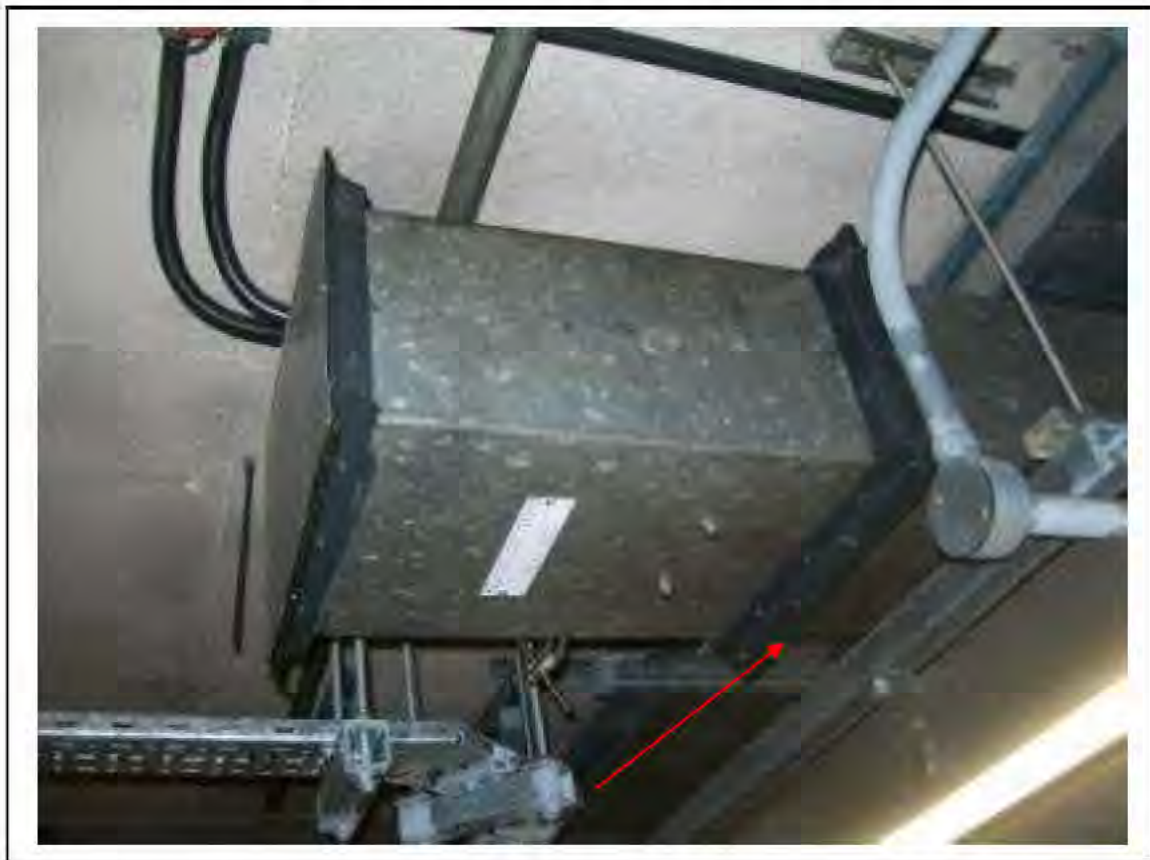
FIGURE 30: KNOWN ASBESTOS IN GASKET IN UMC , 2/151 - DESCRIPTION & RESULT OF ASSESSMENT (SAMPLE REF. K1(4))

Gasket known to contain Chrysotile asbestos, Figure 30 - Material assessment rating: Very low

Sample Number	K1(4)
Location	UMC , 2/151
Material Description	Gasket
Material Comment	Redundant air conditioning duct
Quantity	1m
Product Type	Medium density
Current Condition	Good condition
Surface Treatment	Encapsulated medium density
Asbestos Type	Known Chrysotile
Material Assessment Rating	Very low
Accessibility	Low
Further Comment	Not applicable

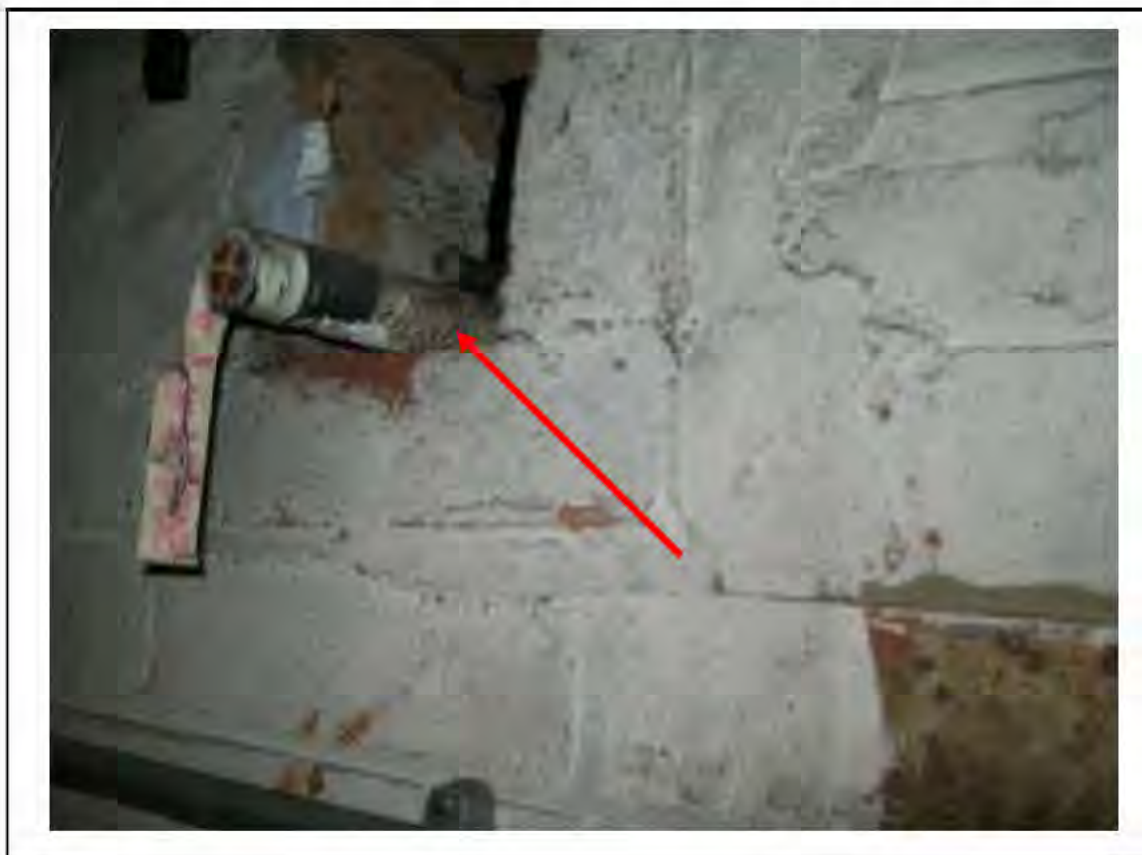
FIGURE 31: KNOWN ASBESTOS IN CABLE BRAIDED IN UMC , 2/151 - DESCRIPTION & RESULT OF ASSESSMENT (SAMPLE REF. K1(5))

Cable braided known to contain Chrysotile asbestos, Figure 31 - Material assessment rating: Very low

Sample Number	K1(5)
Location	UMC , 2/151
Material Description	Cable braided
Material Comment	-
Quantity	1no
Product Type	Medium density
Current Condition	Good condition
Surface Treatment	Encapsulated medium density
Asbestos Type	Known Chrysotile
Material Assessment Rating	Very low
Accessibility	Low
Further Comment	Not applicable

Several asbestos braided cables within the station appear to be redundant – it would be recommended that when opportunity arises these are removed. In particular that in the Escalator Upper Machine Chamber 2/151 (Figure 31) has an exposed cut end. Whilst the asbestos is encapsulated with paint it would be recommended that once confirmed not live or not likely to become live that this end is re-capped.

Whilst the asbestos is encapsulated with paint and the fibres bonded it would be recommended that once confirmed not live or not likely to become live that this end is re – capped as the insulation tape appears to have fallen away.

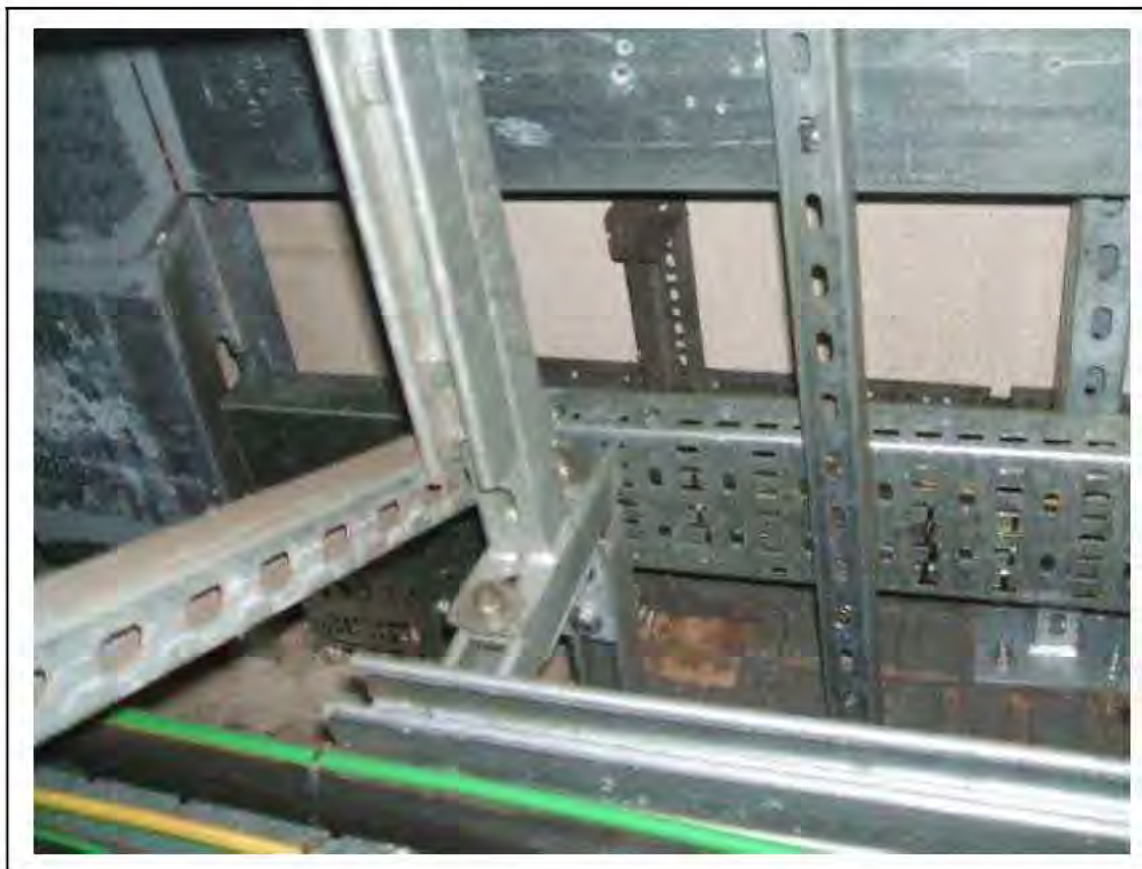
FIGURE 33: PRESUMED ASBESTOS IN RESIDUES WITHIN BOXING TO BEAM IN ESCALATOR INCLINE , 2/171 - DESCRIPTION & RESULT OF ASSESSMENT (SAMPLE REF. P1&2(21))

Possible residues within boxing to beam presumed to contain Amosite & Chrysotile asbestos, Figure 33

Sample Number	P1&2(21)
Location	Escalator Incline , 2/171
Material Description	Possible residues within boxing to beam
Material Comment	Boxing to beam S11, right hand side
Quantity	-
Product Type	-
Current Condition	-
Surface Treatment	-
Asbestos Type	Presumed Amosite & Chrysotile
Material Assessment Rating	-
Accessibility	
Further Comment	Not applicable

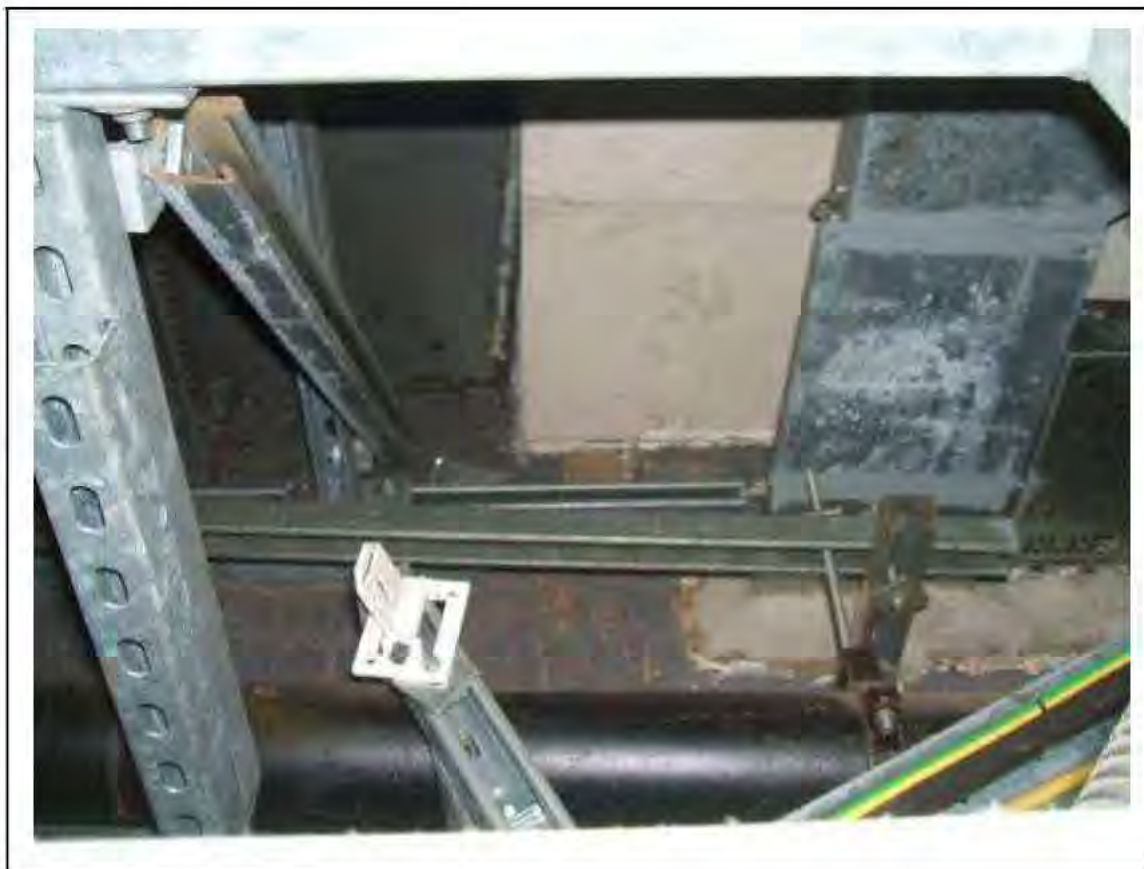
FIGURE 34: PRESUMED ASBESTOS IN RESIDUES BELOW ESCALATOR INCLINE , 2/171 - DESCRIPTION & RESULT OF ASSESSMENT (SAMPLE REF. P1&2(22))

Possible asbestos residues below cladding, boxing to beam S10 left hand side presumed to contain Amosite & Chrysotile asbestos, Figure 34

Sample Number	P1&2(22)
Location	Escalator Incline , 2/171
Material Description	Possible asbestos residues below cladding
Material Comment	Boxing to beam S10, right hand side
Quantity	-
Product Type	-
Current Condition	-
Surface Treatment	-
Asbestos Type	Presumed Amosite & Chrysotile
Material Assessment Rating	-
Accessibility	
Further Comment	Not applicable

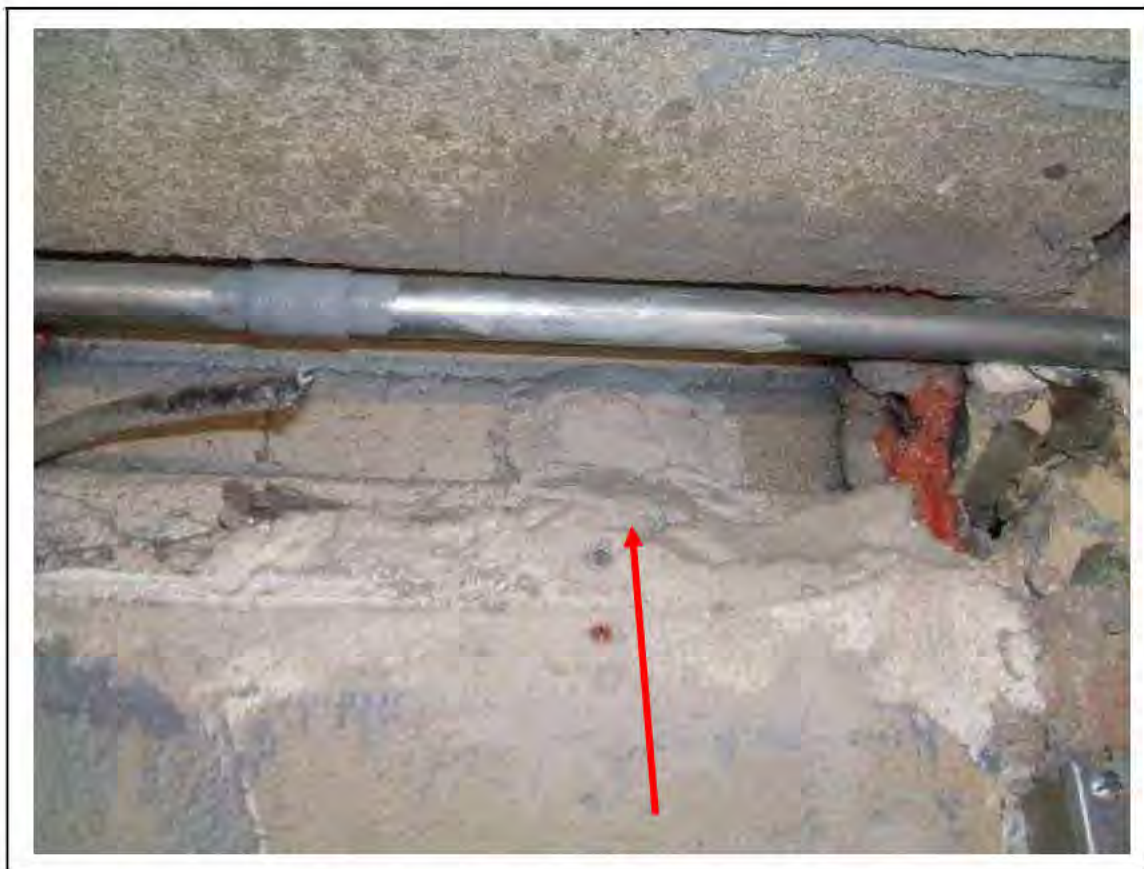
FIGURE 39: PRESUMED ASBESTOS BEHIND RENDER ON BRICK WALL IN PASSAGE , 2/238 - DESCRIPTION & RESULT OF ASSESSMENT (SAMPLE REF. P1&2(26))

Render on brick internal false wall possible residues behind presumed to contain Amosite and Chrysotile asbestos, Figure 39

Sample Number	P1&2(26)
Location	Passage , 2/238
Material Description	Render on brick wall possible residues behind in cavity
Material Comment	Wall 6 (Note: asbestos residue behind in cavity)
Quantity	-
Product Type	-
Current Condition	-
Surface Treatment	-
Asbestos Type	Presumed Amosite and Chrysotile
Material Assessment Rating	-
Accessibility	
Further Comment	Not applicable

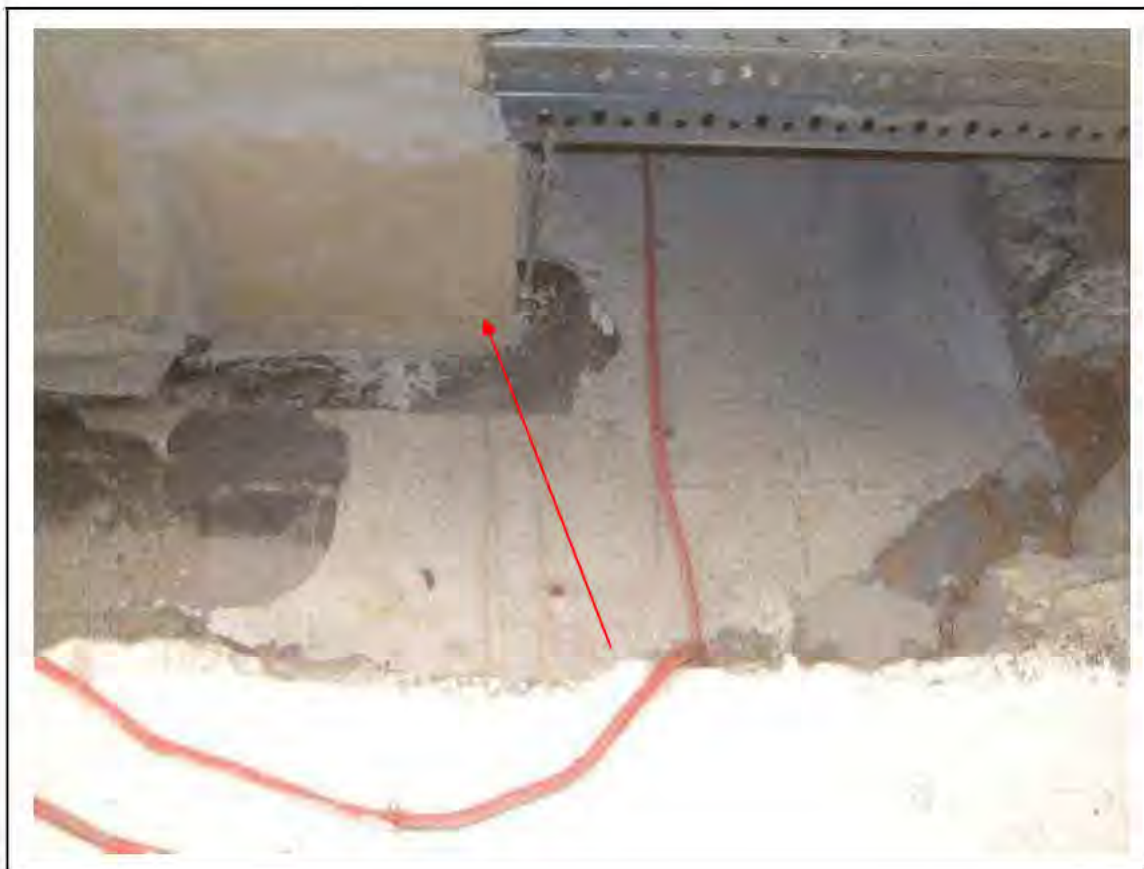
FIGURE 40: PRESUMED ASBESTOS IN BEAM VERMICULITE CLAD IN PASSAGE , 2/238 - DESCRIPTION & RESULT OF ASSESSMENT (SAMPLE REF. P1&2(27))

Beam vermiculite clad presumed to contain Amosite and Chrysotile asbestos below cladding, Figure 40

Sample Number	P1&2(27)
Location	Passage , 2/238
Material Description	Beam vermiculite clad
Material Comment	Possible asbestos residues where beam goes into walls and below vermiculite
Quantity	-
Product Type	-
Current Condition	-
Surface Treatment	-
Asbestos Type	Presumed Amosite and Chrysotile
Material Assessment Rating	-
Accessibility	
Further Comment	Not applicable

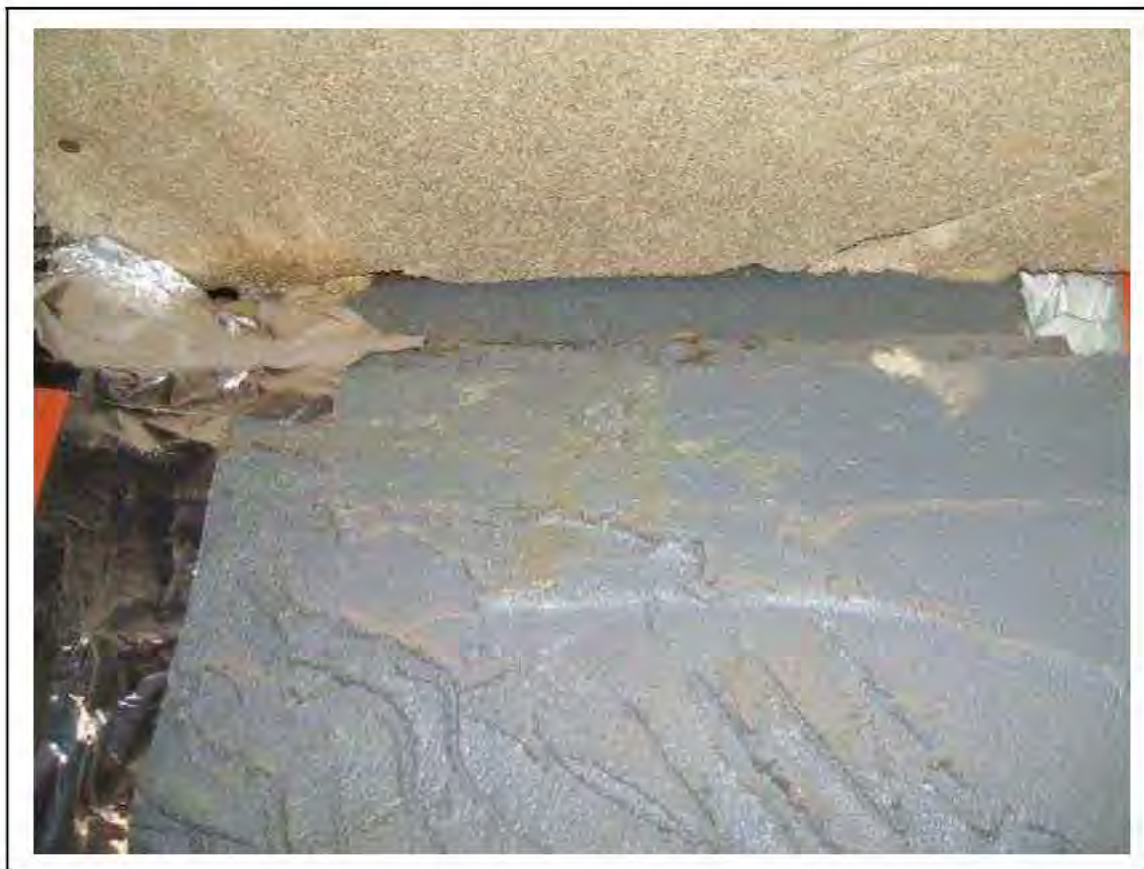
FIGURE 43: PRESUMED ASBESTOS IN BEAM FIBREBOARD CLAD OVER 2/661, 2662 AND IN PASSAGE , 2/238 - DESCRIPTION & RESULT OF ASSESSMENT (SAMPLE REF. P1&2(30))

Beam over 2/661, 2/662 presumed to contain Amosite and Chrysotile asbestos below cladding, Figure 43

Sample Number	P1&2(30)
Location	Passage , 2/238
Material Description	Beam fibreboard clad over 2/661, 2662 and
Material Comment	Asbestos residue debris below Vermiculite
Quantity	-
Product Type	-
Current Condition	-
Surface Treatment	-
Asbestos Type	Presumed Amosite and Chrysotile
Material Assessment Rating	-
Accessibility	
Further Comment	Close up view of beam on column support

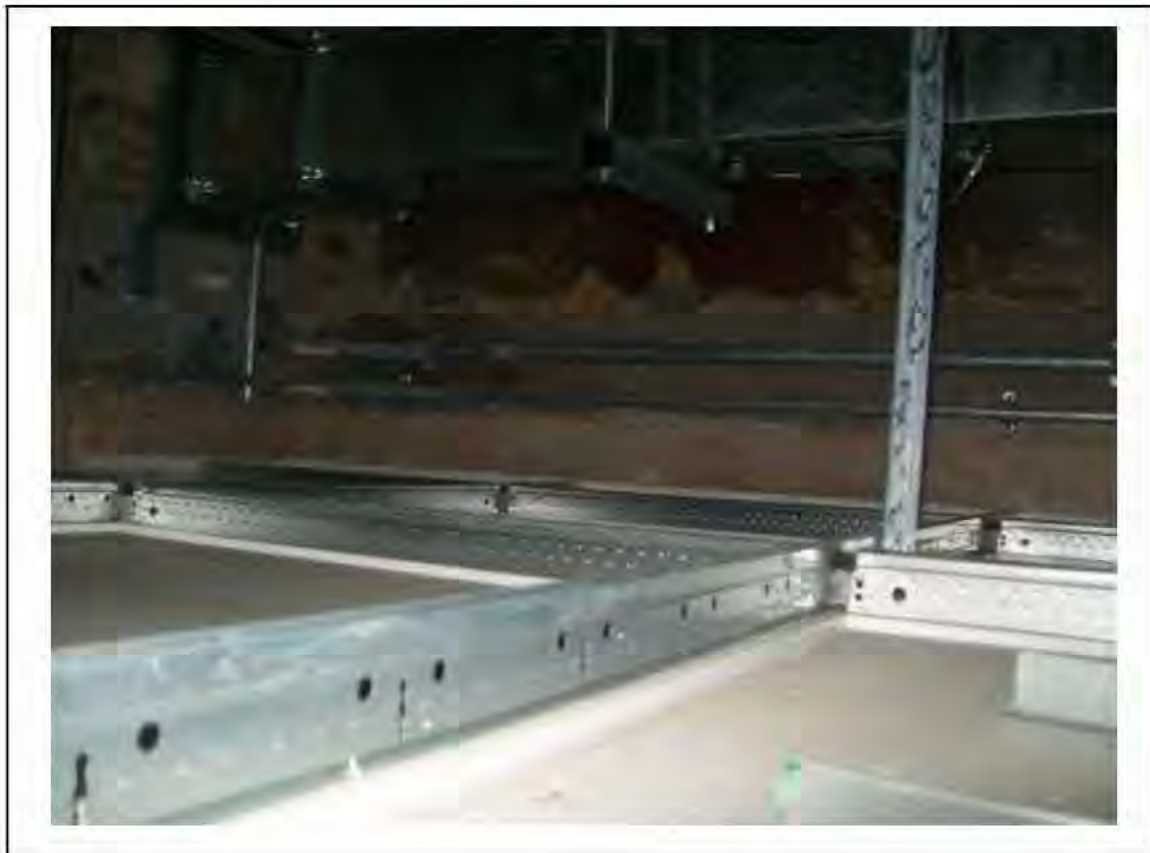
FIGURE 46: PRESUMED ASBESTOS IN RESIDUES WITHIN CALL CAVITY IN MESS ROOM / LOCKER ROOM, 2/281 - DESCRIPTION & RESULT OF ASSESSMENT (SAMPLE REF. P1&2(33))

Residues may be present within wall cavity behind internal false wall presumed to contain Amosite & Chrysotile asbestos, Figure 46

Sample Number	P1&2(33)
Location	Mess Room / Locker Room, 2/281
Material Description	Residues may be present within wall cavity
Material Comment	To external wall behind inner wall (wall 2)
Quantity	-
Product Type	-
Current Condition	-
Surface Treatment	-
Asbestos Type	Presumed Amosite & Chrysotile
Material Assessment Rating	-
Accessibility	
Further Comment	Not applicable

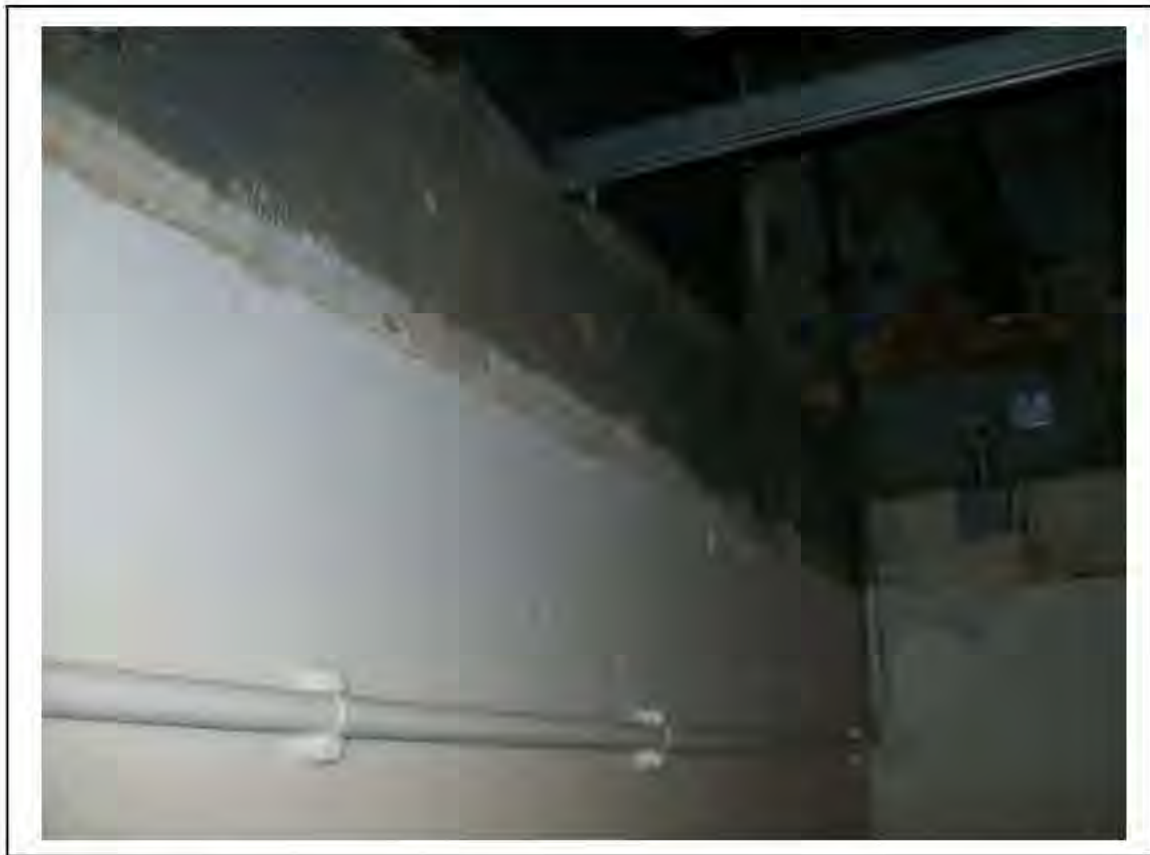
FIGURE 48: PRESUMED ASBESTOS IN RESIDUAL SPRAY INSULATION WITHIN CAVITY IN SVC, 2/401 - DESCRIPTION & RESULT OF ASSESSMENT (SAMPLE REF. P1&2(34))

Residual spray insulation within cavity behind internal false wall presumed to contain Amosite & Chrysotile asbestos, Figure 48

Sample Number	P1&2(34)
Location	SVC, 2/401
Material Description	Residual spray insulation within cavity
Material Comment	Within cavity behind inner external wall
Quantity	-
Product Type	-
Current Condition	-
Surface Treatment	-
Asbestos Type	Presumed Amosite & Chrysotile
Material Assessment Rating	-
Accessibility	
Further Comment	Not applicable

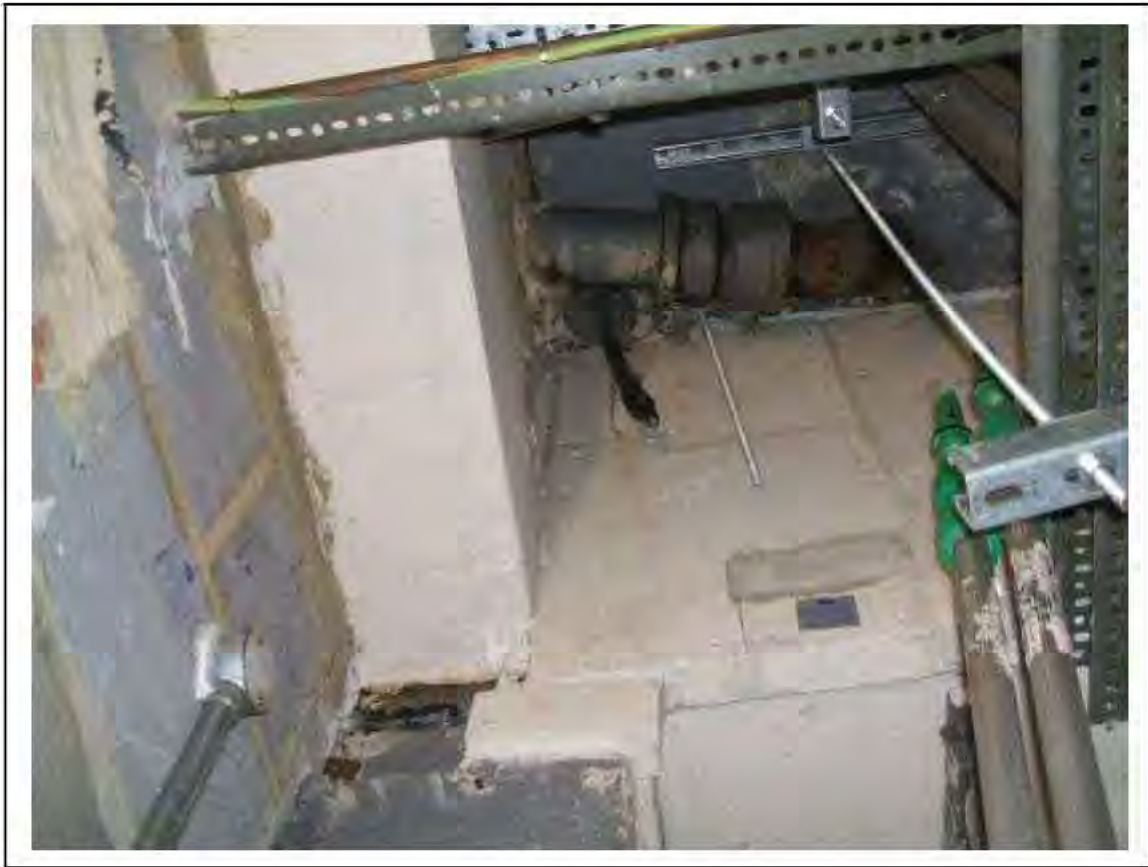
FIGURE 49: PRESUMED ASBESTOS IN RESIDUES WHERE PIPE GOES THROUGH THE CEILING S10 IN STORE, 2/407 - DESCRIPTION & RESULT OF ASSESSMENT (SAMPLE REF. P1&2(35))

Possible residues where pipe goes through the ceiling by S10 presumed to contain Amosite & Chrysotile asbestos, Figure 49

Sample Number	P1&2(35)
Location	Store, 2/407
Material Description	Possible residues where pipe goes through the ceiling S10
Material Comment	See R34777, Fig 34
Quantity	-
Product Type	-
Current Condition	-
Surface Treatment	-
Asbestos Type	Presumed Amosite & Chrysotile
Material Assessment Rating	-
Accessibility	
Further Comment	Not applicable

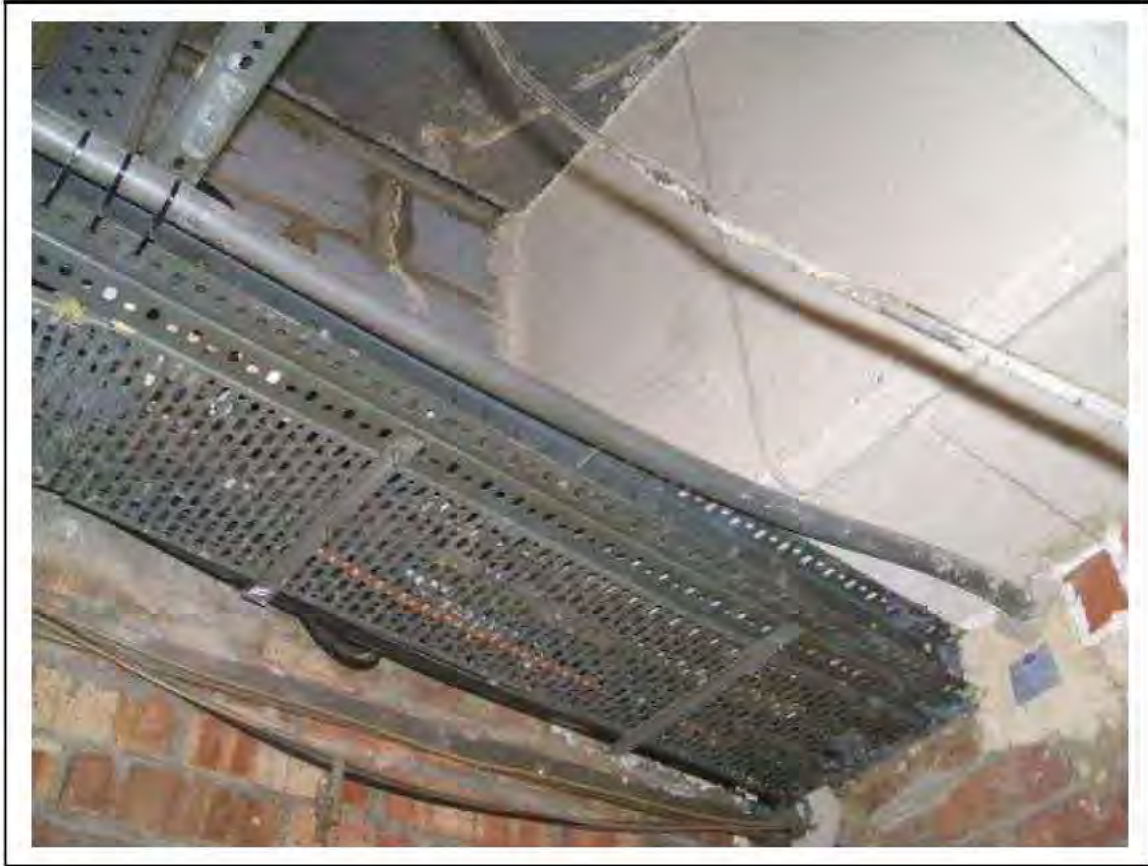
FIGURE 50: PRESUMED ASBESTOS IN RESIDUE IN WALL BETWEEN 2/407 AND ESCALATOR INCLINE 2/171 IN STORE, 2/407 - DESCRIPTION & RESULT OF ASSESSMENT (SAMPLE REF. P1&2(36))

Possible asbestos residue in wall between 2/407 and escalator incline 2/171 presumed to contain Amosite & Chrysotile asbestos where beams S9 and S10 pass through wall, Figure 50

Sample Number	P1&2(36)
Location	Store, 2/407
Material Description	Possible asbestos residue in wall between 2/407 and escalator incline 2/171
Material Comment	To beams S10 & S9
Quantity	-
Product Type	-
Current Condition	-
Surface Treatment	-
Asbestos Type	Presumed Amosite & Chrysotile
Material Assessment Rating	-
Accessibility	
Further Comment	Not applicable

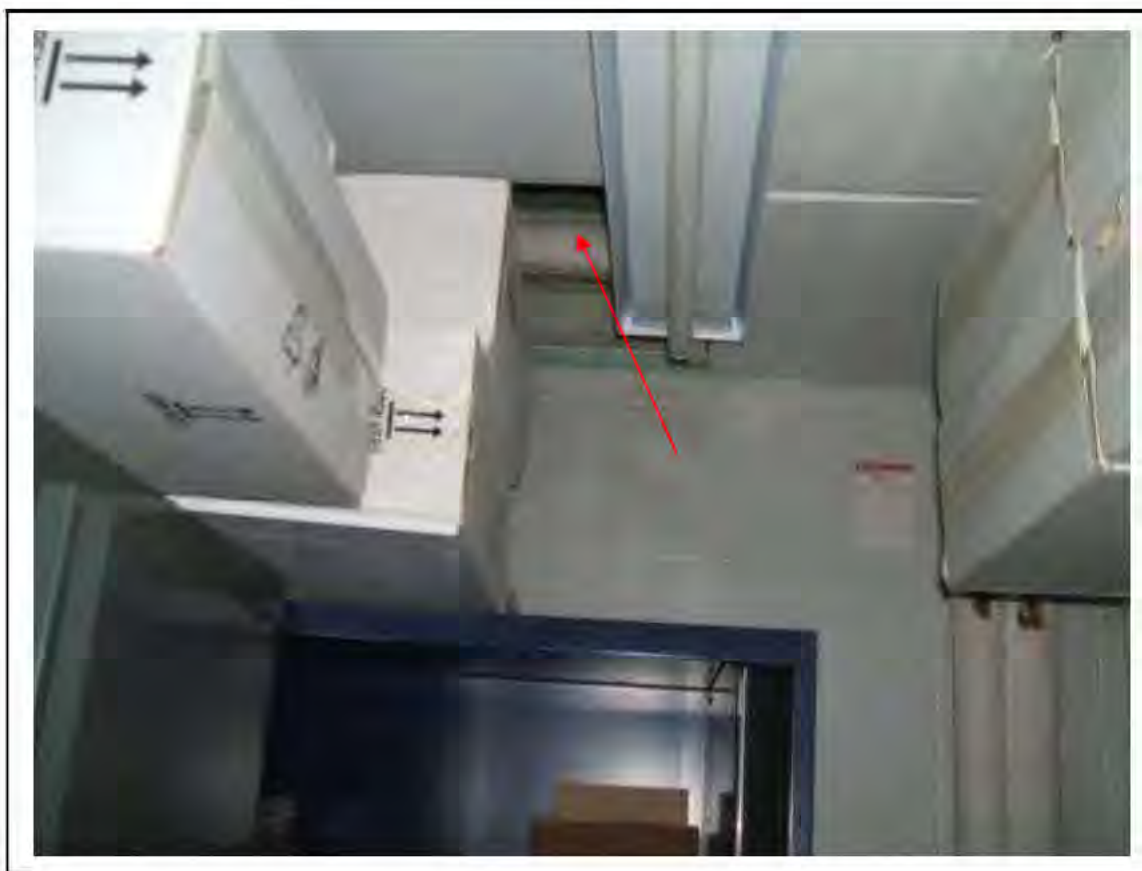
FIGURE 51: PRESUMED ASBESTOS IN RESIDUES TO CAVITY IN STORE , 2/413 - DESCRIPTION & RESULT OF ASSESSMENT (SAMPLE REF. P1&2(37))

Possible residues to cavity behind internal false wall presumed to contain Amosite & Chrysotile asbestos, Figure 51

Sample Number	P1&2(37)
Location	Store , 2/413
Material Description	Possible residues to cavity
Material Comment	Behind external inner wall, wall 2
Quantity	-
Product Type	-
Current Condition	-
Surface Treatment	-
Asbestos Type	Presumed Amosite & Chrysotile
Material Assessment Rating	-
Accessibility	
Further Comment	Not applicable

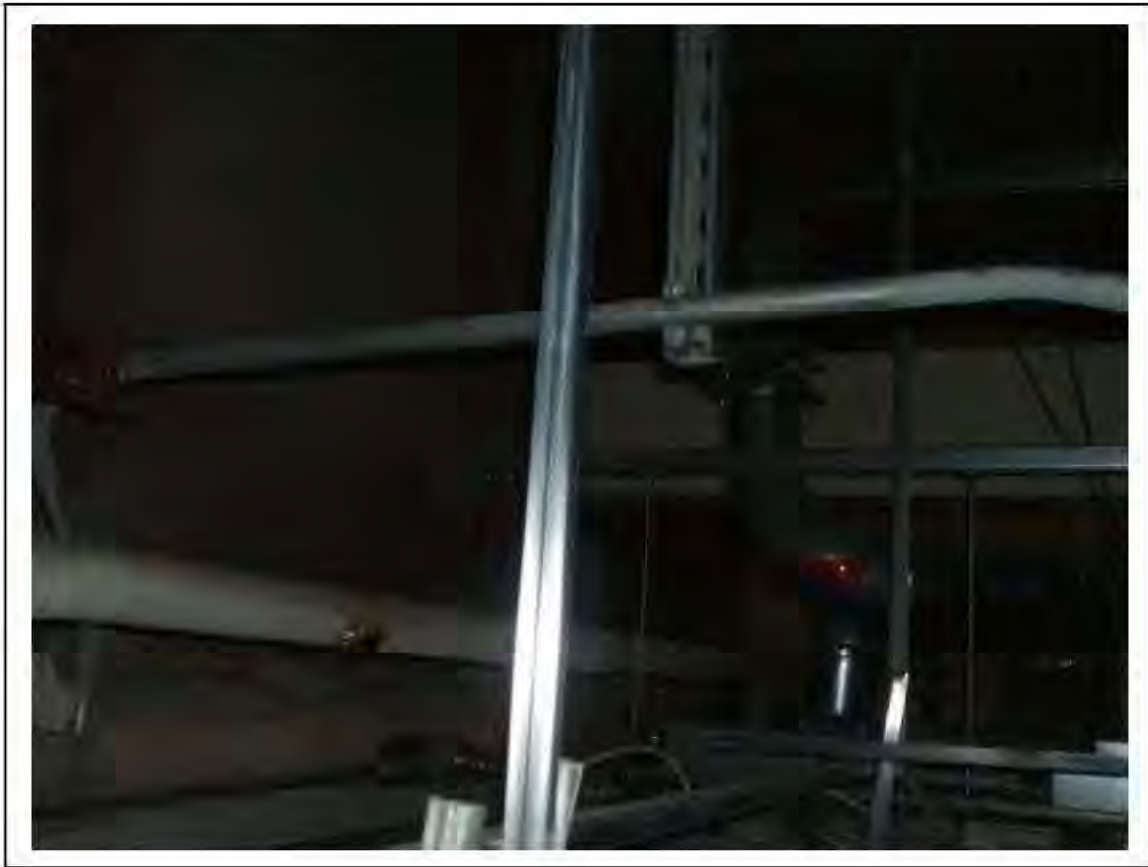
FIGURE 54: PRESUMED ASBESTOS IN RESIDUES IN MALE W/C, 2/417 - DESCRIPTION & RESULT OF ASSESSMENT (SAMPLE REF. P1&2(40))

Possible residues where small beam passes into the walls presumed to contain Amosite & Chrysotile asbestos, Figure 54

Sample Number	P1&2(40)
Location	Male W/C, 2/417
Material Description	Possible residues
Material Comment	Small beam where it goes into rear wall to back wall
Quantity	-
Product Type	-
Current Condition	-
Surface Treatment	-
Asbestos Type	Presumed Amosite & Chrysotile
Material Assessment Rating	-
Accessibility	
Further Comment	Not applicable

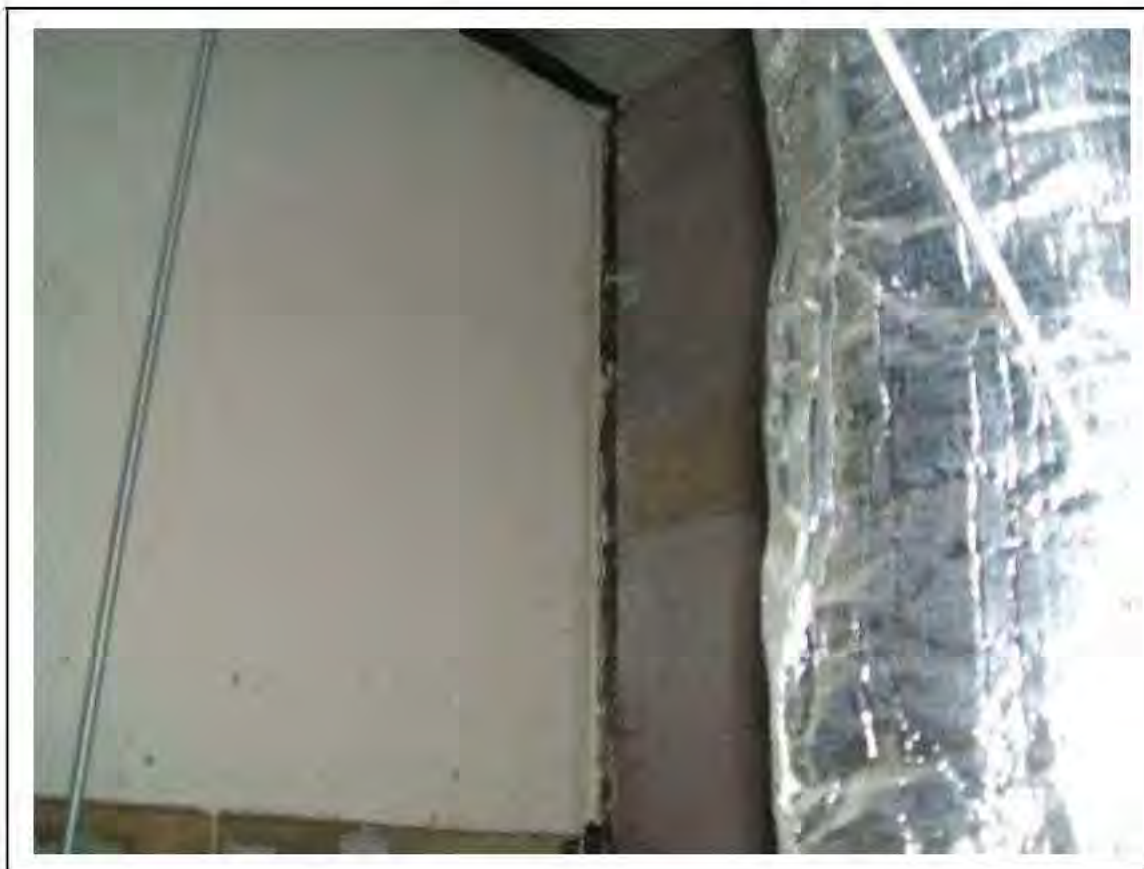
FIGURE 56: PRESUMED ASBESTOS IN RESIDUES IN MALE W/C, 2/417 - DESCRIPTION & RESULT OF ASSESSMENT (SAMPLE REF. P1&2(42))

Possible residues within cavity behind the internal false wall presumed to contain Amosite & Chrysotile asbestos, Figure 56

Sample Number	P1&2(42)
Location	Male W/C, 2/417
Material Description	Possible residues
Material Comment	Behind inner wall in cavity to external wall
Quantity	-
Product Type	-
Current Condition	-
Surface Treatment	-
Asbestos Type	Presumed Amosite & Chrysotile
Material Assessment Rating	-
Accessibility	
Further Comment	Not applicable

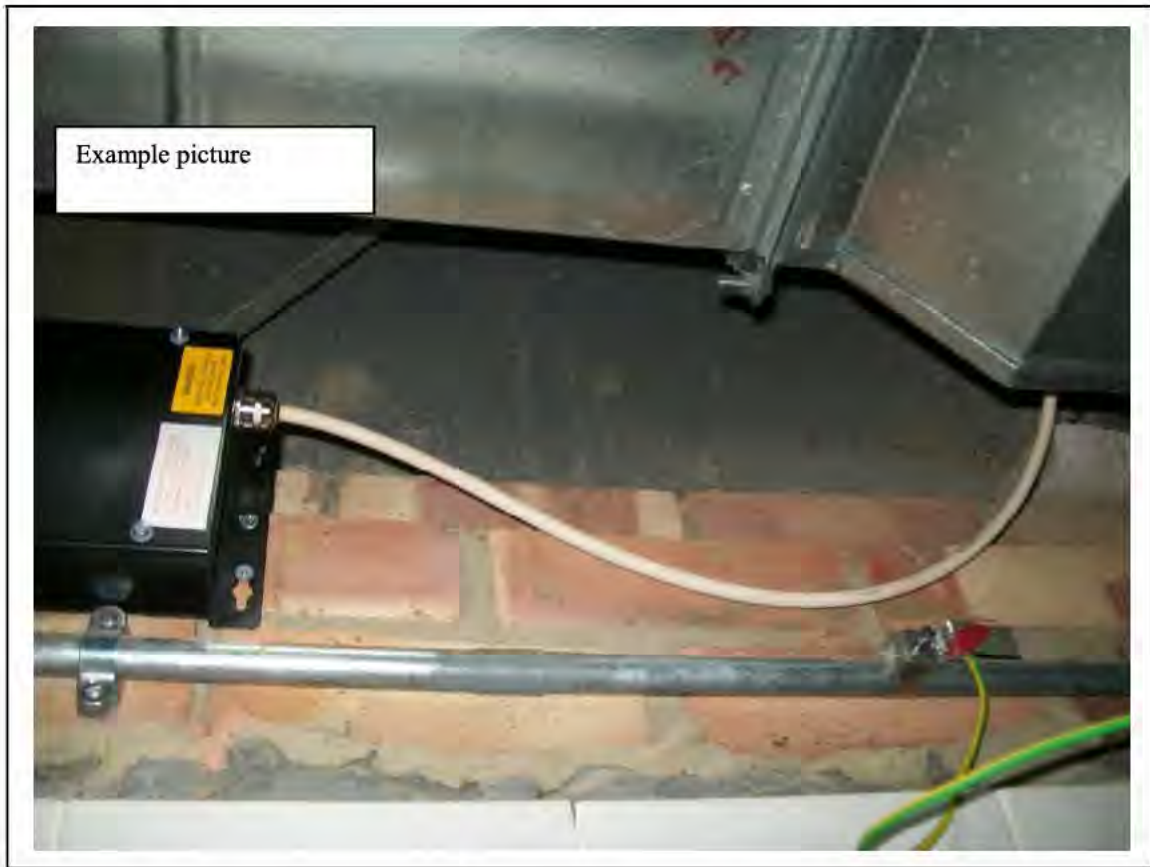
FIGURE 57: PRESUMED ASBESTOS IN RESIDUAL SPRAY INSULATION IN WALL CAVITY IN OFFICE , 2/418 - DESCRIPTION & RESULT OF ASSESSMENT (SAMPLE REF. P1&2(43))

Residual spray insulation in wall cavity presumed to contain Amosite & Chrysotile asbestos, Figure 57

Sample Number	P1&2(43)
Location	Office , 2/418
Material Description	Residual spray insulation in wall cavity
Material Comment	Within wall cavity between inner and external wall (wall 2)
Quantity	-
Product Type	-
Current Condition	-
Surface Treatment	-
Asbestos Type	Presumed Amosite & Chrysotile
Material Assessment Rating	-
Accessibility	
Further Comment	Not applicable

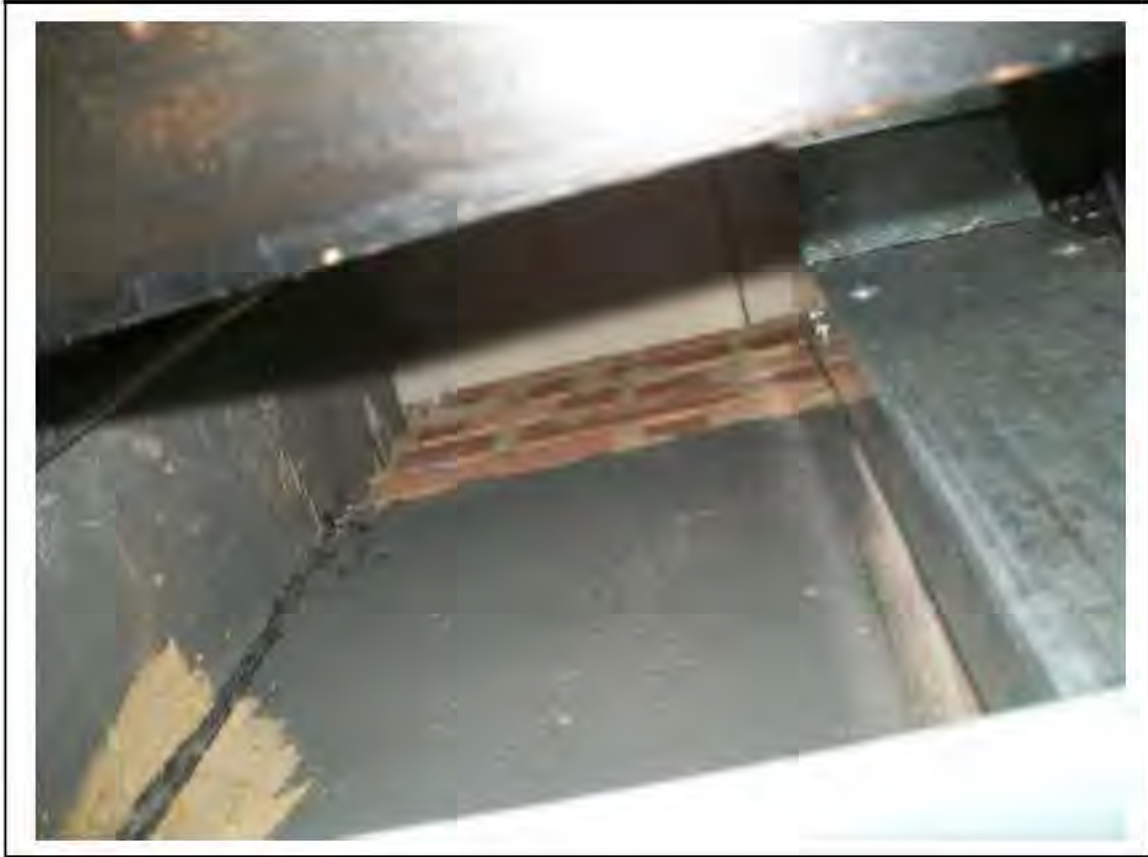
FIGURE 59: PRESUMED ASBESTOS IN POSSIBLE RESIDUES ABOVE SUPALUX PANEL TO CEILING IN SWITCH ROOM , 2/663 - DESCRIPTION & RESULT OF ASSESSMENT (SAMPLE REF. P1&2(44))

Possible residues above supalux panel to ceiling presumed to contain Amosite & Chrysotile asbestos, Figure 59

Sample Number	P1&2(44)
Location	Switch Room , 2/663
Material Description	Possible residues above supalux panel to ceiling
Material Comment	Above supalux panel to ceiling
Quantity	-
Product Type	-
Current Condition	-
Surface Treatment	-
Asbestos Type	Presumed Amosite & Chrysotile
Material Assessment Rating	-
Accessibility	
Further Comment	Not applicable

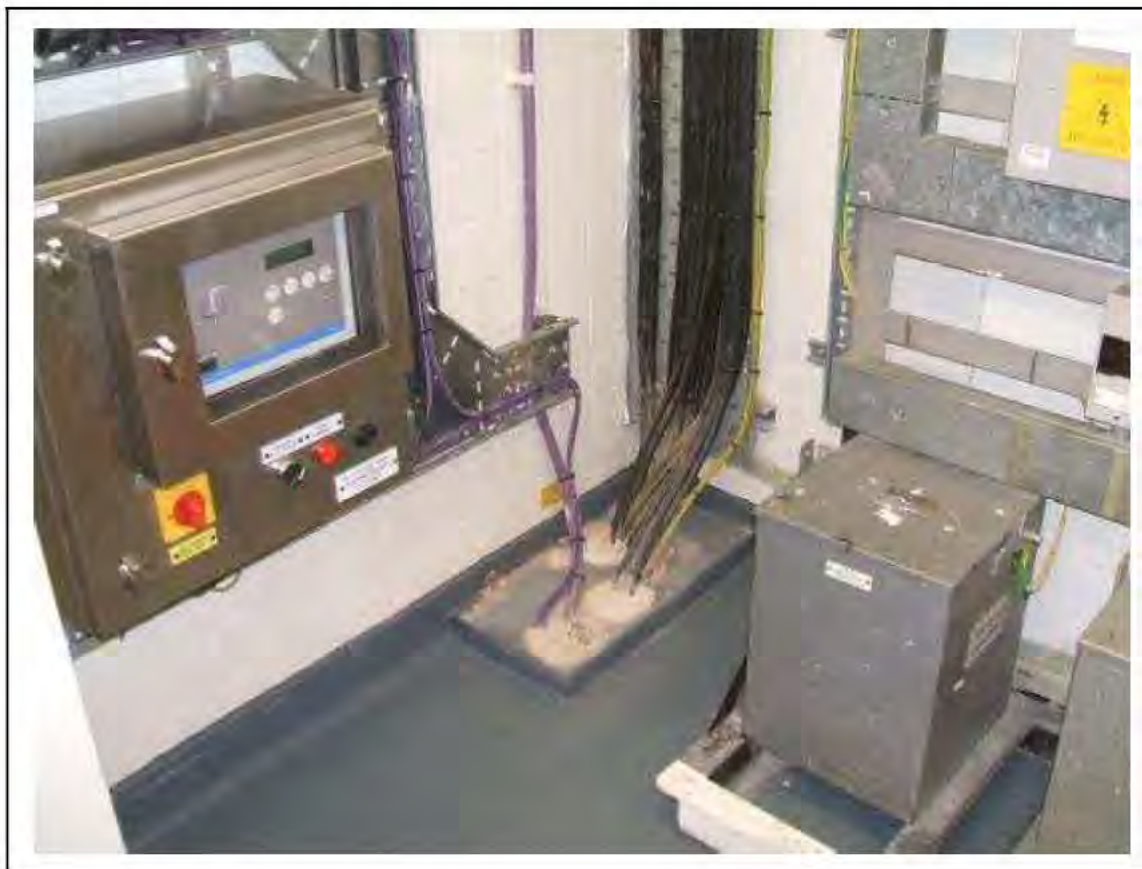
FIGURE 60: PRESUMED ASBESTOS IN CEMENT DUCTS IN SWITCH ROOM E7, 2/667 - DESCRIPTION & RESULT OF ASSESSMENT (SAMPLE REF. P1(7))

Possible cement ducts presumed to contain Chrysotile asbestos, Figure 60

Sample Number	P1(7)
Location	Switch Room E7, 2/667
Material Description	Possible cement ducts
Material Comment	Below floor on wall 8
Quantity	-
Product Type	-
Current Condition	-
Surface Treatment	-
Asbestos Type	Presumed Chrysotile
Material Assessment Rating	-
Accessibility	
Further Comment	Not applicable

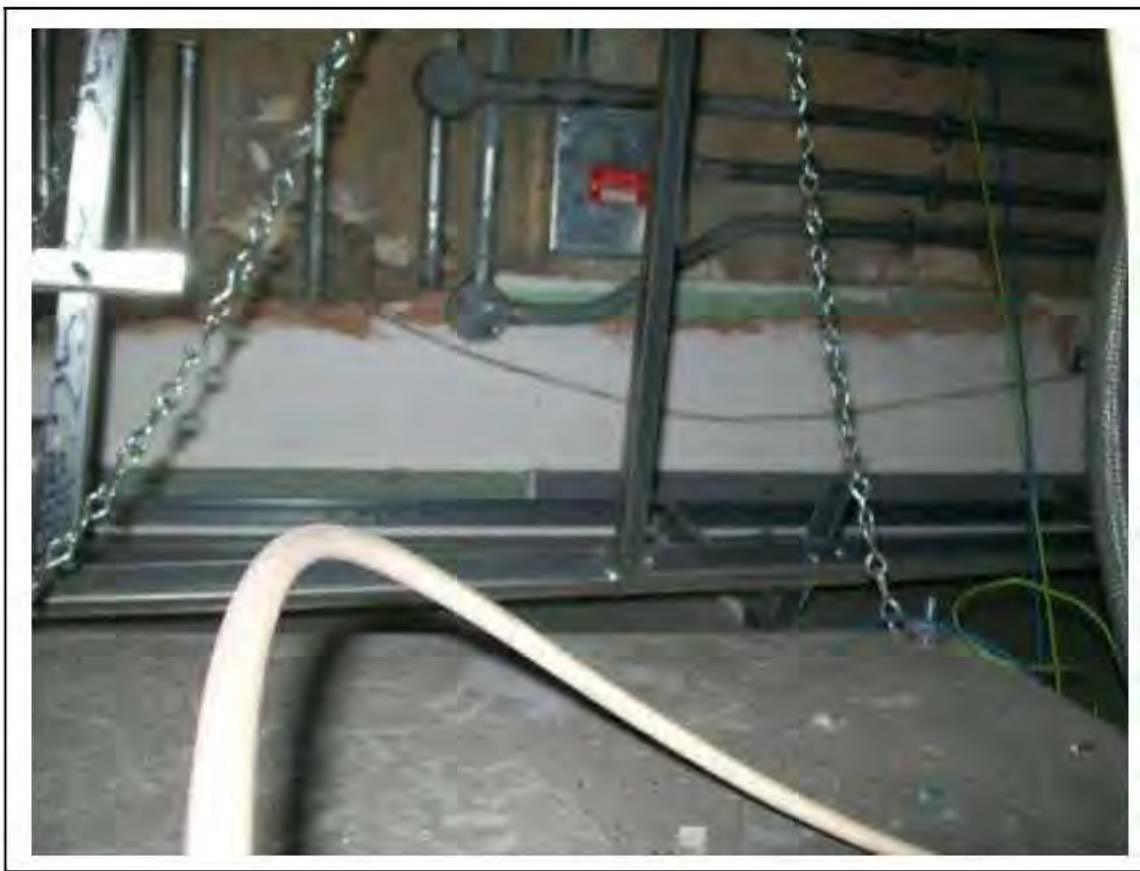
FIGURE 61: PRESUMED ASBESTOS IN RESIDUES WITHIN WALL CAVITY IN OFFICE , 2/801 - DESCRIPTION & RESULT OF ASSESSMENT (SAMPLE REF. P1&2(45))

Residues within wall cavity presumed to contain Amosite & Chrysotile asbestos, Figure 61

Sample Number	P1&2(45)
Location	Office , 2/801
Material Description	Residues within wall cavity
Material Comment	To external walls behind the inner wall, to wall 3
Quantity	-
Product Type	-
Current Condition	-
Surface Treatment	-
Asbestos Type	Presumed Amosite & Chrysotile
Material Assessment Rating	-
Accessibility	
Further Comment	Not applicable

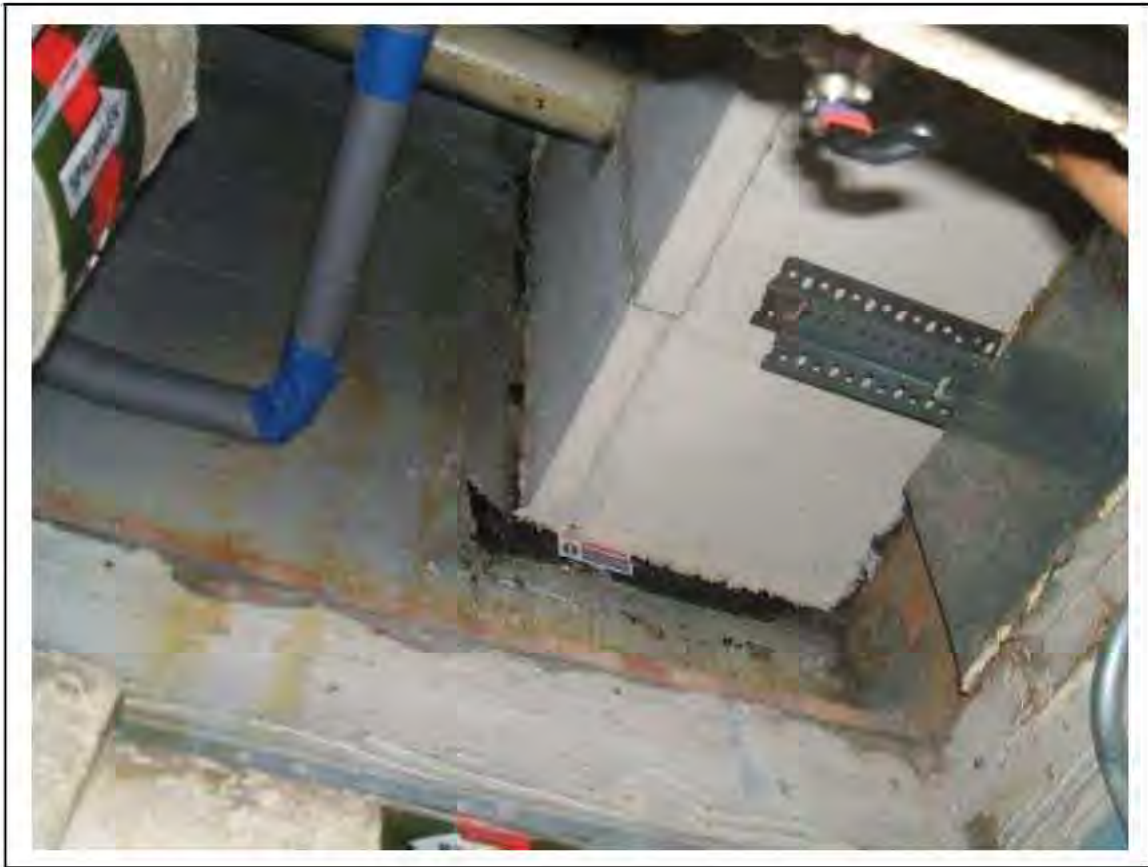
FIGURE 62: PRESUMED ASBESTOS IN RESIDUES WHERE BEAM ENTERS EXTERNAL WALL IN SERVICE VOID , 2/901 - DESCRIPTION & RESULT OF ASSESSMENT (SAMPLE REF. P1&2(46))

Possible residues where beam enters external wall presumed to contain Amosite & Chrysotile asbestos, Figure 62

Sample Number	P1&2(46)
Location	Service Void , 2/901
Material Description	Possible residues where beam enters external wall
Material Comment	Residual spray coating
Quantity	-
Product Type	-
Current Condition	-
Surface Treatment	-
Asbestos Type	Presumed Amosite & Chrysotile
Material Assessment Rating	-
Accessibility	
Further Comment	Not applicable
