Hazardous Materials - TfL Engineering

Re-inspection Sign-Off for Brixton

Re-inspection Reference: V059/4RS-200403

Station	Brixton
Original Management Survey	R346601
Date of Original Management	31st August 2012
Re-inspection Reference:	V059-4RS-200403
Next Planned Re-inspection	Periodical re-inspection according to HM Management Plan

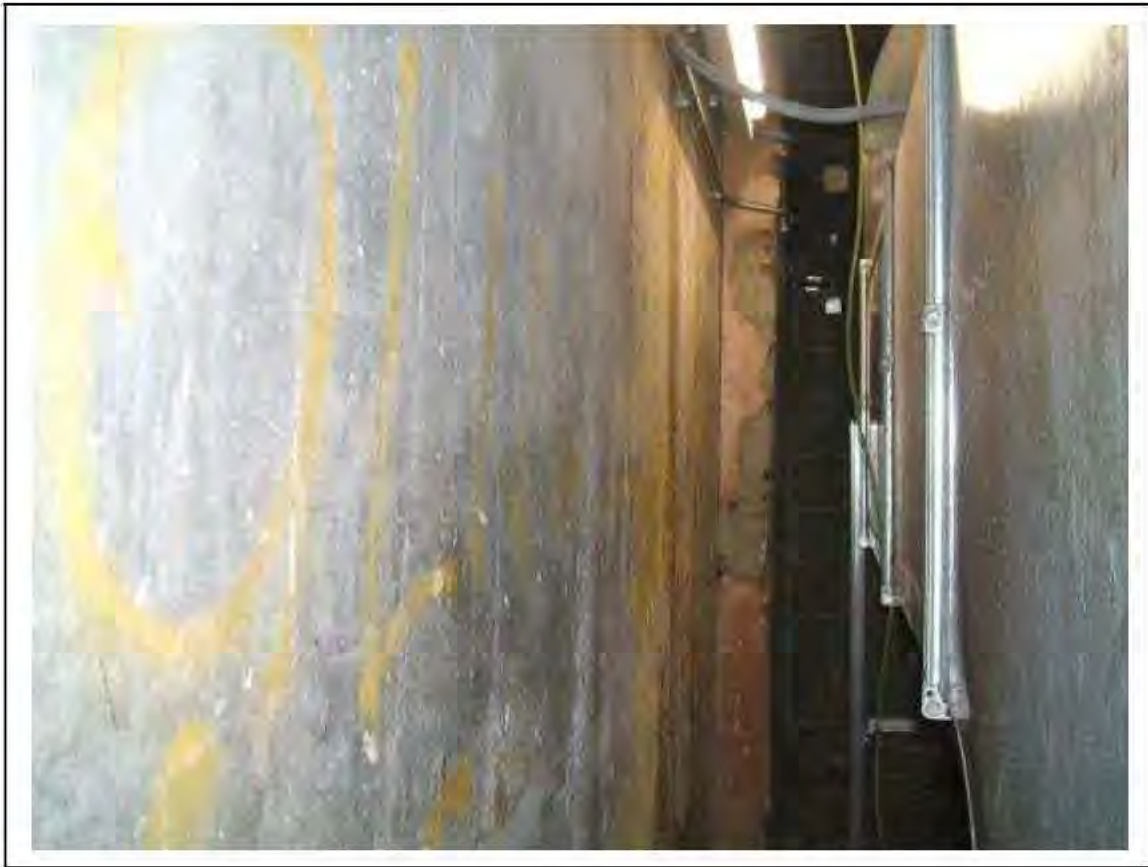
Possible residues behind rear false wall presumed to contain Amosite & Chrysotile asbestos, Figure 64

FIGURE 64: PRESUMED ASBESTOS IN RESIDUES BEHIND REAR FALSE WALL IN SERVICE VOID , 2/902 - DESCRIPTION & RESULT OF ASSESSMENT (SAMPLE REF. P1&2(48))

Sample Number	P1&2(48)
Location	Service Void , 2/902
Material Description	Possible residues behind rear false wall
Material Comment	Possible residual spray coating from beams above behind false wall to rear
Quantity	-
Product Type	-
Current Condition	-
Surface Treatment	-
Asbestos Type	Presumed Amosite & Chrysotile
Material Assessment Rating	-
Accessibility	
Further Comment	Not applicable

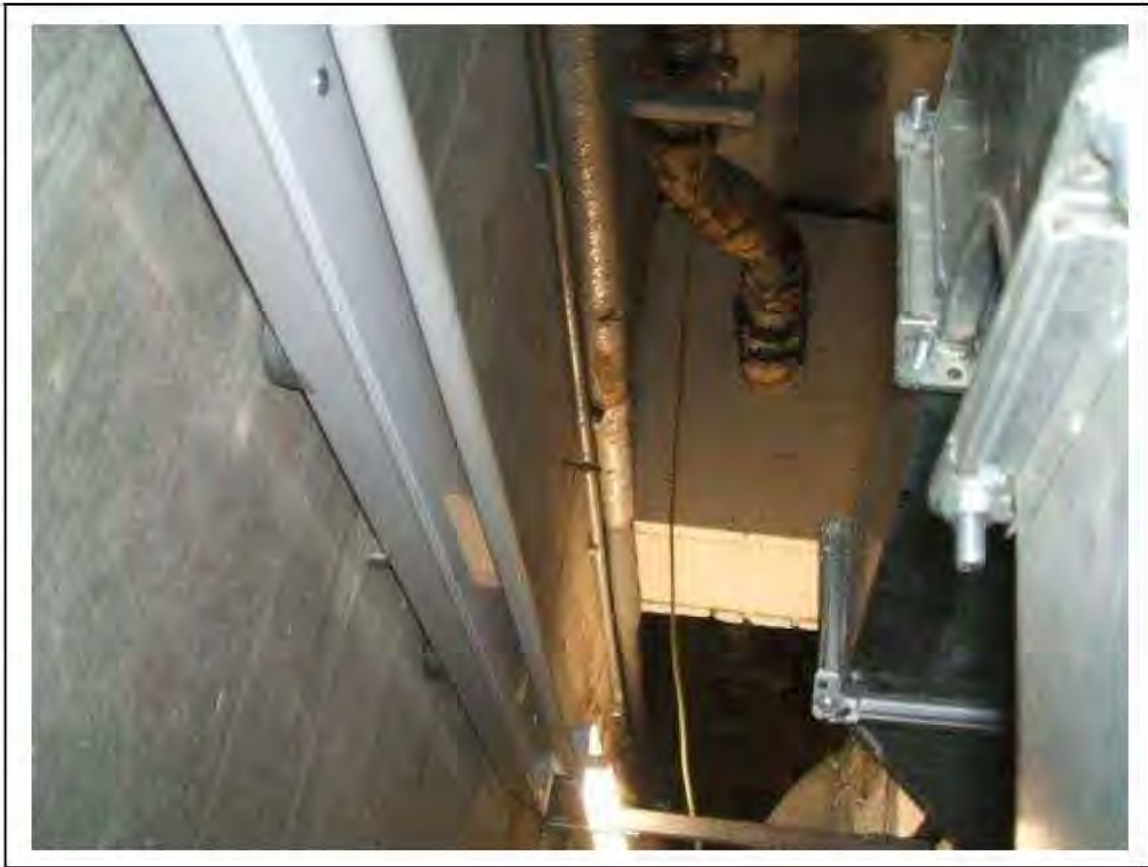
Possible residues where beams enter wall presumed to contain Amosite & Chrysotile asbestos, Figure 65

FIGURE 65: PRESUMED ASBESTOS IN RESIDUES WHERE BEAMS ENTER WALL IN SERVICE VOID , 2/902 - DESCRIPTION & RESULT OF ASSESSMENT (SAMPLE REF. P1&2(49))

Sample Number	P1&2(49)
Location	Service Void , 2/902
Material Description	Possible residues where beams enter wall
Material Comment	Possible residual spray coating
Quantity	-
Product Type	-
Current Condition	-
Surface Treatment	-
Asbestos Type	Presumed Amosite & Chrysotile
Material Assessment Rating	-
Accessibility	
Further Comment	Not applicable

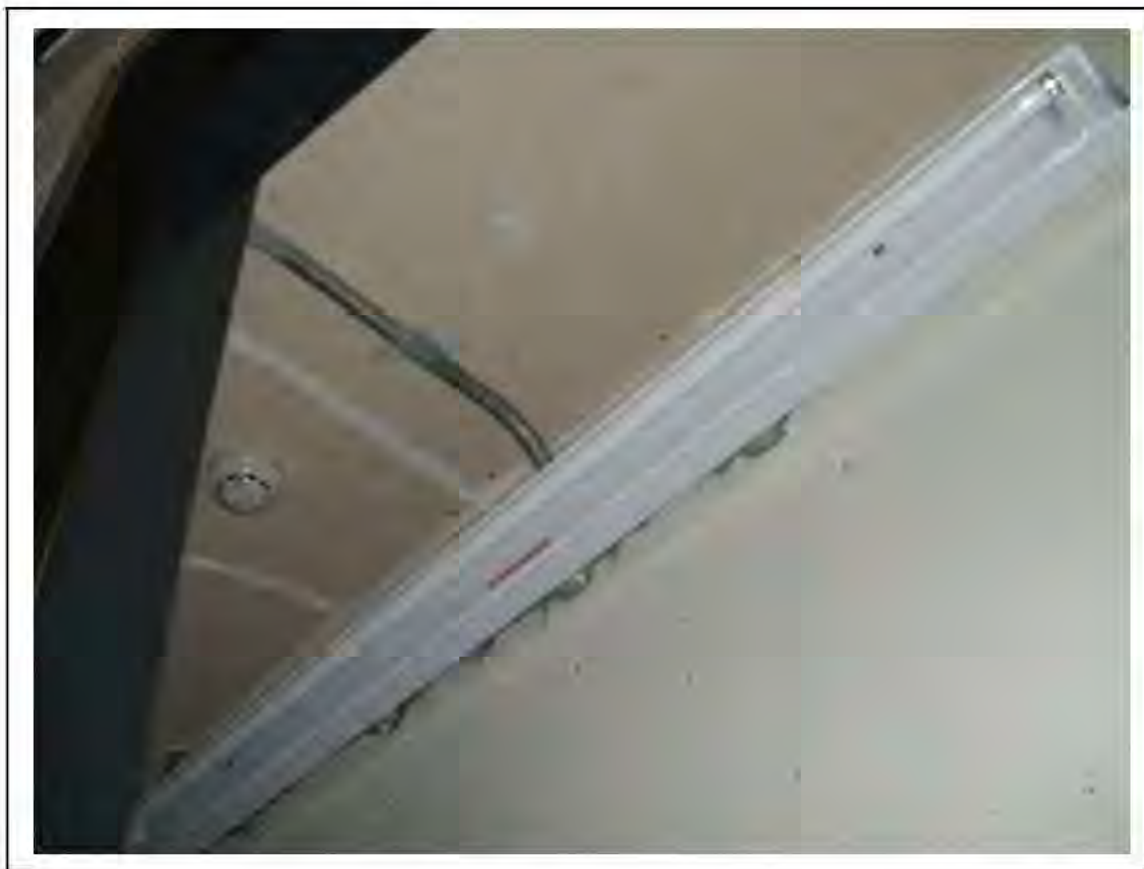
Residues in void above presumed to contain Amosite & Chrysotile asbestos, Figure 66

FIGURE 66: PRESUMED ASBESTOS IN RESIDUES IN VOID ABOVE IN DISUSED ROOM , 2/952 - DESCRIPTION & RESULT OF ASSESSMENT (SAMPLE REF. P1&2(50))

Sample Number	P1&2(50)
Location	Disused Room , 2/952
Material Description	Residues in void above
Material Comment	Above false ceiling entrance to void over escalators, see report 4RS-IRG-034523-R34778
Quantity	-
Product Type	-
Current Condition	-
Surface Treatment	-
Asbestos Type	Presumed Amosite & Chrysotile
Material Assessment Rating	-
Accessibility	
Further Comment	Not applicable

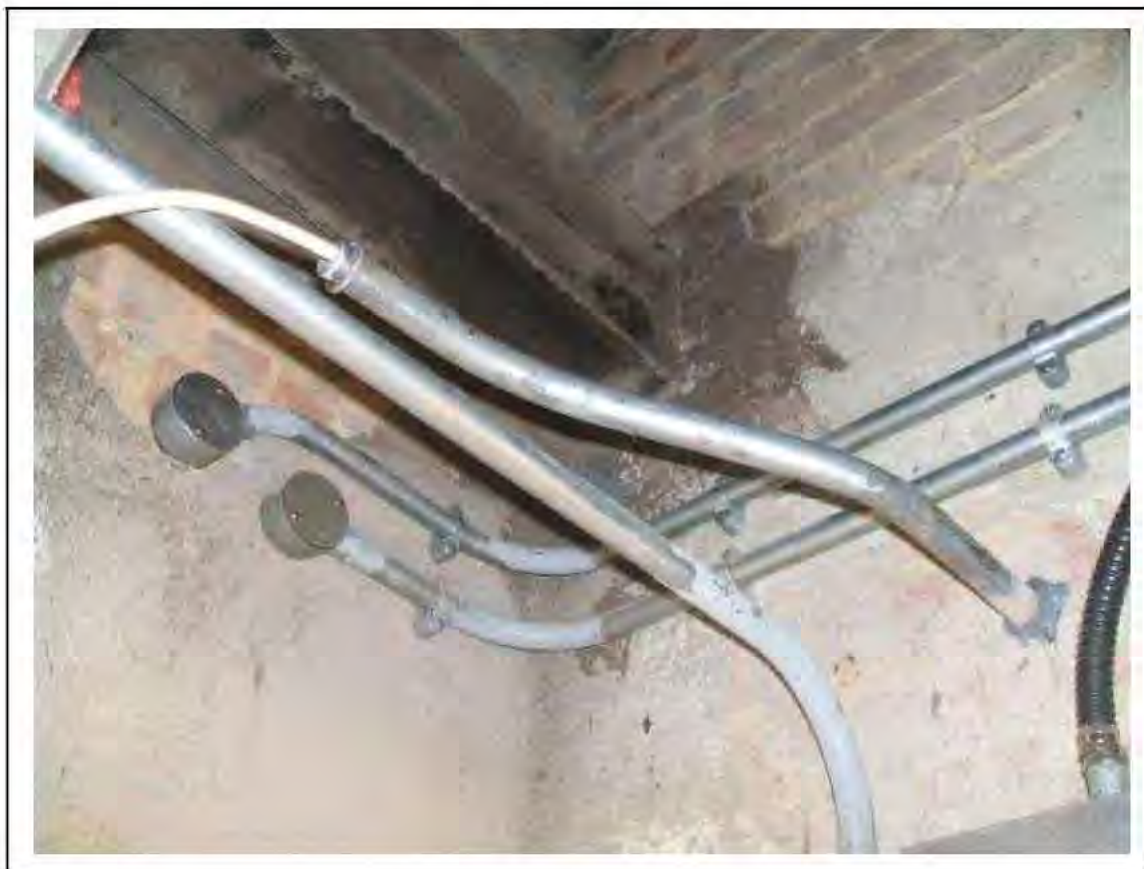
Residue below foam confirmed to contain Amosite asbestos, Figure 67 - Material assessment rating: Medium

FIGURE 67: CONFIRMED ASBESTOS IN RESIDUE BELOW FOAM IN VENT ACCESS , 2/953 - DESCRIPTION & RESULT OF ASSESSMENT (SAMPLE REF. 120445/150812/04)

Sample Number	120445/150812/04
Location	Vent Access , 2/953
Material Description	Residue below foam
Material Comment	To small beam
Quantity	<0.1m ²
Product Type	Highly friable
Current Condition	Extensive damage (assumed below foam)
Surface Treatment	Encapsulated highly friable
Asbestos Type	Amosite
Material Assessment Rating	High
Accessibility	Low
Further Comment	Not applicable

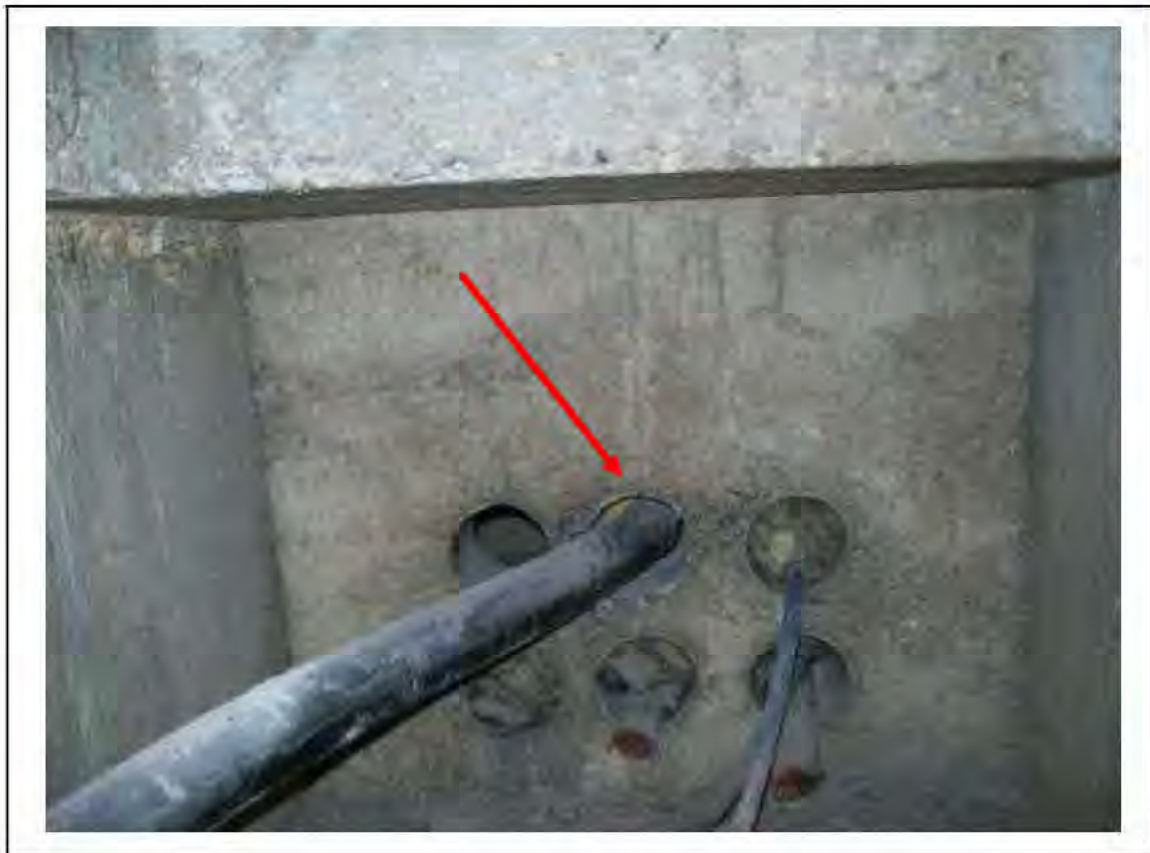
Ducts in cable pit known to contain Chrysotile asbestos, Figure 71 - Material assessment rating: Very low

FIGURE 71: KNOWN ASBESTOS IN DUCTS IN CABLE PIT IN VENT ACCESS , 2/953 - DESCRIPTION & RESULT OF ASSESSMENT (SAMPLE REF. K1(7) PREVIOUS SAMPLE ECS78286)

Sample Number	K1(7) Previous sample ECS78286
Location	Vent Access , 2/953
Material Description	Ducts in cable pit
Material Comment	Go into substation
Quantity	6
Product Type	Composite
Current Condition	Good condition
Surface Treatment	Composite
Asbestos Type	Known Chrysotile
Material Assessment Rating	Very low
Accessibility	Low
Further Comment	Not applicable

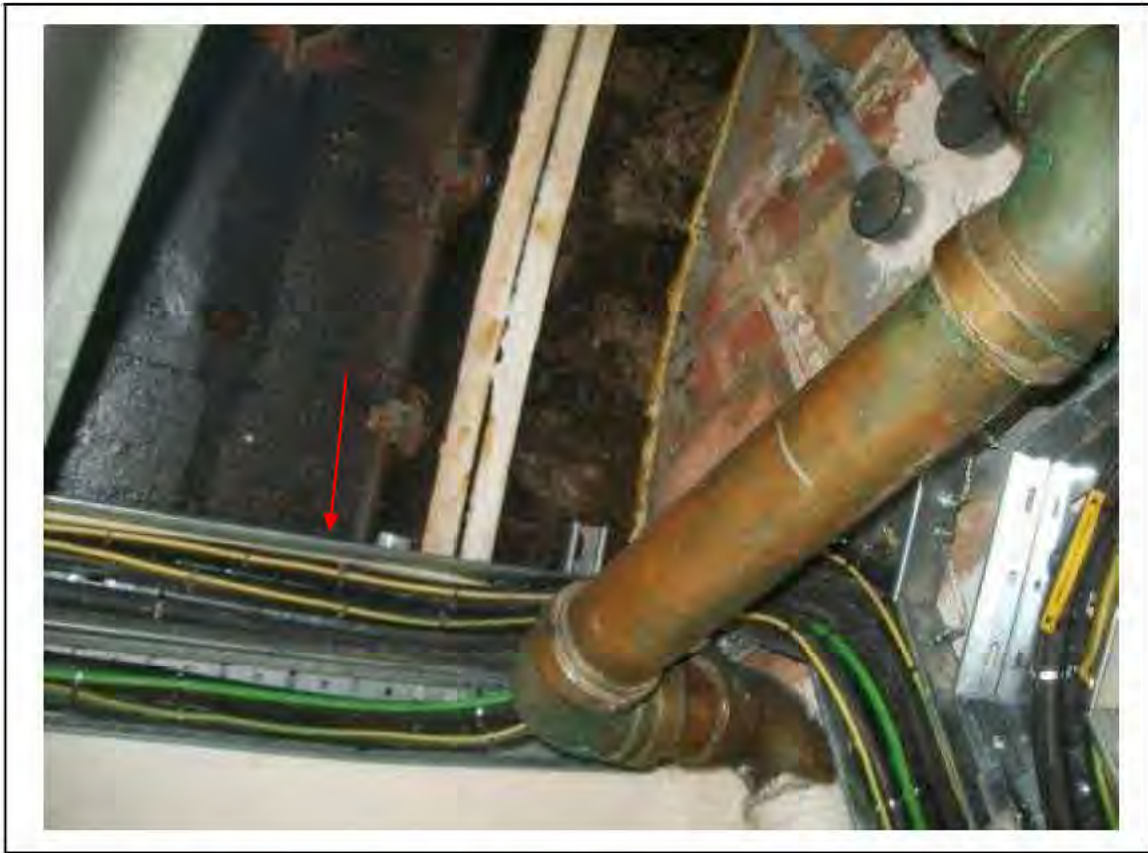
Cellactite known to contain Chrysotile asbestos, Figure 72 - Material assessment rating: Very low

FIGURE 72: KNOWN ASBESTOS IN CELLACTITE IN SWITCH ROOM E14, 3/047 - DESCRIPTION & RESULT OF ASSESSMENT (SAMPLE REF. K1(8))

Sample Number	K1(8)
Location	Switch Room E14, 3/047
Material Description	Cellactite
Material Comment	Suspected to be present behind false wall (wall 3)
Quantity	unknown
Product Type	Composite
Current Condition	-
Surface Treatment	Composite
Asbestos Type	Known Chrysotile
Material Assessment Rating	Very low
Accessibility	Very low
Further Comment	Not applicable

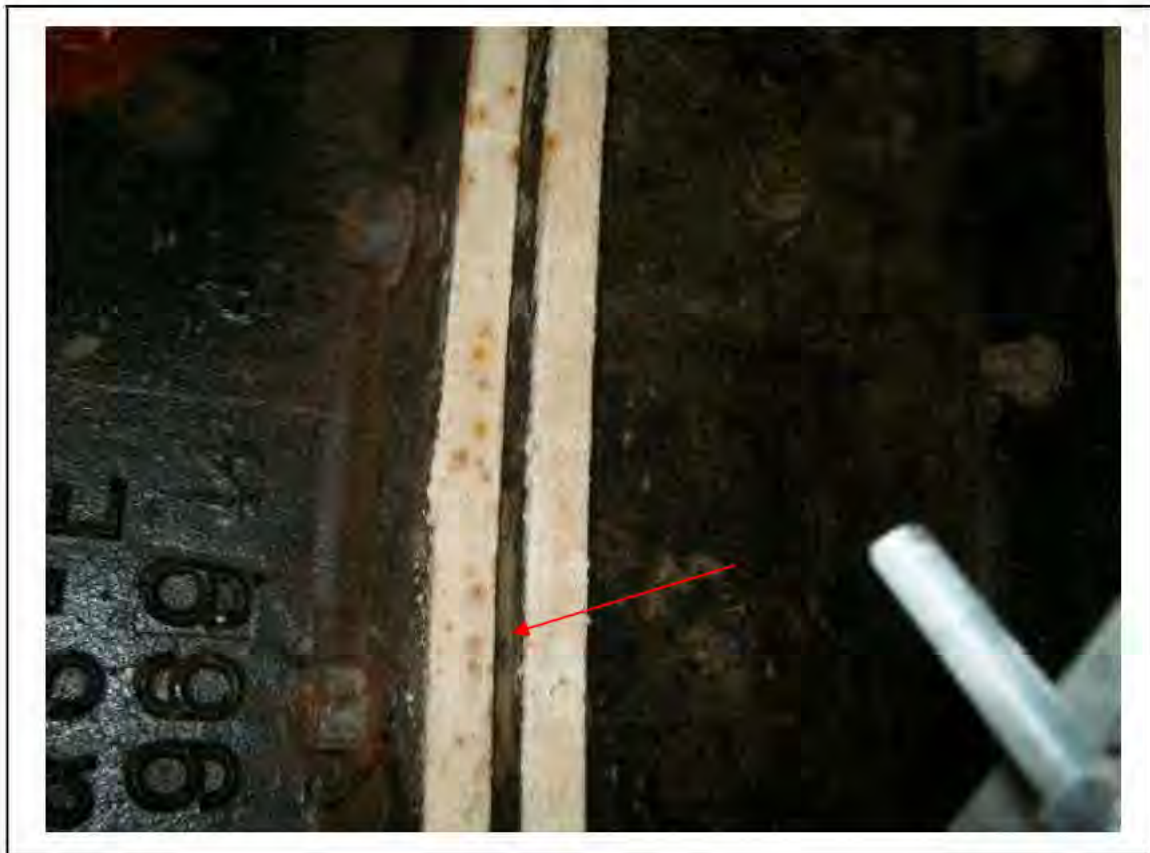
Caulking to tunnel ring joints confirmed to contain Amosite and Chrysotile asbestos, Figure 73 - Material assessment rating: Low

FIGURE 73: CONFIRMED ASBESTOS IN CAULKING TO TUNNEL RING JOINTS IN SWITCH ROOM E14, 3/047 - DESCRIPTION & RESULT OF ASSESSMENT (SAMPLE REF. AS 120445/150812/03)

Sample Number	As 120445/150812/03
Location	Switch Room E14, 3/047
Material Description	Caulking to tunnel ring joints
Material Comment	Ceiling and behind wall 3
Quantity	throughout
Product Type	Medium density
Current Condition	Good condition
Surface Treatment	Encapsulated medium density
Asbestos Type	Amosite and Chrysotile
Material Assessment Rating	Low
Accessibility	Low
Further Comment	Not applicable

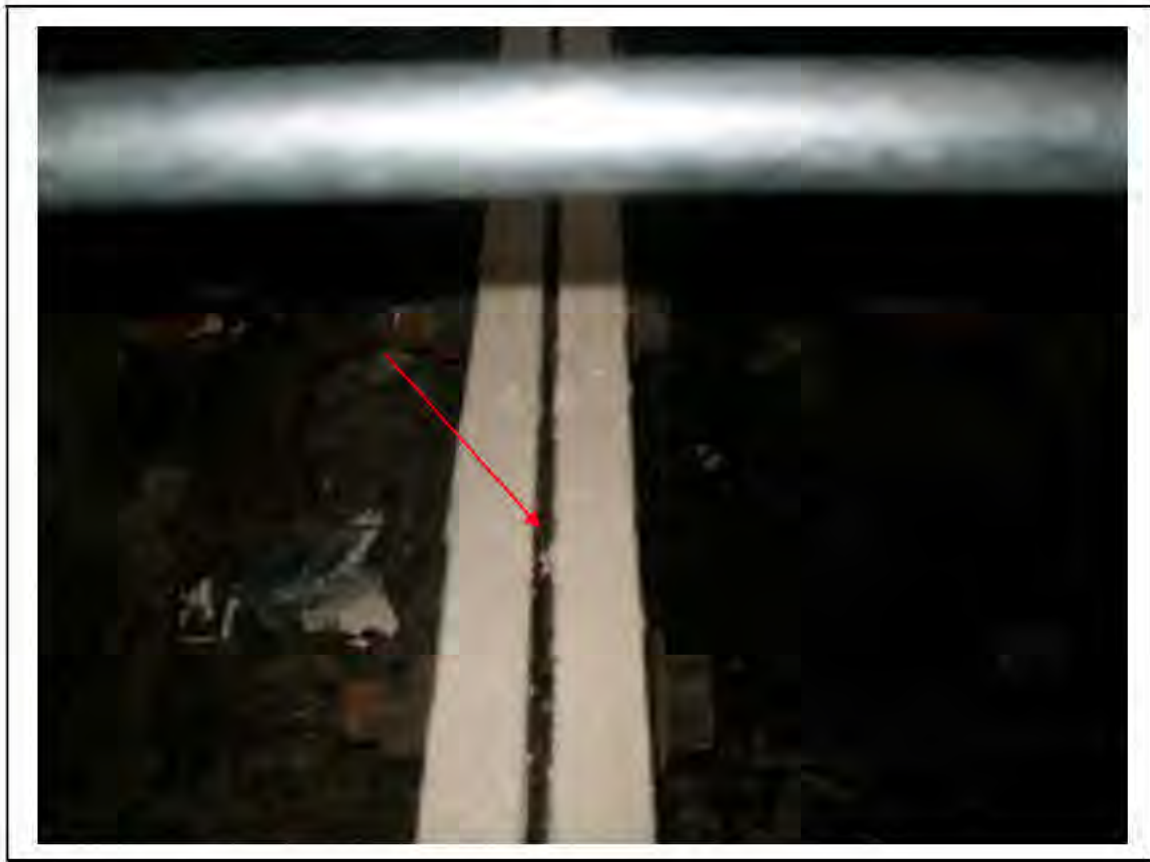
Caulking confirmed to contain Amosite and Chrysotile asbestos, Figure 74 - Material assessment rating: Low

FIGURE 74: CONFIRMED ASBESTOS IN CAULKING IN MESS ROOM , 3/053 - DESCRIPTION & RESULT OF ASSESSMENT (SAMPLE REF. 120445/150812/03)

Sample Number	120445/150812/03
Location	Mess Room , 3/053
Material Description	Caulking
Material Comment	Tunnel ring flanges within false ceiling
Quantity	throughout
Product Type	Medium density
Current Condition	Slight damage
Surface Treatment	Encapsulated medium density
Asbestos Type	Amosite and Chrysotile
Material Assessment Rating	Low
Accessibility	Low
Further Comment	Not applicable

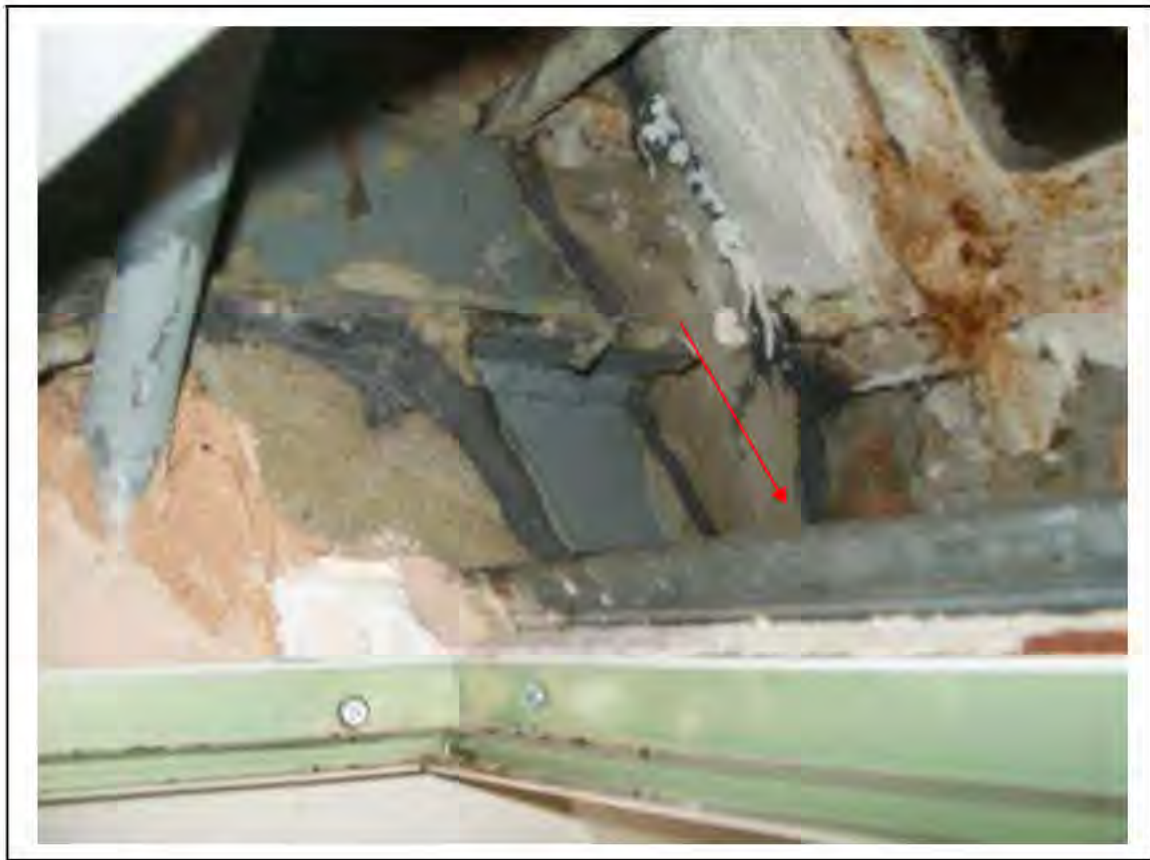
Cellactite corrugated sheeting known to contain Chrysotile asbestos, Figure 75 - Material assessment rating: Very low

FIGURE 75: KNOWN ASBESTOS IN CELLACTITE CORRUGATED SHEETING IN MESS ROOM , 3/053 - DESCRIPTION & RESULT OF ASSESSMENT (SAMPLE REF. K1(9))

Sample Number	K1(9)
Location	Mess Room , 3/053
Material Description	Cellactite corrugated sheeting
Material Comment	Within wall cavity
Quantity	unknown
Product Type	Composite
Current Condition	-
Surface Treatment	Composite
Asbestos Type	Known Chrysotile
Material Assessment Rating	Very low
Accessibility	Low
Further Comment	Not applicable

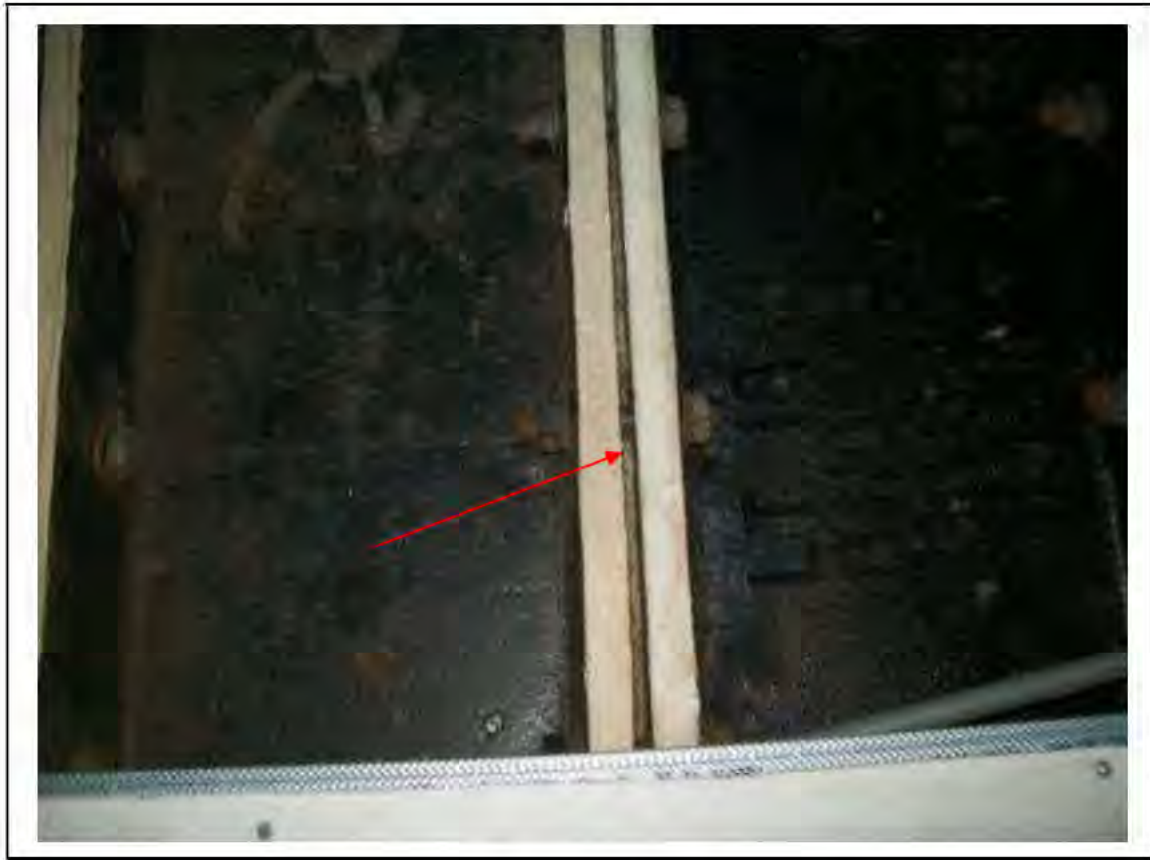
Caulking confirmed to contain Amosite and Chrysotile asbestos, Figure 77 - Material assessment rating: Low

FIGURE 77: CONFIRMED ASBESTOS IN CAULKING IN MALE W/ C, 3/082 - DESCRIPTION & RESULT OF ASSESSMENT (SAMPLE REF. SAME AS 120445/150812/03)

Sample Number	Same as 120445/150812/03
Location	Male W/ C, 3/082
Material Description	Caulking
Material Comment	Tunnel ring flanges within false ceiling
Quantity	throughout
Product Type	Medium density
Current Condition	Slight damage
Surface Treatment	Encapsulated medium density
Asbestos Type	Amosite and Chrysotile
Material Assessment Rating	Low
Accessibility	Low
Further Comment	Not applicable

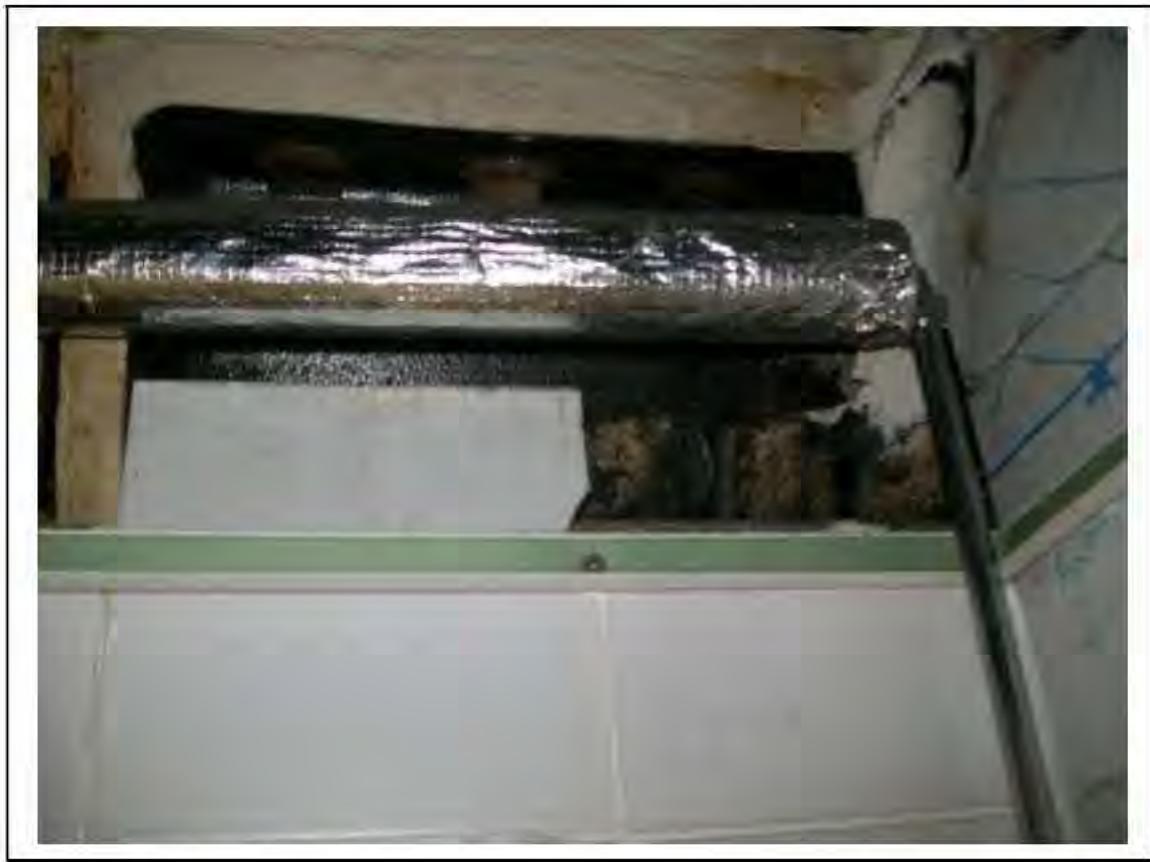
Cellactite corrugated sheeting known to contain Chrysotile asbestos, Figure 78 - Material assessment rating: Very low

FIGURE 78: KNOWN ASBESTOS IN CELLACTITE CORRUGATED SHEETING IN MALE W/ C, 3/082 - DESCRIPTION & RESULT OF ASSESSMENT (SAMPLE REF. K1(11))

Sample Number	K1(11)
Location	Male W/ C, 3/082
Material Description	Cellactite corrugated sheeting
Material Comment	Within wall cavity
Quantity	throughout
Product Type	Composite
Current Condition	-
Surface Treatment	Composite
Asbestos Type	Known Chrysotile
Material Assessment Rating	Very low
Accessibility	Very Low
Further Comment	Not applicable

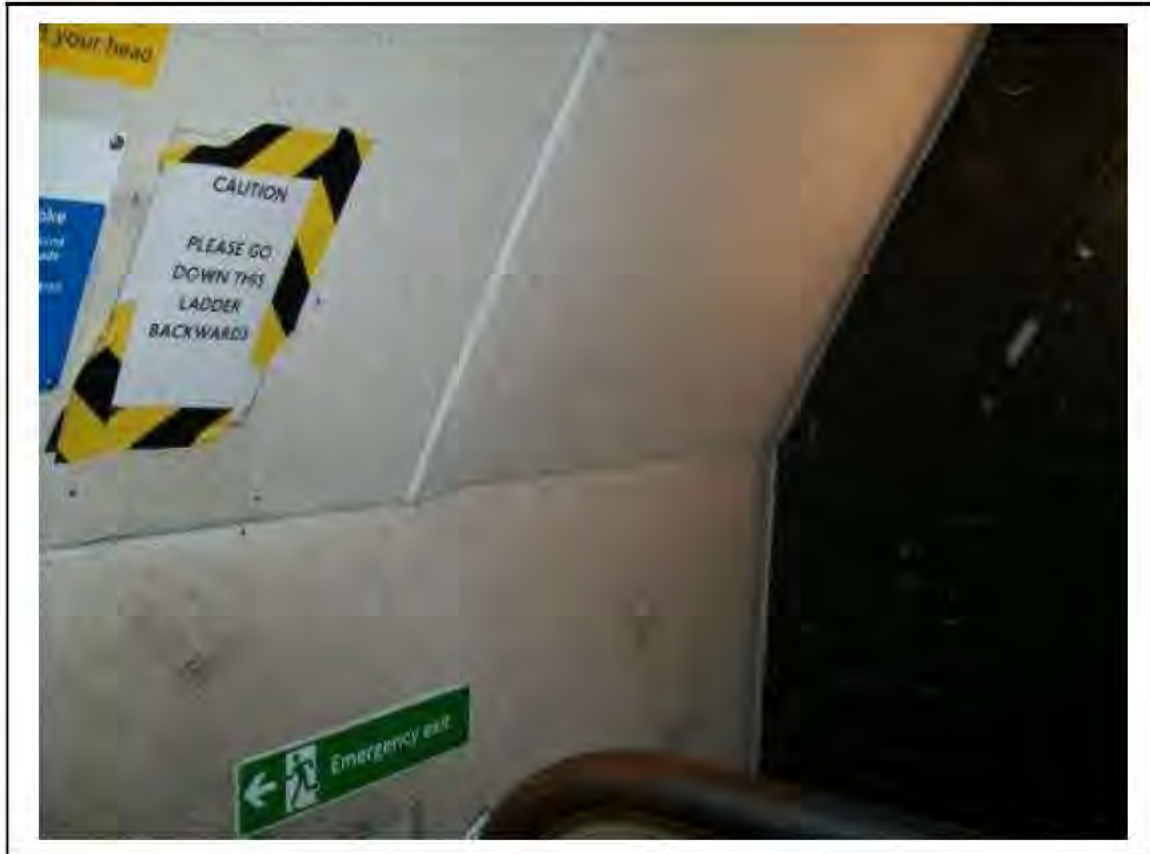
Supalux, possible cellactite and caulking behind presumed to contain Amosite and Chrysotile asbestos, Figure 82

FIGURE 82: PRESUMED ASBESTOS BEHIND SUPALUX, POSSIBLE CELLACTITE AND CAULKING BEHIND IN LMC ACCESS, 3/161 - DESCRIPTION & RESULT OF ASSESSMENT (SAMPLE REF. P1&2(54))

Sample Number	P1&2(54)
Location	LMC Access, 3/161
Material Description	Supalux, possible cellactite and caulking behind
Material Comment	Wall 1 and ceiling
Quantity	-
Product Type	-
Current Condition	-
Surface Treatment	-
Asbestos Type	Presumed Amosite and Chrysotile
Material Assessment Rating	-
Accessibility	-
Further Comment	Not applicable

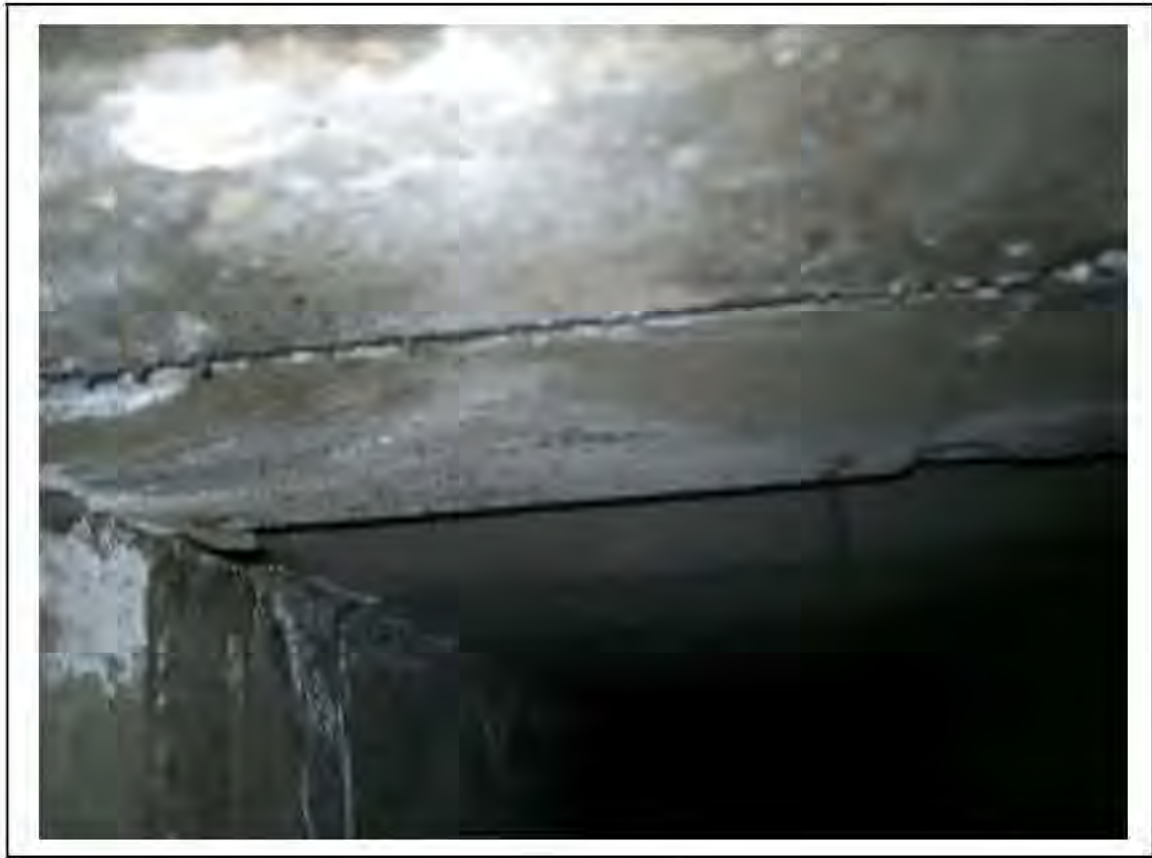
Ducts by escalators confirmed to contain Amosite and Chrysotile asbestos, Figure 83 - Material assessment rating: Medium

FIGURE 83: CONFIRMED ASBESTOS IN DUCTS BY ESCALATORS IN LMC, 3/161 - DESCRIPTION & RESULT OF ASSESSMENT (SAMPLE REF. 120445/180812/02)

Sample Number	120445/180812/02
Location	LMC, 3/161
Material Description	Ducts by escalators
Material Comment	Shuttering
Quantity	Unknown (20x10cm visible)
Product Type	Medium density
Current Condition	Moderate damage
Surface Treatment	Unencapsulated medium density
Asbestos Type	Amosite and Chrysotile
Material Assessment Rating	Medium
Accessibility	Low
Further Comment	Not applicable

Asbestos shuttering to in floor ducts in the Upper and Lower Escalator Machine Chambers 2/151 and 3/161 (and incline between). Whilst the duct (Figure 83) in which the small amount of asbestos insulation board shuttering was found in the Lower Machine Chamber 3/161 appeared to be out of use it would be recommended that further surveys of these ducts be conducted when opportunity arises to determine if other small patches of asbestos board shuttering are present. This may require specialist equipment the ducts being too small to physically enter in many locations.

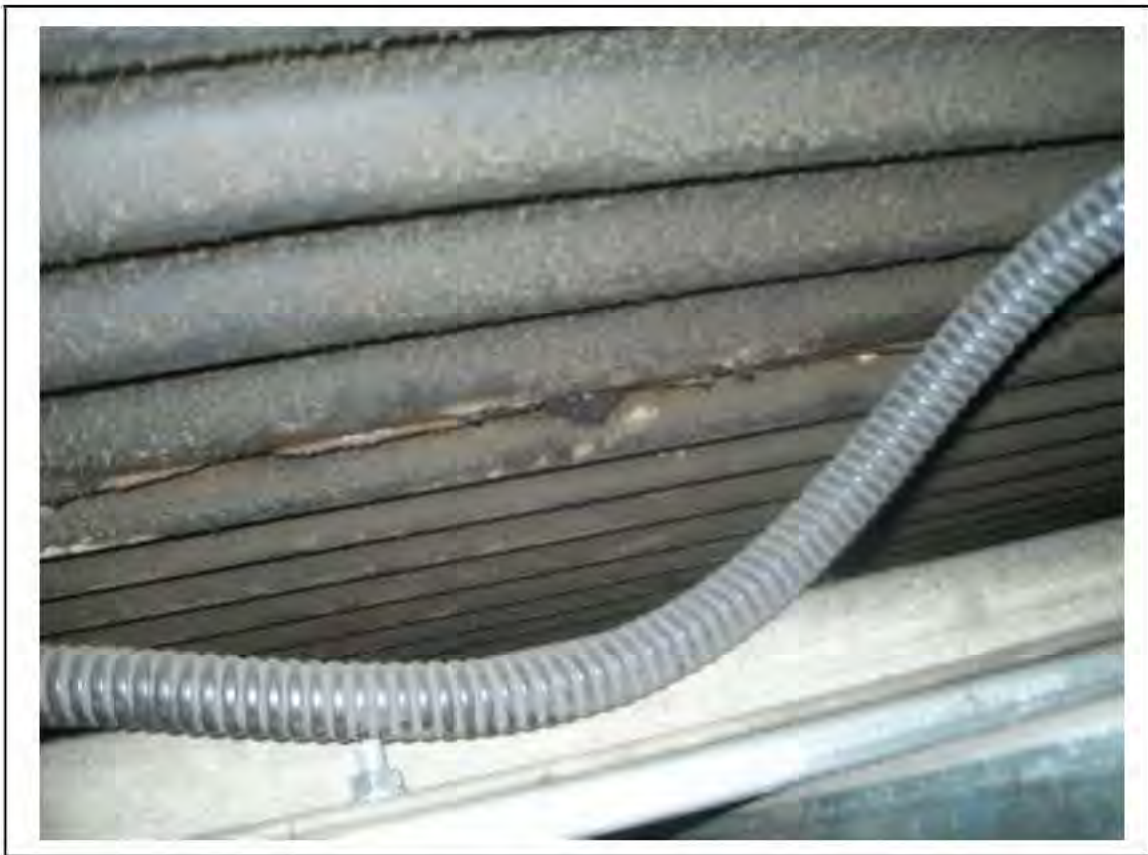
Cellactite known to contain Chrysotile asbestos, Figure 84 - Material assessment rating: Very low

FIGURE 84: KNOWN ASBESTOS IN CELLACTITE IN PASSAGE , 3/201 - DESCRIPTION & RESULT OF ASSESSMENT (SAMPLE REF. K1(13))

Sample Number	K1(13)
Location	Passage , 3/201
Material Description	Cellactite
Material Comment	Above false ceiling
Quantity	14m ²
Product Type	Composite
Current Condition	Good condition
Surface Treatment	Composite
Asbestos Type	Known Chrysotile
Material Assessment Rating	Very low
Accessibility	Low
Further Comment	Not applicable

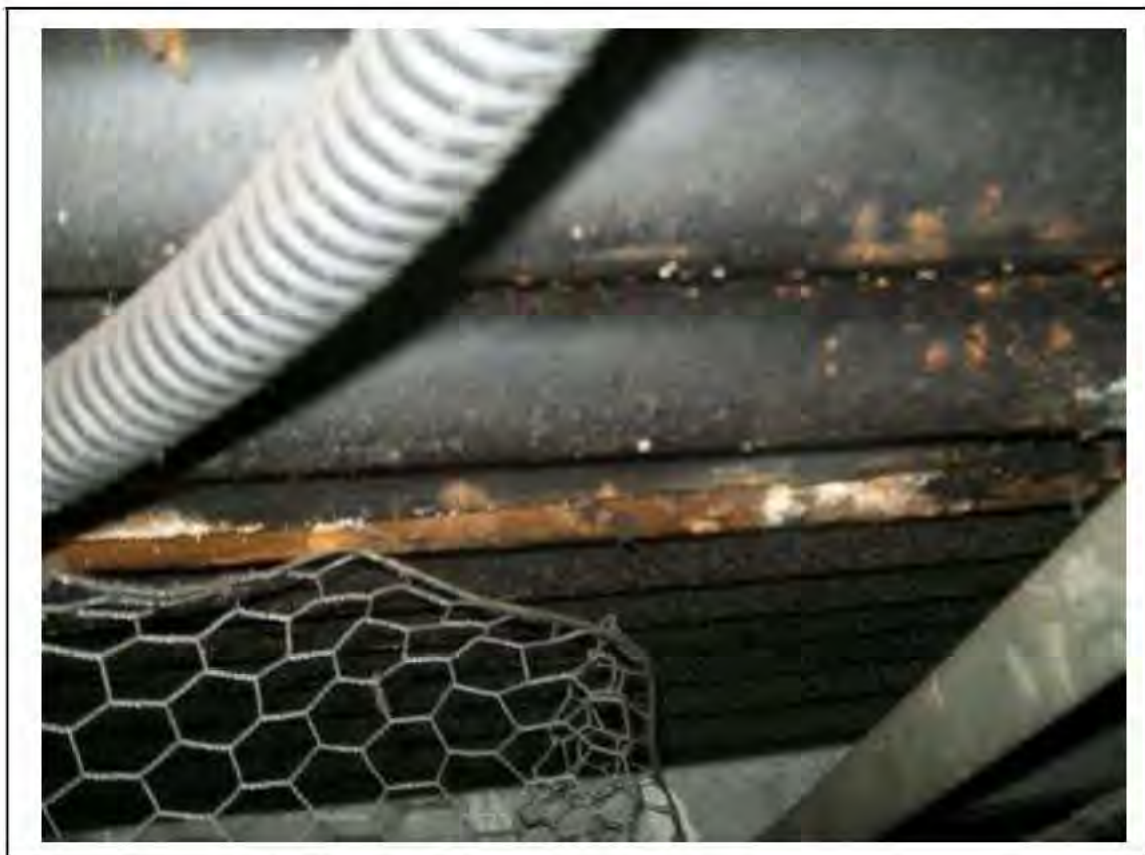
Cellactite known to contain Chrysotile asbestos, Figure 85 - Material assessment rating: Very low

FIGURE 85: KNOWN ASBESTOS IN CELLACTITE IN PASSAGE , 3/202 - DESCRIPTION & RESULT OF ASSESSMENT (SAMPLE REF. K1(14))

Sample Number	K1(14)
Location	Passage , 3/202
Material Description	Cellactite
Material Comment	-
Quantity	14m ²
Product Type	Composite
Current Condition	Good condition
Surface Treatment	Composite
Asbestos Type	Known Chrysotile
Material Assessment Rating	Very low
Accessibility	Low
Further Comment	Not applicable

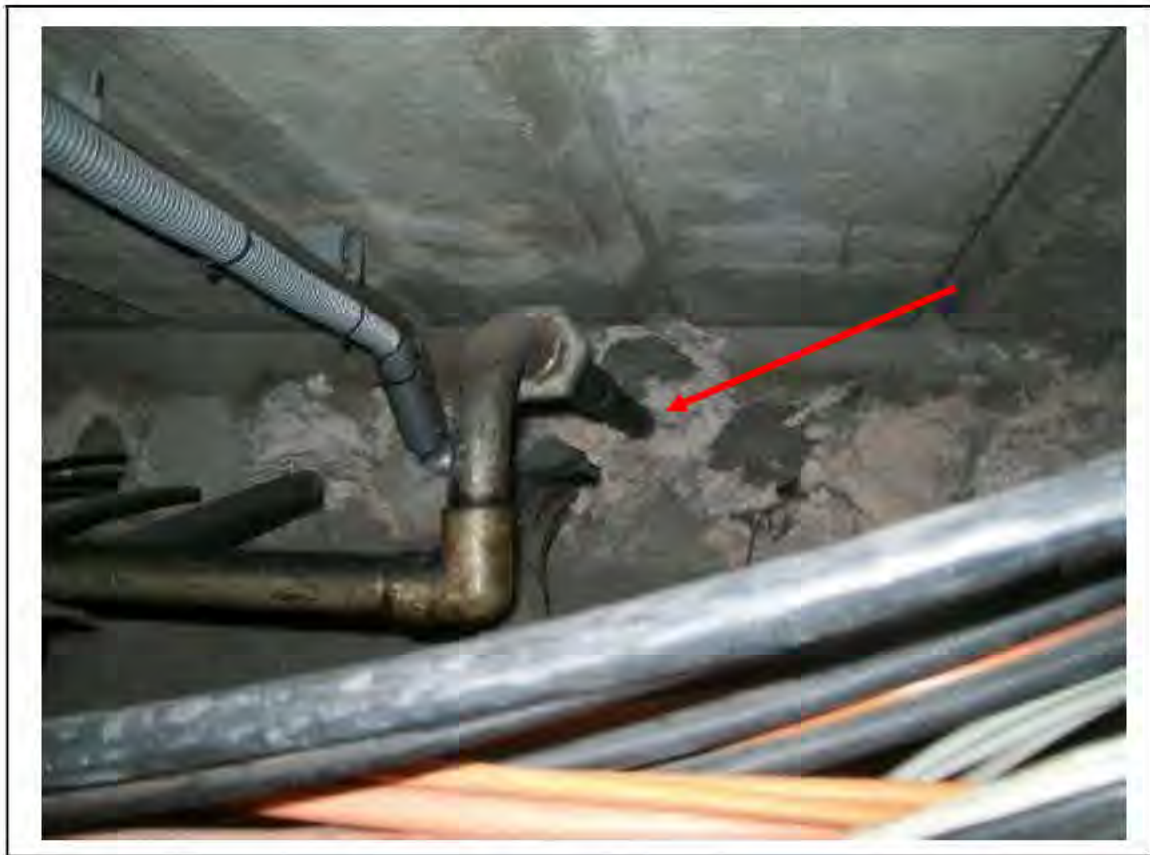
Floor cable ducts confirmed to contain Chrysotile asbestos, Figure 86 - Material assessment rating: Very low

FIGURE 86: CONFIRMED ASBESTOS IN CABLE FLOOR DUCTS IN PASSAGE FLOOR DUCTS, 3/202 - DESCRIPTION & RESULT OF ASSESSMENT (SAMPLE REF. SAME AS 120445/190812/01)

Sample Number	Same as 120445/190812/01
Location	Passage floor ducts, 3/202
Material Description	Cable floor ducts
Material Comment	Run to platform invert cables sleeves
Quantity	12
Product Type	Composite
Current Condition	Good condition
Surface Treatment	Composite
Asbestos Type	Chrysotile
Material Assessment Rating	Very low
Accessibility	Low
Further Comment	Not applicable

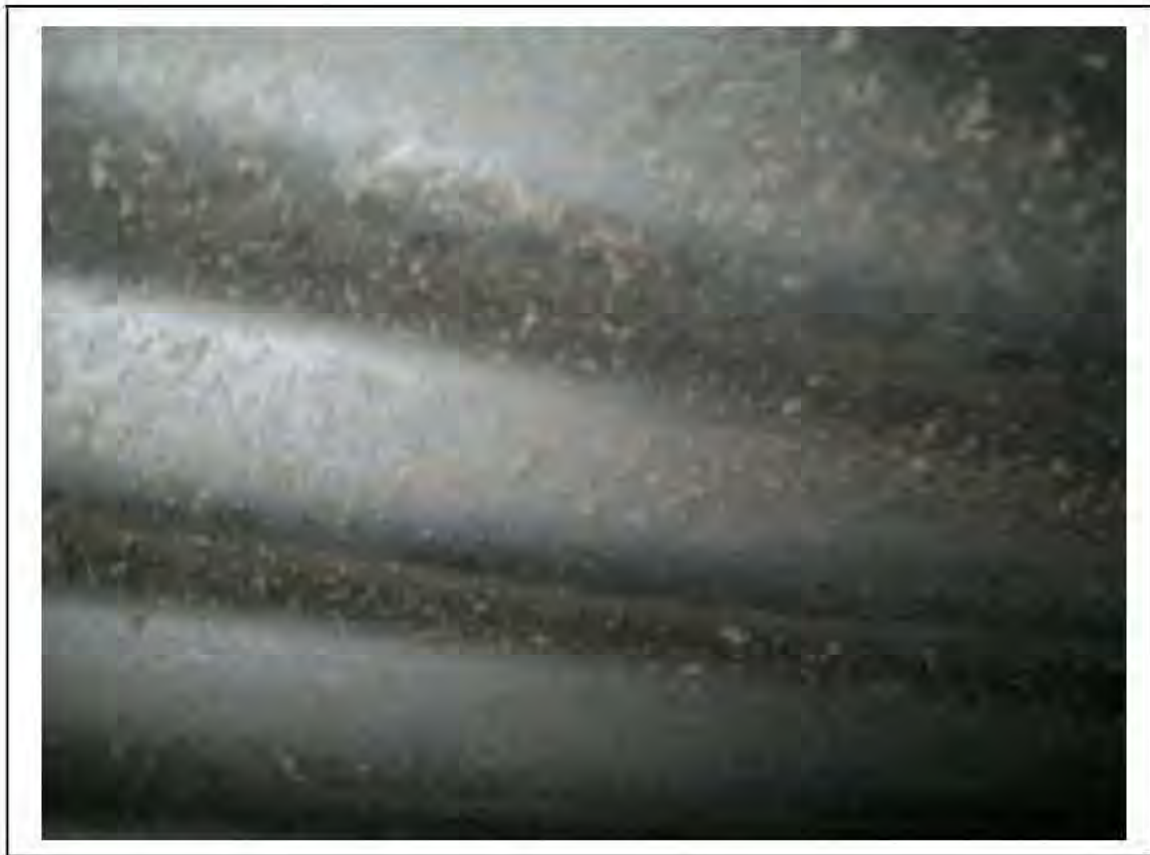
Cellactite known to contain Chrysotile asbestos, Figure 87 - Material assessment rating: Very low

FIGURE 87: KNOWN ASBESTOS IN CELLACTITE IN PASSAGE , 3/203 - DESCRIPTION & RESULT OF ASSESSMENT (SAMPLE REF. K1(15))

Sample Number	K1(15)
Location	Passage , 3/203
Material Description	Cellactite
Material Comment	Above false ceiling
Quantity	14m ²
Product Type	Composite
Current Condition	Good condition
Surface Treatment	Composite
Asbestos Type	Known Chrysotile
Material Assessment Rating	Very low
Accessibility	Low
Further Comment	Not applicable

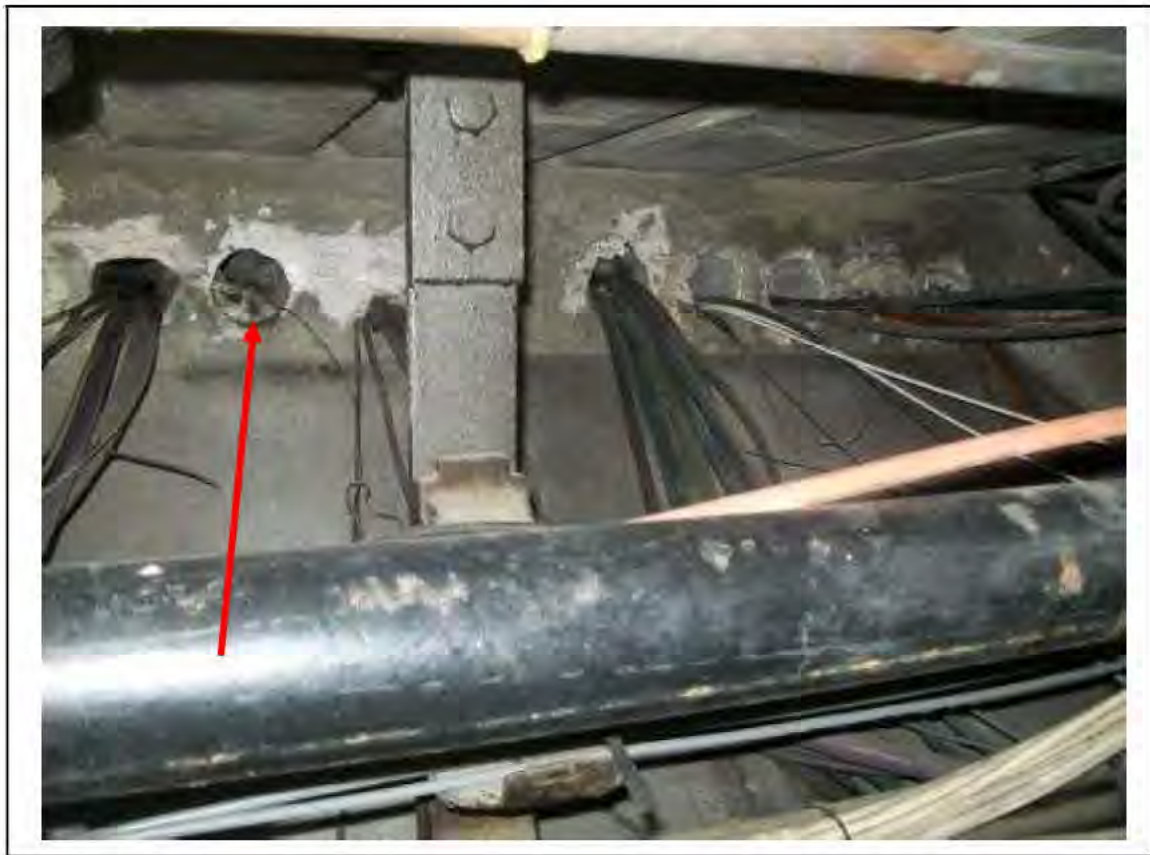
Floor cable ducts confirmed to contain Chrysotile asbestos, Figure 88 - Material assessment rating: Very low

FIGURE 88: CONFIRMED ASBESTOS IN FLOOR CABLE DUCTS IN PASSAGE , 3/203 - DESCRIPTION & RESULT OF ASSESSMENT (SAMPLE REF. SAME AS 120445/190812/01)

Sample Number	Same as 120445/190812/01
Location	Passage , 3/203
Material Description	Floor cable ducts
Material Comment	Run to platform invert
Quantity	10no
Product Type	Composite
Current Condition	Good condition
Surface Treatment	Composite
Asbestos Type	Chrysotile
Material Assessment Rating	Very low
Accessibility	Low
Further Comment	Not applicable

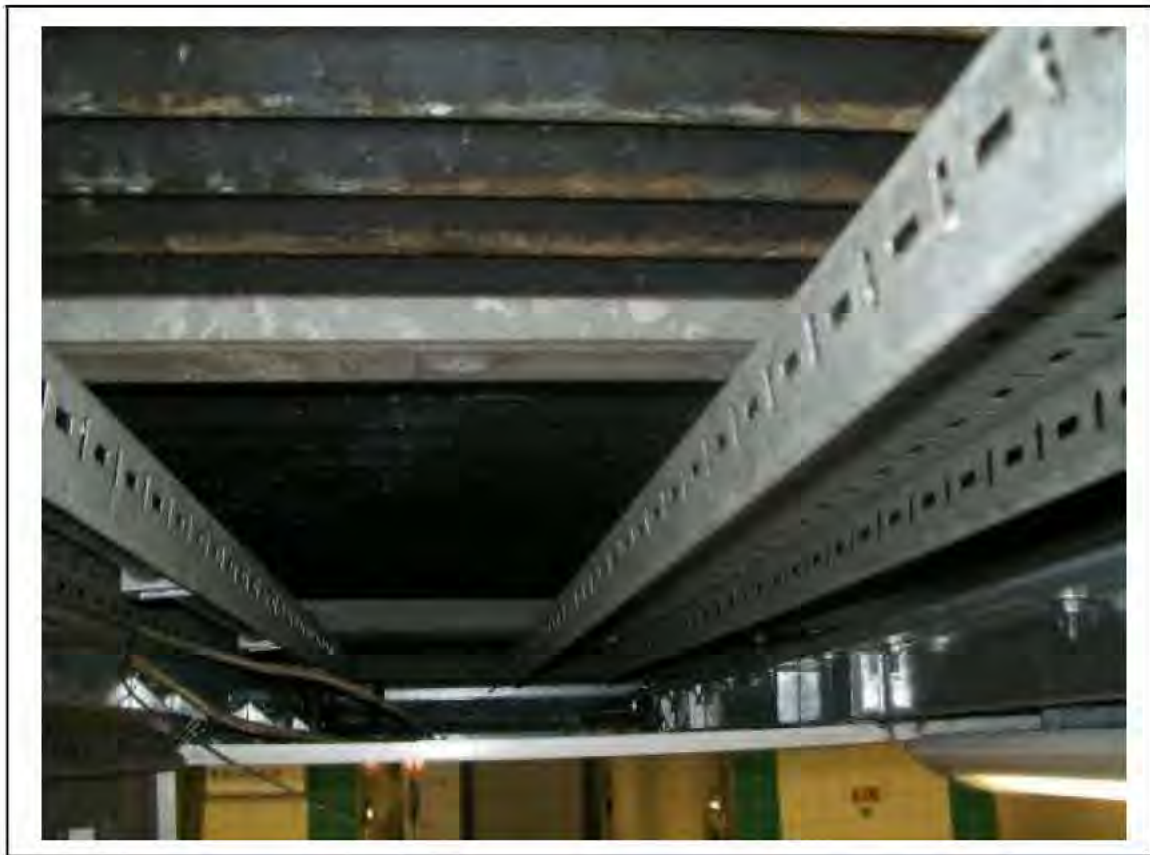
Cellactite known to contain Chrysotile asbestos, Figure 89 - Material assessment rating: Very low

FIGURE 89: KNOWN ASBESTOS IN CELLACTITE IN PASSAGE , 3/204 - DESCRIPTION & RESULT OF ASSESSMENT (SAMPLE REF. K1(16))

Sample Number	K1(16)
Location	Passage , 3/204
Material Description	Cellactite
Material Comment	Above false ceiling (cut back at platform side)
Quantity	12m ²
Product Type	Composite
Current Condition	Good condition
Surface Treatment	Composite
Asbestos Type	Known Chrysotile
Material Assessment Rating	Very low
Accessibility	Low
Further Comment	Not applicable
