Hazardous Materials - TfL Engineering

Re-inspection Sign-Off for Brixton

Re-inspection Reference: V059/4RS-200403

Station	Brixton
Original Management Survey	R346601
Date of Original Management	31st August 2012
Re-inspection Reference:	V059-4RS-200403
Next Planned Re-inspection	Periodical re-inspection according to HM Management Plan

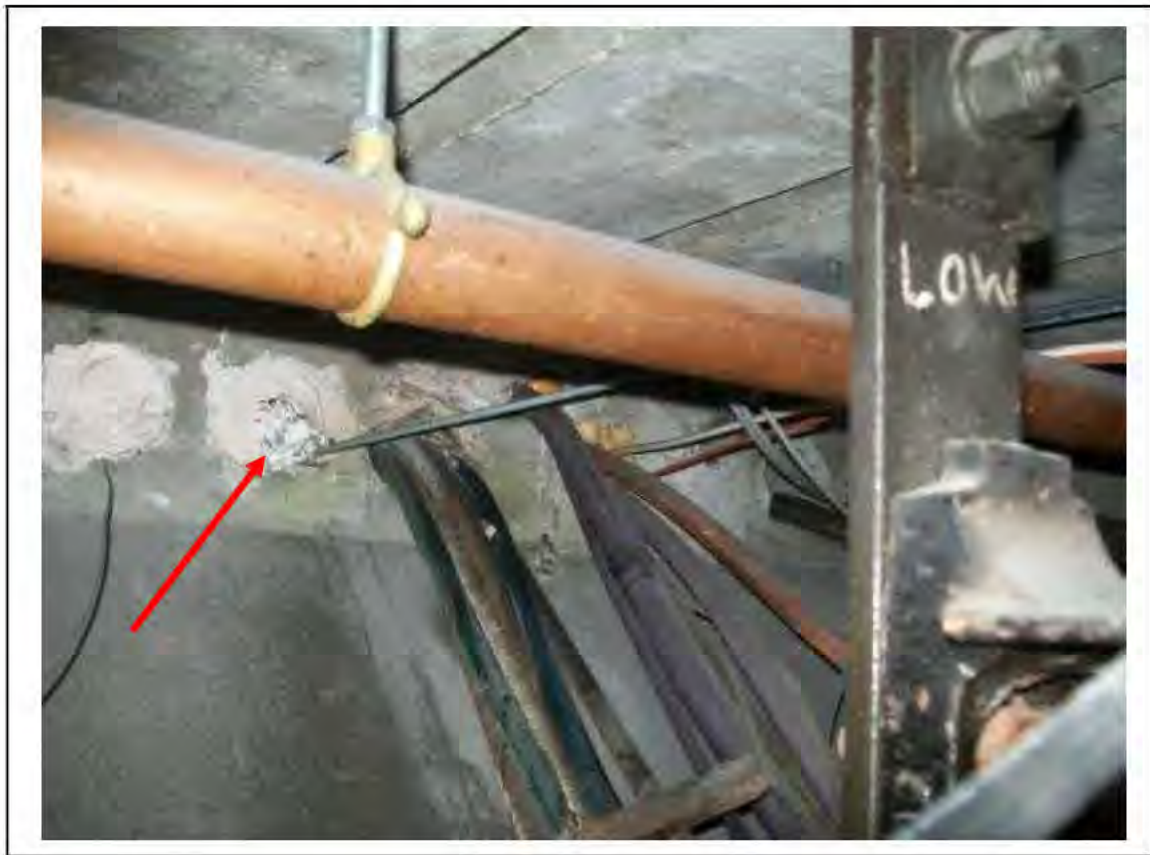
Cable ducts confirmed to contain Chrysotile asbestos, Figure 90 - Material assessment rating: Very low

FIGURE 90: CONFIRMED ASBESTOS IN CABLE DUCTS IN PASSAGE FLOOR, 3/205 - DESCRIPTION & RESULT OF ASSESSMENT (SAMPLE REF. SAME AS 120445/190812/01)

Sample Number	Same as 120445/190812/01
Location	Passage floor ducts, 3/205
Material Description	Cable ducts
Material Comment	Go to platform invert
Quantity	10no
Product Type	Composite
Current Condition	Good condition
Surface Treatment	Composite
Asbestos Type	Chrysotile
Material Assessment Rating	Very low
Accessibility	Low
Further Comment	Not applicable

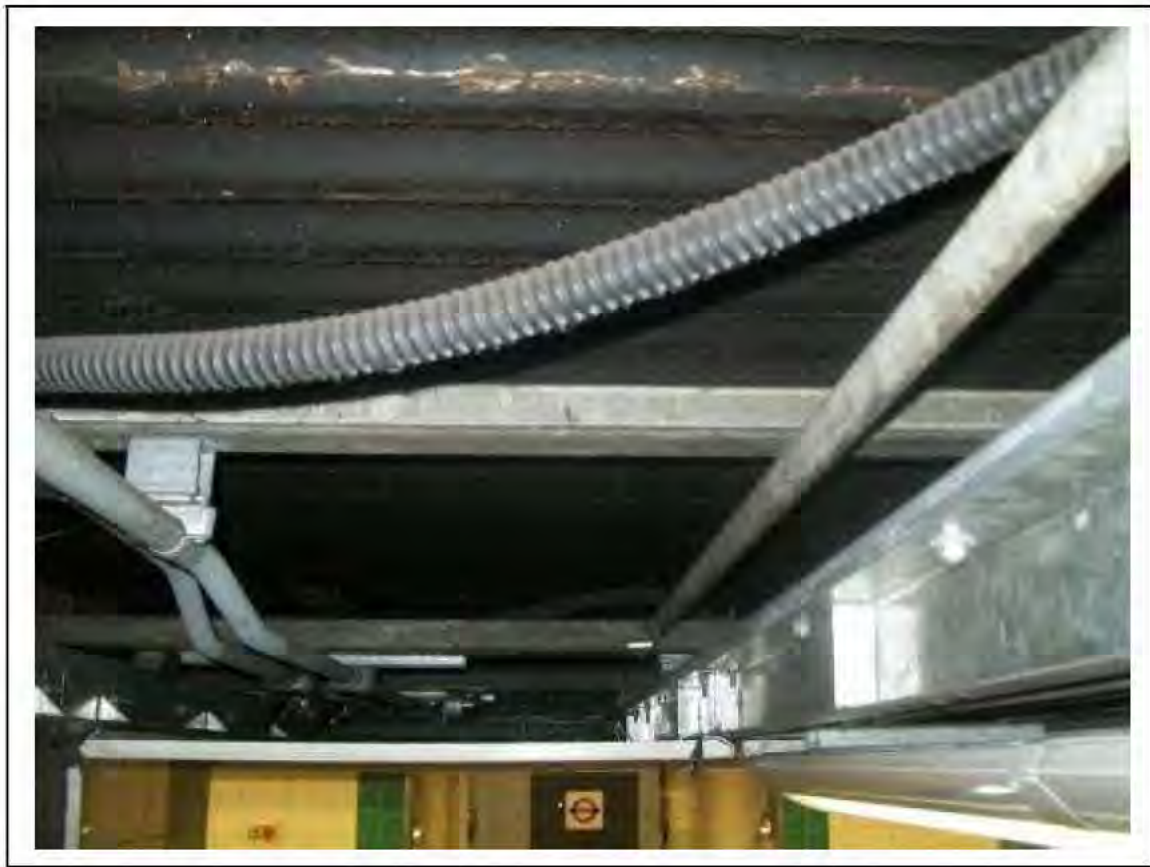
Cellactite known to contain Chrysotile asbestos, Figure 91 - Material assessment rating: Very low

FIGURE 91: KNOWN ASBESTOS IN CELLACTITE IN PASSAGE, 3/205 - DESCRIPTION & RESULT OF ASSESSMENT (SAMPLE REF. K1(17))

Sample Number	K1(17)
Location	Passage, 3/205
Material Description	Cellactite
Material Comment	Above false ceiling
Quantity	12m ²
Product Type	Composite
Current Condition	Good condition
Surface Treatment	Composite
Asbestos Type	Known Chrysotile
Material Assessment Rating	Very low
Accessibility	Low
Further Comment	Not applicable

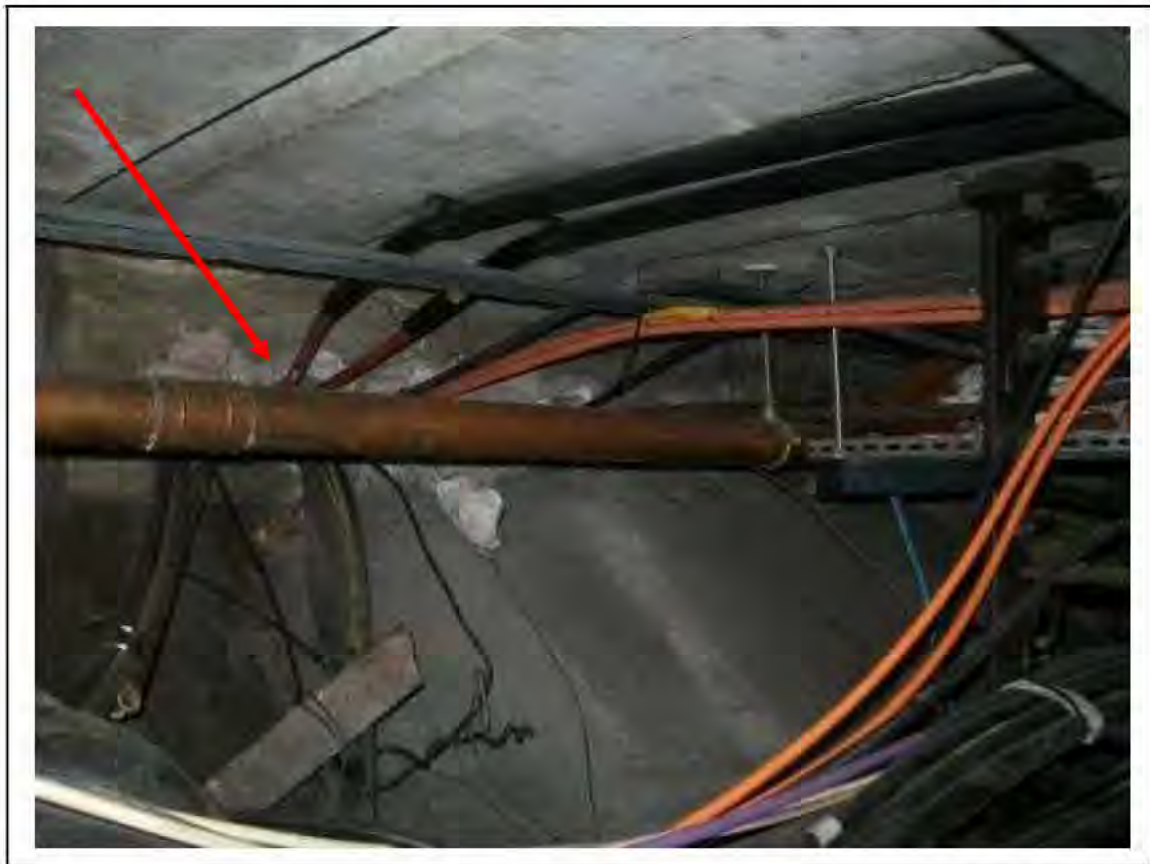
Cable ducts confirmed to contain Chrysotile asbestos, Figure 92 - Material assessment rating: Very low

FIGURE 92: CONFIRMED ASBESTOS IN CABLE DUCTS IN PASSAGE FLOOR DUCTS, 3/206 - DESCRIPTION & RESULT OF ASSESSMENT (SAMPLE REF. SAME AS 120445/190812/01)

Sample Number	Same as 120445/190812/01
Location	Passage floor ducts, 3/206
Material Description	Cable ducts
Material Comment	-
Quantity	10no
Product Type	Composite
Current Condition	Good condition
Surface Treatment	Composite
Asbestos Type	Chrysotile
Material Assessment Rating	Very low
Accessibility	Low
Further Comment	Not applicable

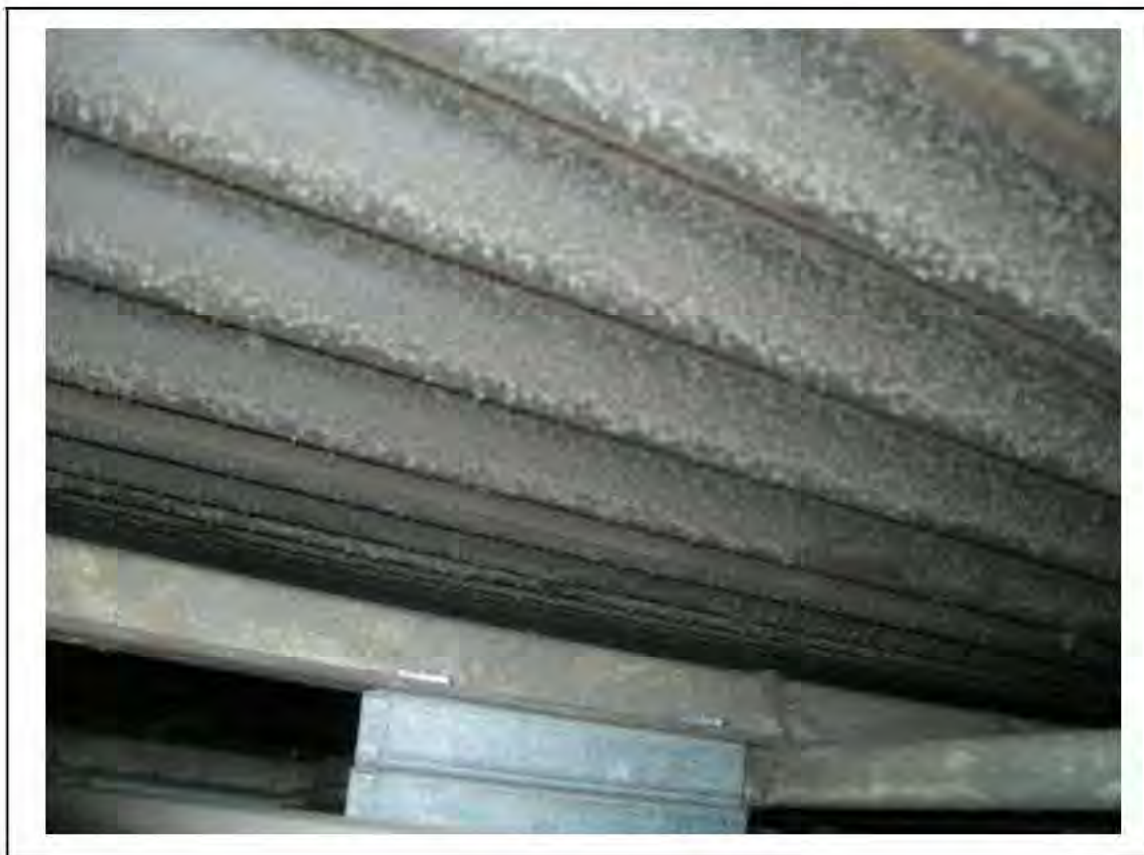
FIGURE 93: KNOWN ASBESTOS IN CELLACTITE IN PASSAGE, 3/206 - DESCRIPTION & RESULT OF ASSESSMENT (SAMPLE REF. K1(18))

Sample Number	K1(18)
Location	Passage, 3/206
Material Description	Cellactite
Material Comment	Above false ceiling
Quantity	12m ²
Product Type	Composite
Current Condition	Good condition
Surface Treatment	Composite
Asbestos Type	Known Chrysotile
Material Assessment Rating	Very low
Accessibility	Low
Further Comment	Not applicable

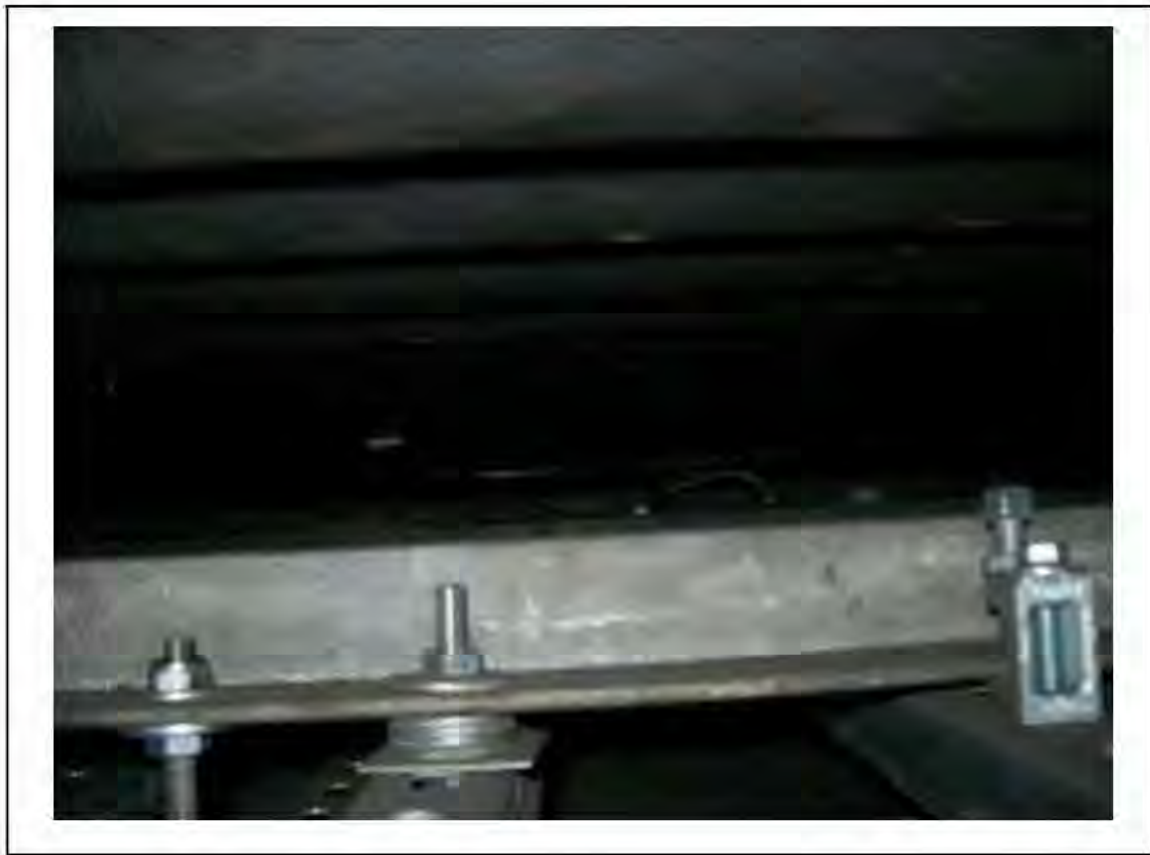
FIGURE 94: KNOWN ASBESTOS IN CELLACTITE IN PASSAGE , 3/207 - DESCRIPTION & RESULT OF ASSESSMENT (SAMPLE REF. K1(19))

Sample Number	K1(19)
Location	Passage , 3/207
Material Description	Cellactite
Material Comment	Above false ceiling, platform 2 end
Quantity	14m ²
Product Type	Composite
Current Condition	Good condition
Surface Treatment	Composite
Asbestos Type	Known Chrysotile
Material Assessment Rating	Very low
Accessibility	-
Further Comment	Not applicable

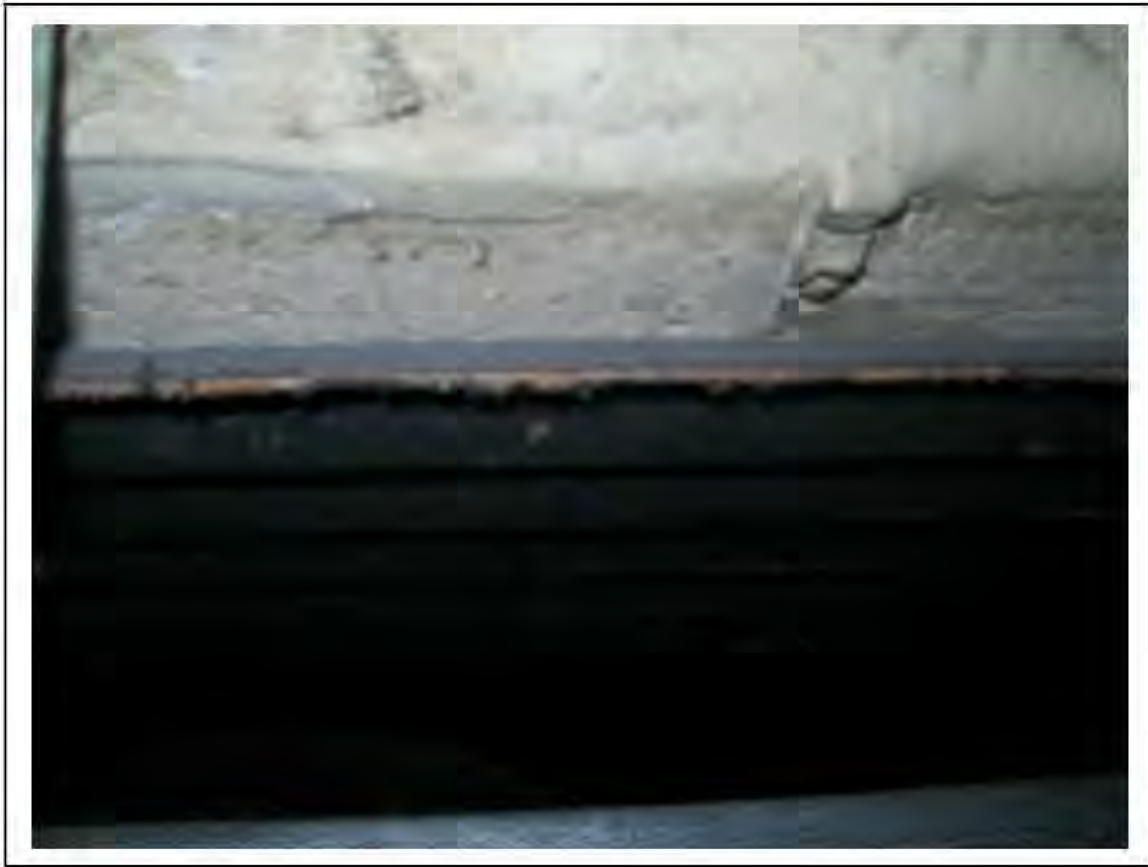
FIGURE 96: KNOWN ASBESTOS IN CELLACTITE IN PASSAGE , 3/207 - DESCRIPTION & RESULT OF ASSESSMENT (SAMPLE REF. K1(20))

Sample Number	K1(20)
Location	Passage , 3/207
Material Description	Cellactite
Material Comment	Platform 1 end
Quantity	10m ²
Product Type	Composite
Current Condition	Good condition
Surface Treatment	Composite
Asbestos Type	Known Chrysotile
Material Assessment Rating	Very low
Accessibility	Low
Further Comment	Not applicable

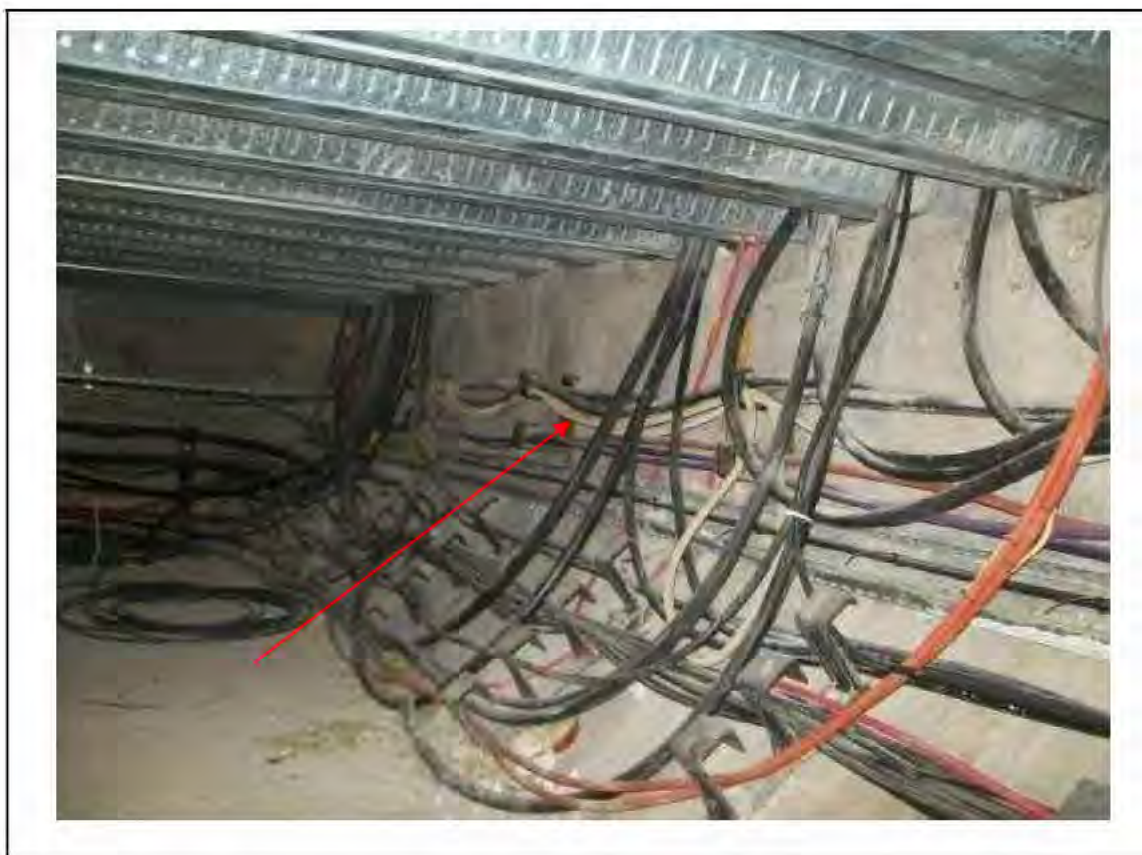
FIGURE 97: KNOWN ASBESTOS IN BRAIDED CABLE IN PASSAGE CABLE DUCT/TRENCH, 3/207 - DESCRIPTION & RESULT OF ASSESSMENT (SAMPLE REF. K1(21))

Sample Number	K1(21)
Location	Passage cable duct/trench, 3/207
Material Description	Braided cable
Material Comment	To platform 1 within j hangers
Quantity	1no
Product Type	Medium density
Current Condition	Slight damage
Surface Treatment	Unencapsulated medium density
Asbestos Type	Known Chrysotile
Material Assessment Rating	Low
Accessibility	Low
Further Comment	Not applicable

Passage cable duct/trench	3/207	Loose mmmf insulation, metal pipeworks and foam insulation	-	-	-	-	-	-	Within ducts	-
K1(21)	Passage cable duct/trench	3/207	Braided cable	1no	2	1	2	1	K1	To platform 1 within j hangers	Figure 97
	Passage	3/208	Metal slats	-	-	-	-	-	-	False ceiling	-
	Passage	3/208	Paving slabs	-	-	-	-	-	-	Floor	-

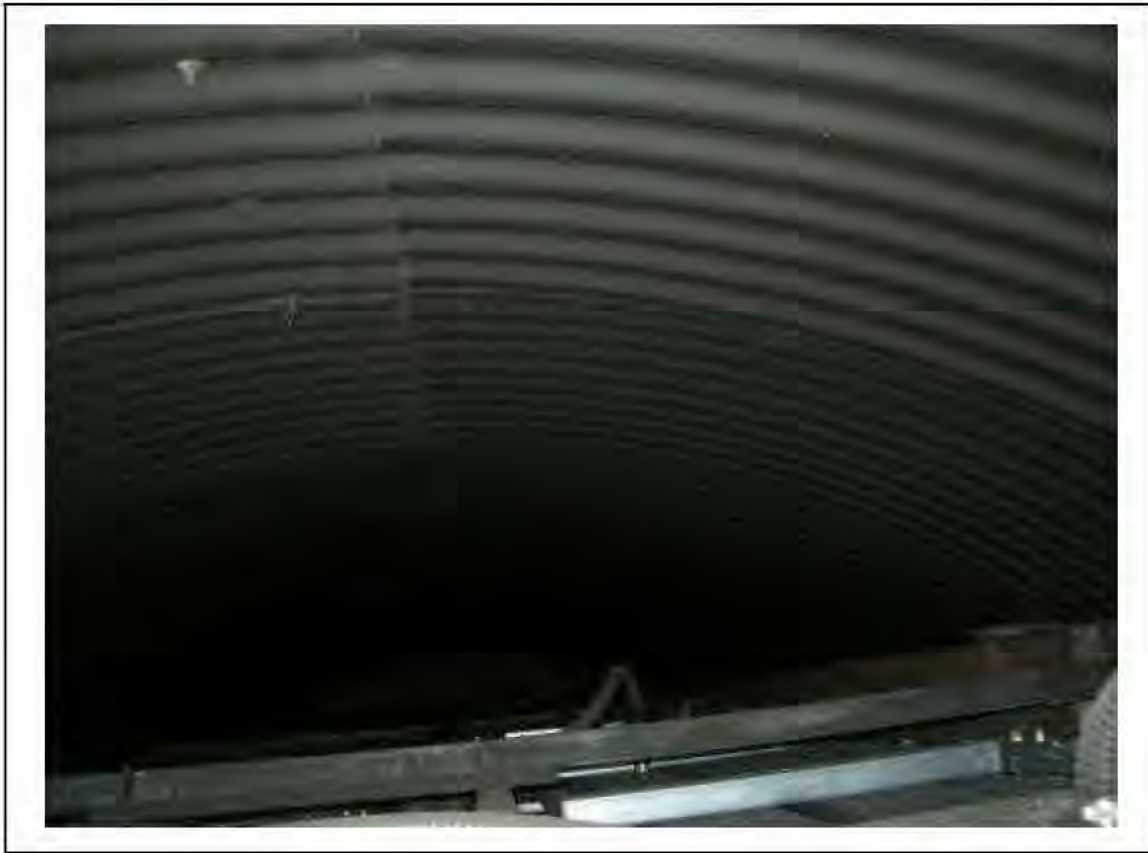
FIGURE 98: KNOWN ASBESTOS IN CELLACTITE IN PASSAGE , 3/208 - DESCRIPTION & RESULT OF ASSESSMENT (SAMPLE REF. K1(22))

Sample Number	K1(22)
Location	Passage , 3/208
Material Description	Cellactite
Material Comment	Above false ceiling
Quantity	30m
Product Type	Composite
Current Condition	Good condition
Surface Treatment	Composite
Asbestos Type	Known Chrysotile
Material Assessment Rating	Very low
Accessibility	Low
Further Comment	Not applicable

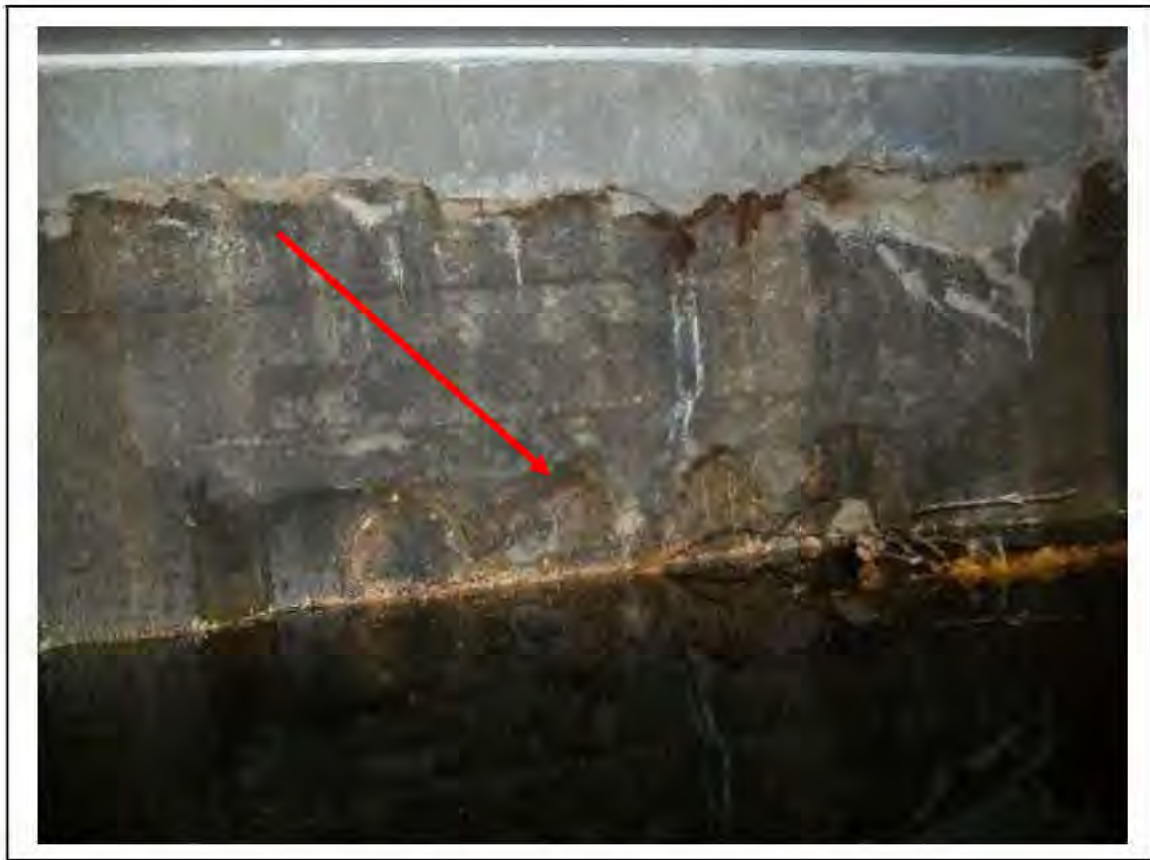
FIGURE 99: CONFIRMED ASBESTOS IN CEMENT DUCT IN CROSS PASSAGE FLOOR DUCT, 3/208 - DESCRIPTION & RESULT OF ASSESSMENT (SAMPLE REF. 120445/200812/01)

Sample Number	120445/200812/01
Location	Cross Passage floor duct, 3/208
Material Description	Cement duct
Material Comment	Either side within duct
Quantity	8no
Product Type	Composite
Current Condition	Good condition
Surface Treatment	Composite
Asbestos Type	Chrysotile
Material Assessment Rating	Very low
Accessibility	Low
Further Comment	Not applicable

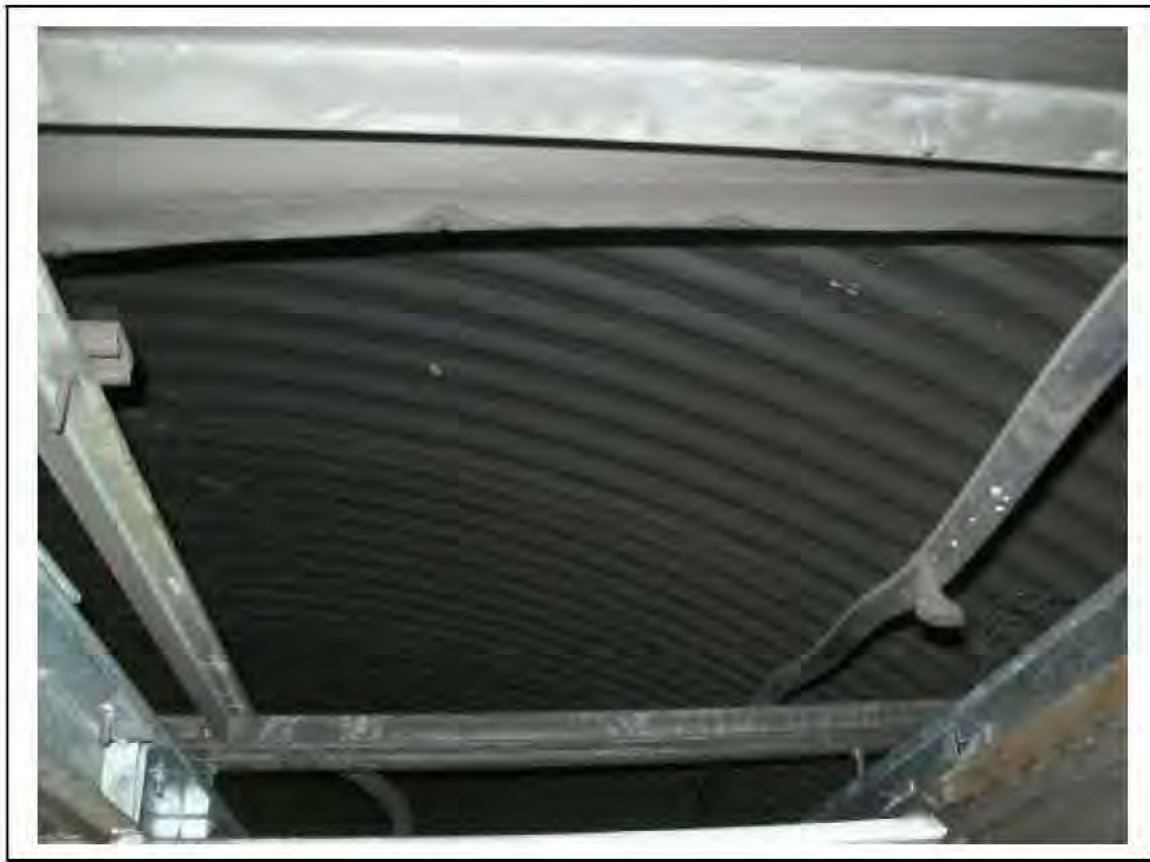
FIGURE 100: KNOWN ASBESTOS IN CELLACTITE IN PASSAGE , 3/209 - DESCRIPTION & RESULT OF ASSESSMENT (SAMPLE REF. K1(23))

Sample Number	K1(23)
Location	Passage , 3/209
Material Description	Cellactite
Material Comment	Above false ceiling
Quantity	30m
Product Type	Composite
Current Condition	Good condition
Surface Treatment	Composite
Asbestos Type	Known Chrysotile
Material Assessment Rating	Very low
Accessibility	Low
Further Comment	Not applicable

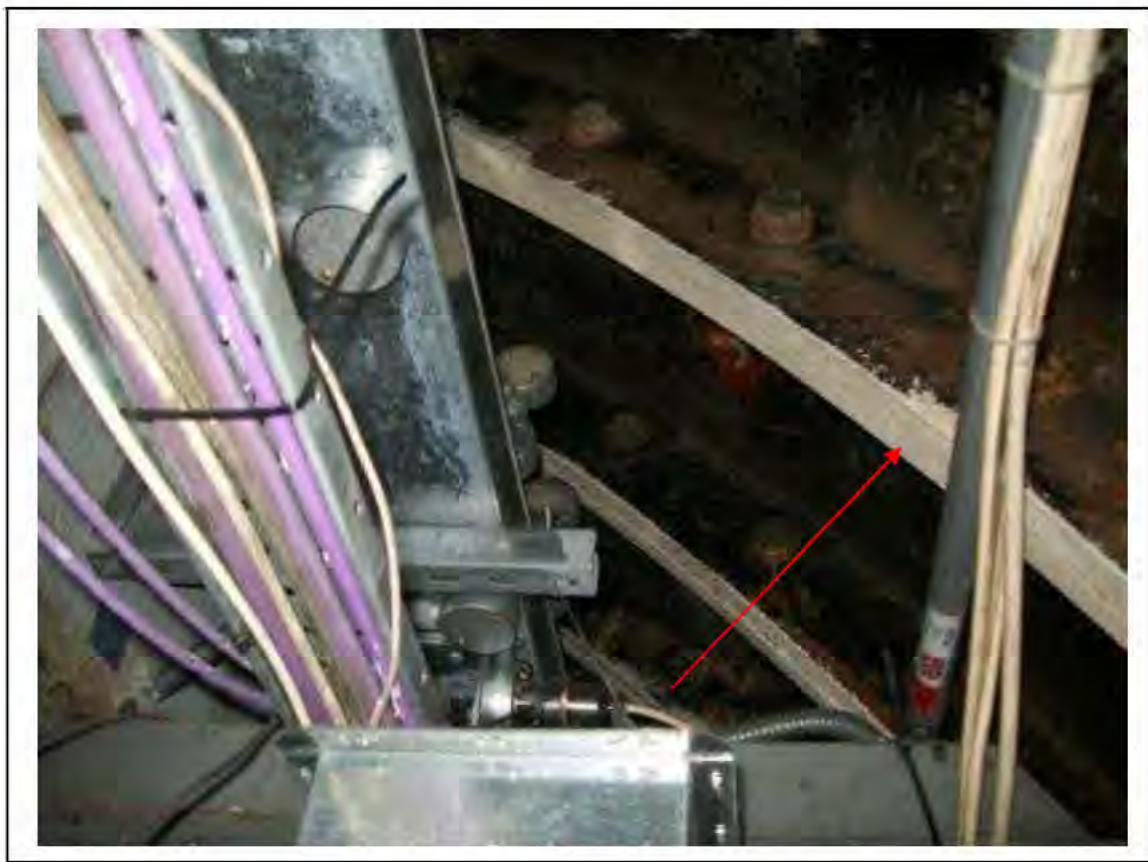
FIGURE 101: CONFIRMED ASBESTOS IN CAULKING IN CORRIDOR , 3/236 - DESCRIPTION & RESULT OF ASSESSMENT (SAMPLE REF. SAME AS 120445/150812/03)

Sample Number	Same as 120445/150812/03
Location	Corridor , 3/236
Material Description	Caulking
Material Comment	Tunnel ring flanges within false ceiling
Quantity	throughout
Product Type	Medium density
Current Condition	Slight damage
Surface Treatment	Encapsulated medium density
Asbestos Type	Amosite and Chrysotile
Material Assessment Rating	Medium
Accessibility	Low
Further Comment	Not applicable

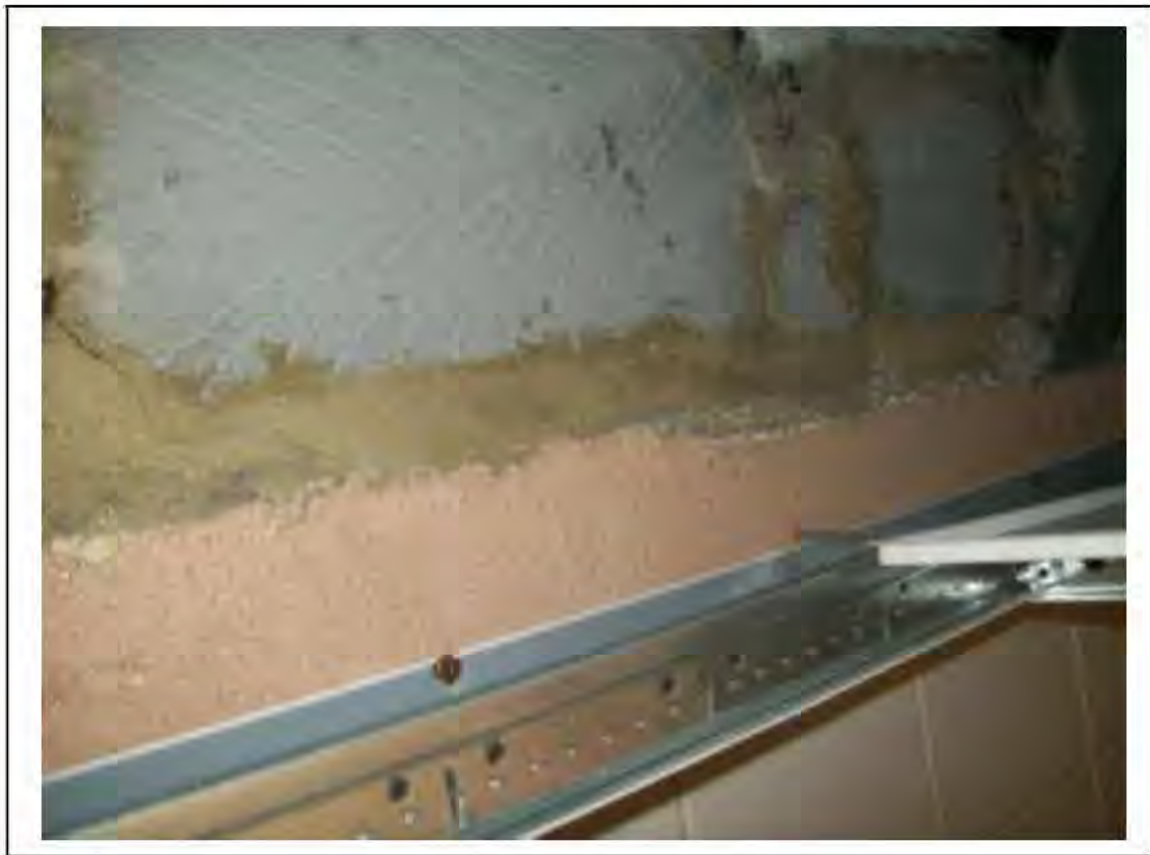
FIGURE 103: KNOWN ASBESTOS IN CELLACTITE CORRUGATED SHEETING IN CORRIDOR, 3/237 - DESCRIPTION & RESULT OF ASSESSMENT (SAMPLE REF. K1(24))

Sample Number	K1(24)
Location	Corridor, 3/237
Material Description	Cellactite corrugated sheeting
Material Comment	Within wall cavity
Quantity	throughout
Product Type	-
Current Condition	-
Surface Treatment	-
Asbestos Type	Known Chrysotile
Material Assessment Rating	-
Accessibility	-
Further Comment	Not applicable

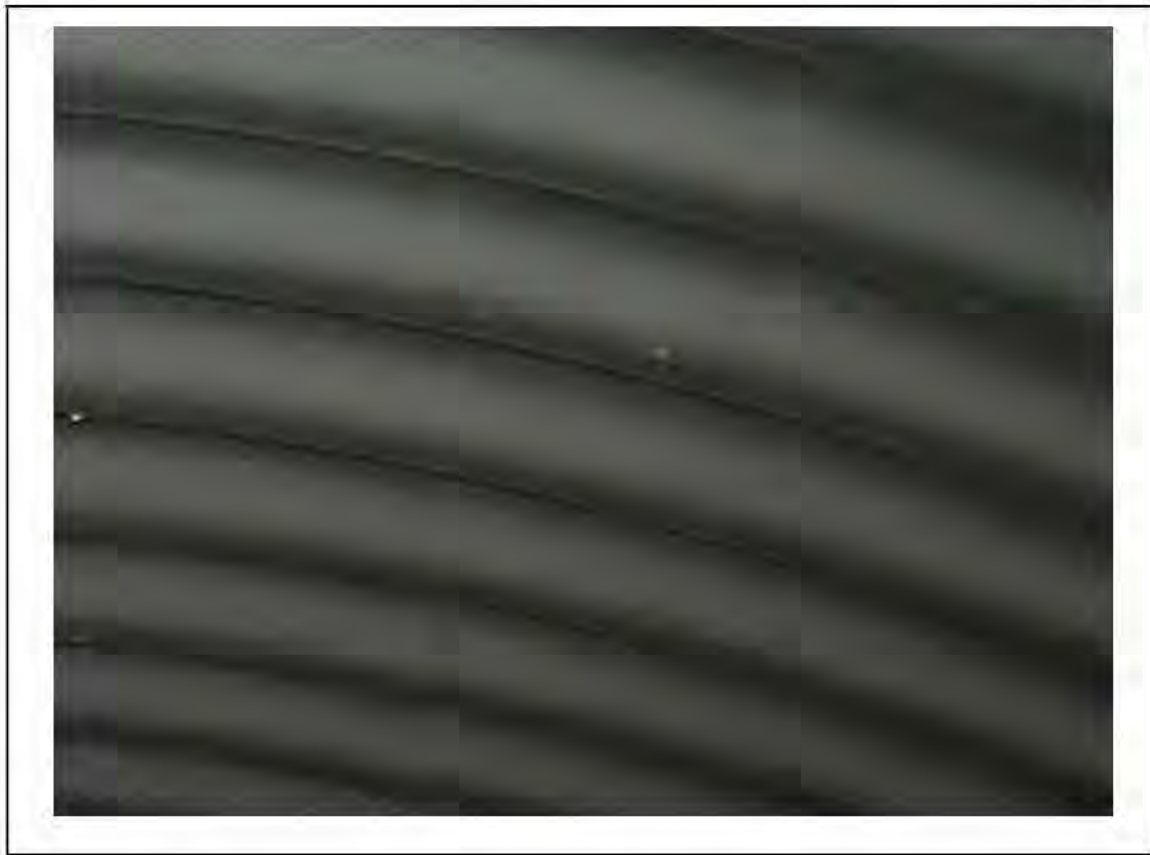
FIGURE 105: CONFIRMED ASBESTOS IN CELLACTITE IN PLATFORMS 1 & 2, 3/261 & 3/262 - DESCRIPTION & RESULT OF ASSESSMENT (SAMPLE REF. 061128/24SPH)

Sample Number	061128/24SPH
Location	Platforms 1 & 2, 3/261 & 3/262
Material Description	Cellactite
Material Comment	-
Quantity	throughout
Product Type	Composite
Current Condition	-
Surface Treatment	Composite
Asbestos Type	Chrysotile
Material Assessment Rating	Very low
Accessibility	Low
Further Comment	Not applicable

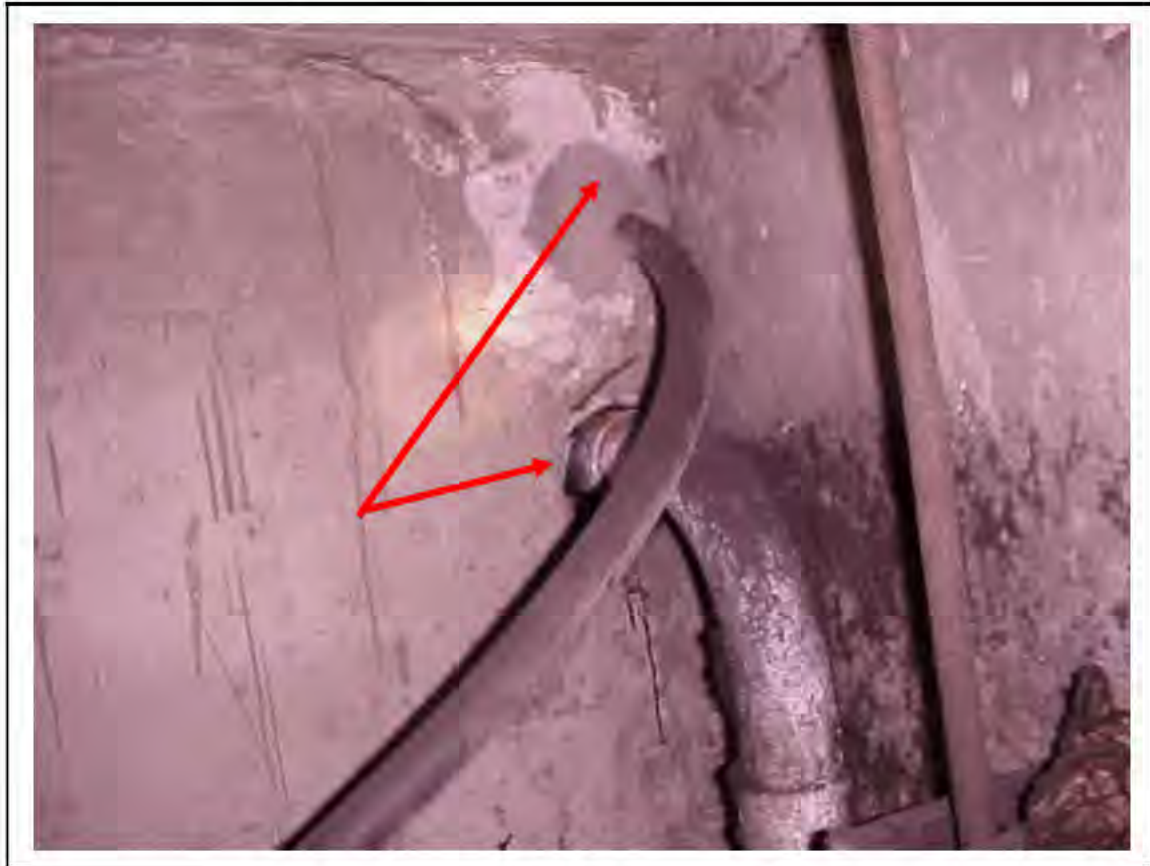
FIGURE 106: CONFIRMED ASBESTOS IN CABLE SLEEVES IN VICTORIA LINE, PLATFORM 1 INVERT, 3/261, DOWN HATCH NEAR 3/711 - DESCRIPTION & RESULT OF ASSESSMENT (SAMPLE REF. 034219/7)

Sample Number	034219/7
Location	Victoria Line, Platform 1, 3/261, Down hatch near 3/711
Material Description	Cable sleeves
Material Comment	Head wall
Quantity	x2
Product Type	Composite
Current Condition	Good condition
Surface Treatment	Composite
Asbestos Type	Chrysotile
Material Assessment Rating	Very low
Accessibility	Low
Further Comment	Not applicable

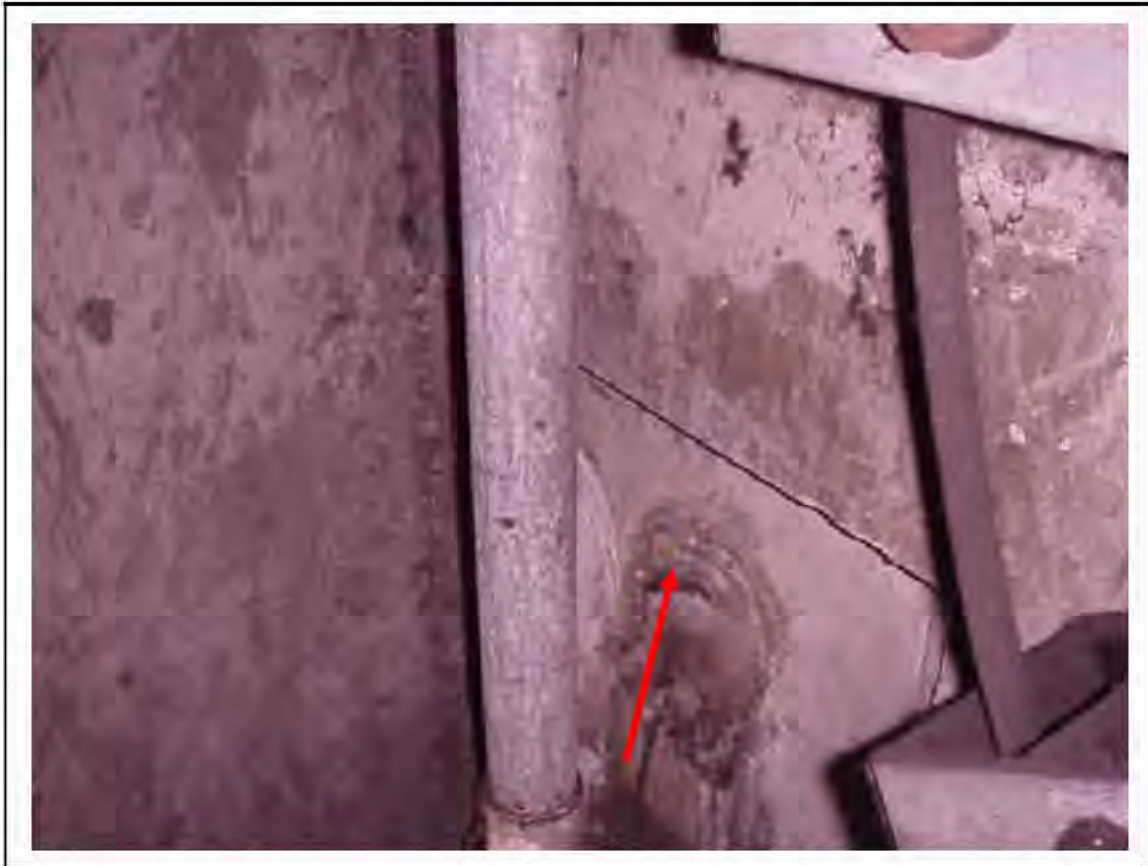
FIGURE 107: CONFIRMED ASBESTOS IN CABLE SLEEVES IN VICTORIA LINE, PLATFORM 1 INVERT, 3/261, DOWN HATCH NEAR 3/711 - DESCRIPTION & RESULT OF ASSESSMENT (SAMPLE REF. 034219/8)

Sample Number	034219/8
Location	Victoria Line, Platform 1, 3/261, Down hatch near 3/711
Material Description	Cable sleeves
Material Comment	Pit side lower level
Quantity	x2
Product Type	Composite
Current Condition	Good condition
Surface Treatment	Composite
Asbestos Type	Chrysotile
Material Assessment Rating	Very low
Accessibility	Low
Further Comment	Not applicable

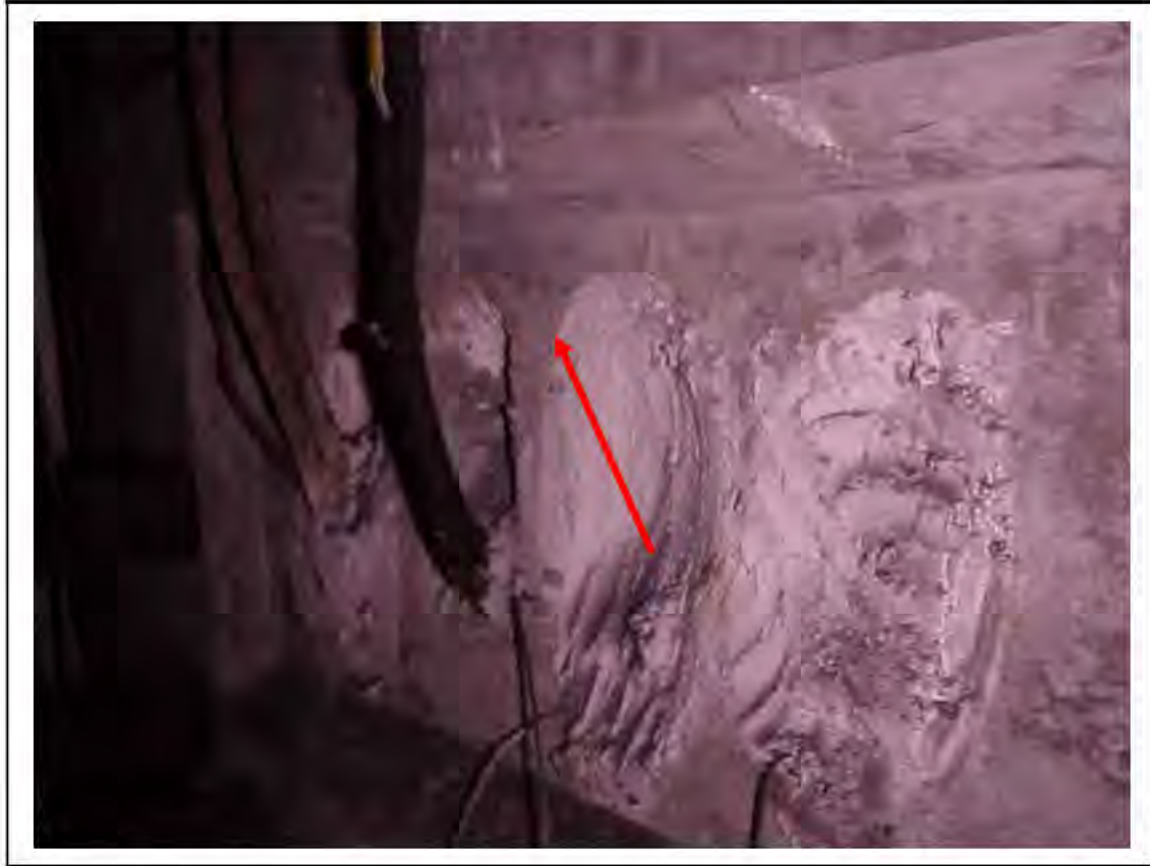
FIGURE 108: CONFIRMED ASBESTOS IN CABLE SLEEVES IN VICTORIA LINE, PLATFORM 1 INVERT, 3/261, DOWN HATCH NEAR 3/711 - DESCRIPTION & RESULT OF ASSESSMENT (SAMPLE REF. AS 034219/7&8)

Sample Number	As 034219/7&8
Location	Victoria Line, Platform 1, 3/261, Down hatch near 3/711
Material Description	Cable sleeves
Material Comment	Pit side
Quantity	x4
Product Type	Composite
Current Condition	Good condition
Surface Treatment	Composite
Asbestos Type	Chrysotile
Material Assessment Rating	Very low
Accessibility	Low
Further Comment	Not applicable

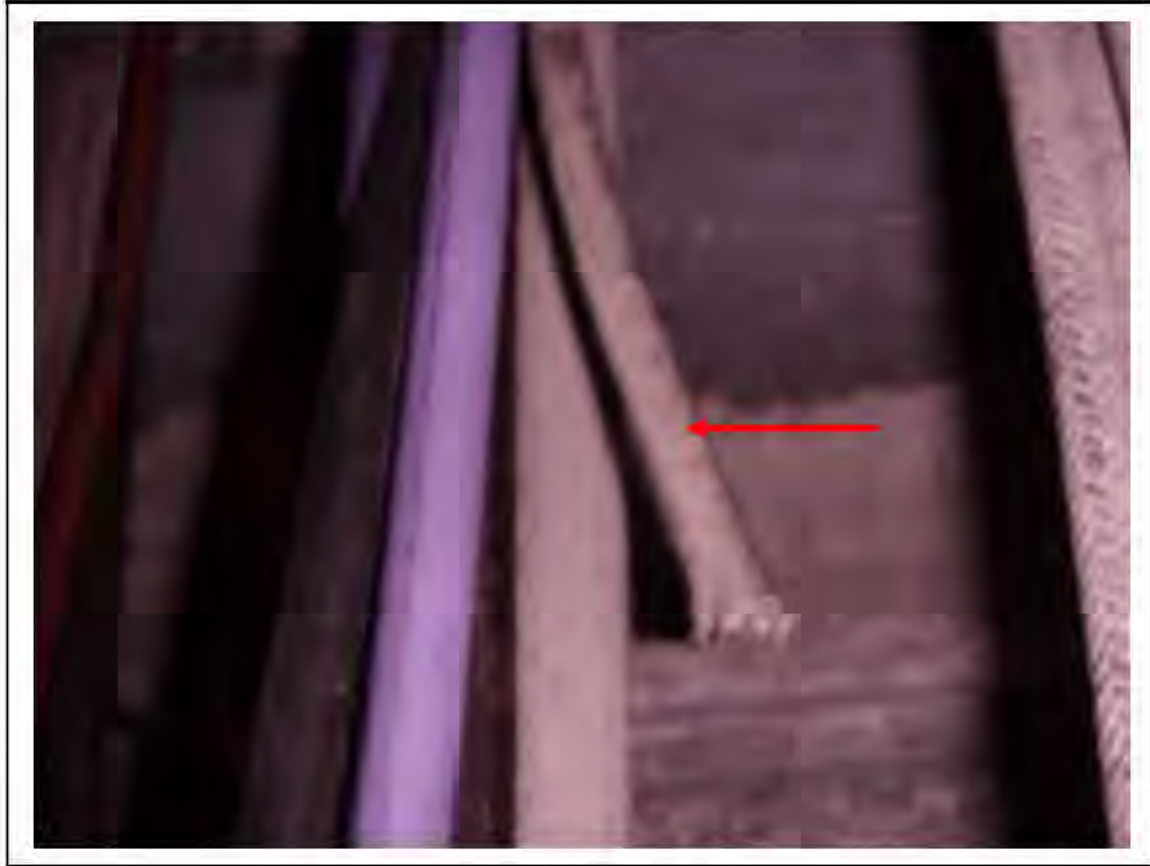
FIGURE 110: CONFIRMED ASBESTOS IN CABLE IN VICTORIA LINE, PLATFORM 1 INVERT, 3/261, DOWN HATCH NEAR 3/711 - DESCRIPTION & RESULT OF ASSESSMENT (SAMPLE REF. 034219/9)

Sample Number	034219/9
Location	Victoria Line, Platform 1, 3/261, Down hatch near 3/711
Material Description	Cable
Material Comment	Cut by ceiling new head wall
Quantity	1x0.5cm Ø 30m visible
Product Type	Medium density
Current Condition	Slight damage
Surface Treatment	Unencapsulated medium density
Asbestos Type	Chrysotile
Material Assessment Rating	Low
Accessibility	Low
Further Comment	Not applicable

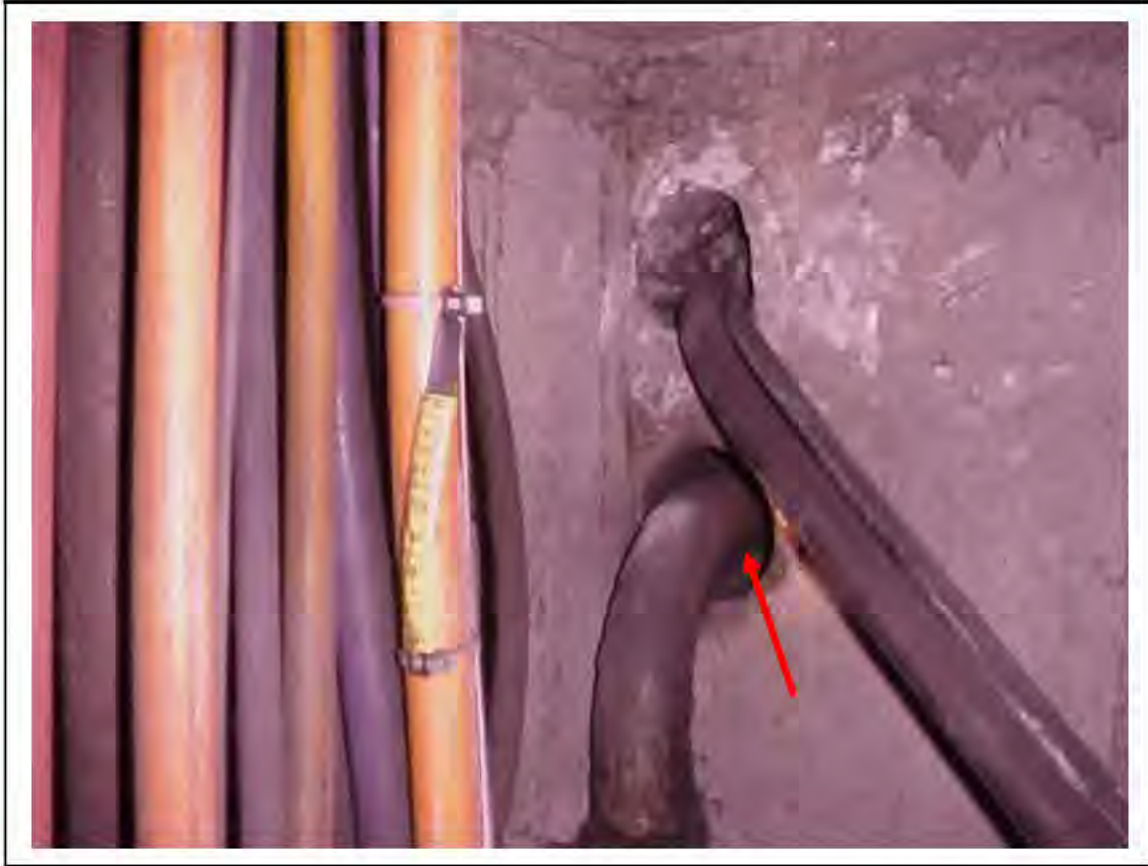
FIGURE 116: CONFIRMED ASBESTOS IN CABLE SLEEVES IN VICTORIA LINE, PLATFORM 1 INVERT, 3/261, OTHER END 3/706 - DESCRIPTION & RESULT OF ASSESSMENT (SAMPLE REF. SAME AS 034219/7,8,10)

Sample Number	Same as 034219/7,8,10
Location	Victoria Line, Platform 1, 3/261, Other end 3/706
Material Description	Cable sleeves
Material Comment	Head wall
Quantity	x2
Product Type	Composite
Current Condition	Good condition
Surface Treatment	Composite
Asbestos Type	Chrysotile
Material Assessment Rating	Very low
Accessibility	Low
Further Comment	Not applicable

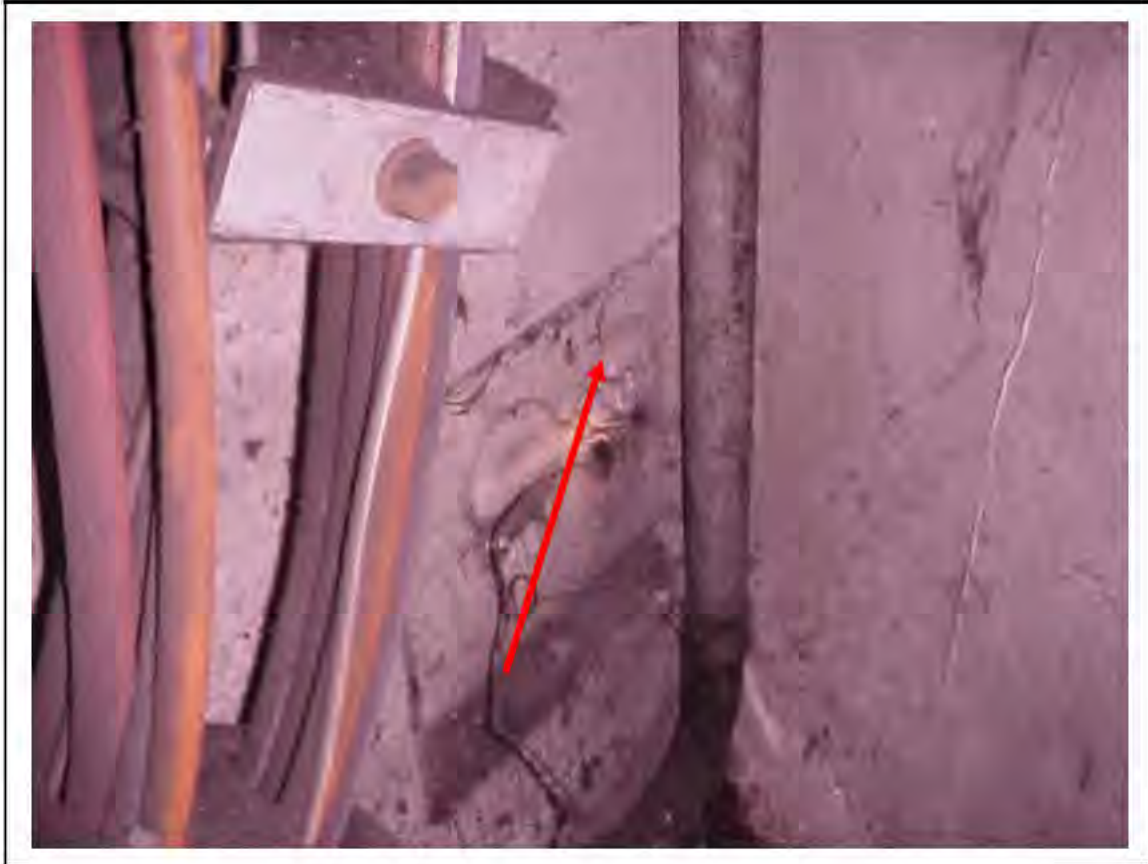
FIGURE 117: CONFIRMED ASBESTOS IN CABLE SLEEVES IN VICTORIA LINE, PLATFORM 1 INVERT, 3/261, OTHER END 3/706 - DESCRIPTION & RESULT OF ASSESSMENT (SAMPLE REF. SAME AS 034219/7,8,10)

Sample Number	Same as 034219/7,8,10
Location	Victoria Line, Platform 1, 3/261, Other end 3/706
Material Description	Cable sleeves
Material Comment	Lower level pit side
Quantity	x2
Product Type	Composite
Current Condition	Good condition
Surface Treatment	Composite
Asbestos Type	Chrysotile
Material Assessment Rating	Very low
Accessibility	Low
Further Comment	Not applicable

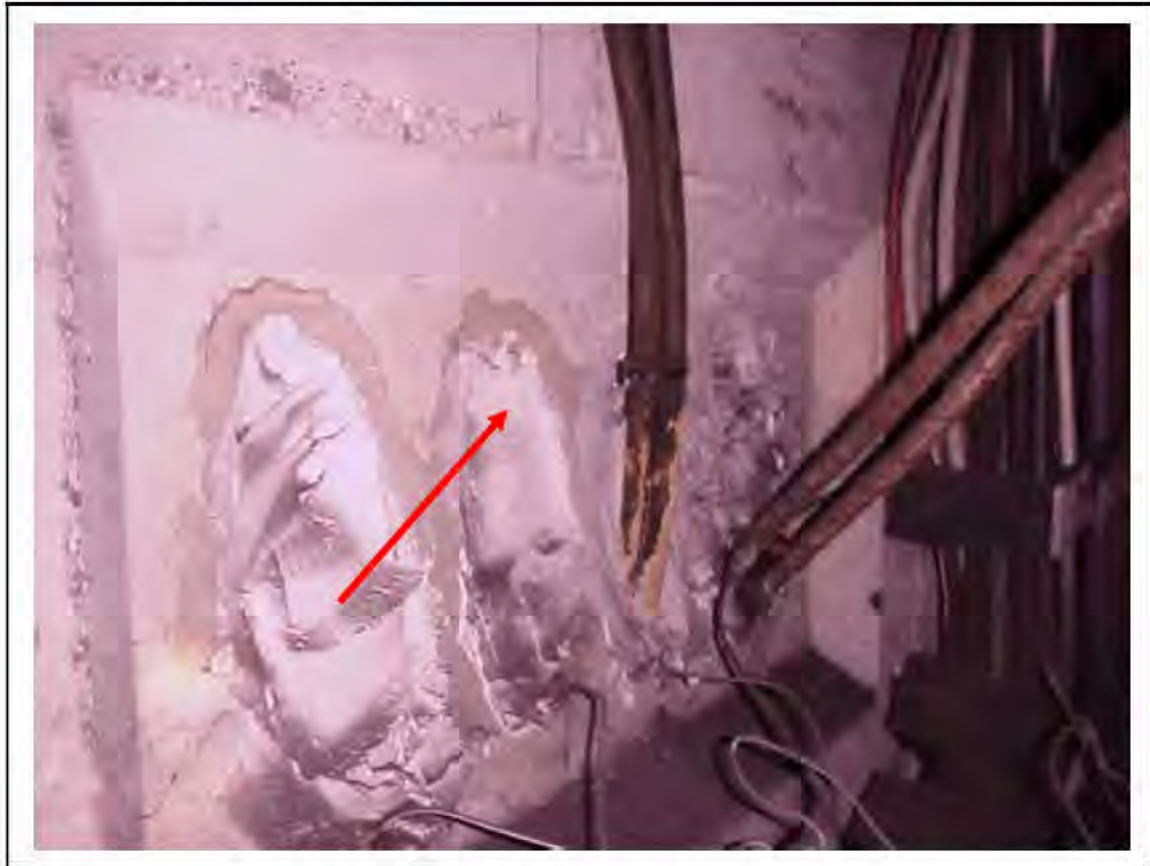
FIGURE 118: CONFIRMED ASBESTOS IN CABLE SLEEVES IN VICTORIA LINE, PLATFORM 1 INVERT, 3/261, OTHER END 3/706 - DESCRIPTION & RESULT OF ASSESSMENT (SAMPLE REF. SAME AS 034219/7,8,10)

Sample Number	Same as 034219/7,8,10
Location	Victoria Line, Platform 1, 3/261, Other end 3/706
Material Description	Cable sleeves
Material Comment	Pit side
Quantity	x2
Product Type	Composite
Current Condition	Good condition
Surface Treatment	Composite
Asbestos Type	Chrysotile
Material Assessment Rating	Very low
Accessibility	Low
Further Comment	Not applicable
