Hazardous Materials - TfL Engineering

Re-inspection Sign-Off for Brixton

Re-inspection Reference: V059/4RS-200403

Station	Brixton
Original Management Survey	R346601
Date of Original Management	31st August 2012
Re-inspection Reference:	V059-4RS-200403
Next Planned Re-inspection	Periodical re-inspection according to HM Management Plan

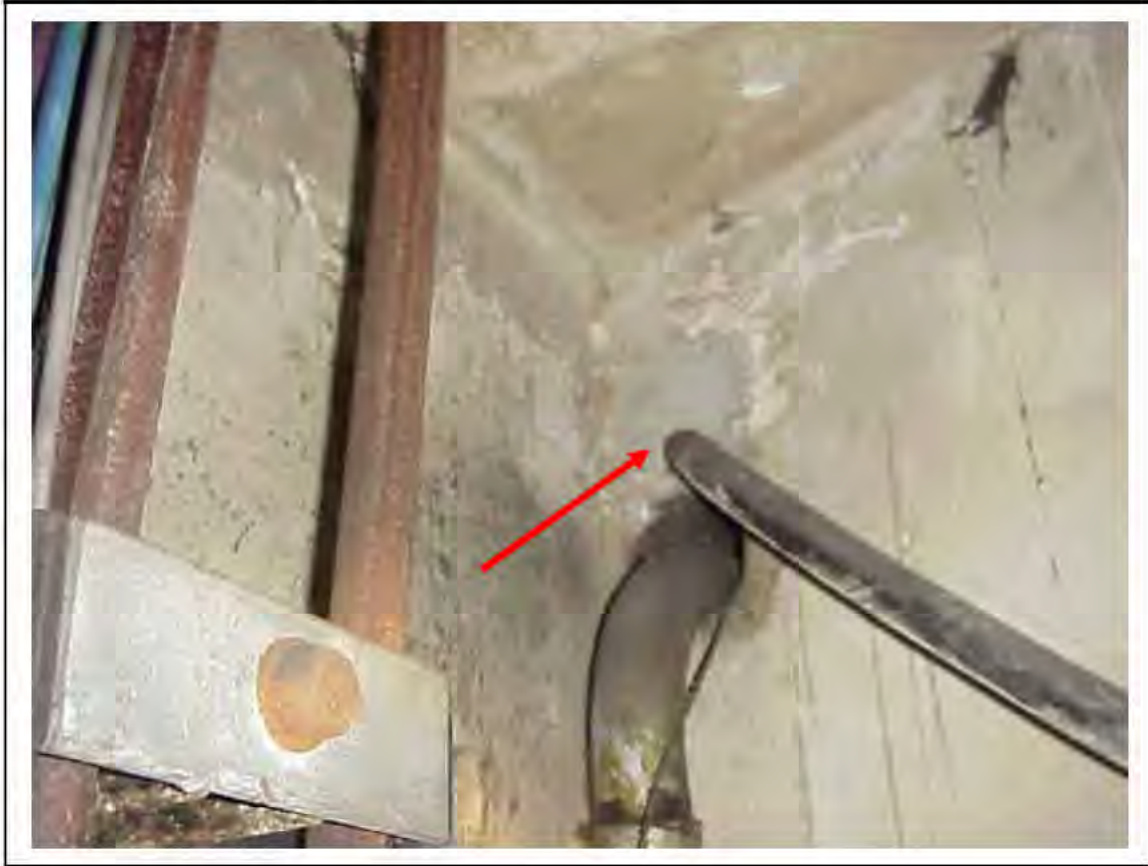
FIGURE 120: CONFIRMED ASBESTOS IN CABLE SLEEVES IN VICTORIA LINE, PLATFORM 2 INVERT, 3/262, DOWN HATCH NEAR 3/712 - DESCRIPTION & RESULT OF ASSESSMENT (SAMPLE REF. 034219/1)

Sample Number	034219/1
Location	Victoria Line, Platform 2, 3/262, Down hatch near 3/712
Material Description	Cable sleeves
Material Comment	Head wall pit side
Quantity	x2
Product Type	Composite
Current Condition	Good condition
Surface Treatment	Composite
Asbestos Type	Chrysotile
Material Assessment Rating	Very low
Accessibility	Low
Further Comment	Not applicable

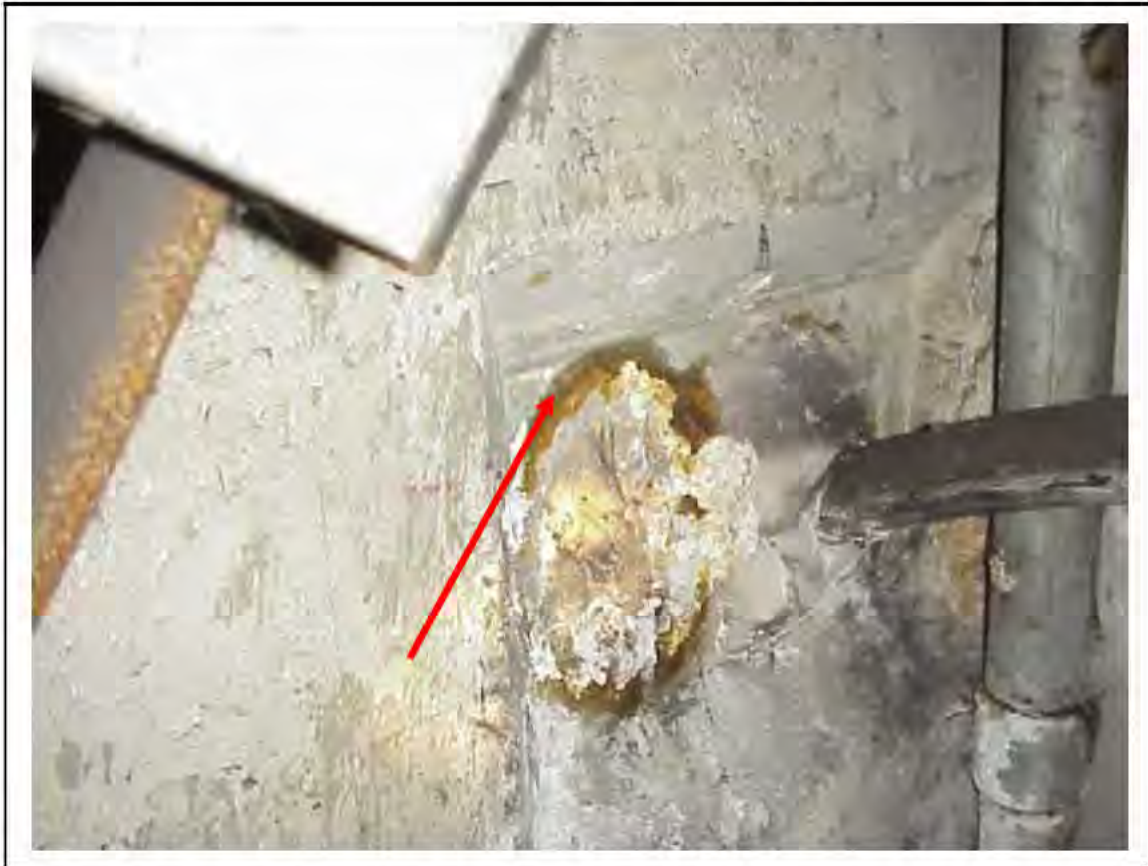
FIGURE 121: CONFIRMED ASBESTOS IN CABLE SLEEVES IN VICTORIA LINE, PLATFORM 2 INVERT, 3/262, DOWN HATCH NEAR 3/712 - DESCRIPTION & RESULT OF ASSESSMENT (SAMPLE REF. 034219/2)

Sample Number	034219/2
Location	Victoria Line, Platform 2, 3/262, Down hatch near 3/712
Material Description	Cable sleeves
Material Comment	Pit side lower level near head wall
Quantity	x2
Product Type	Composite
Current Condition	Good condition
Surface Treatment	Composite
Asbestos Type	Chrysotile
Material Assessment Rating	Very low
Accessibility	Low
Further Comment	Not applicable

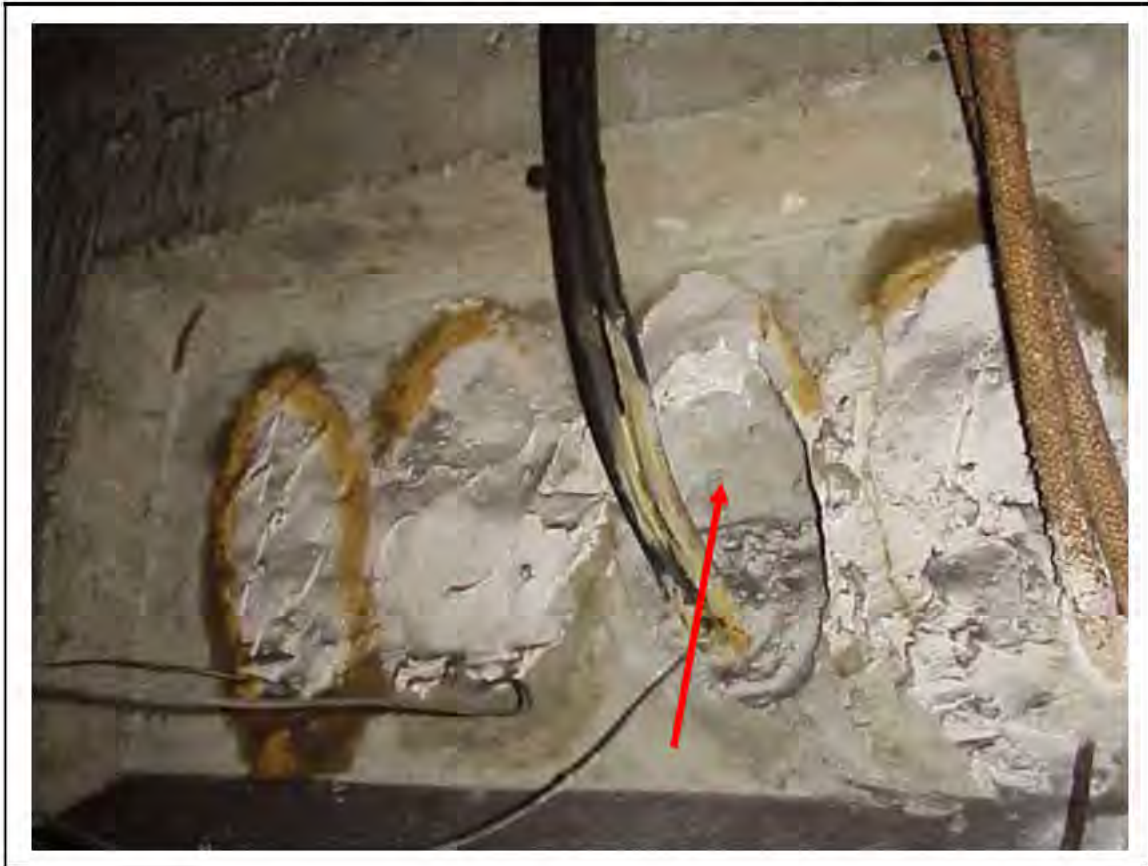
FIGURE 122: CONFIRMED ASBESTOS IN CABLE SLEEVES IN VICTORIA LINE, PLATFORM 2 INVERT, 3/262, DOWN HATCH NEAR 3/712 - DESCRIPTION & RESULT OF ASSESSMENT (SAMPLE REF. 034219/3)

Sample Number	034219/3
Location	Victoria Line, Platform 2, 3/262, Down hatch near 3/712
Material Description	Cable sleeves
Material Comment	Slight damage in on pit side 1m from head wall
Quantity	x4
Product Type	Composite
Current Condition	Slight damage
Surface Treatment	Composite
Asbestos Type	Chrysotile
Material Assessment Rating	Very low
Accessibility	Low
Further Comment	Not applicable

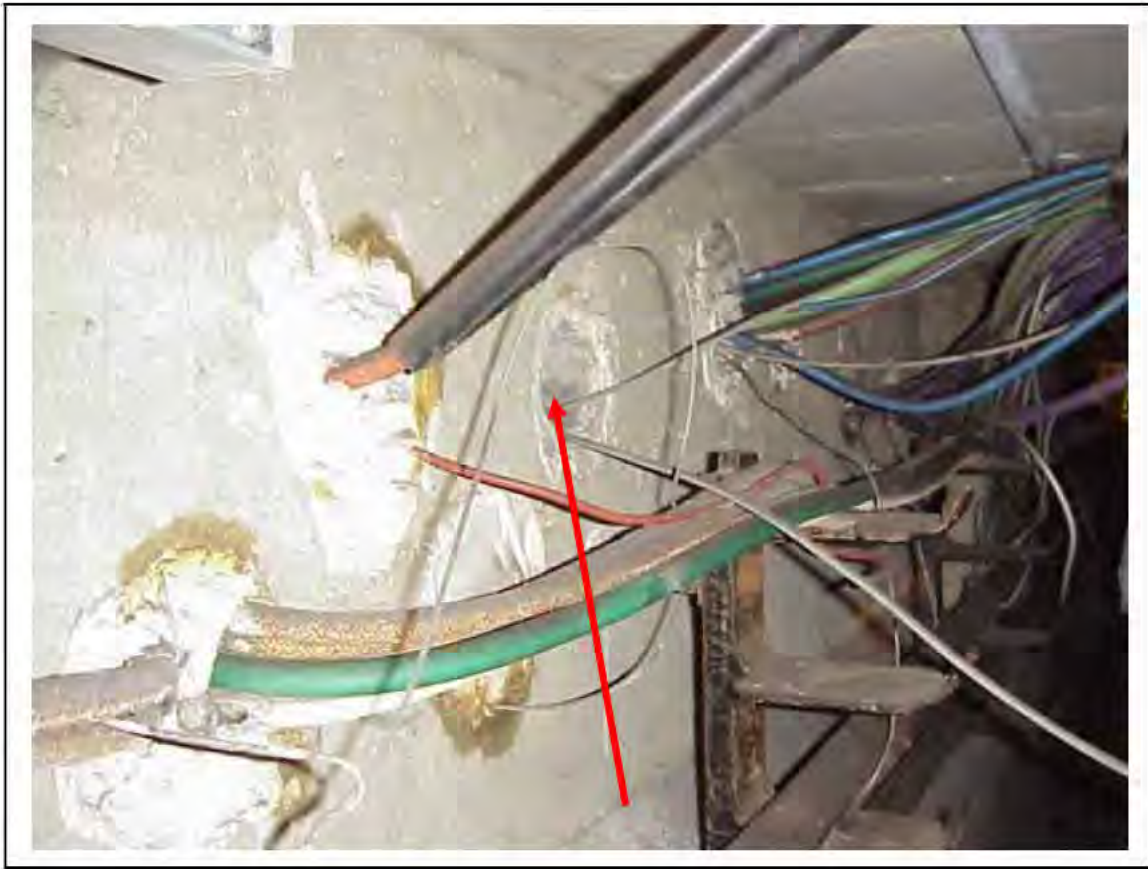
FIGURE 125: CONFIRMED ASBESTOS IN CABLE SLEEVES IN VICTORIA LINE, PLATFORM 2 INVERT, 3/262, 15M DOWN - DESCRIPTION & RESULT OF ASSESSMENT (SAMPLE REF. 034219/4)

Sample Number	034219/4
Location	Victoria Line, Platform 2, 3/262, 15m down
Material Description	Cable sleeves
Material Comment	Platform side
Quantity	x20
Product Type	Composite
Current Condition	Good condition
Surface Treatment	Composite
Asbestos Type	Chrysotile
Material Assessment Rating	Very low
Accessibility	Low
Further Comment	Not applicable

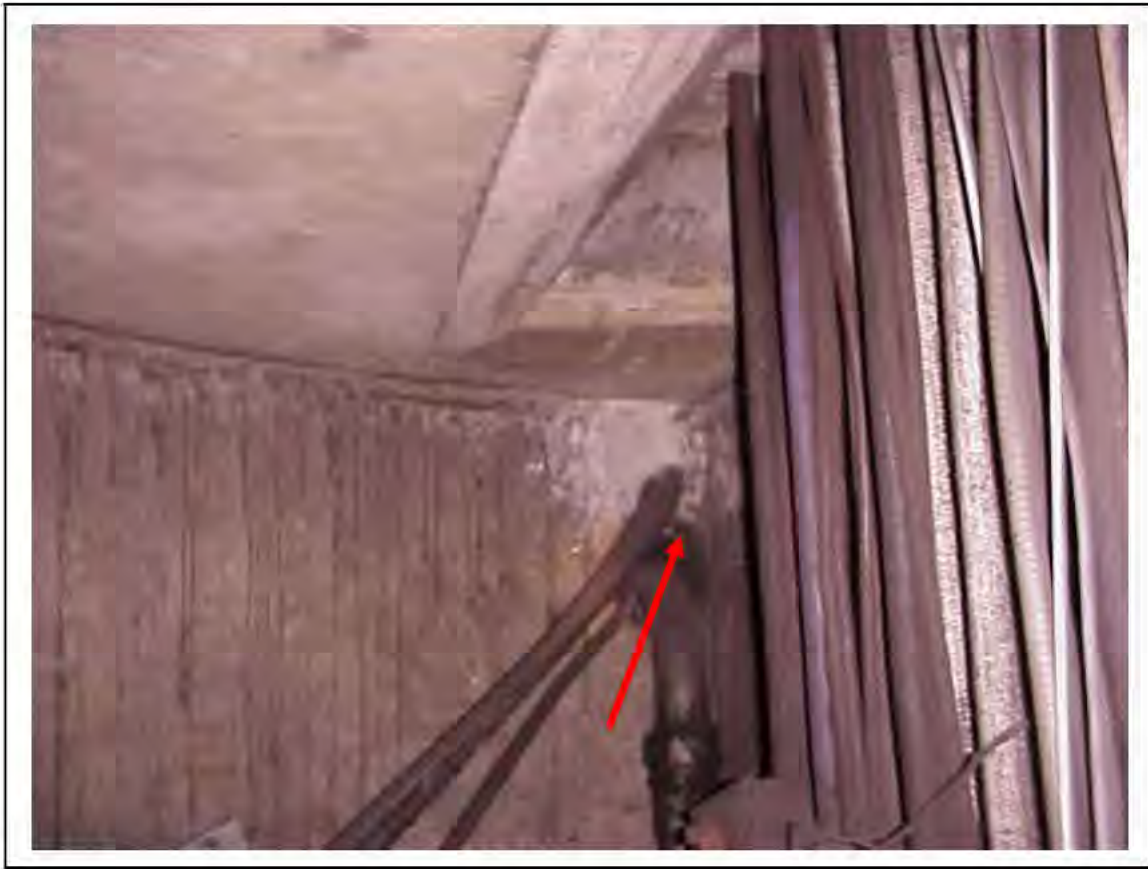
FIGURE 130: CONFIRMED ASBESTOS IN CABLE SLEEVES IN VICTORIA LINE, PLATFORM 2 INVERT, 3/262, OTHER END 3/706 - DESCRIPTION & RESULT OF ASSESSMENT (SAMPLE REF. SAME AS 034219/5)

Sample Number	Same as 034219/5
Location	Victoria Line, Platform 2, 3/262, Other end 3/706
Material Description	Cable sleeves
Material Comment	Head wall
Quantity	x2
Product Type	Composite
Current Condition	Slight damage
Surface Treatment	Composite
Asbestos Type	Chrysotile
Material Assessment Rating	Very low
Accessibility	Low
Further Comment	Not applicable

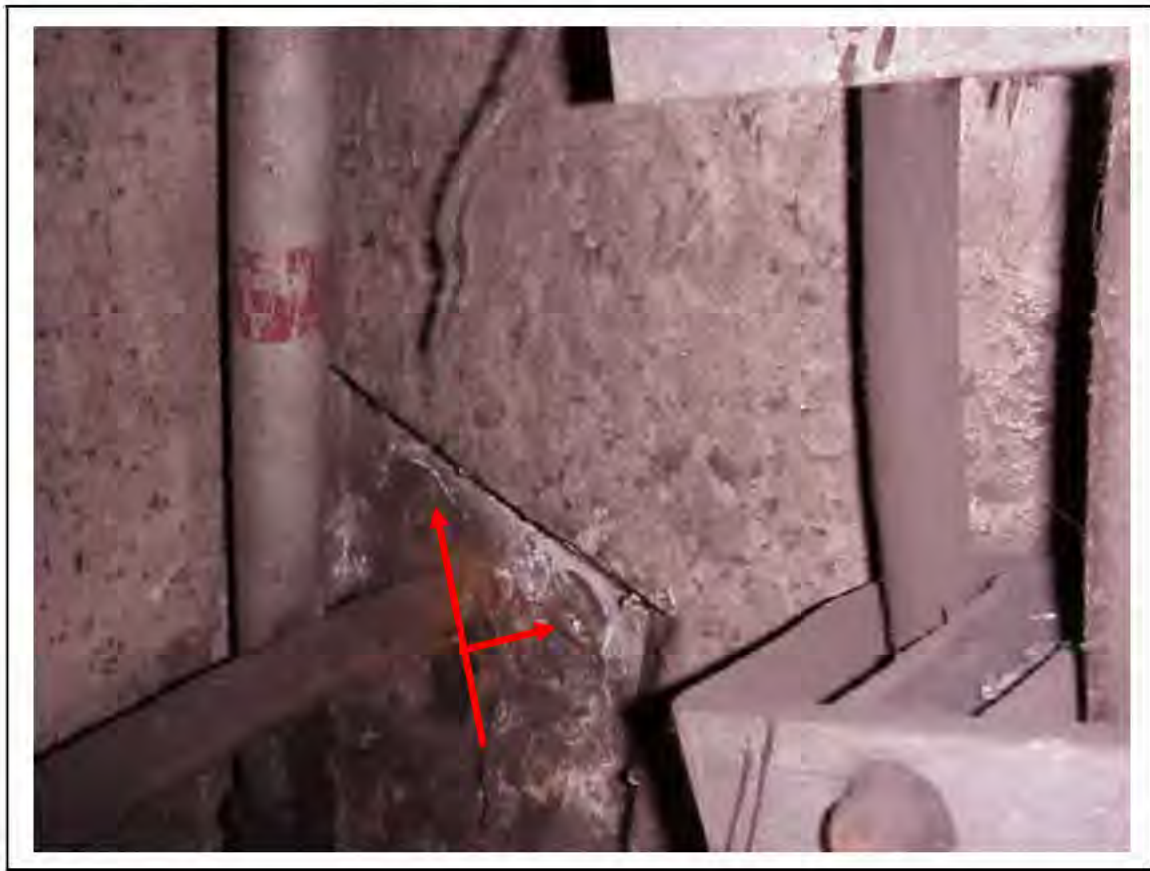
FIGURE 131: CONFIRMED ASBESTOS IN CABLE SLEEVES IN VICTORIA LINE, PLATFORM 2 INVERT, 3/262, OTHER END 3/706 - DESCRIPTION & RESULT OF ASSESSMENT (SAMPLE REF. SAME AS 034219/5)

Sample Number	Same as 034219/5
Location	Victoria Line, Platform 2, 3/262, Other end 3/706
Material Description	Cable sleeves
Material Comment	Pit side lower level
Quantity	x2
Product Type	Composite
Current Condition	Slight damage
Surface Treatment	Composite
Asbestos Type	Chrysotile
Material Assessment Rating	Very low
Accessibility	Low
Further Comment	Not applicable

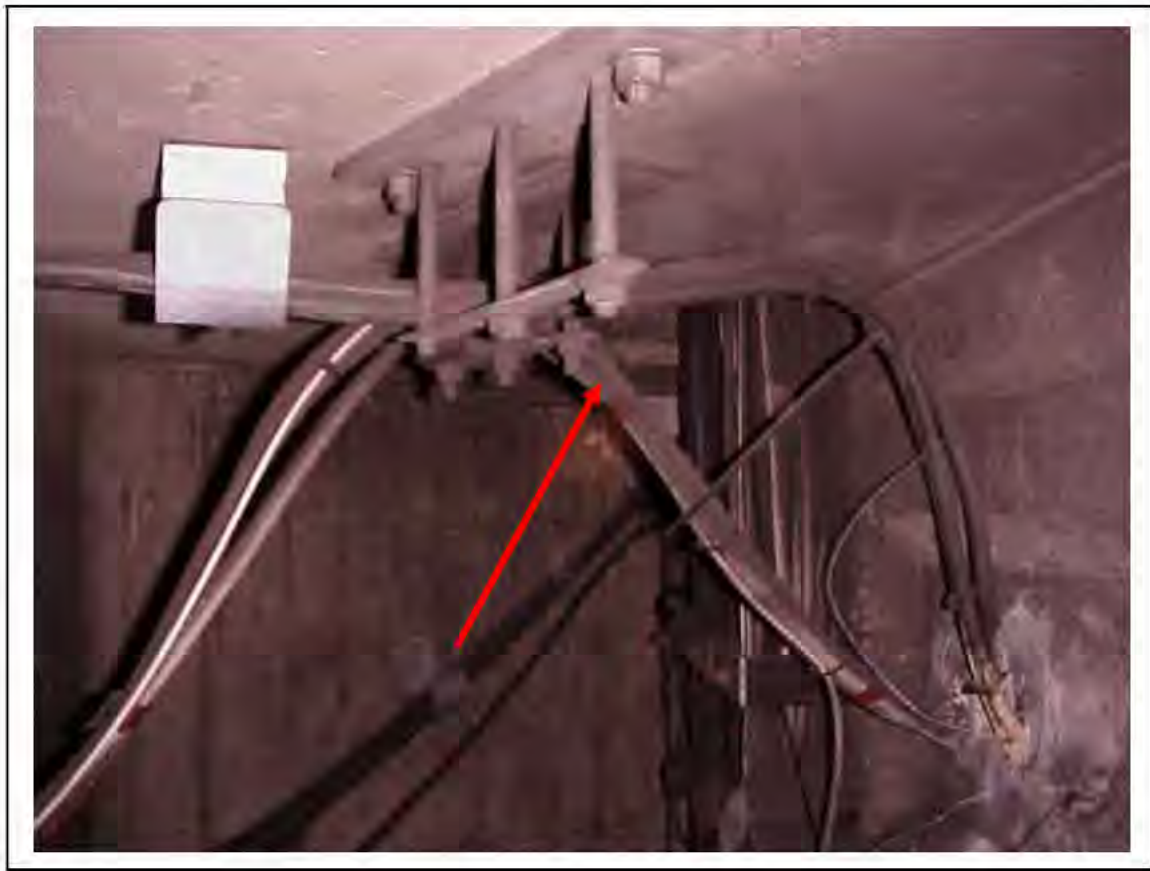
FIGURE 132: KNOWN ASBESTOS IN CABLES IN VICTORIA LINE, PLATFORM 2 INVERT, 3/262, OTHER END 3/706 - DESCRIPTION & RESULT OF ASSESSMENT (SAMPLE REF. K1(33))

Sample Number	K1(33)
Location	Victoria Line, Platform 2, 3/262, Other end 3/706
Material Description	Cables
Material Comment	From out of duct and then cross over
Quantity	3x1 cm Ø
Product Type	Medium density
Current Condition	Good condition
Surface Treatment	Unencapsulated medium density
Asbestos Type	Known Chrysotile
Material Assessment Rating	Low
Accessibility	Low
Further Comment	Not applicable

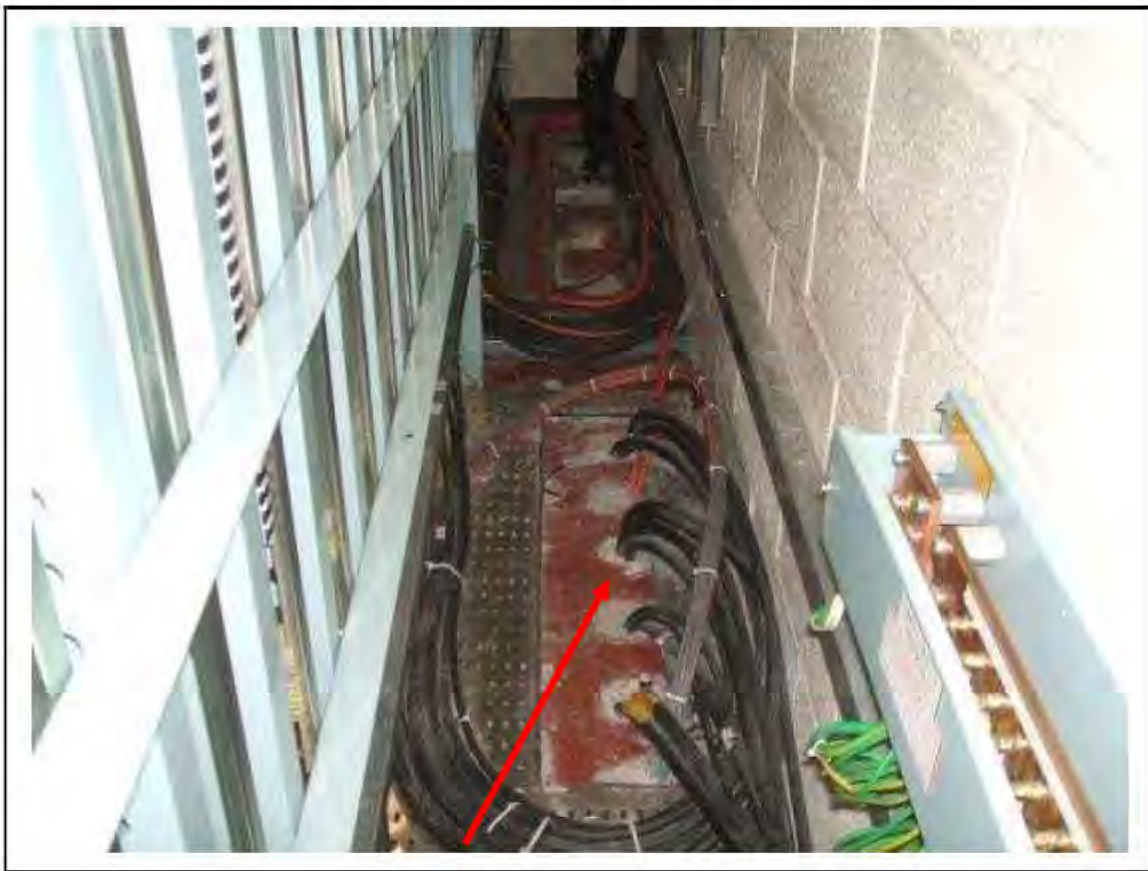
FIGURE 133: PRESUMED ASBESTOS IN DUCTS IN SER, 3/371 - DESCRIPTION & RESULT OF ASSESSMENT (SAMPLE REF. P1(9))

Sample Number	P1(9)
Location	SER, 3/371
Material Description	Ducts
Material Comment	Possible asbestos ducts within floor
Quantity	-
Product Type	-
Current Condition	-
Surface Treatment	-
Asbestos Type	Presumed Chrysotile
Material Assessment Rating	-
Accessibility	
Further Comment	Not applicable

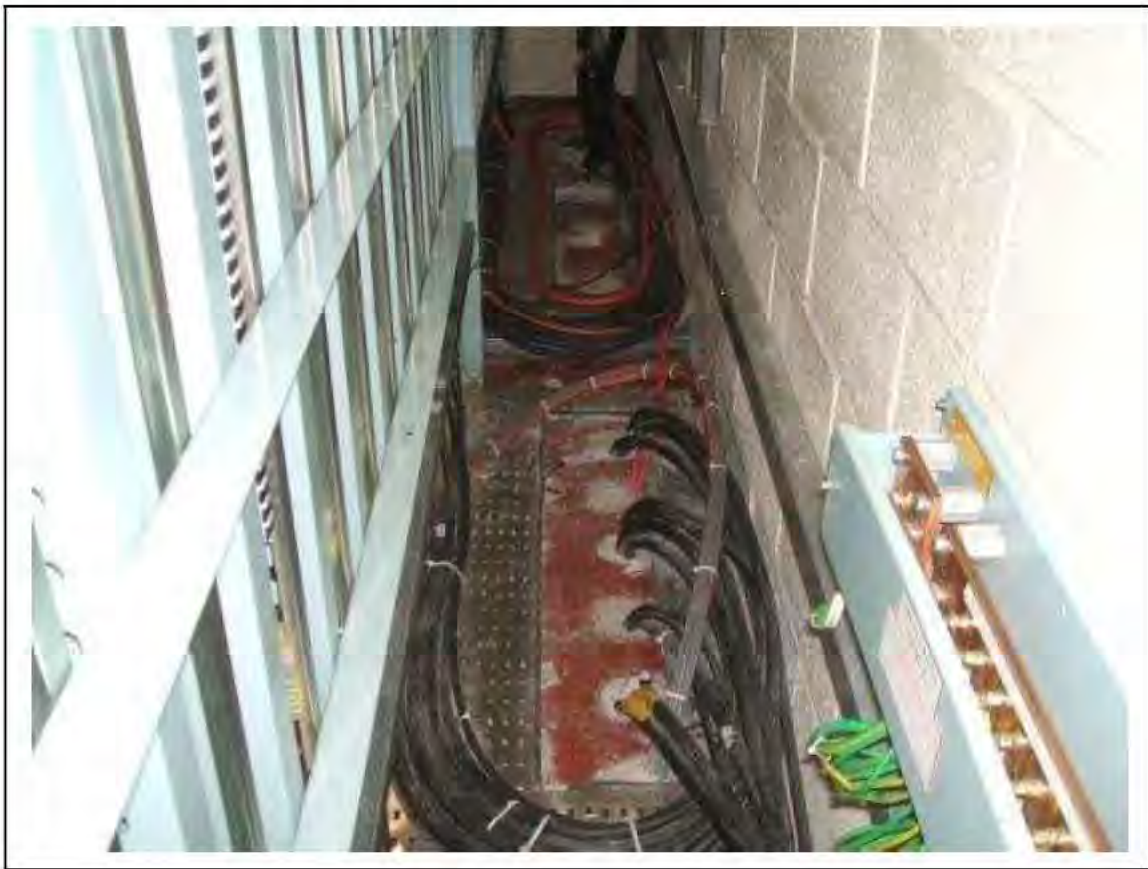
FIGURE 134: PRESUMED ASBESTOS IN POSSIBLE CAULKING IN SER, 3/371 - DESCRIPTION & RESULT OF ASSESSMENT (SAMPLE REF. P1&2(55))

Sample Number	P1&2(55)
Location	SER, 3/371
Material Description	Possible caulking
Material Comment	To tunnel ring joints which may be behind walls and ceiling
Quantity	throughout
Product Type	Medium density
Current Condition	-
Surface Treatment	-
Asbestos Type	Presumed Amosite & Chrysotile
Material Assessment Rating	Very low
Accessibility	
Further Comment	Not applicable

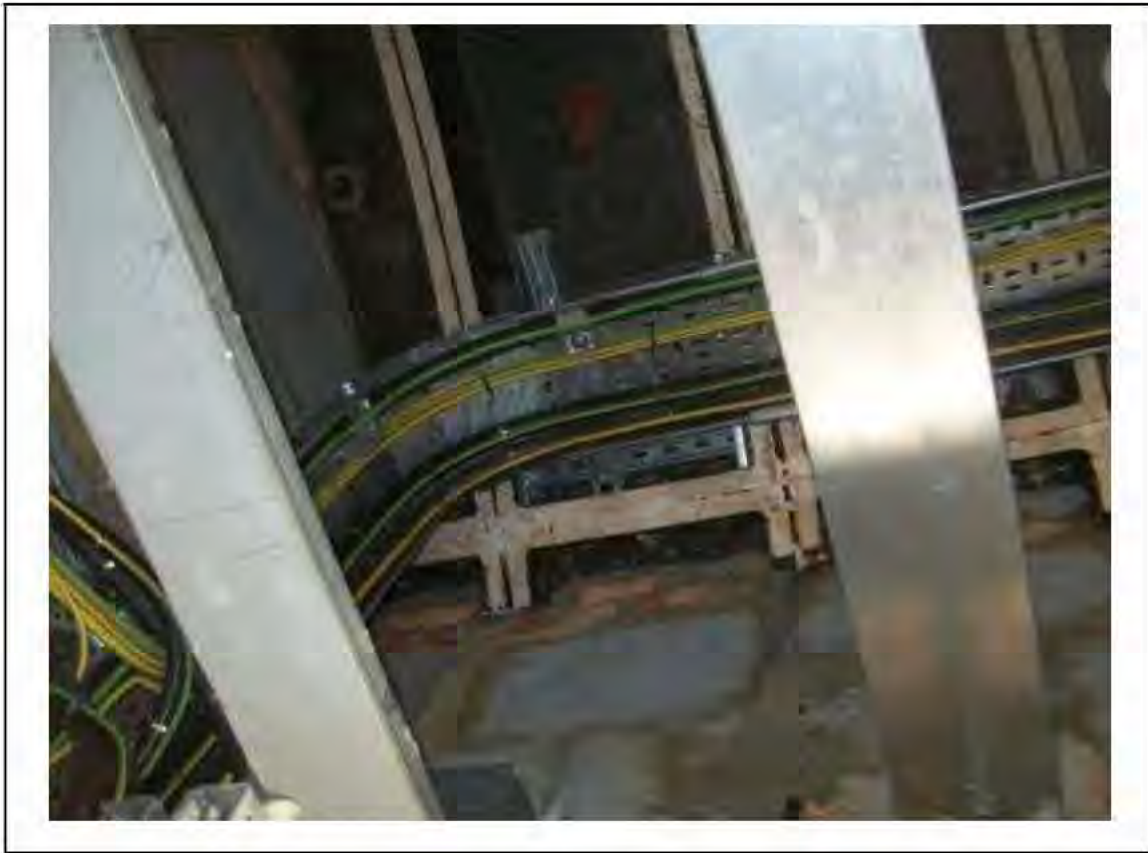
**FIGURE 136: KNOWN ASBESTOS IN CAULKING IN SWITCH ROOM E10 , 3/412
- DESCRIPTION & RESULT OF ASSESSMENT (SAMPLE REF.
SAME AS 120445/150812/03)**

Sample Number	Same as 120445/150812/03
Location	Switch Room E10 , 3/412
Material Description	Caulking
Material Comment	Ceiling to tunnel ring flanges
Quantity	throughout
Product Type	Medium density
Current Condition	Good condition
Surface Treatment	Encapsulated medium density
Asbestos Type	Known Amosite and Chrysotile
Material Assessment Rating	Low
Accessibility	Low
Further Comment	Not applicable

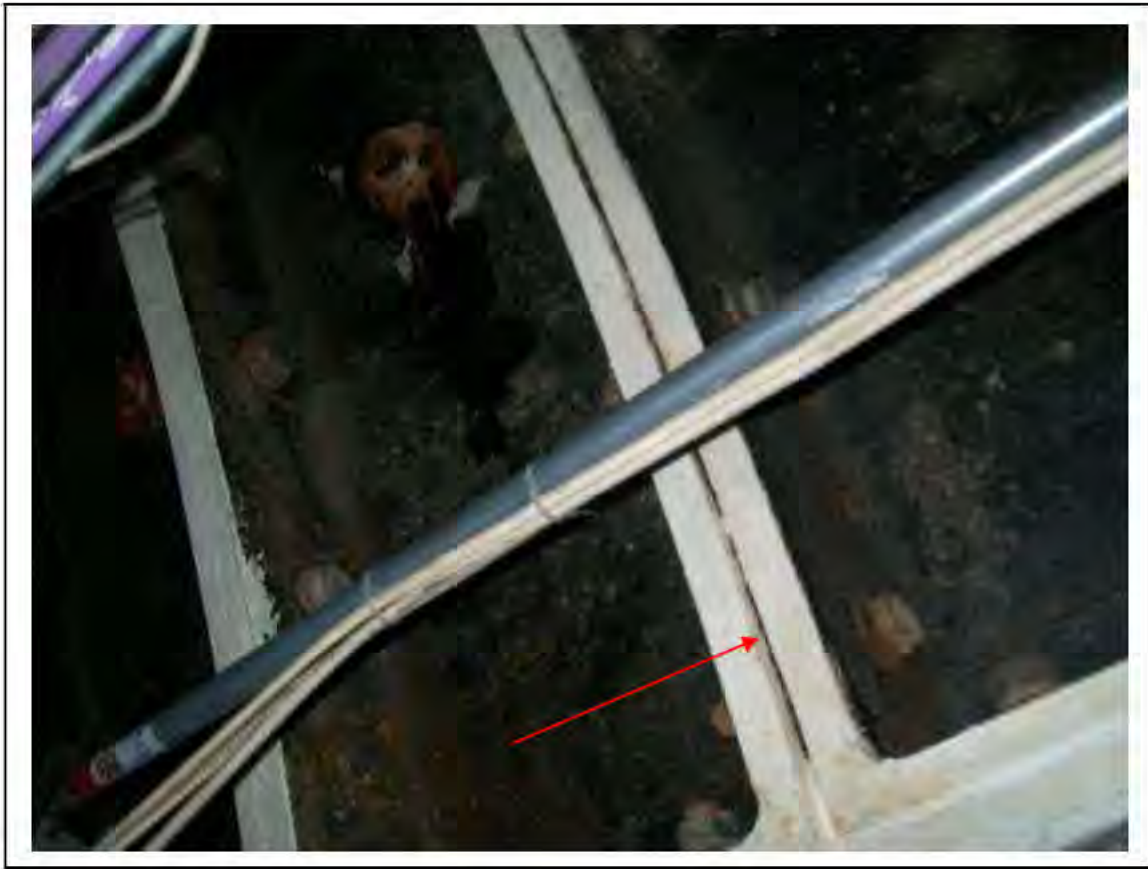
**FIGURE 137: CONFIRMED ASBESTOS IN CAULKING IN LADIES LOBBY ,
3/413 - DESCRIPTION & RESULT OF ASSESSMENT (SAMPLE
REF. SAME AS 120445/150812/03)**

Sample Number	Same as 120445/150812/03
Location	Ladies Lobby , 3/413
Material Description	Caulking
Material Comment	Tunnel ring flanges within false ceiling
Quantity	throughout
Product Type	Medium density
Current Condition	Slight damage
Surface Treatment	Encapsulated medium density
Asbestos Type	Amosite and Chrysotile
Material Assessment Rating	Medium
Accessibility	Low
Further Comment	Not applicable

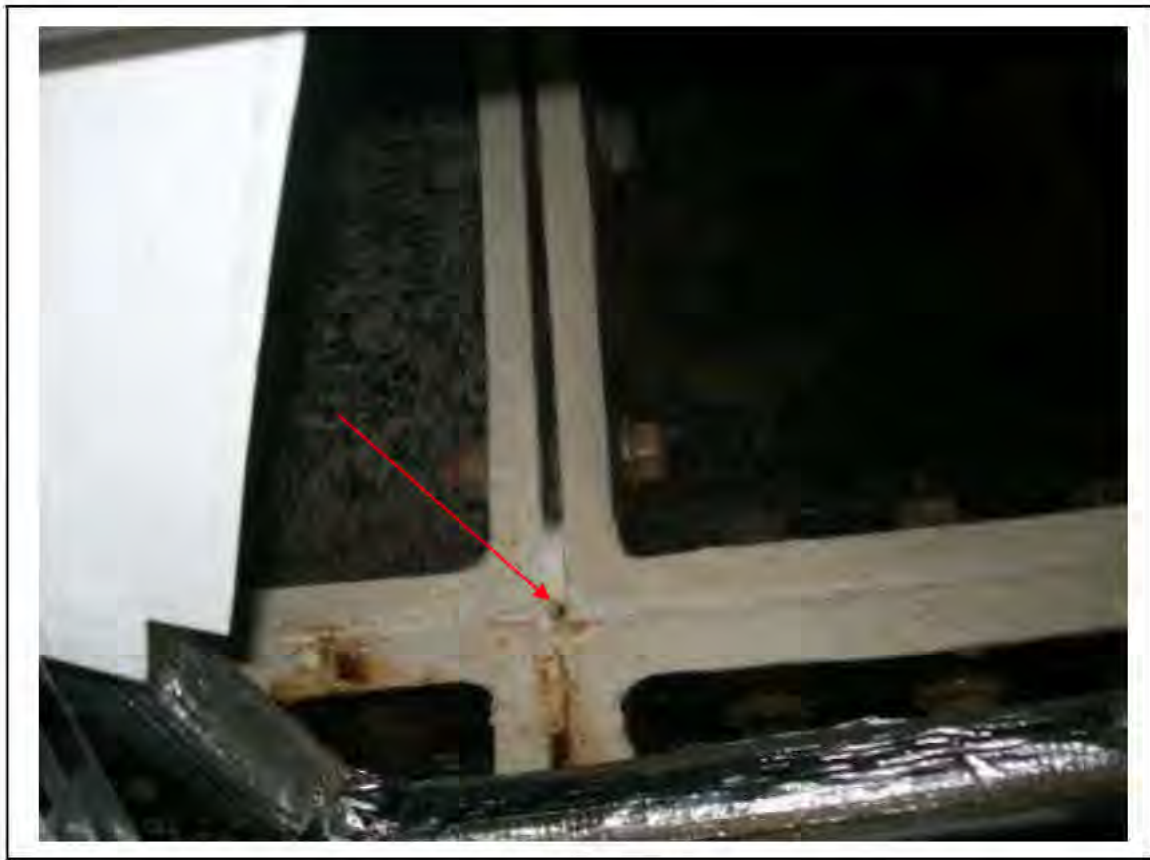
FIGURE 138: CONFIRMED ASBESTOS IN CAULKING IN LADIES W/C, 3/417 - DESCRIPTION & RESULT OF ASSESSMENT (SAMPLE REF. SAME AS 120445/150812/03)

Sample Number	Same as 120445/150812/03
Location	Ladies W/C, 3/417
Material Description	Caulking
Material Comment	Tunnel ring flanges within false ceiling
Quantity	throughout
Product Type	Medium density
Current Condition	Slight damage
Surface Treatment	Encapsulated medium density
Asbestos Type	Amosite and Chrysotile
Material Assessment Rating	Medium
Accessibility	Low
Further Comment	Not applicable

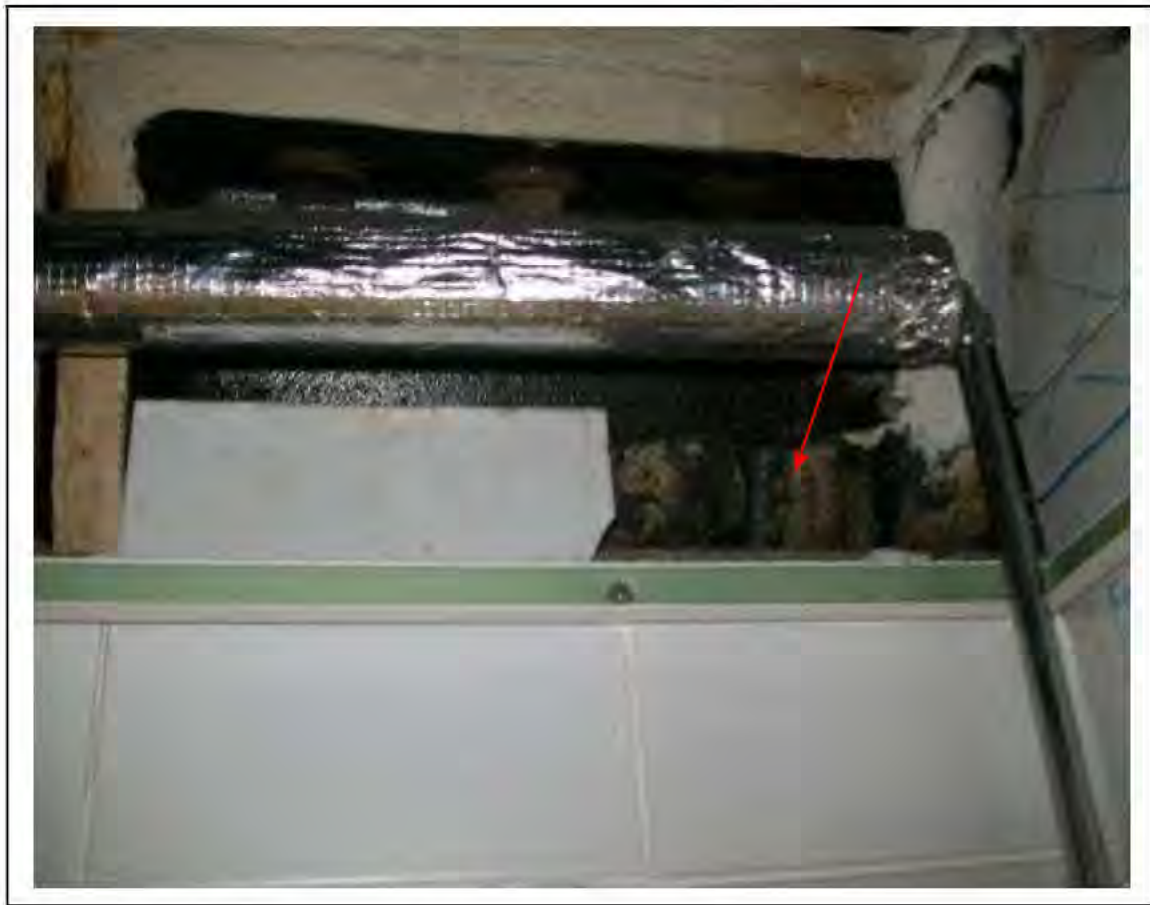
FIGURE 139: KNOWN ASBESTOS IN CELLACTITE CORRUGATED SHEETING IN LADIES W/C, 3/417 - DESCRIPTION & RESULT OF ASSESSMENT (SAMPLE REF. K1(34))

Sample Number	K1(34)
Location	Ladies W/C, 3/417
Material Description	Cellactite corrugated sheeting
Material Comment	Within wall cavity
Quantity	throughout
Product Type	Composite
Current Condition	-
Surface Treatment	Composite
Asbestos Type	Known Chrysotile
Material Assessment Rating	Very low
Accessibility	
Further Comment	Not applicable

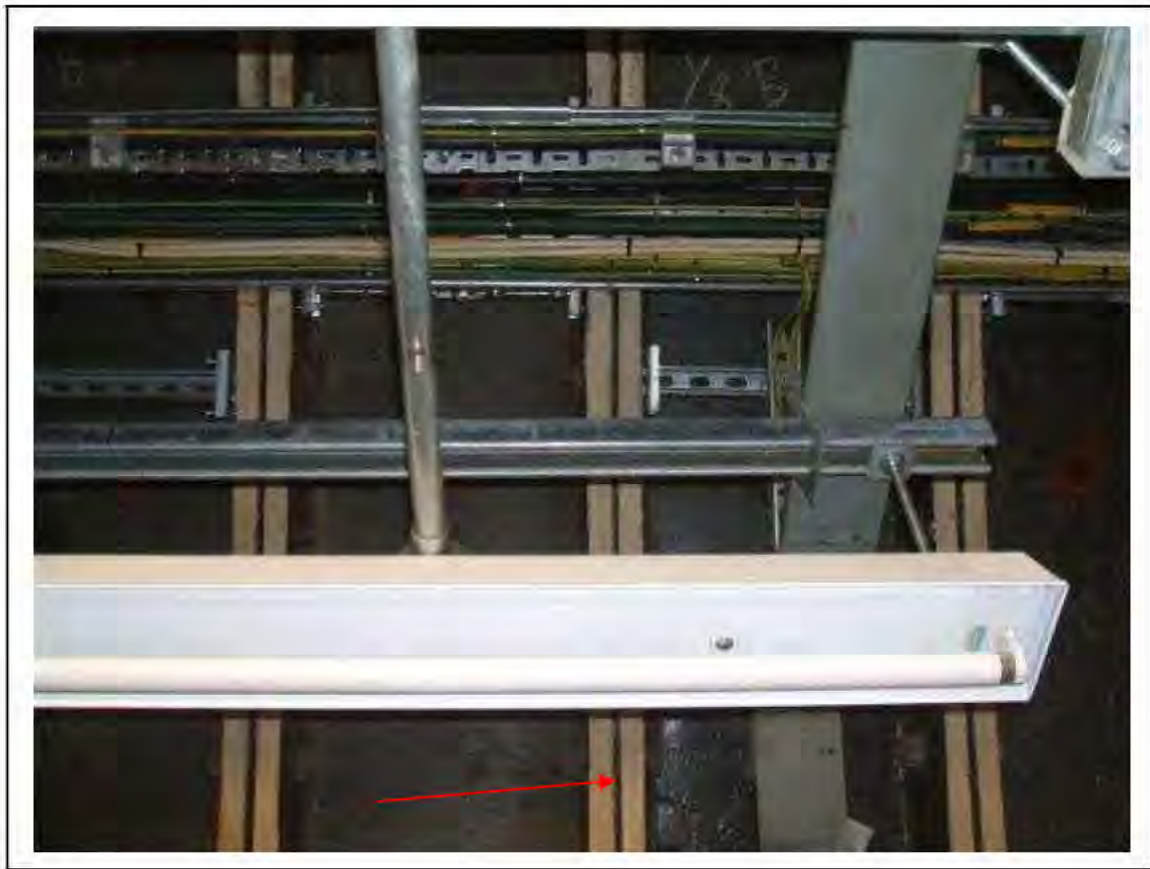
FIGURE 140: STRONGLY PRESUMED ASBESTOS IN TUNNEL RING CAULKING IN SWITCH ROOM E5, 3/662 - DESCRIPTION & RESULT OF ASSESSMENT (SAMPLE REF. SP1&2(1))

Sample Number	SP1&2(1)
Location	Switch Room E5, 3/662
Material Description	Tunnel ring caulking
Material Comment	Ceiling and behind walls
Quantity	throughout
Product Type	Medium density
Current Condition	Slight damage
Surface Treatment	Encapsulated medium density
Asbestos Type	Strongly Presumed Amosite & Chrysotile
Material Assessment Rating	Low
Accessibility	Low
Further Comment	Not applicable

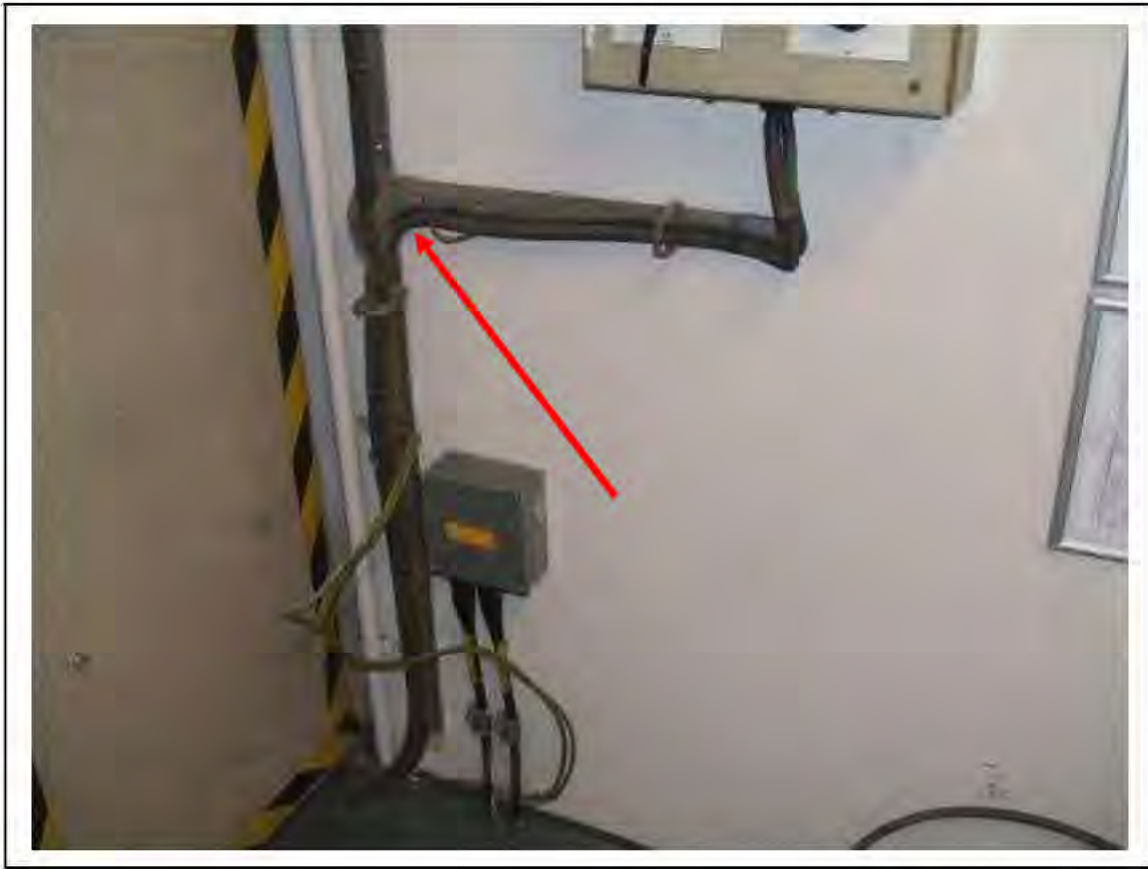
FIGURE 141: KNOWN ASBESTOS IN BRAIDED CABLES IN SWITCH ROOM E5, 3/662 - DESCRIPTION & RESULT OF ASSESSMENT (SAMPLE REF. K1(35))

Sample Number	K1(35)
Location	Switch Room E5, 3/662
Material Description	Braided cables
Material Comment	Pump controls
Quantity	2
Product Type	Medium density
Current Condition	Good condition
Surface Treatment	Unencapsulated medium density
Asbestos Type	Known Chrysotile
Material Assessment Rating	Low
Accessibility	Medium
Further Comment	Not applicable

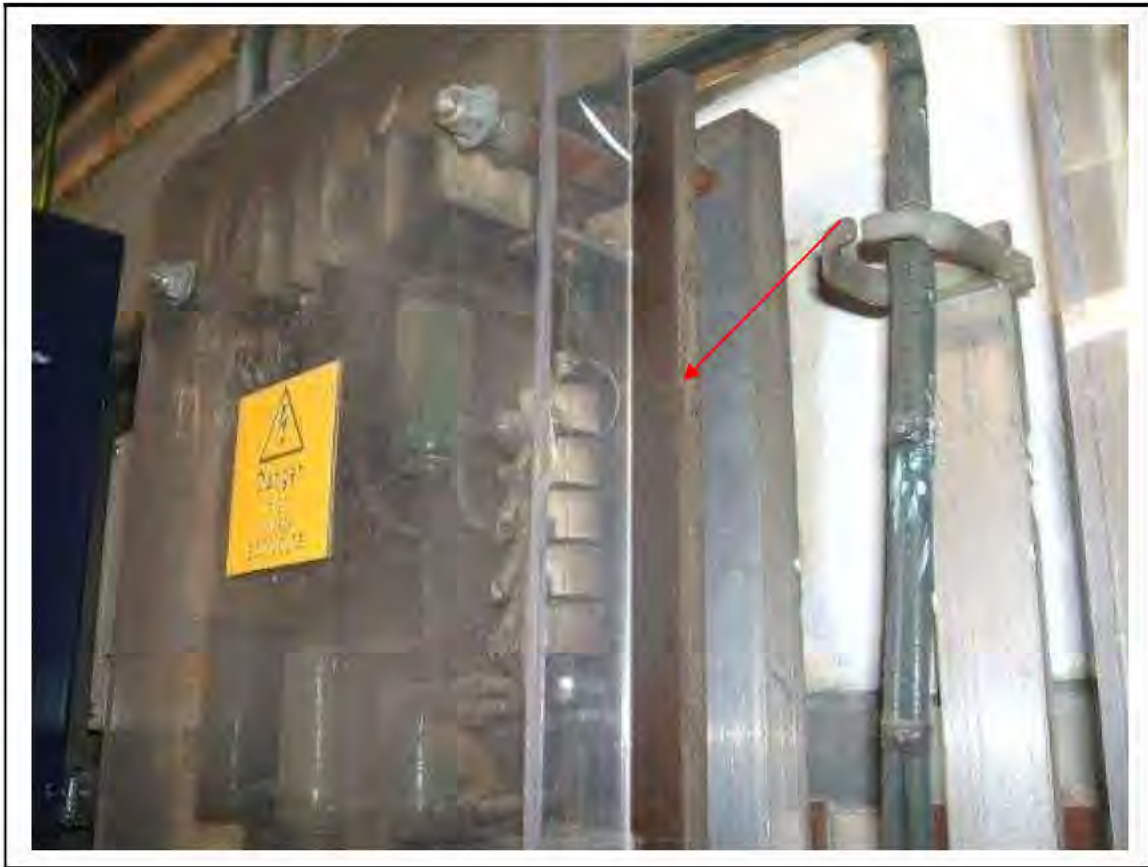
FIGURE 142: STRONGLY PRESUMED ASBESTOS IN SILUMINITE BOARD IN SWITCH ROOM E5, 3/662 - DESCRIPTION & RESULT OF ASSESSMENT (SAMPLE REF. SP1(1))

Sample Number	SP1(1)
Location	Switch Room E5, 3/662
Material Description	Possible siluminite board
Material Comment	To 600v unit
Quantity	30x20cm
Product Type	Composite
Current Condition	Good condition
Surface Treatment	Composite
Asbestos Type	Strongly Presumed Chrysotile
Material Assessment Rating	Very low
Accessibility	Low
Further Comment	Not applicable

REMOVED

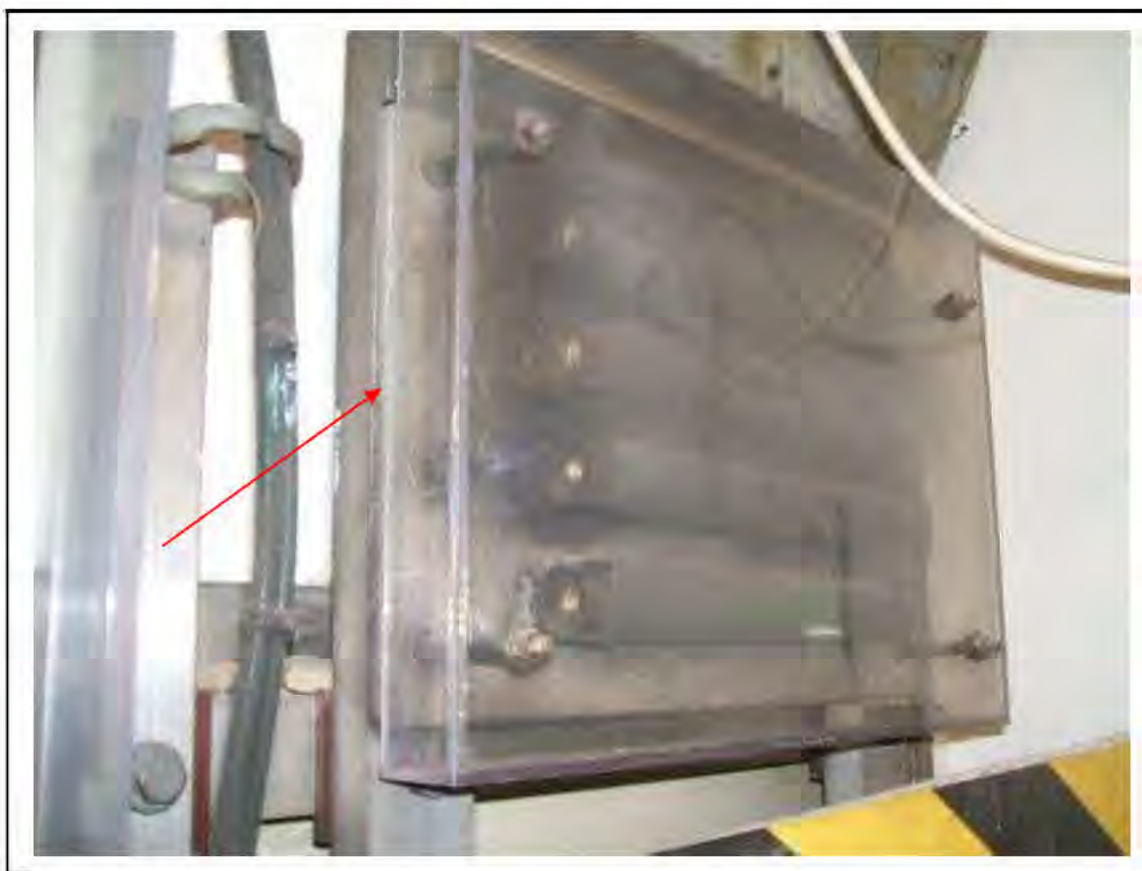
FIGURE 143: STRONGLY PRESUMED ASBESTOS IN CEMENT BOARD IN SWITCH ROOM E5, 3/662 - DESCRIPTION & RESULT OF ASSESSMENT (SAMPLE REF. SP1(2))

Sample Number	SP1(2)
Location	Switch Room E5, 3/662
Material Description	Possible cement board
Material Comment	To resistors
Quantity	30x20cm
Product Type	Composite
Current Condition	Good condition
Surface Treatment	Composite
Asbestos Type	Strongly Presumed Chrysotile
Material Assessment Rating	Very low
Accessibility	Low
Further Comment	Not applicable

REMOVED

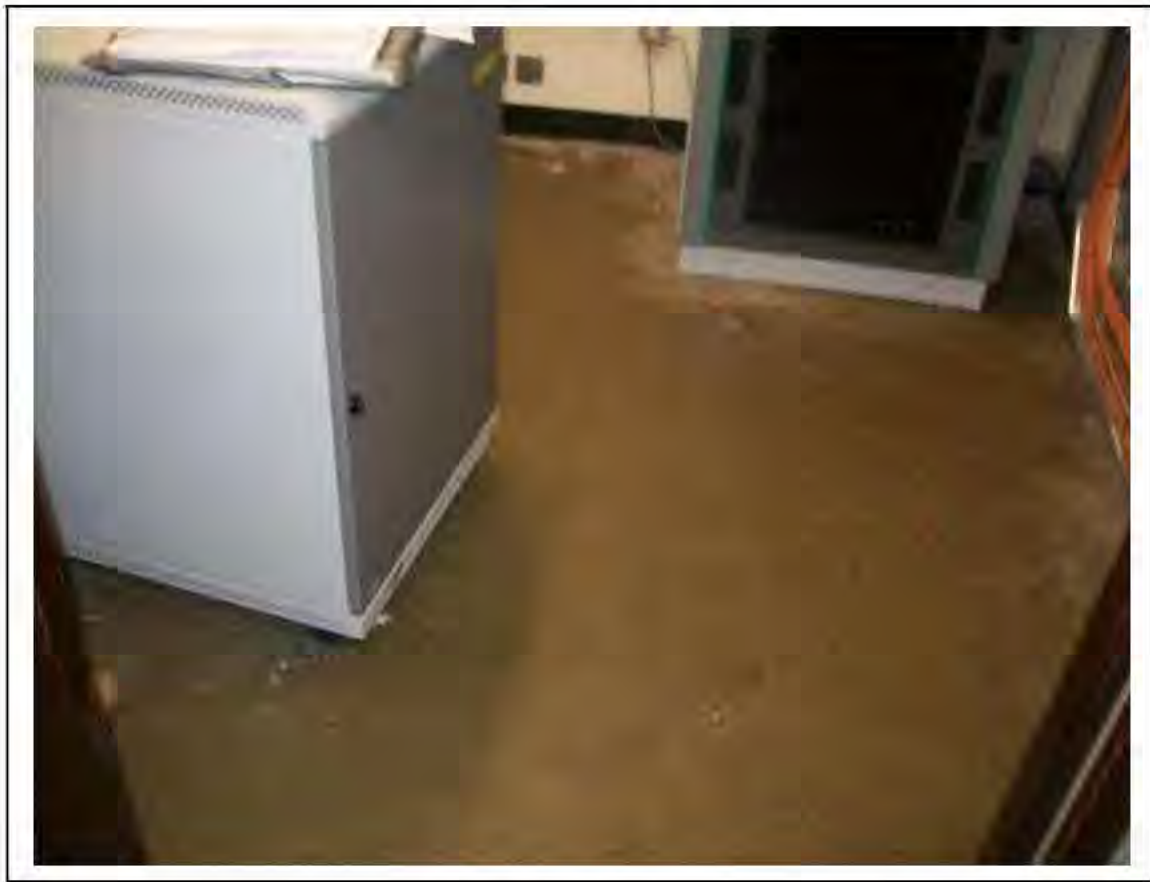
FIGURE 144: CONFIRMED ASBESTOS IN MARLEY TILES ON CONCRETE SLAB IN CER (OLD), 3/668 - DESCRIPTION & RESULT OF ASSESSMENT (SAMPLE REF. 120445/150812/01)

Sample Number	120445/150812/01
Location	CER (Old), 3/668
Material Description	Marley tiles on concrete slab
Material Comment	Floor
Quantity	12m ²
Product Type	Composite
Current Condition	Good condition
Surface Treatment	Composite
Asbestos Type	Chrysotile
Material Assessment Rating	Very low
Accessibility	Low
Further Comment	Not applicable

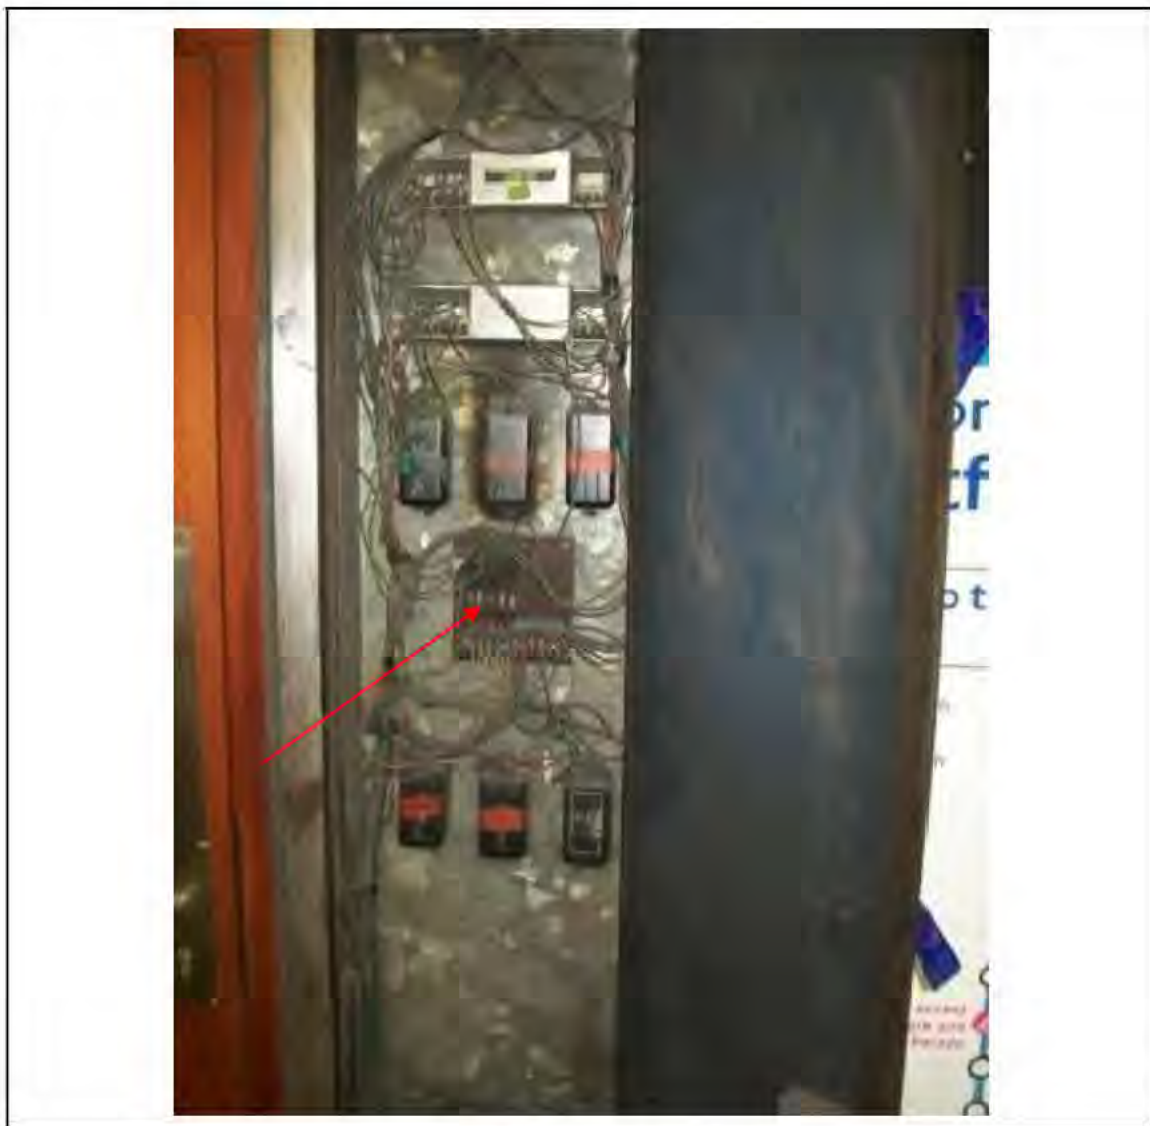
FIGURE 145: STRONGLY PRESUMED ASBESTOS IN SILUMINITE PANEL IN LIGHTING CUPBOARD , 3/669 - DESCRIPTION & RESULT OF ASSESSMENT (SAMPLE REF. SP1(3))

Sample Number	SP1(3)
Location	Lighting Cupboard , 3/669
Material Description	Siluminite panel
Material Comment	-
Quantity	15x15cm
Product Type	Composite
Current Condition	Good condition
Surface Treatment	Composite
Asbestos Type	Strongly Presumed Chrysotile
Material Assessment Rating	Very low
Accessibility	Low
Further Comment	Not applicable
