Hazardous Materials - TfL Engineering

Re-inspection Sign-Off for Brixton

Re-inspection Reference: V059/4RS-200403

Station	Brixton
Original Management Survey	R346601
Date of Original Management	31st August 2012
Re-inspection Reference:	V059-4RS-200403
Next Planned Re-inspection	Periodical re-inspection according to HM Management Plan

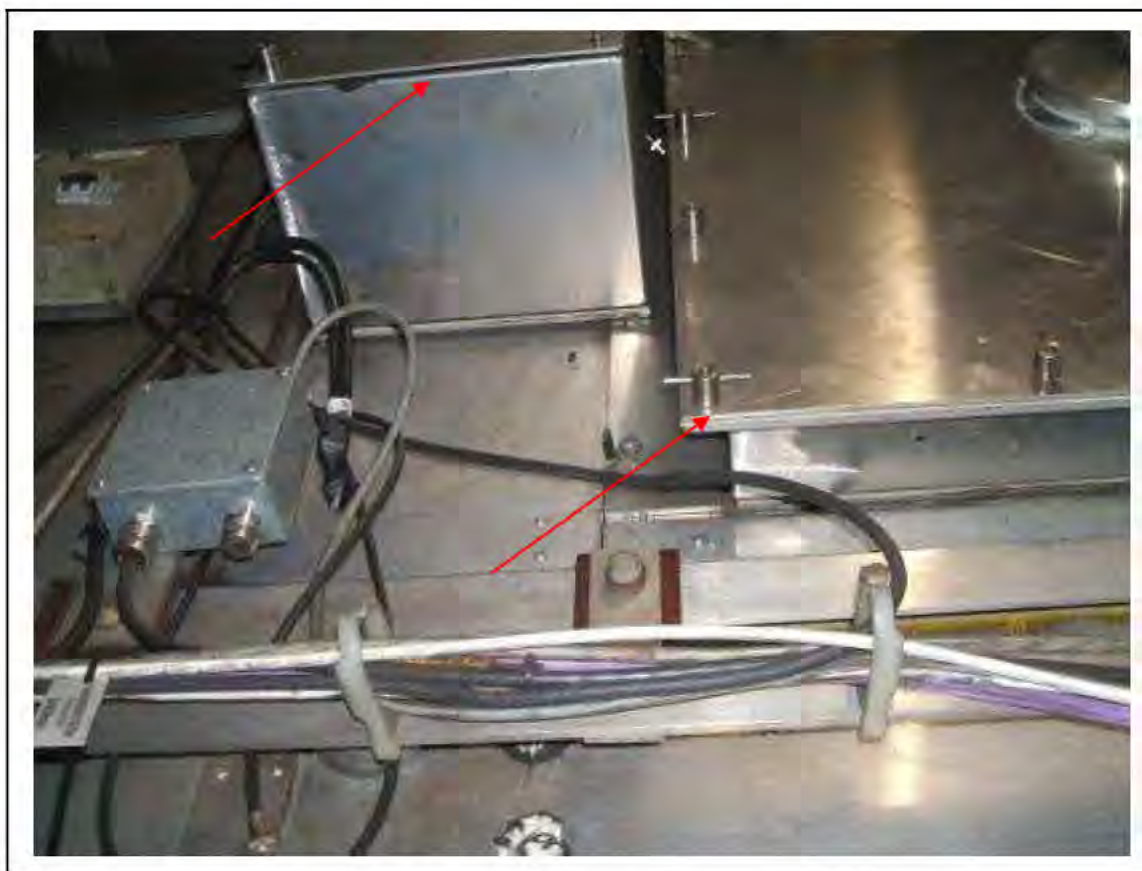
FIGURE 146: STRONGLY PRESUMED ASBESTOS IN SILUMINITE PACKING IN IMR (CORRIDOR FROM PLATFORM 1), 3/706 - DESCRIPTION & RESULT OF ASSESSMENT (SAMPLE REF. SP1(4))

Sample Number	SP1(4)
Location	IMR (corridor from Platform 1), 3/706
Material Description	Possible siluminite packing
Material Comment	To high level units
Quantity	1no, 20x20cm, 1no, 70x70cm
Product Type	Composite
Current Condition	Good condition
Surface Treatment	Composite
Asbestos Type	Strongly Presumed Chrysotile
Material Assessment Rating	Very low
Accessibility	Low
Further Comment	Not applicable

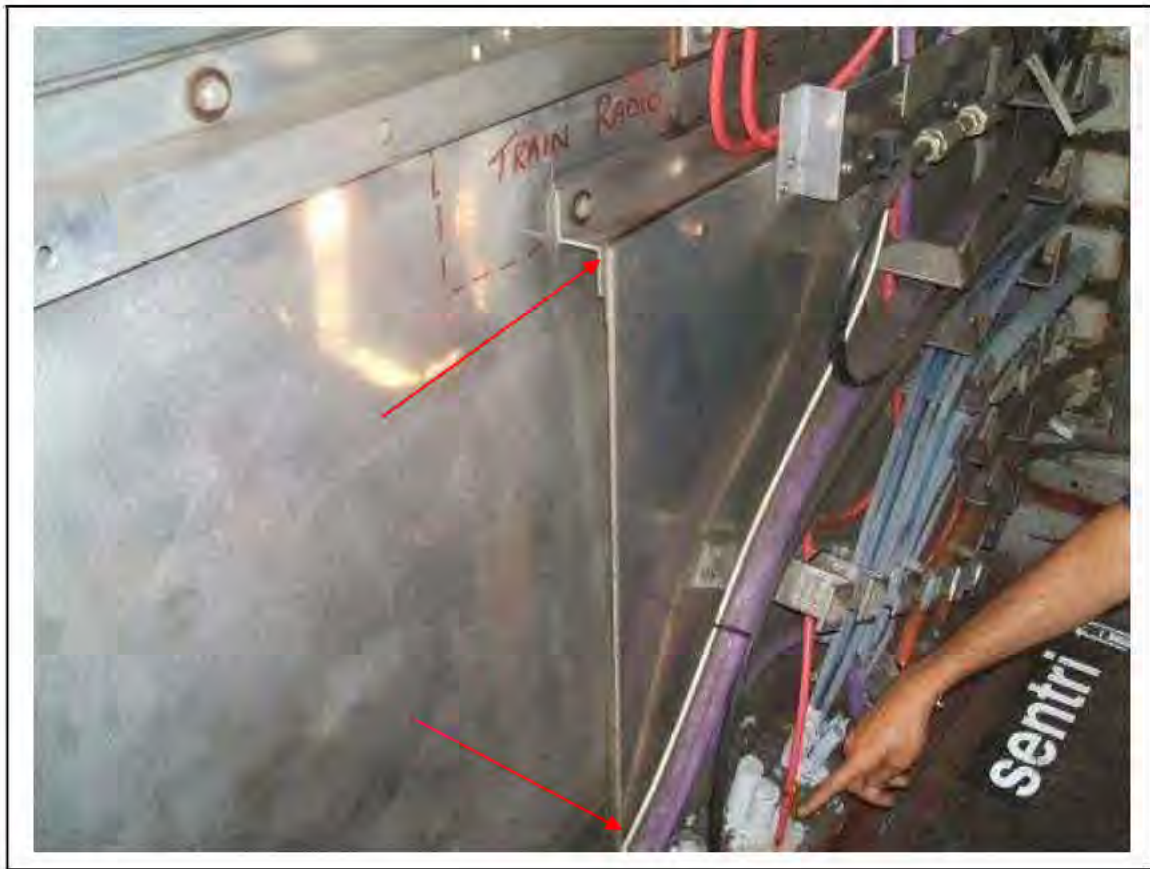
FIGURE 147: STRONGLY PRESUMED ASBESTOS IN PACKING STRIPS IN IMR (CORRIDOR FROM PLATFORM 1), 3/706 - DESCRIPTION & RESULT OF ASSESSMENT (SAMPLE REF. SP1(5))

Sample Number	SP1(5)
Location	IMR (corridor from Platform 1), 3/706
Material Description	Packing strips
Material Comment	To cable management
Quantity	2no, 70x10cm
Product Type	Composite
Current Condition	Good condition
Surface Treatment	Composite
Asbestos Type	Strongly Presumed Chrysotile
Material Assessment Rating	Very low
Accessibility	Low
Further Comment	Not applicable

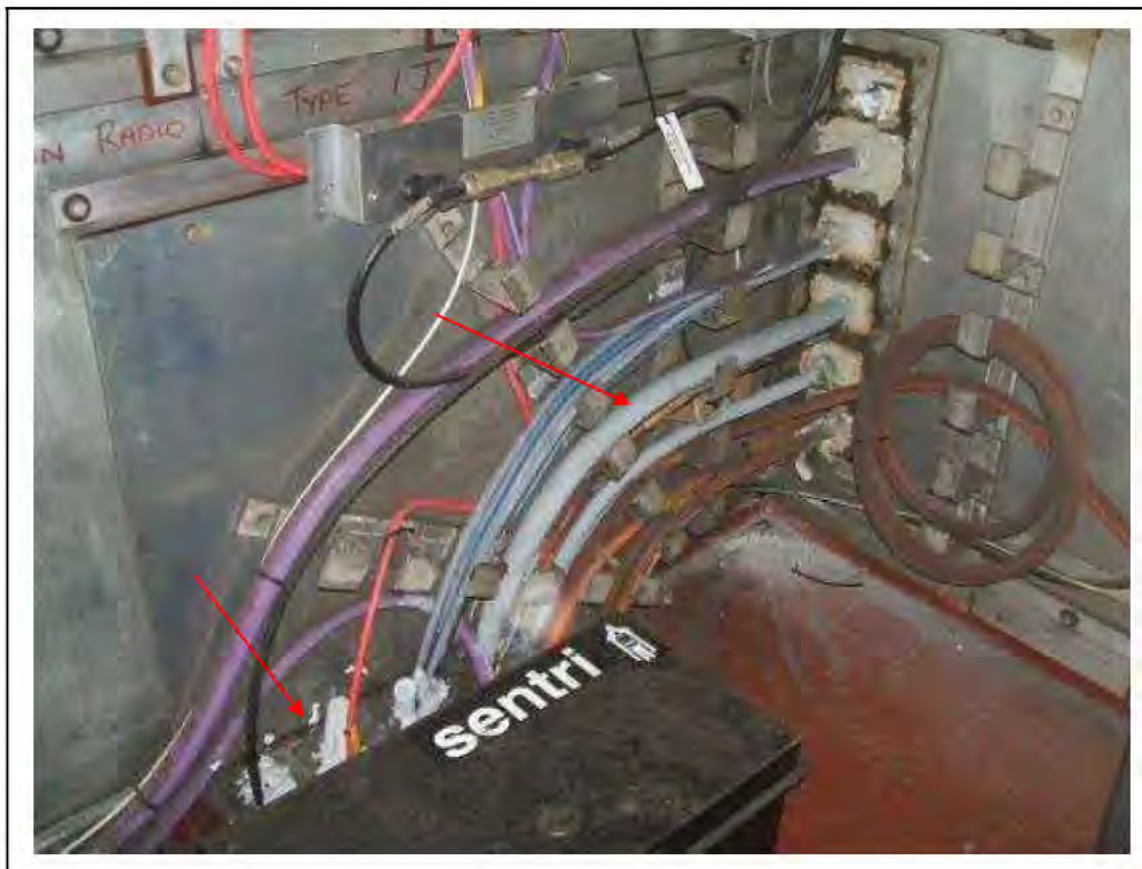
FIGURE 148: KNOWN ASBESTOS IN BRAIDED CABLES IN IMR (CORRIDOR FROM PLATFORM 1), 3/706 - DESCRIPTION & RESULT OF ASSESSMENT (SAMPLE REF. K1(36))

Sample Number	K1(36)
Location	IMR (corridor from Platform 1), 3/706
Material Description	Braided cables
Material Comment	Some cut
Quantity	~20no, 5x5cm
Product Type	Medium density
Current Condition	Slight damage
Surface Treatment	Encapsulated medium density
Asbestos Type	Known Chrysotile
Material Assessment Rating	Low
Accessibility	Medium
Further Comment	Not applicable

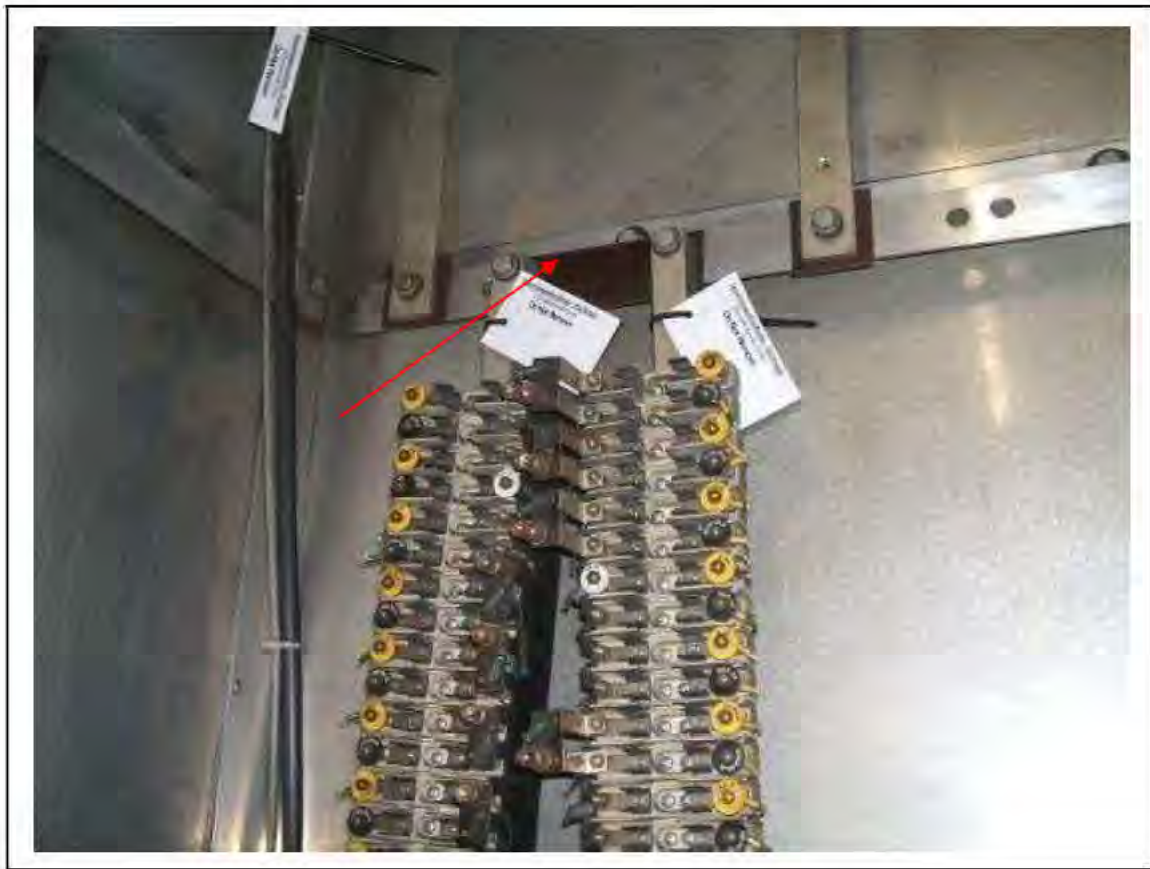
FIGURE 149: STRONGLY PRESUMED ASBESTOS IN SILUMINITE LABEL IN IMR (CORRIDOR FROM PLATFORM 1), 3/706 - DESCRIPTION & RESULT OF ASSESSMENT (SAMPLE REF. SP1(6))

Sample Number	SP1(6)
Location	IMR (corridor from Platform 1), 3/706
Material Description	Possible siluminite label
Material Comment	To fuse bay
Quantity	10x5cm
Product Type	Composite
Current Condition	Good condition
Surface Treatment	Composite
Asbestos Type	Strongly Presumed Chrysotile
Material Assessment Rating	Very low
Accessibility	Low
Further Comment	Not applicable

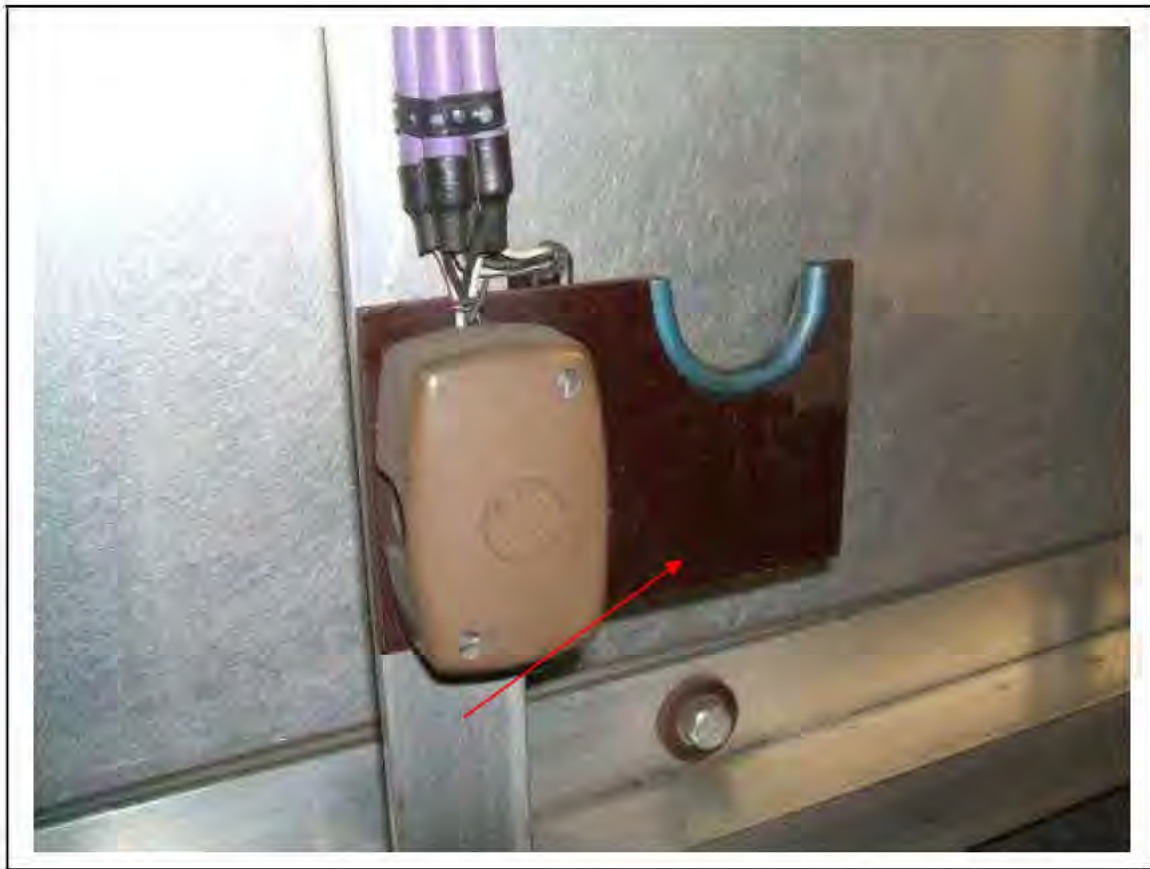
FIGURE 150: STRONGLY PRESUMED ASBESTOS IN SILUMINITE BOARD IN IMR (CORRIDOR FROM PLATFORM 1), 3/706 - DESCRIPTION & RESULT OF ASSESSMENT (SAMPLE REF. SP1(7))

Sample Number	SP1(7)
Location	IMR (corridor from Platform 1), 3/706
Material Description	Siluminite board
Material Comment	To telephone connector box
Quantity	10x5cm
Product Type	Composite
Current Condition	Good condition
Surface Treatment	Composite
Asbestos Type	Strongly Presumed Chrysotile
Material Assessment Rating	Very low
Accessibility	Low
Further Comment	Not applicable

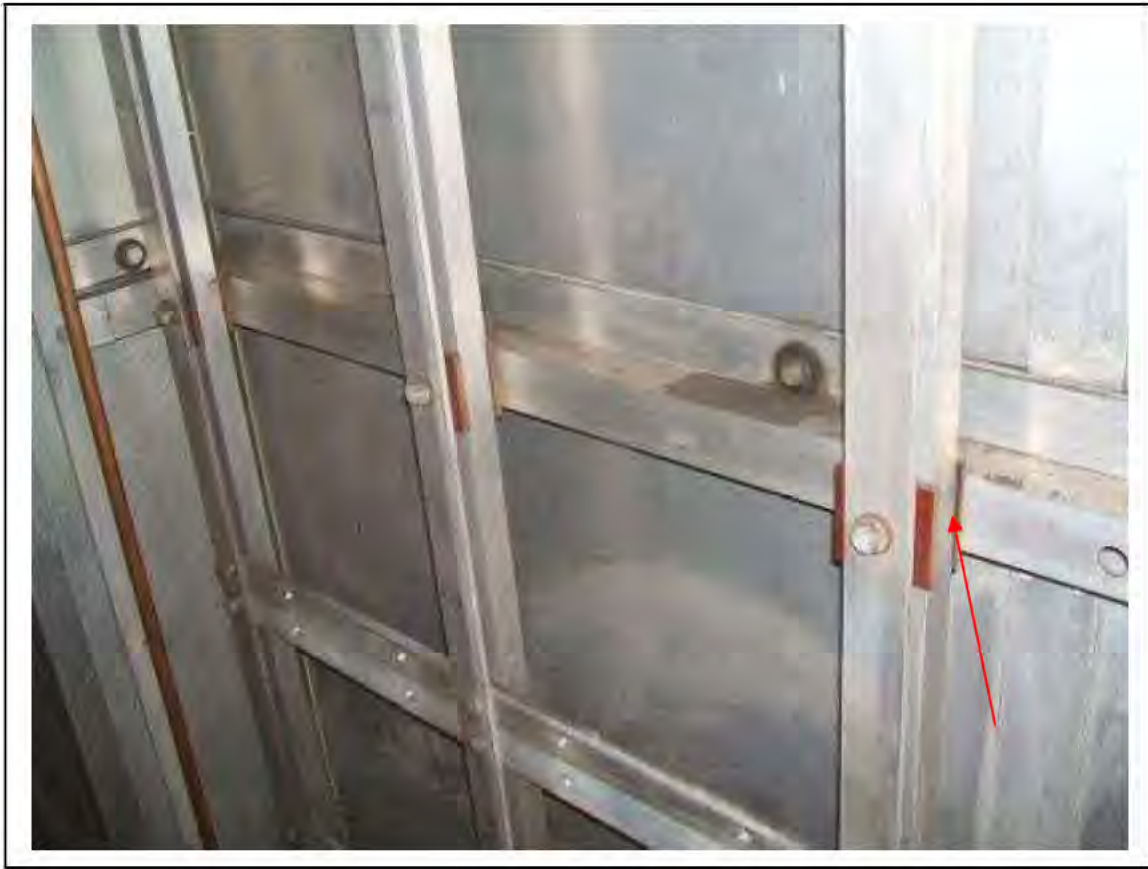
FIGURE 151: STRONGLY PRESUMED ASBESTOS IN SILUMINITE PACKING IN IMR , 3/706 - DESCRIPTION & RESULT OF ASSESSMENT (SAMPLE REF. SP1(8))

Sample Number	SP1(8)
Location	IMR , 3/706
Material Description	Siluminite packing
Material Comment	To some aluminium strips but most are paxolin
Quantity	5x5cm
Product Type	Composite
Current Condition	Good condition
Surface Treatment	Composite
Asbestos Type	Strongly Presumed Chrysotile
Material Assessment Rating	Very low
Accessibility	Low
Further Comment	Not applicable

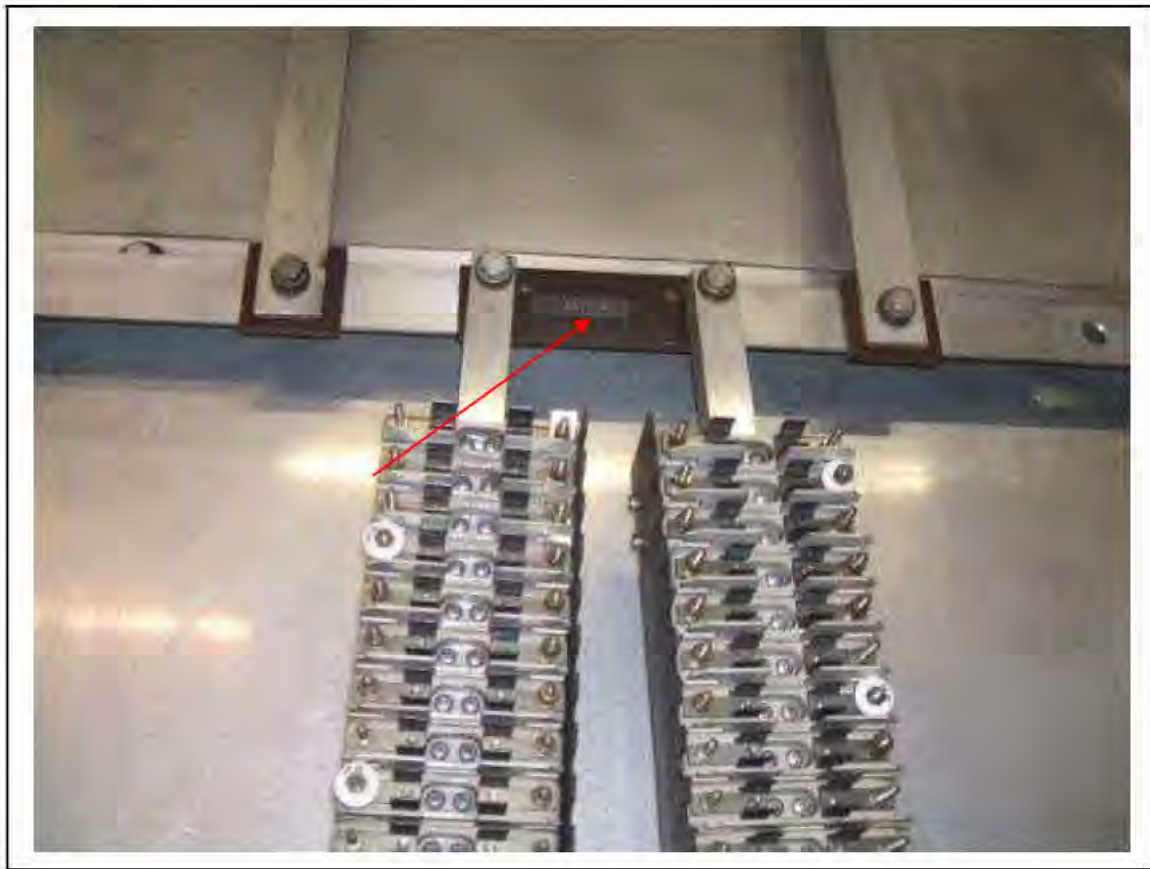
FIGURE 152: STRONGLY PRESUMED ASBESTOS IN SILUMINITE LABELS IN IMR, 3/706 - DESCRIPTION & RESULT OF ASSESSMENT (SAMPLE REF. SP1(9))

Sample Number	SP1(9)
Location	IMR, 3/706
Material Description	Siluminite labels
Material Comment	To bay 8 and bay 19
Quantity	10x5cm
Product Type	Composite
Current Condition	Good condition
Surface Treatment	Composite
Asbestos Type	Strongly Presumed Chrysotile
Material Assessment Rating	Very low
Accessibility	Low
Further Comment	Not applicable

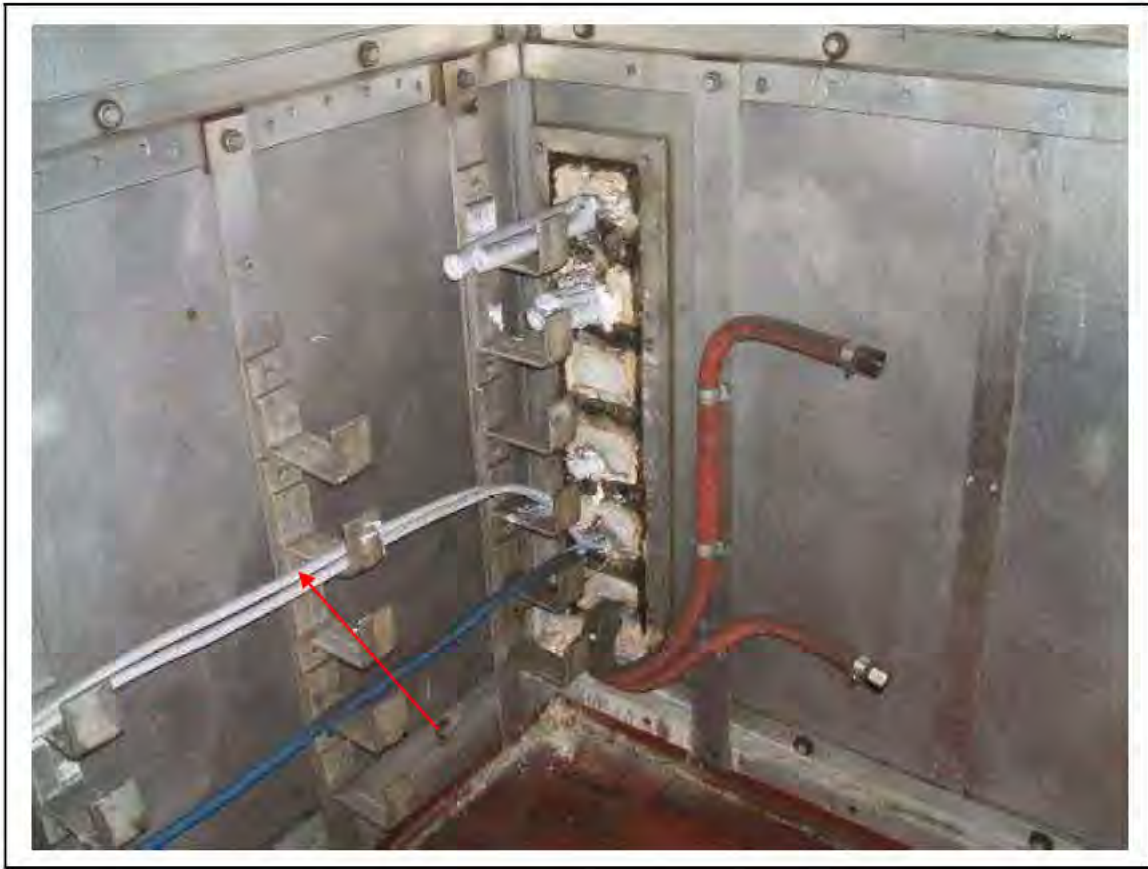
FIGURE 153: KNOWN ASBESTOS IN BRAIDED CABLES IN IMR, 3/706 - DESCRIPTION & RESULT OF ASSESSMENT (SAMPLE REF. K1(37))

Sample Number	K1(37)
Location	IMR, 3/706
Material Description	Braided cables
Material Comment	Some cut back
Quantity	~12no
Product Type	Medium density
Current Condition	Slight damage
Surface Treatment	Encapsulated medium density
Asbestos Type	Known Chrysotile
Material Assessment Rating	Low
Accessibility	Medium
Further Comment	Not applicable

SP1(8)	IMR	3/706	Siluminite packing	5x5cm	1	0	0	1	SP1	To some aluminium strips but most are paxolin	Figure 151
SP1(9)	IMR	3/706	Siluminite labels	10x5cm	1	0	0	1	SP1	To bay 8 and bay 19	Figure 152
K1(37)	IMR	3/706	Braided cables	~12no	2	1	1	2	K1	Some cut back	Figure 153
K1(38)	IMR	3/706	Braided cables	~15no	2	1	1	2	K1	All cut back	Figure 154

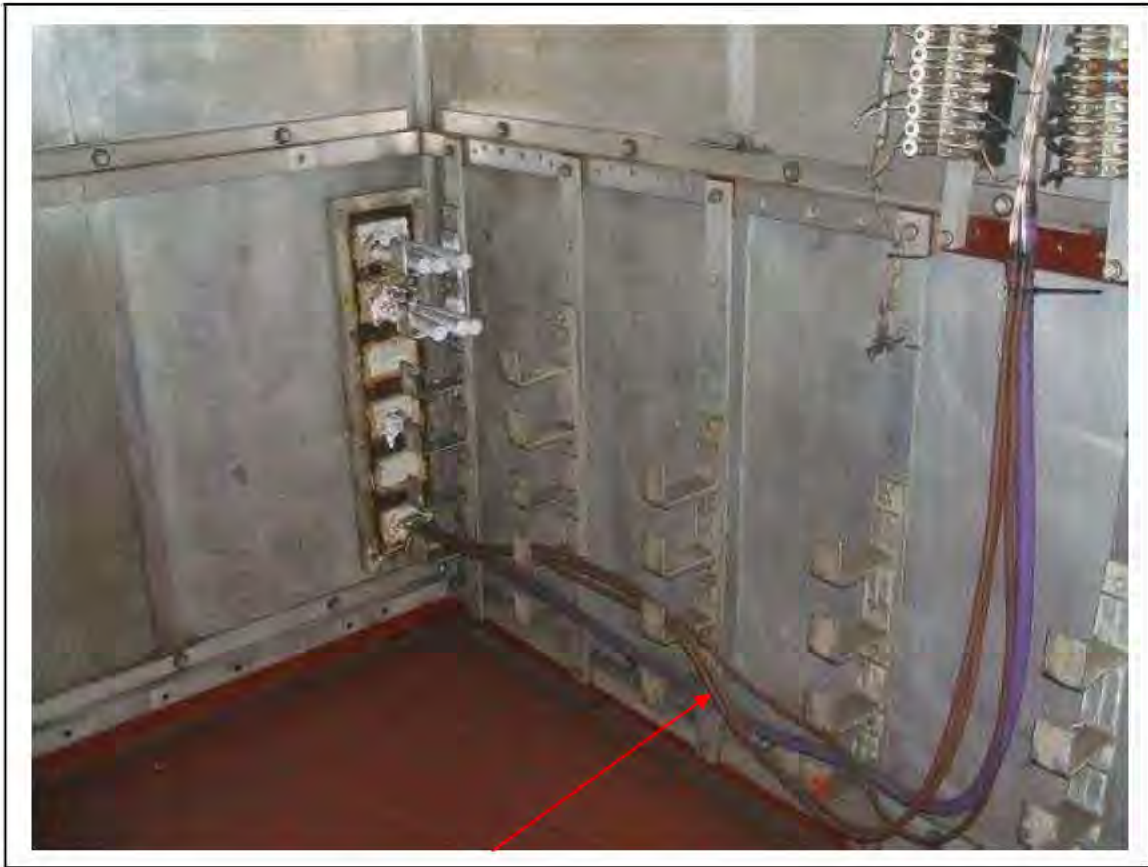
FIGURE 154: KNOWN ASBESTOS IN BRAIDED CABLES IN IMR, 3/706 - DESCRIPTION & RESULT OF ASSESSMENT (SAMPLE REF. K1(38))

Sample Number	K1(38)
Location	IMR, 3/706
Material Description	Braided cables
Material Comment	All cut back
Quantity	~15no
Product Type	Medium density
Current Condition	Slight damage
Surface Treatment	Encapsulated medium density
Asbestos Type	Known Chrysotile
Material Assessment Rating	Low
Accessibility	Medium
Further Comment	Not applicable

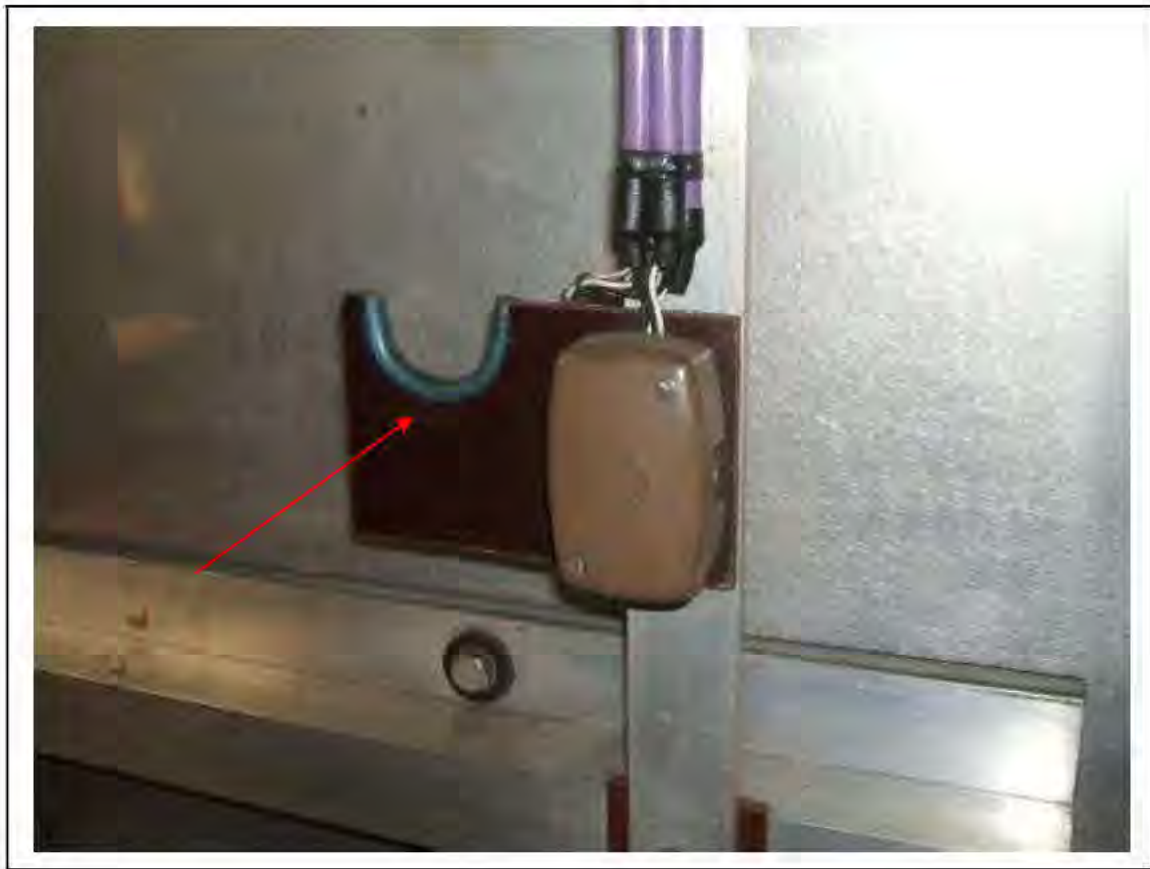
FIGURE 155: STRONGLY PRESUMED ASBESTOS IN SILUMINITE PANEL IN IMR (CORRIDOR TO PLATFORM 2), 3/706 - DESCRIPTION & RESULT OF ASSESSMENT (SAMPLE REF. SP1(10))

Sample Number	SP1(10)
Location	IMR (corridor to Platform 2), 3/706
Material Description	Siluminite panel
Material Comment	To telephone connector box
Quantity	10x5cm
Product Type	Composite
Current Condition	Good condition
Surface Treatment	Composite
Asbestos Type	Strongly Presumed Chrysotile
Material Assessment Rating	Very low
Accessibility	Low
Further Comment	Not applicable

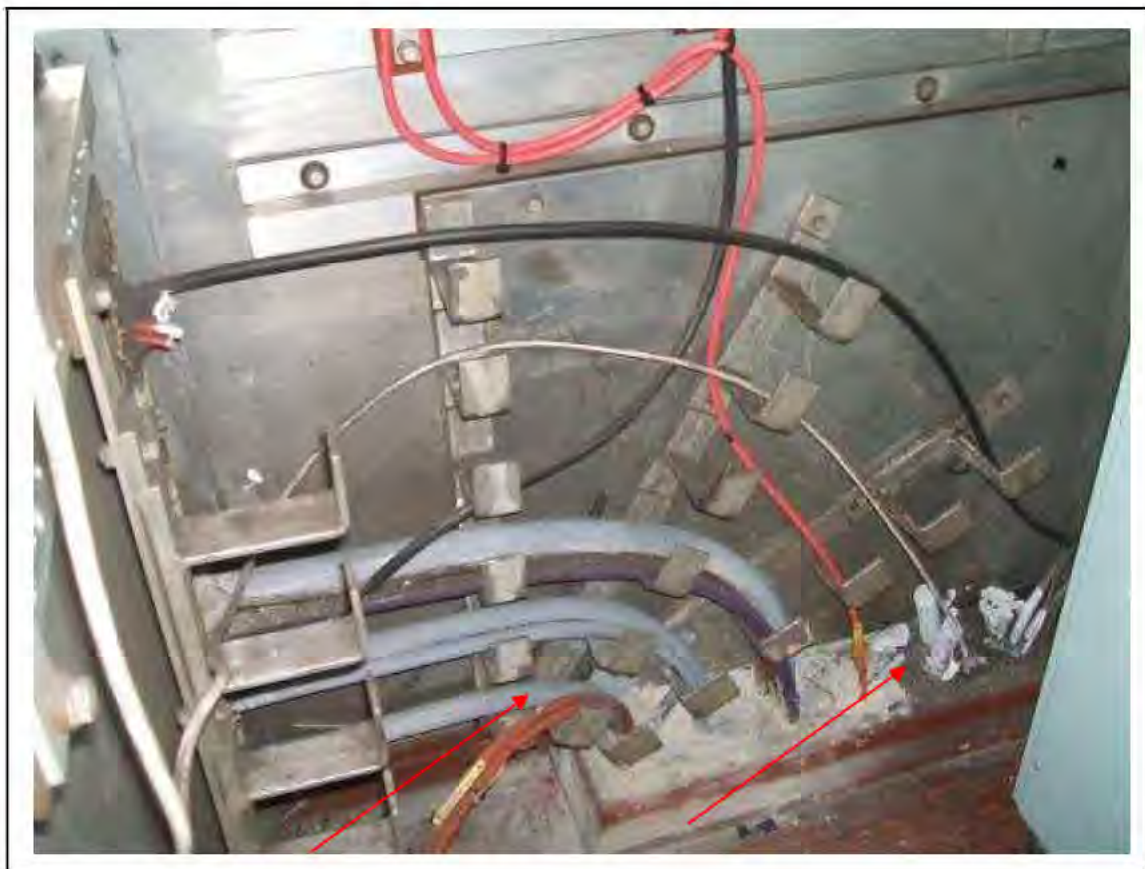
FIGURE 156: KNOWN ASBESTOS IN BRAIDED CABLES IN IMR (CORRIDOR TO PLATFORM 2), 3/706 - DESCRIPTION & RESULT OF ASSESSMENT (SAMPLE REF. K1(39))

Sample Number	K1(39)
Location	IMR (corridor to Platform 2), 3/706
Material Description	Braided cables
Material Comment	Most cut back
Quantity	~28no
Product Type	Medium density
Current Condition	Slight damage
Surface Treatment	Encapsulated medium density
Asbestos Type	Known Chrysotile
Material Assessment Rating	Low
Accessibility	Medium
Further Comment	Not applicable

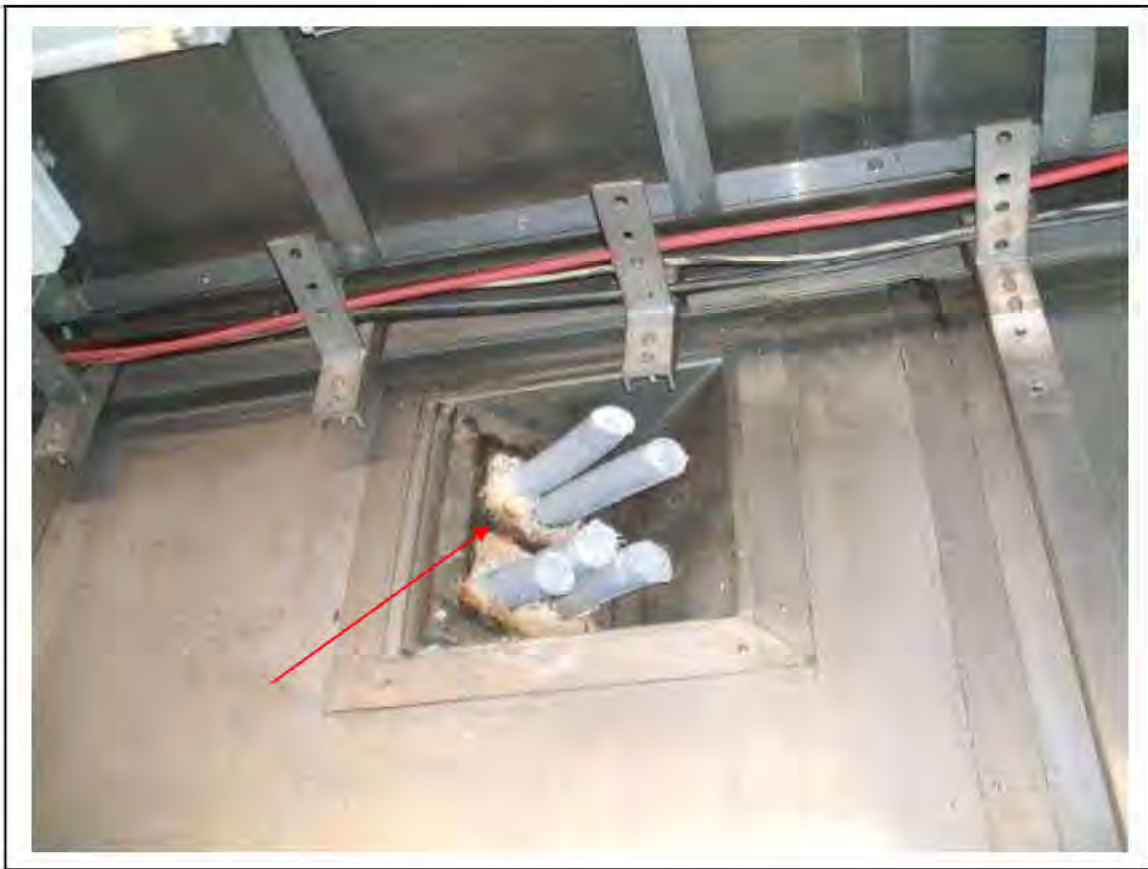
FIGURE 157: KNOWN ASBESTOS IN BRAIDED CABLES IN IMR (CORRIDOR TO PLATFORM 2), 3/706 - DESCRIPTION & RESULT OF ASSESSMENT (SAMPLE REF. K1(40))

Sample Number	K1(40)
Location	IMR (corridor to Platform 2), 3/706
Material Description	Braided cables
Material Comment	Cut back
Quantity	5no
Product Type	Medium density
Current Condition	Slight damage
Surface Treatment	Encapsulated medium density
Asbestos Type	Known Chrysotile
Material Assessment Rating	Low
Accessibility	Medium
Further Comment	Not applicable

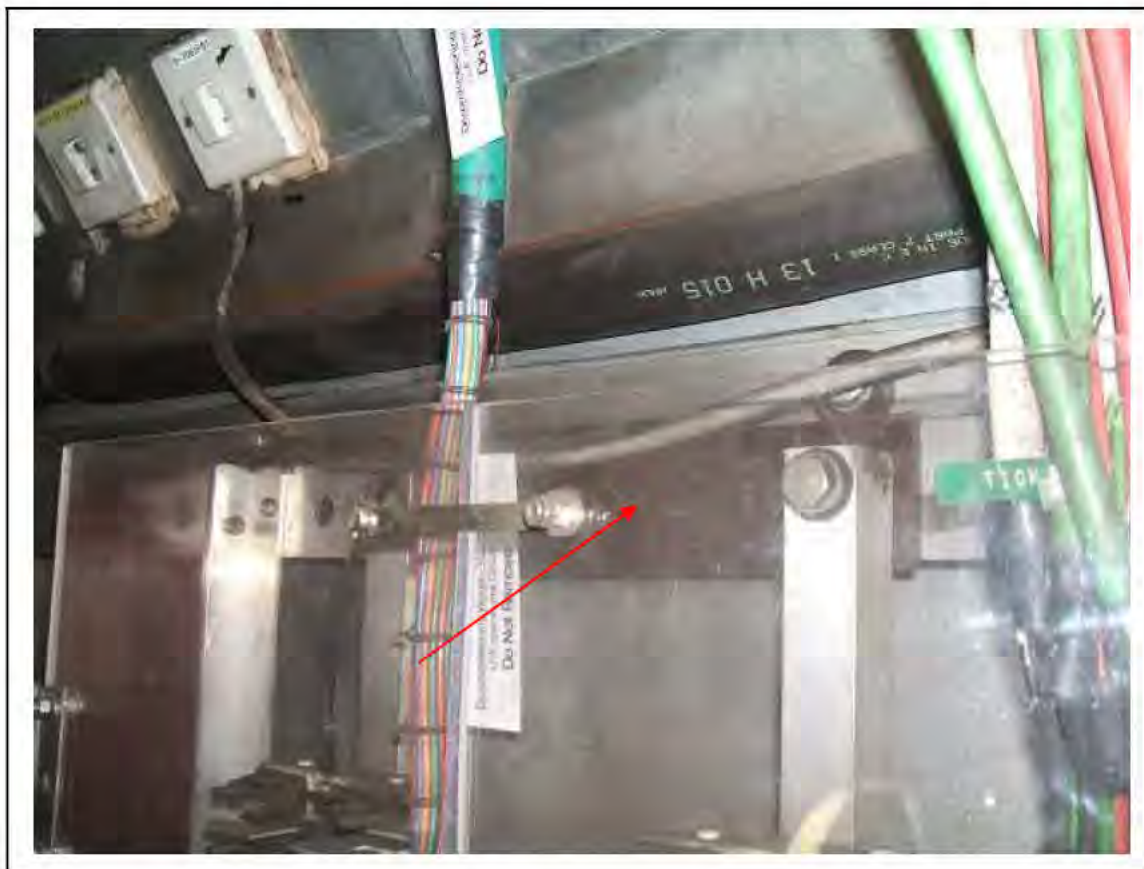
FIGURE 158: STRONGLY PRESUMED ASBESTOS IN SILUMINITE LABELS IN IMR (CORRIDOR TO PLATFORM 2), 3/706 - DESCRIPTION & RESULT OF ASSESSMENT (SAMPLE REF. SP1(11))

Sample Number	SP1(11)
Location	IMR (corridor to Platform 2), 3/706
Material Description	Siluminite labels
Material Comment	To fuse bay
Quantity	10x5cm
Product Type	Composite
Current Condition	Good condition
Surface Treatment	Composite
Asbestos Type	Strongly Presumed Chrysotile
Material Assessment Rating	Very low
Accessibility	Low
Further Comment	Not applicable

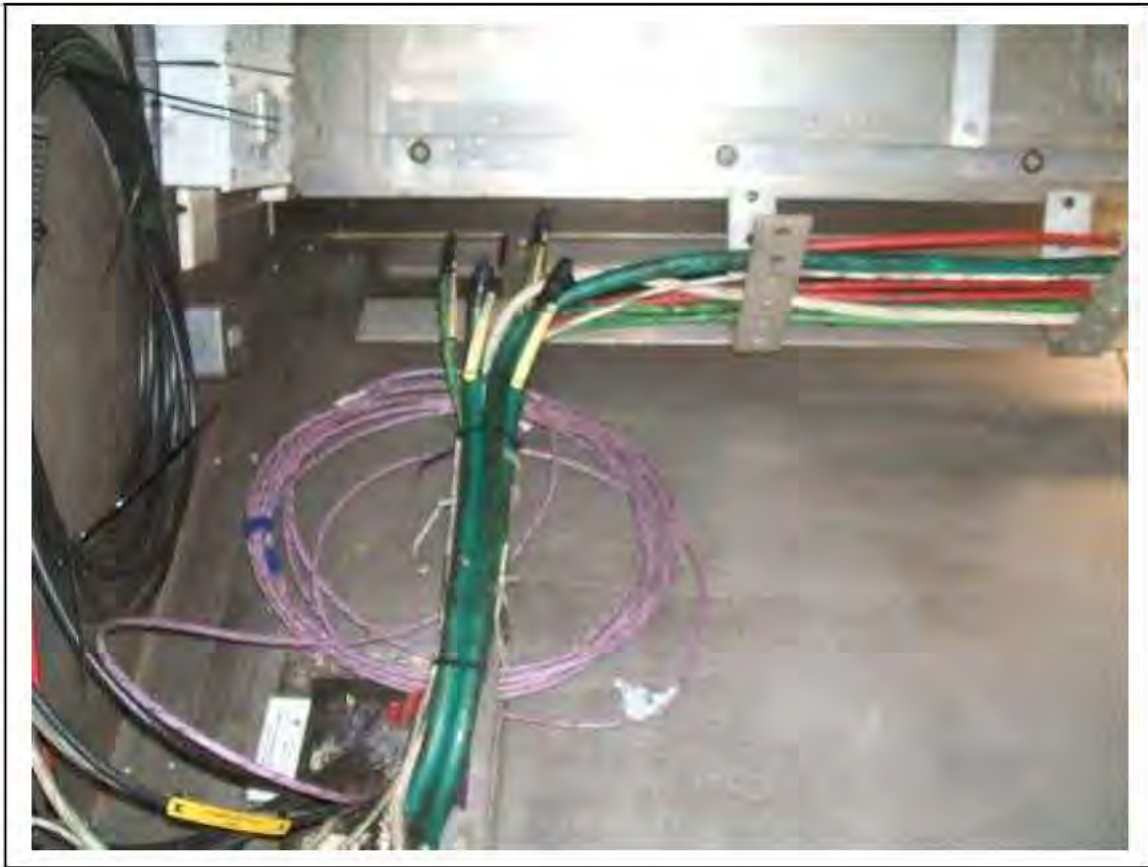
FIGURE 159: KNOWN ASBESTOS IN BRAIDED CABLE IN IMR (CORRIDOR TO PLATFORM 2), 3/706 - DESCRIPTION & RESULT OF ASSESSMENT (SAMPLE REF. K1(41))

Sample Number	K1(41)
Location	IMR (corridor to Platform 2), 3/706
Material Description	Braided cable
Material Comment	Fuse bay, high level
Quantity	1no, 2lm
Product Type	Medium density
Current Condition	Slight damage
Surface Treatment	Encapsulated medium density
Asbestos Type	Known Chrysotile
Material Assessment Rating	Low
Accessibility	Low
Further Comment	Not applicable

Ref No.	Area Surveyed		Material Description	Quantity (m ²)	Product Type	Current Condition	Surface Treatment	Accessibility	Asbestos Type	Comments and Recommendations	Figure
	Location	Room/Plant No									
	IMR	3/706	Quarry tiles	-	-	-	-	-	-	Floor	-
	IMR (main room)	3/706	Aluminium	-	-	-	-	-	-	Walls and ceiling	-
	IMR (corridor to Platform 2)	3/706	Quarry tiles	-	-	-	-	-	-	Floor	-
	IMR (corridor to Platform 2)	3/706	Aluminium	-	-	-	-	-	-	Walls and ceiling	-
SP1(10)	IMR (corridor to Platform 2)	3/706	Siluminite panel	10x5cm	1	0	0	1	SP1	To telephone connector box	Figure 155
K1(39)	IMR (corridor to Platform 2)	3/706	Braided cables	~28no	2	1	1	2	K1	Most cut back	Figure 156
K1(40)	IMR (corridor to Platform 2)	3/706	Braided cables	5no	2	1	1	2	K1	Cut back	Figure 157
SP1(11)	IMR (corridor to Platform 2)	3/706	Siluminite labels	10x5cm	1	0	0	1	SP1	To fuse bay	Figure 158
K1(41)	IMR (corridor to Platform 2)	3/706	Braided cable	1no, 2lm	2	1	1	1	K1	Fuse bay, high level	Figure 159

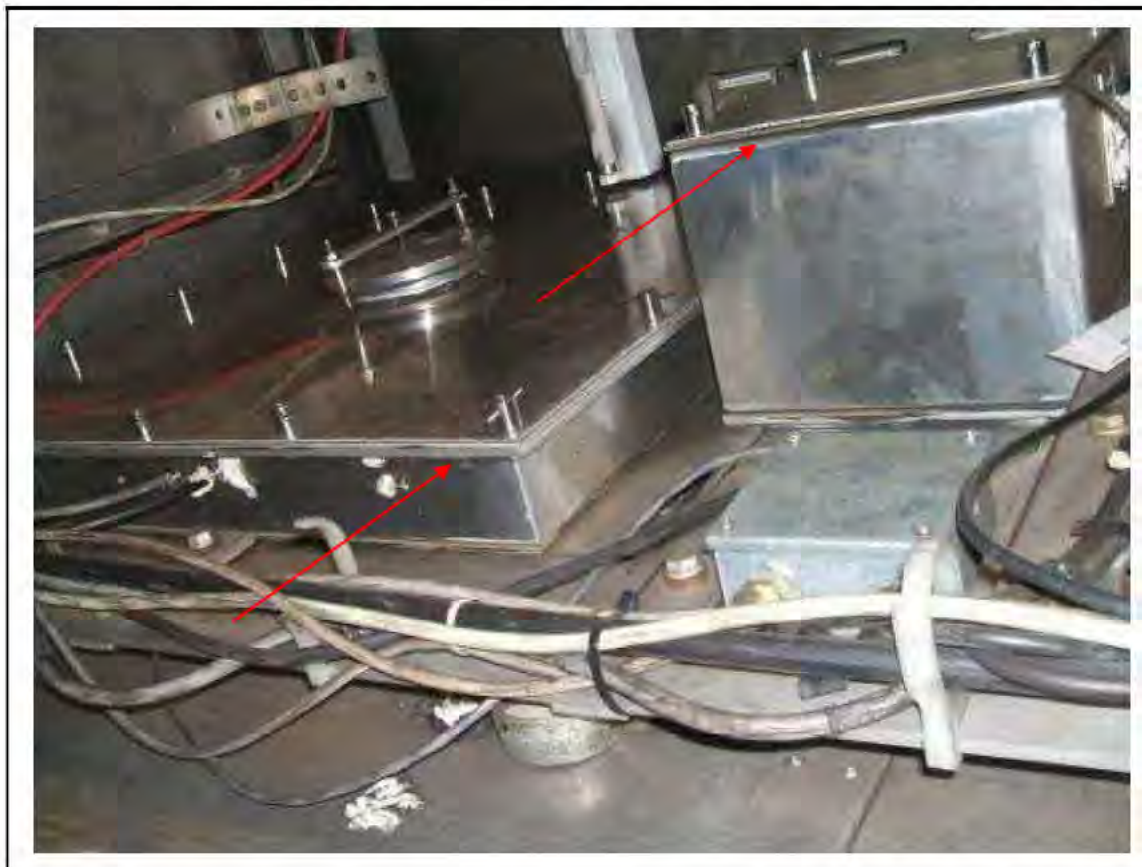
FIGURE 160: STRONGLY PRESUMED ASBESTOS IN POSSIBLE SILUMINITE PACKING IN IMR (CORRIDOR TO PLATFORM 2), 3/706 - DESCRIPTION & RESULT OF ASSESSMENT (SAMPLE REF. SP1(12))

Sample Number	SP1(12)
Location	IMR (corridor to Platform 2), 3/706
Material Description	Possible siluminite packing
Material Comment	High level units
Quantity	1no, 20x20cm, 1no, 70x70cm
Product Type	Composite
Current Condition	Good condition
Surface Treatment	Composite
Asbestos Type	Strongly Presumed Chrysotile
Material Assessment Rating	Very low
Accessibility	Low
Further Comment	Not applicable

SP1(12)	IMR (corridor to Platform 2)	3/706	Possible siluminite packing	1no, 20x20cm, 1no, 70x70cm	1	0	0	1	SP1	High level units	Figure 160
SP1(13)	IMR (corridor to Platform 2)	3/706	Siluminite packing strips	2, 10x70cm	1	0	0	1	SP1	To cable management	Figure 161
	IMR	3/707	Quarry tiles	-	-	-	-	-	-	Floor	-

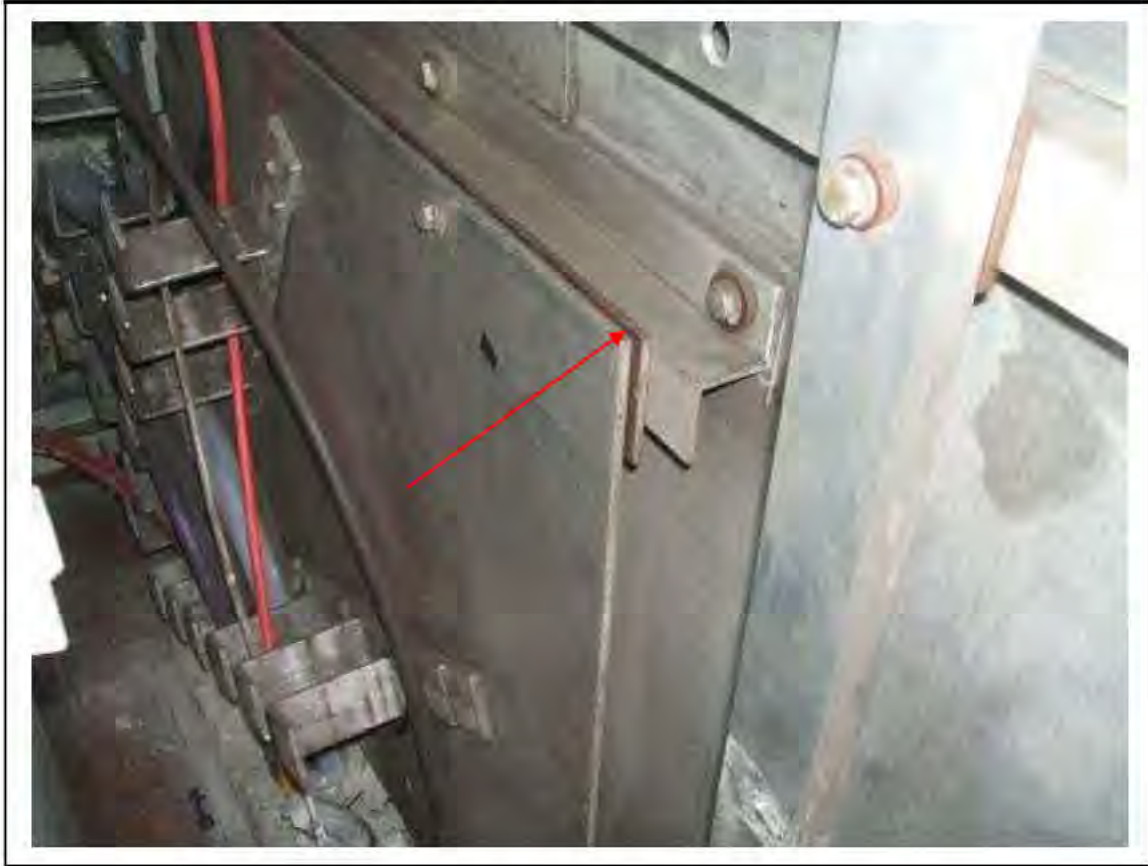
FIGURE 161: STRONGLY PRESUMED ASBESTOS IN SILUMINITE PACKING STRIPS IN IMR (CORRIDOR TO PLATFORM 2), 3/706 - DESCRIPTION & RESULT OF ASSESSMENT (SAMPLE REF. SP1(13))

Sample Number	SP1(13)
Location	IMR (corridor to Platform 2), 3/706
Material Description	Siluminite packing strips
Material Comment	To cable management
Quantity	2, 10x70cm
Product Type	Composite
Current Condition	Good condition
Surface Treatment	Composite
Asbestos Type	Strongly Presumed Chrysotile
Material Assessment Rating	Very low
Accessibility	Low
Further Comment	Not applicable

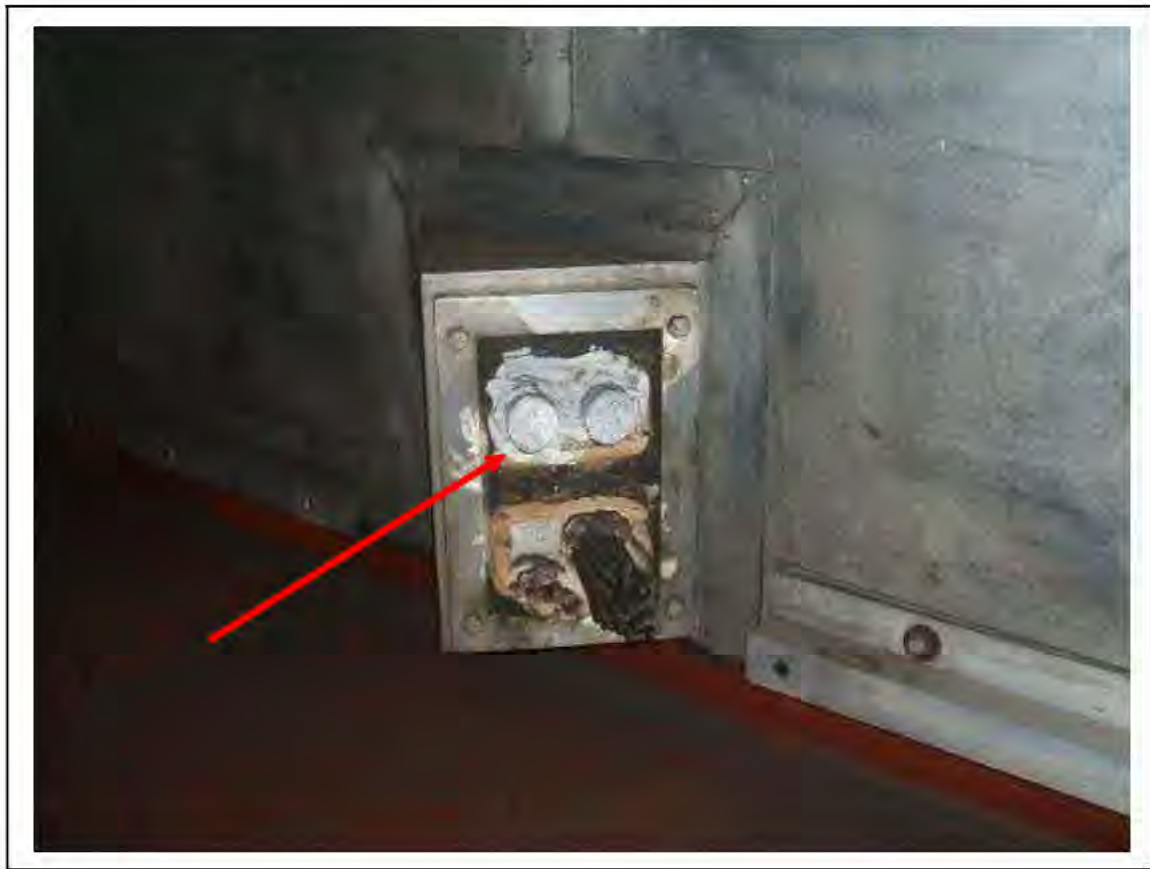
FIGURE 162: KNOWN ASBESTOS IN BRAIDED CABLE IN IMR, 3/707 - DESCRIPTION & RESULT OF ASSESSMENT (SAMPLE REF. K1(42))

Sample Number	K1(42)
Location	IMR, 3/707
Material Description	Braided cables
Material Comment	Cut back
Quantity	2
Product Type	Medium density
Current Condition	Slight damage
Surface Treatment	Encapsulated medium density
Asbestos Type	Known Chrysotile
Material Assessment Rating	Low
Accessibility	Medium
Further Comment	Not applicable

Ref No.	Area Surveyed		Material Description	Quantity (m ²)	Product Type	Current Condition	Surface Treatment	Accessibility	Asbestos Type	Comments and Recommendations	Figure
	Location	Room/Plant No									
	IMR	3/707	Aluminium	-	-	-	-	-	-	Walls and ceiling	-
K1(42)	IMR	3/707	Braided cable	2	2	1	1	2	K1	Cut back	Figure 162
	IMR	3/707	Steel	-	-	-	-	-	-	Door	-
	Relay Room	3/711	Quarry tiles	-	-	-	-	-	-	Floor	-
	Relay Room	3/711	Aluminium sheets	-	-	-	-	-	-	Walls and ceiling	-
SP1(14)	Relay Room	3/711	Braided cables	~12no	2	1	1	2	SP1	Walls 2 and 3	Figure 163
SP1(15)	Relay Room	3/711	Siluminite packing to aluminium strip joints	~20no, 5x5cm	1	0	0	1	SP1	Some are non asbestos paxolin	Figure 164
SP1(16)	Relay Room	3/711	Siluminite packing strips	2no, 70x10cm	1	0	0	1	SP1	Cable management	Figure 165
SP1(17)	Relay Room	3/711	Possible packing	1no, 20x20cm, 1no, 70x70	1	0	0	1	SP1	High level units	Figure 166
SP1(18)	Relay Room	3/711	Siluminite	2no, 4x4cm	1	0	0	1	SP1	To disused switches	Figure 167

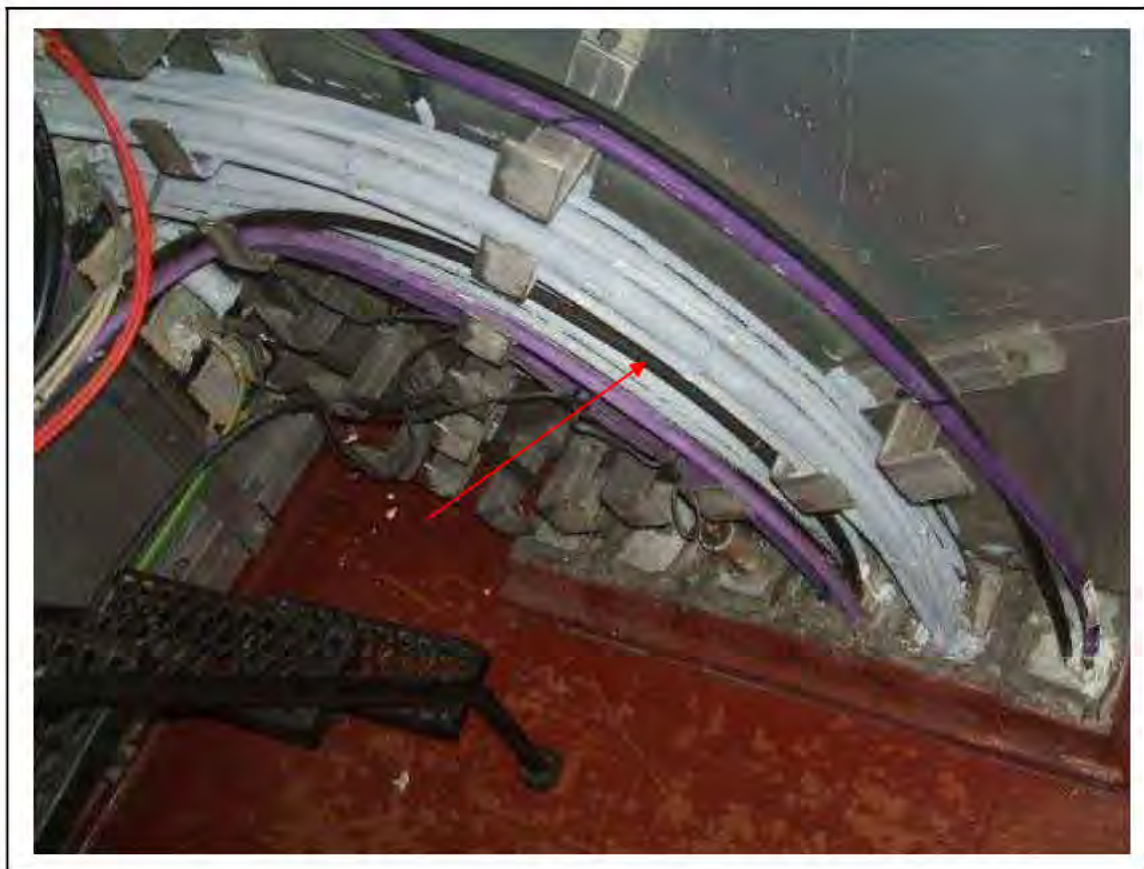
FIGURE 163: STRONGLY PRESUMED ASBESTOS IN BRAIDED CABLES IN RELAY ROOM , 3/711 - DESCRIPTION & RESULT OF ASSESSMENT (SAMPLE REF. SP1(14))

Sample Number	SP1(14)
Location	Relay Room , 3/711
Material Description	Braided cables
Material Comment	Walls 2 and 3
Quantity	~12no
Product Type	Medium density
Current Condition	Slight damage
Surface Treatment	Encapsulated medium density
Asbestos Type	Strongly Presumed Chrysotile
Material Assessment Rating	Low
Accessibility	Medium
Further Comment	Not applicable

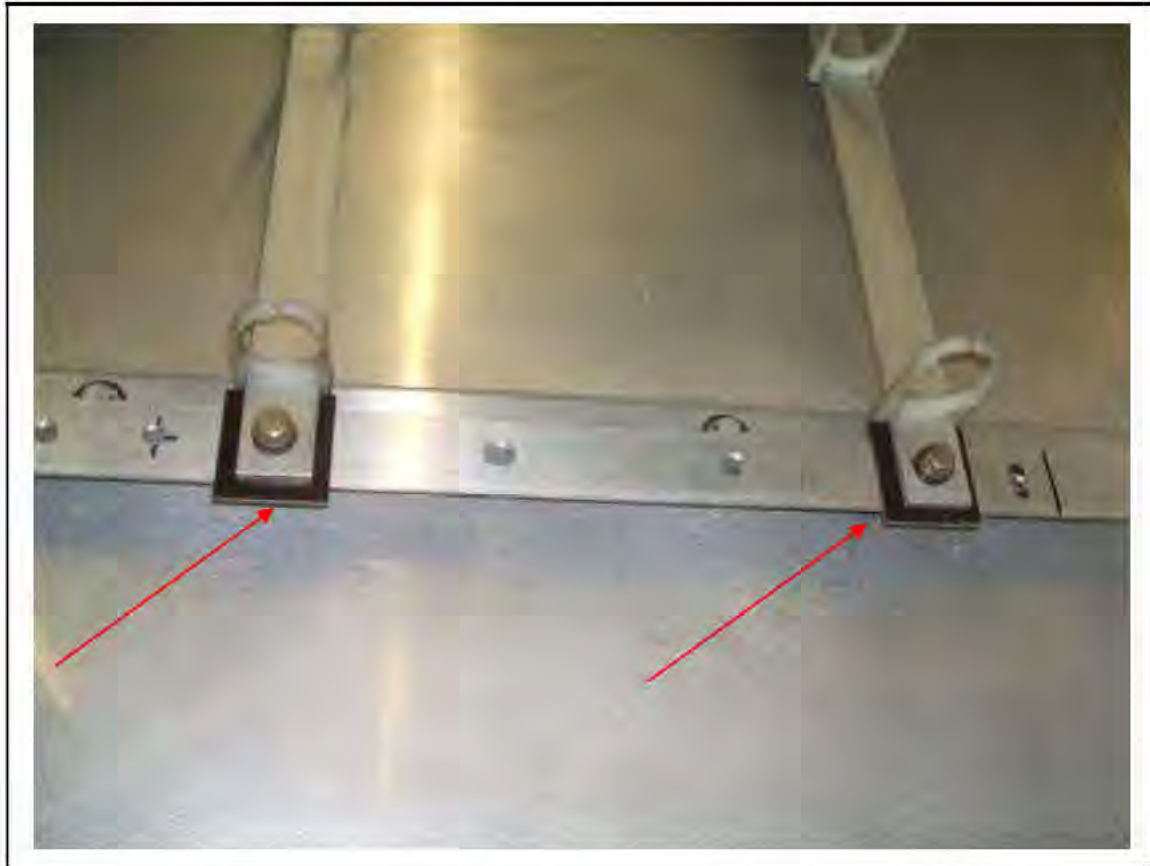
FIGURE 164: STRONGLY PRESUMED ASBESTOS IN SILUMINITE PACKING TO ALUMINIUM STRIP JOINTS IN RELAY ROOM , 3/711 - DESCRIPTION & RESULT OF ASSESSMENT (SAMPLE REF. SP1(15))

Sample Number	SP1(15)
Location	Relay Room , 3/711
Material Description	Siluminite packing to aluminium strip joints
Material Comment	Some are non asbestos paxolin
Quantity	~20no, 5x5cm
Product Type	Composite
Current Condition	Good condition
Surface Treatment	Composite
Asbestos Type	Strongly Presumed Chrysotile
Material Assessment Rating	Very low
Accessibility	Low
Further Comment	Not applicable
