Hazardous Materials - TfL Engineering

Re-inspection Sign-Off for Brixton

Re-inspection Reference: V059/4RS-200403

Station	Brixton
Original Management Survey	R346601
Date of Original Management	31st August 2012
Re-inspection Reference:	V059-4RS-200403
Next Planned Re-inspection	Periodical re-inspection according to HM Management Plan

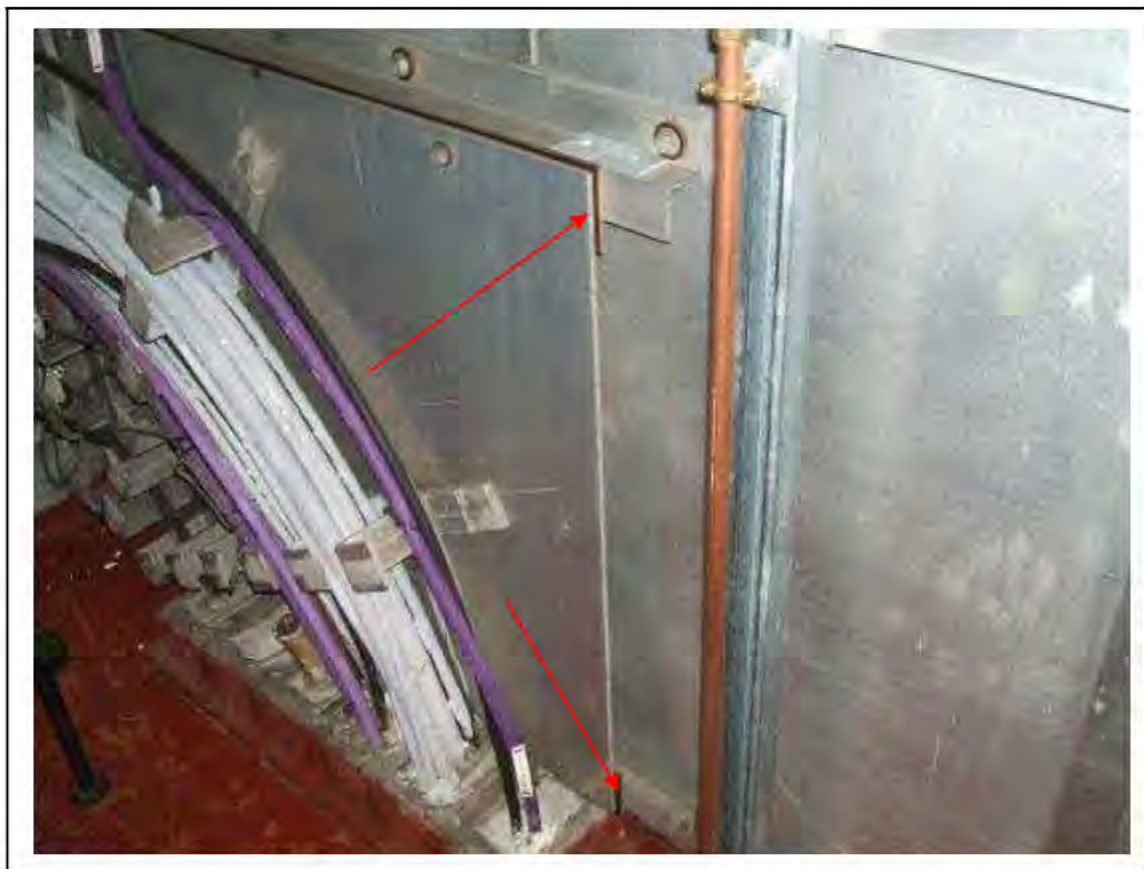
Siluminite packing strips strongly presumed to contain Chrysotile asbestos, Figure 165 - Material assessment rating: Very low

FIGURE 165: STRONGLY PRESUMED ASBESTOS IN SILUMINITE PACKING STRIPS IN RELAY ROOM , 3/711 - DESCRIPTION & RESULT OF ASSESSMENT (SAMPLE REF. SP1(16))

Sample Number	SP1(16)
Location	Relay Room , 3/711
Material Description	Siluminite packing strips
Material Comment	Cable management
Quantity	2no, 70x10cm
Product Type	Composite
Current Condition	Good condition
Surface Treatment	Composite
Asbestos Type	Strongly Presumed Chrysotile
Material Assessment Rating	Very low
Accessibility	Low
Further Comment	Not applicable

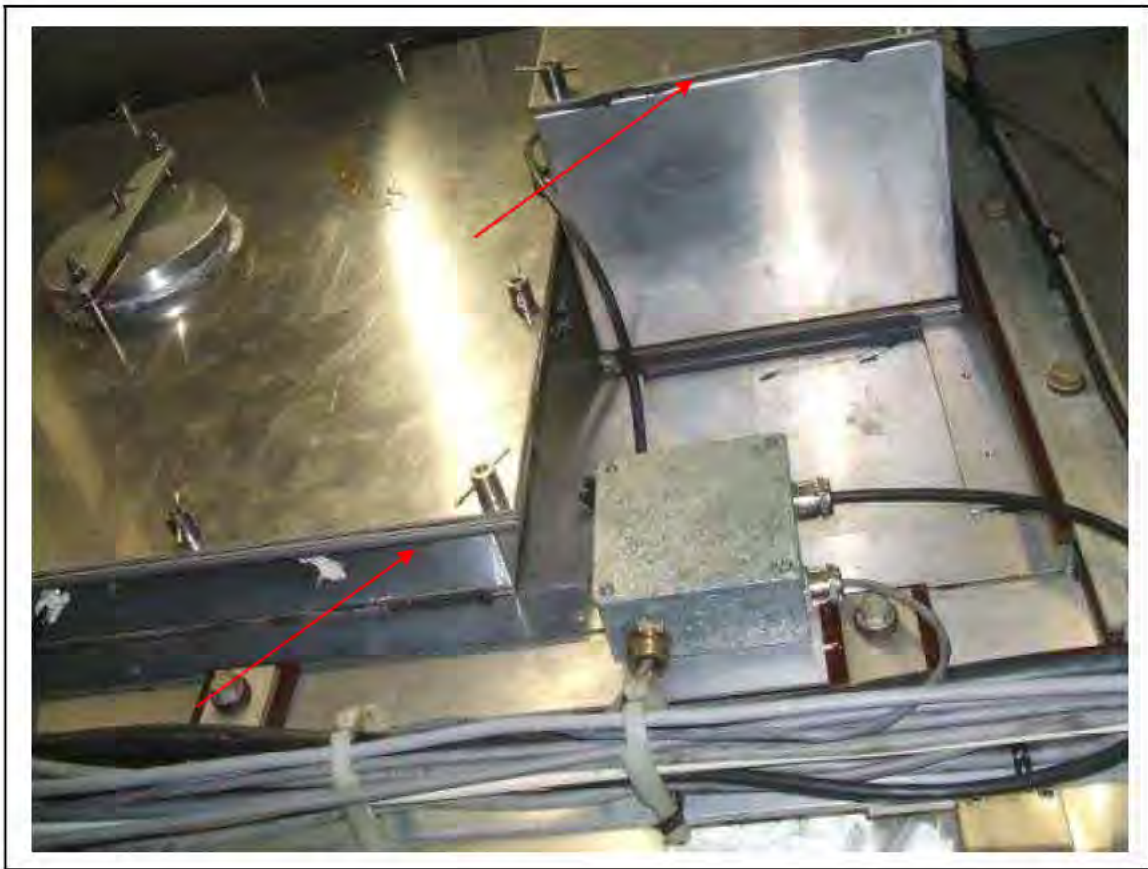
Possible packing strongly presumed to contain Chrysotile asbestos, Figure 166 - Material assessment rating: Very low

FIGURE 166: STRONGLY PRESUMED ASBESTOS IN PACKING IN RELAY ROOM , 3/711 - DESCRIPTION & RESULT OF ASSESSMENT (SAMPLE REF. SP1(17))

Sample Number	SP1(17)
Location	Relay Room , 3/711
Material Description	Possible packing
Material Comment	High level units
Quantity	1no, 20x20cm, 1no, 70x70
Product Type	Composite
Current Condition	Good condition
Surface Treatment	Composite
Asbestos Type	Strongly Presumed Chrysotile
Material Assessment Rating	Very low
Accessibility	Low
Further Comment	Not applicable

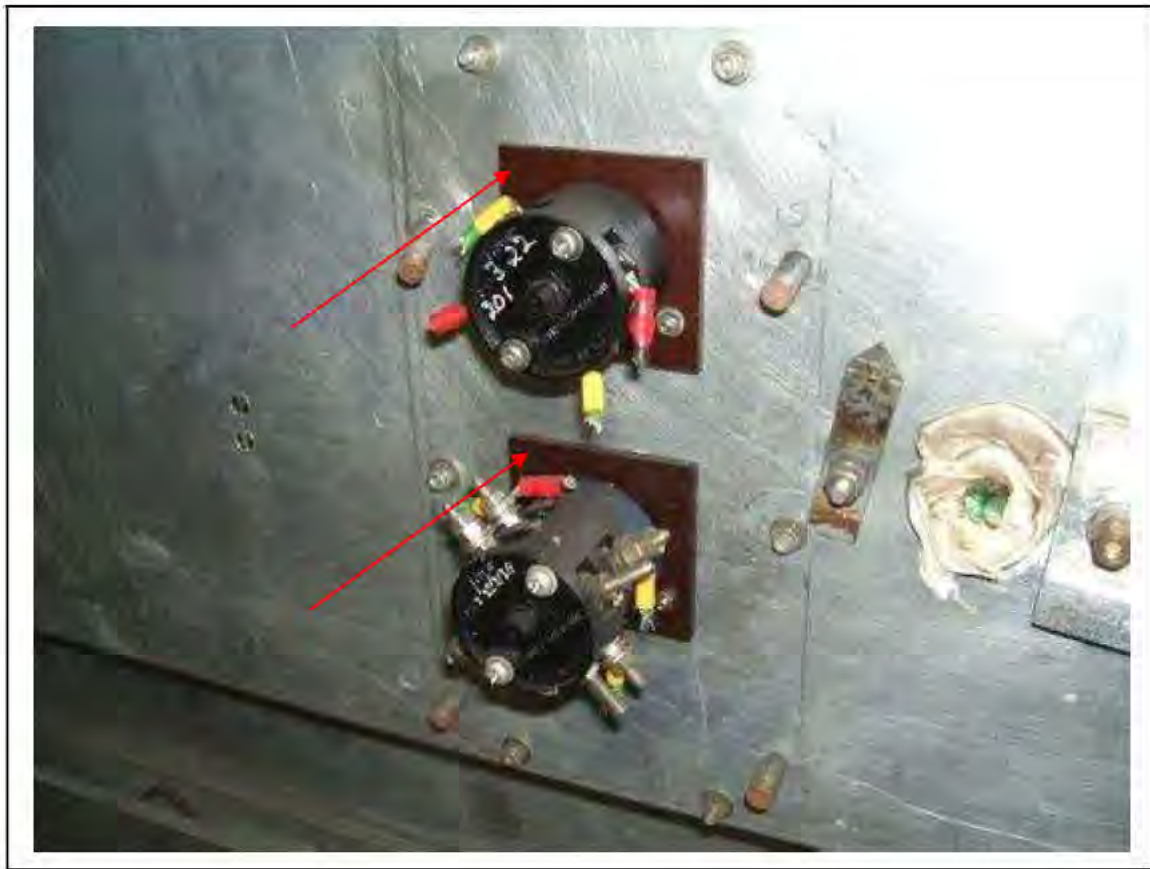
Siluminite strongly presumed to contain Chrysotile asbestos, Figure 167 - Material assessment rating: Very low

FIGURE 167: STRONGLY PRESUMED ASBESTOS IN SILUMINITE IN RELAY ROOM , 3/711 - DESCRIPTION & RESULT OF ASSESSMENT (SAMPLE REF. SP1(18))

Sample Number	SP1(18)
Location	Relay Room , 3/711
Material Description	Siluminite
Material Comment	To disused switches
Quantity	2no, 4x4cm
Product Type	Composite
Current Condition	Good condition
Surface Treatment	Composite
Asbestos Type	Strongly Presumed Chrysotile
Material Assessment Rating	Very low
Accessibility	Low
Further Comment	Not applicable

Ref No.	Area Surveyed		Material Description	Quantity (m ²)	Product Type	Current Condition	Surface Treatment	Accessibility	Asbestos Type	Comments and Recommendations	Figure
	Location	Room/Plant No									
	IMR	3/707	Aluminium	-	-	-	-	-	-	Walls and ceiling	-
K1(42)	IMR	3/707	Braided cable	2	2	1	1	2	K1	Cut back	Figure 162
	IMR	3/707	Steel	-	-	-	-	-	-	Door	-
	Relay Room	3/711	Quarry tiles	-	-	-	-	-	-	Floor	-
	Relay Room	3/711	Aluminium sheets	-	-	-	-	-	-	Walls and ceiling	-
SP1(14)	Relay Room	3/711	Braided cables	~12no	2	1	1	2	SP1	Walls 2 and 3	Figure 163
SP1(15)	Relay Room	3/711	Siluminite packing to aluminium strip joints	~20no, 5x5cm	1	0	0	1	SP1	Some are non asbestos paxolin	Figure 164
SP1(16)	Relay Room	3/711	Siluminite packing strips	2no, 70x10cm	1	0	0	1	SP1	Cable management	Figure 165
SP1(17)	Relay Room	3/711	Possible packing	1no, 20x20cm, 1no, 70x70	1	0	0	1	SP1	High level units	Figure 166
SP1(18)	Relay Room	3/711	Siluminite	2no, 4x4cm	1	0	0	1	SP1	To disused switches	Figure 167

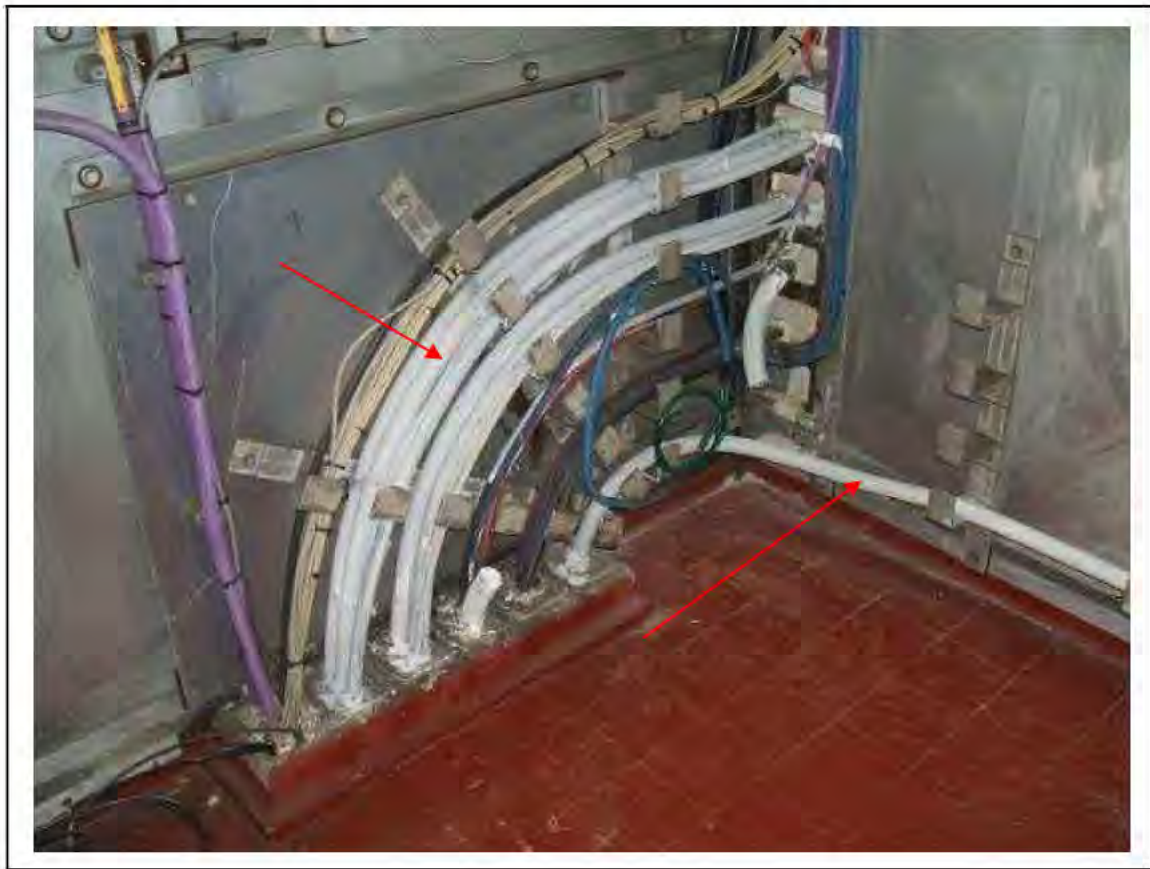
Braided cables known to contain Chrysotile asbestos, Figure 168 - Material assessment rating: Low

FIGURE 168: KNOWN ASBESTOS IN BRAIDED CABLES IN RELAY ROOM , 3/712 - DESCRIPTION & RESULT OF ASSESSMENT (SAMPLE REF. K1(43))

Sample Number	K1(43)
Location	Relay Room , 3/712
Material Description	Braided cables
Material Comment	Walls 2 and 3
Quantity	~12no
Product Type	Medium density
Current Condition	Slight damage
Surface Treatment	Encapsulated medium density
Asbestos Type	Known Chrysotile
Material Assessment Rating	Low
Accessibility	Medium
Further Comment	Not applicable

Ref No.	Area Surveyed		Material Description	Quantity (m ²)	Product Type	Current Condition	Surface Treatment	Accessibility	Asbestos Type	Comments and Recommendations	Figure
	Location	Room/Plant No									
K1(43)	Relay Room	3/712	Braided cables	~12no	2	1	1	2	K1	Walls 2 and 3	Figure 168
	Relay Room	3/712	Ducts	-	-	-	-	-	-	Concrete	-
K1(44)	Relay Room	3/712	Braided cable stub	1no	2	1	1	2	K1	-	Figure 169
SP1(19)	Relay Room	3/712	Siluminite panel	70x20cm	1	0	0	1	SP1	Wall 2, high level	Figure 170
SP1(20)	Relay Room	3/712	Siluminite panel to time switch unit	2no, 20x30cm	1	0	0	1	SP1	-	Figure 171
SP1(21)	Relay Room	3/712	Packing to aluminium strip joints (siluminite)	~20no, 5x5cm	1	0	0	1	SP1	Not all are siluminite	Figure 172
SP1(22)	Relay Room	3/712	Siluminite	10x5cm	1	0	0	1	SP1	Fuse bay 3 label	Figure 173
SP1(23)	Relay Room	3/712	Siluminite packing strips	2no, 100x5cm	1	0	0	1	SP1	Cable management	Figure 174

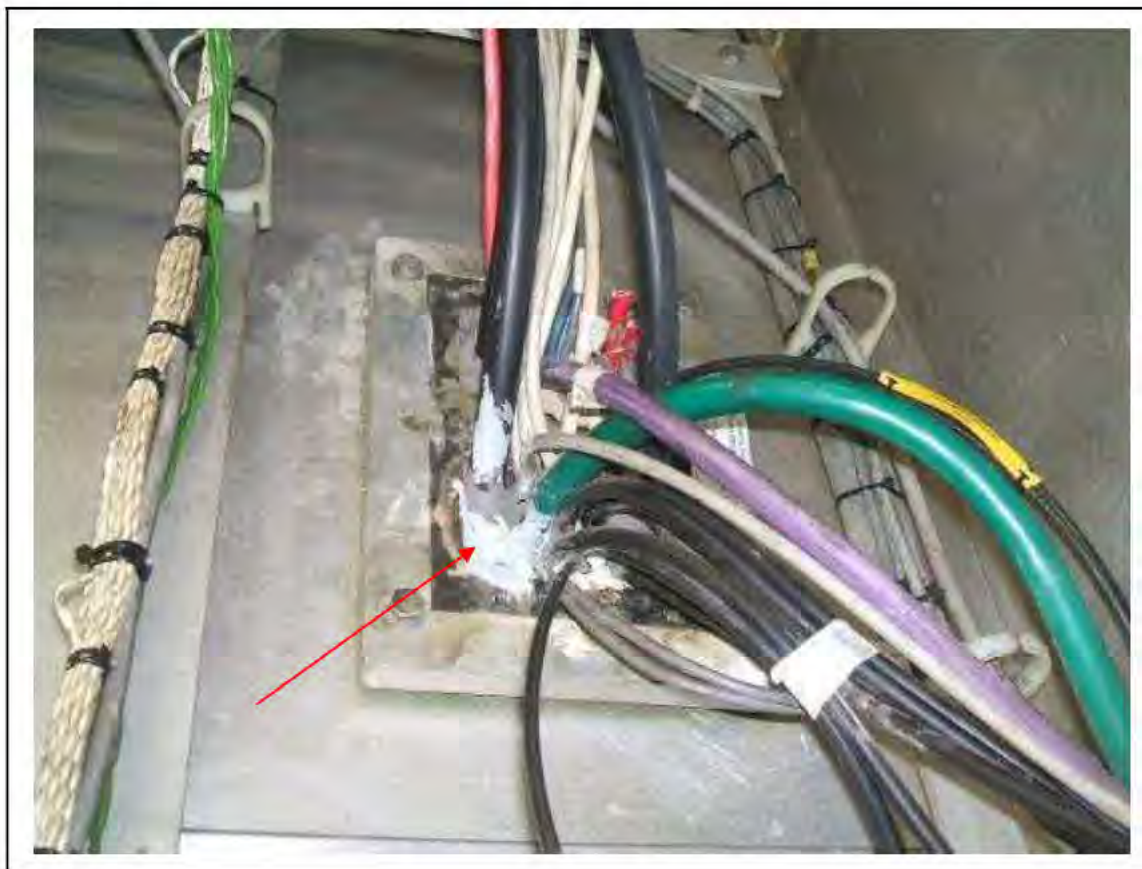
Braided cable stub known to contain Chrysotile asbestos, Figure 169 - Material assessment rating: Low

FIGURE 169: KNOWN ASBESTOS IN BRAIDED CABLE STUB IN RELAY ROOM , 3/712 - DESCRIPTION & RESULT OF ASSESSMENT (SAMPLE REF. K1(44))

Sample Number	K1(44)
Location	Relay Room , 3/712
Material Description	Braided cable stub
Material Comment	-
Quantity	1no
Product Type	Medium density
Current Condition	Slight damage
Surface Treatment	Encapsulated medium density
Asbestos Type	Known Chrysotile
Material Assessment Rating	Low
Accessibility	Medium
Further Comment	Not applicable

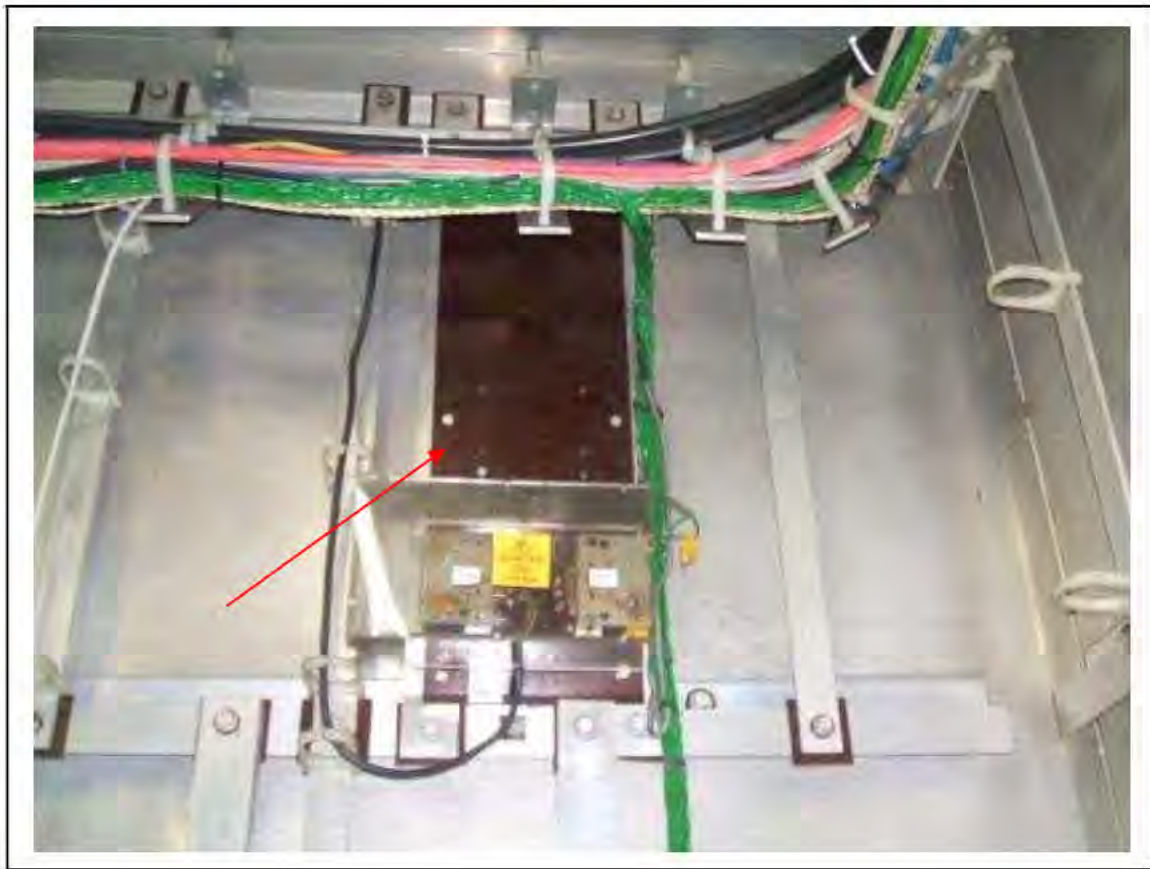
Siluminite panel strongly presumed to contain Chrysotile asbestos, Figure 170 - Material assessment rating: Very low

FIGURE 170: STRONGLY PRESUMED ASBESTOS IN SILUMINITE PANEL IN RELAY ROOM , 3/712 - DESCRIPTION & RESULT OF ASSESSMENT (SAMPLE REF. SP1(19))

Sample Number	SP1(19)
Location	Relay Room , 3/712
Material Description	Siluminite panel
Material Comment	Wall 2, high level
Quantity	70x20cm
Product Type	Composite
Current Condition	Good condition
Surface Treatment	Composite
Asbestos Type	Strongly Presumed Chrysotile
Material Assessment Rating	Very low
Accessibility	Low
Further Comment	Not applicable

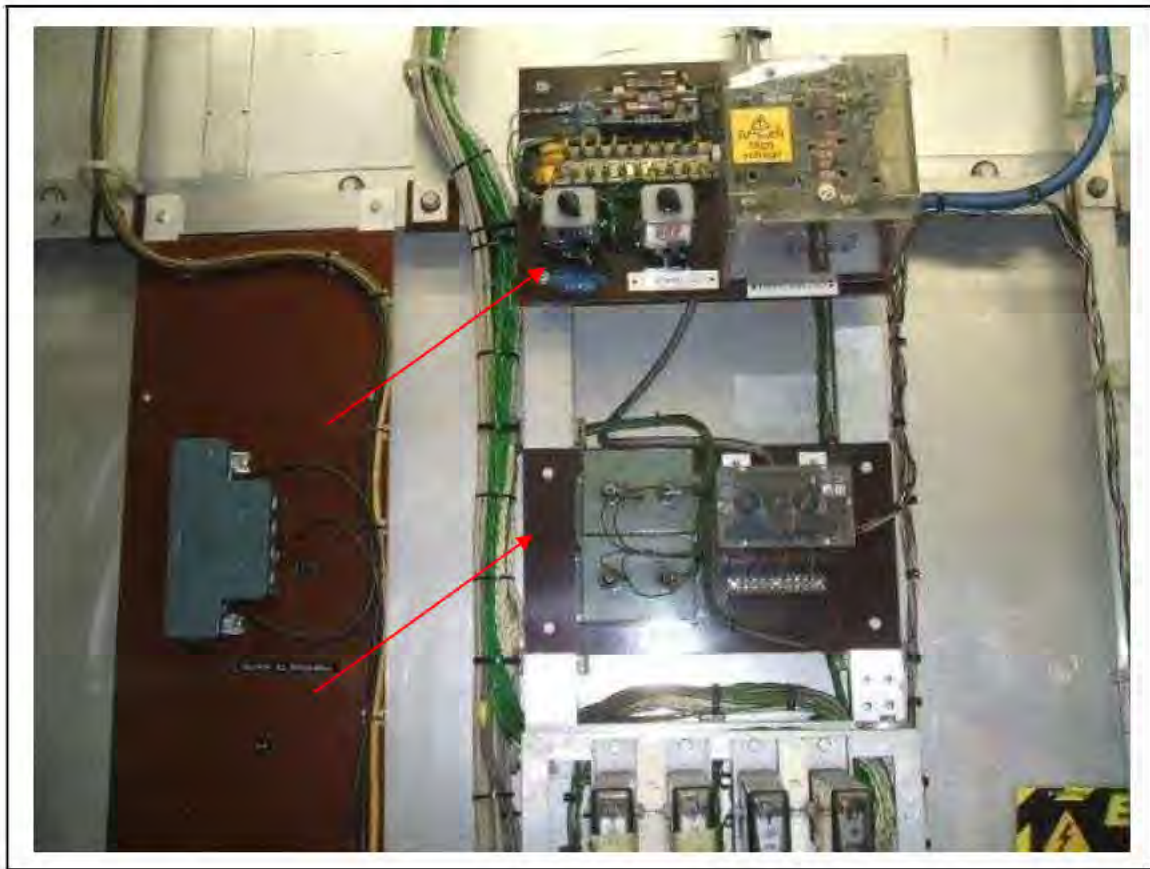
Siluminite panel to time switch unit strongly presumed to contain Chrysotile asbestos, Figure 171 - Material assessment rating: Very low

FIGURE 171: STRONGLY PRESUMED ASBESTOS IN SILUMINITE PANEL TO TIME SWITCH UNIT IN RELAY ROOM , 3/712 - DESCRIPTION & RESULT OF ASSESSMENT (SAMPLE REF. SP1(20))

Sample Number	SP1(20)
Location	Relay Room , 3/712
Material Description	Siluminite panel to time switch unit
Material Comment	-
Quantity	2no, 20x30cm
Product Type	Composite
Current Condition	Good condition
Surface Treatment	Composite
Asbestos Type	Strongly Presumed Chrysotile
Material Assessment Rating	Very low
Accessibility	Low
Further Comment	Not applicable

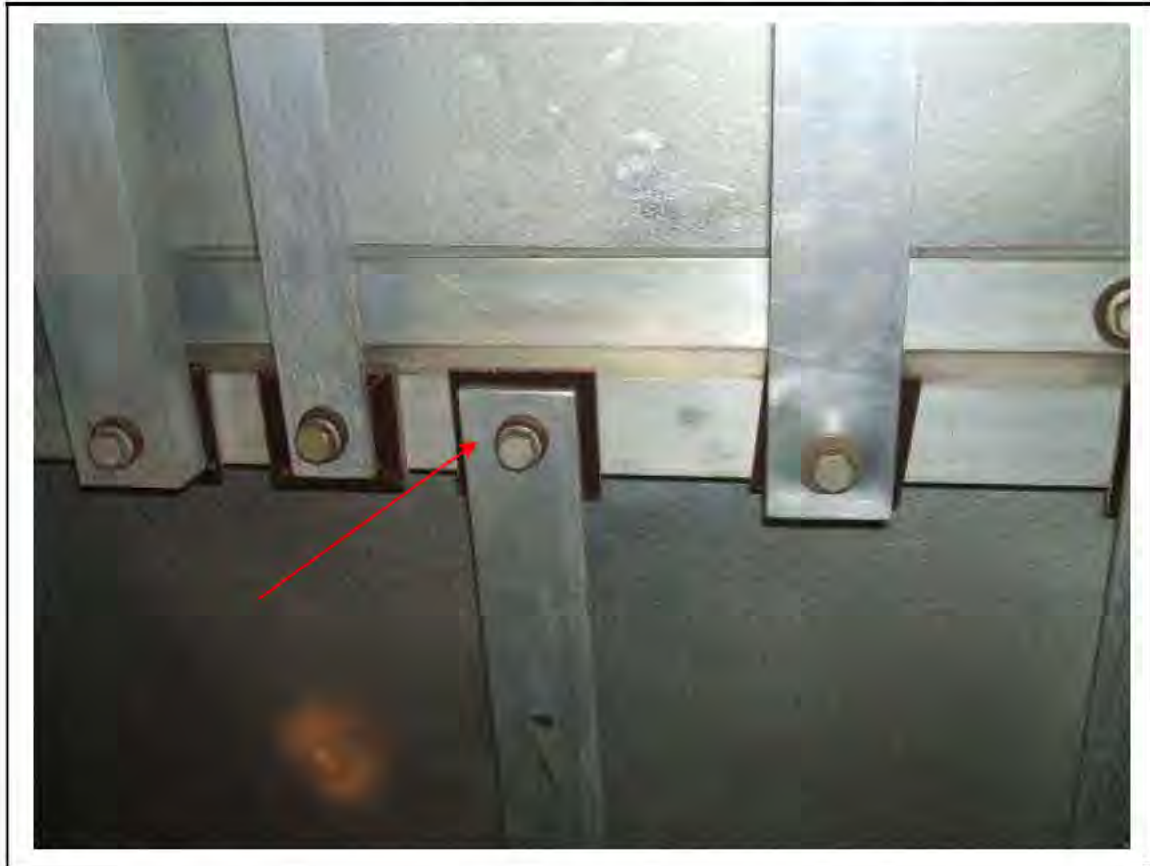
Packing to aluminium strip joints (siluminite) strongly presumed to contain Chrysotile asbestos, Figure 172 - Material assessment rating: Very low

FIGURE 172: STRONGLY PRESUMED ASBESTOS IN PACKING TO ALUMINIUM STRIP JOINTS (SILUMINITE) IN RELAY ROOM , 3/712 - DESCRIPTION & RESULT OF ASSESSMENT (SAMPLE REF. SP1(21))

Sample Number	SP1(21)
Location	Relay Room , 3/712
Material Description	Packing to aluminium strip joints (siluminite)
Material Comment	Not all are siluminite
Quantity	~20no, 5x5cm
Product Type	Composite
Current Condition	Good condition
Surface Treatment	Composite
Asbestos Type	Strongly Presumed Chrysotile
Material Assessment Rating	Very low
Accessibility	Low
Further Comment	Not applicable

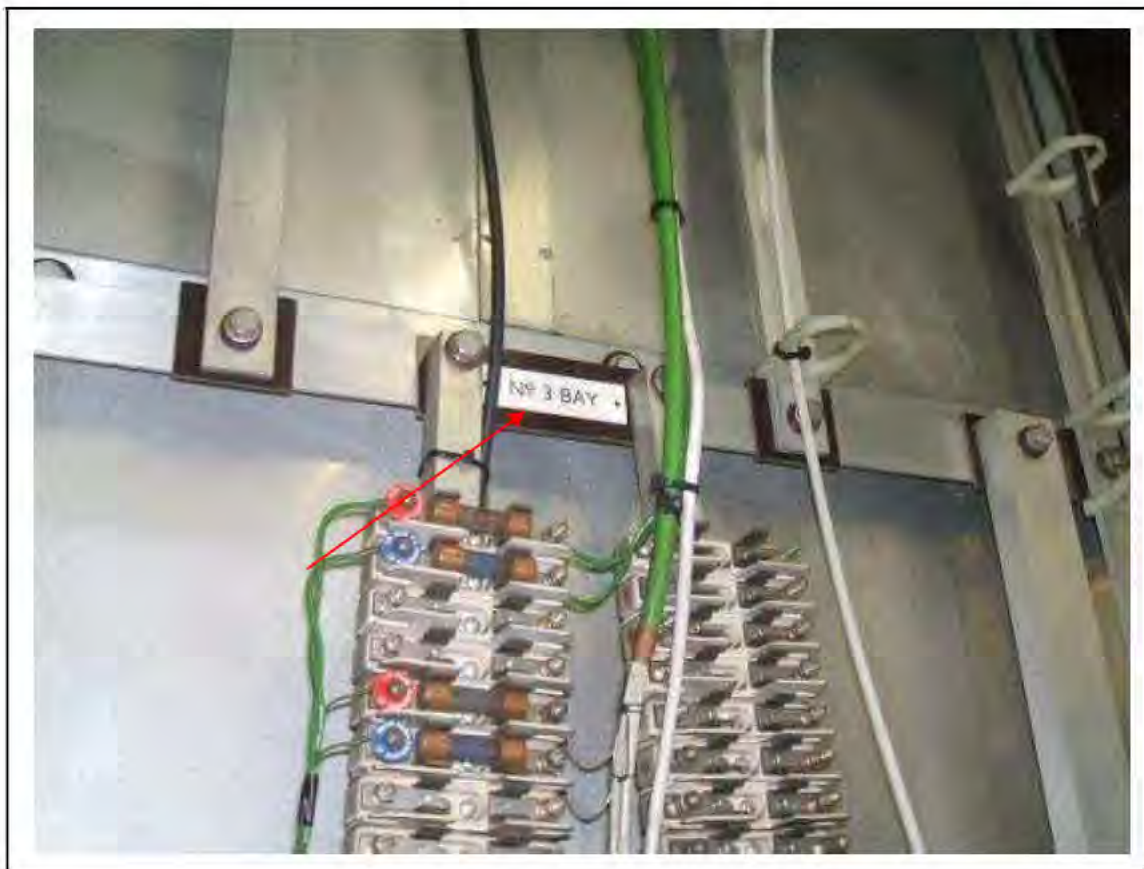
Siluminite strongly presumed to contain Chrysotile asbestos, Figure 173 - Material assessment rating: Very low

FIGURE 173: STRONGLY PRESUMED ASBESTOS IN SILUMINITE IN RELAY ROOM , 3/712 - DESCRIPTION & RESULT OF ASSESSMENT (SAMPLE REF. SP1(22))

Sample Number	SP1(22)
Location	Relay Room , 3/712
Material Description	Siluminite
Material Comment	Fuse bay 3 label
Quantity	10x5cm
Product Type	Composite
Current Condition	Good condition
Surface Treatment	Composite
Asbestos Type	Strongly Presumed Chrysotile
Material Assessment Rating	Very low
Accessibility	Low
Further Comment	Not applicable

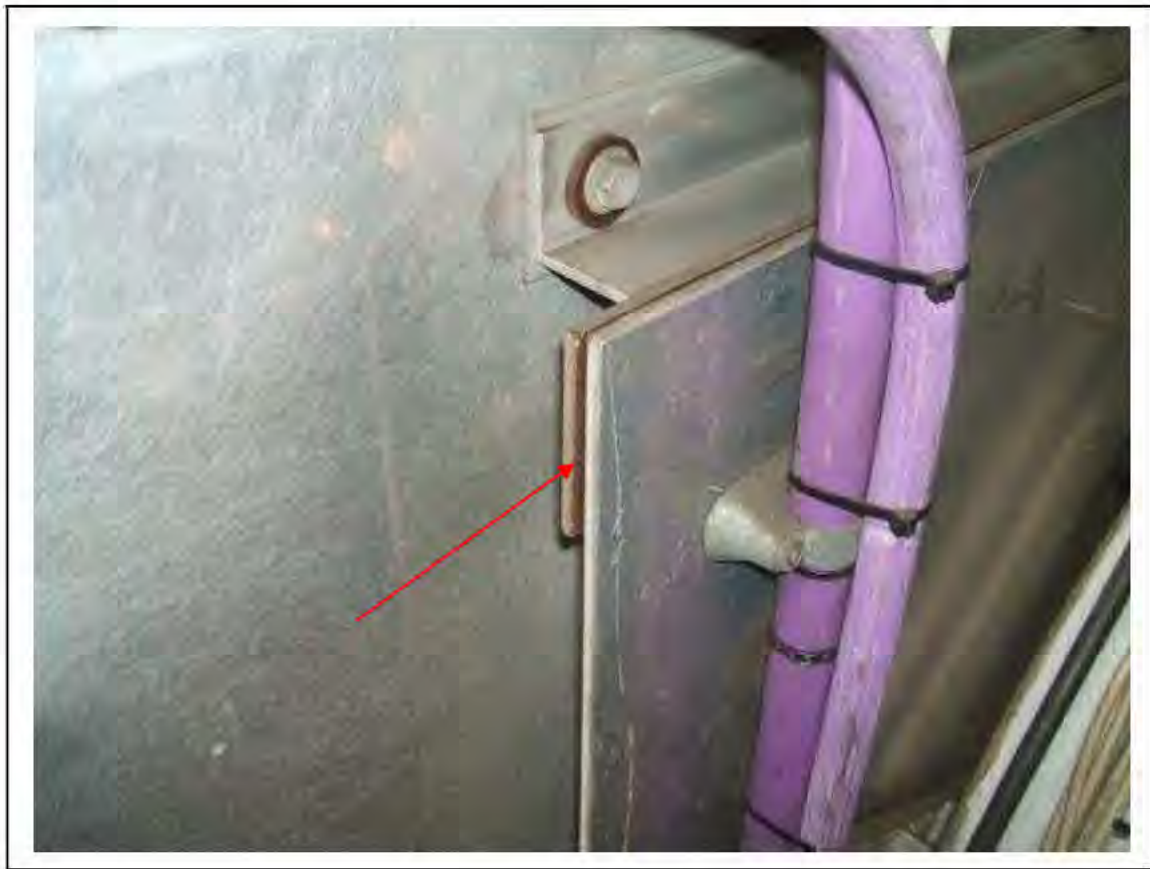
Siluminite packing strips strongly presumed to contain Chrysotile asbestos, Figure 174 - Material assessment rating: Very low

FIGURE 174: STRONGLY PRESUMED ASBESTOS IN SILUMINITE PACKING STRIPS IN RELAY ROOM , 3/712 - DESCRIPTION & RESULT OF ASSESSMENT (SAMPLE REF. SP1(23))

Sample Number	SP1(23)
Location	Relay Room , 3/712
Material Description	Siluminite packing strips
Material Comment	Cable management
Quantity	2no, 100x5cm
Product Type	Composite
Current Condition	Good condition
Surface Treatment	Composite
Asbestos Type	Strongly Presumed Chrysotile
Material Assessment Rating	Very low
Accessibility	Low
Further Comment	Not applicable

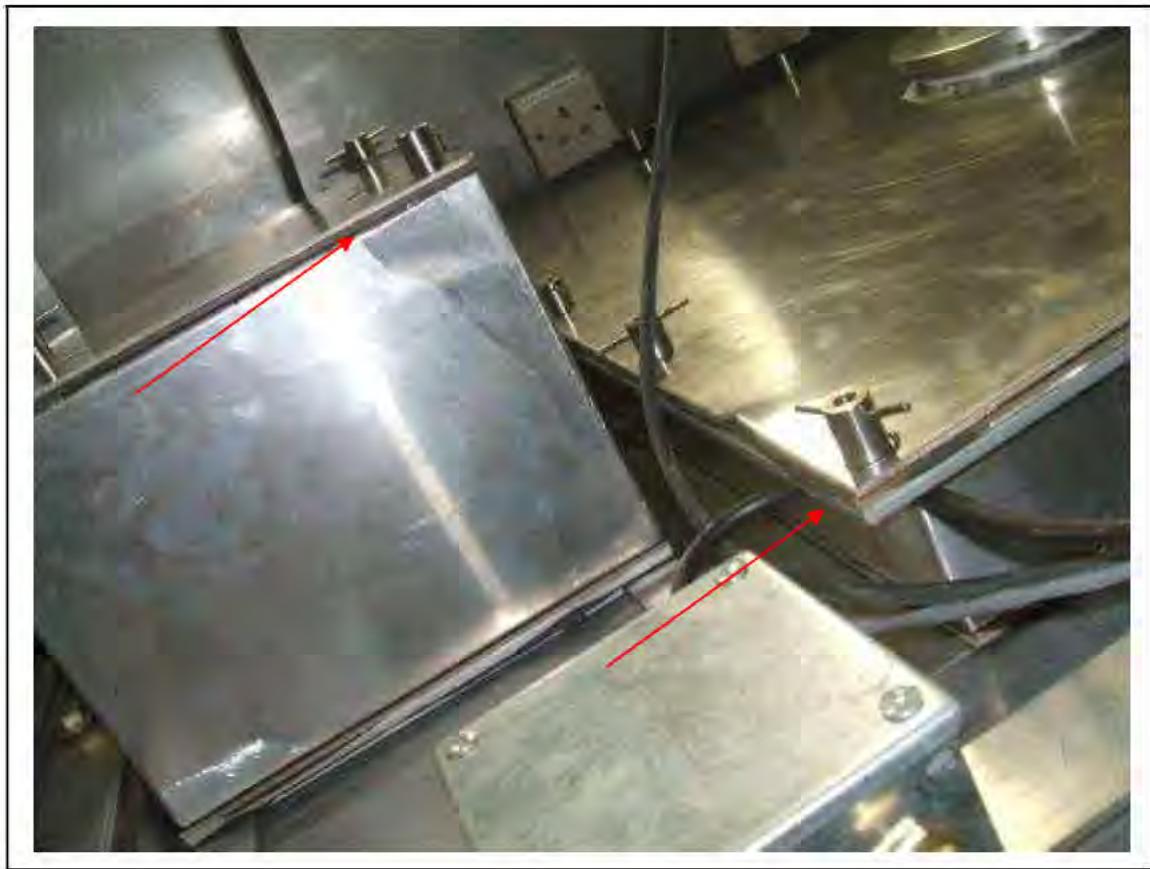
Siluminite packing strongly presumed to contain Chrysotile asbestos, Figure 175 - Material assessment rating: Very low

FIGURE 175: STRONGLY PRESUMED ASBESTOS IN SILUMINITE PACKING IN RELAY ROOM , 3/712 - DESCRIPTION & RESULT OF ASSESSMENT (SAMPLE REF. SP1(24))

Sample Number	SP1(24)
Location	Relay Room , 3/712
Material Description	Siluminite packing
Material Comment	High level wall unit
Quantity	1no, 20x20cm and 1no, 70x70cm
Product Type	Composite
Current Condition	Good condition
Surface Treatment	Composite
Asbestos Type	Strongly Presumed Chrysotile
Material Assessment Rating	Very low
Accessibility	Low
Further Comment	Not applicable

SP1(24)	Relay Room	3/712	Siluminite packing	1no, 20x20cm and 1no, 70x70cm	1	0	0	1	SP1	High level wall unit	Figure 175
SP1(25)	Relay Room	3/712	Siluminite boards	2no, 50x10cm	1	0	0	1	SP1	To relay rack no1	Figure 176
	CER	3/731	Quarry tiles	-	-	-	-	-	-	Floor	-
	CER	3/731	Tiles and brick	-	-	-	-	-	-	Walls	-

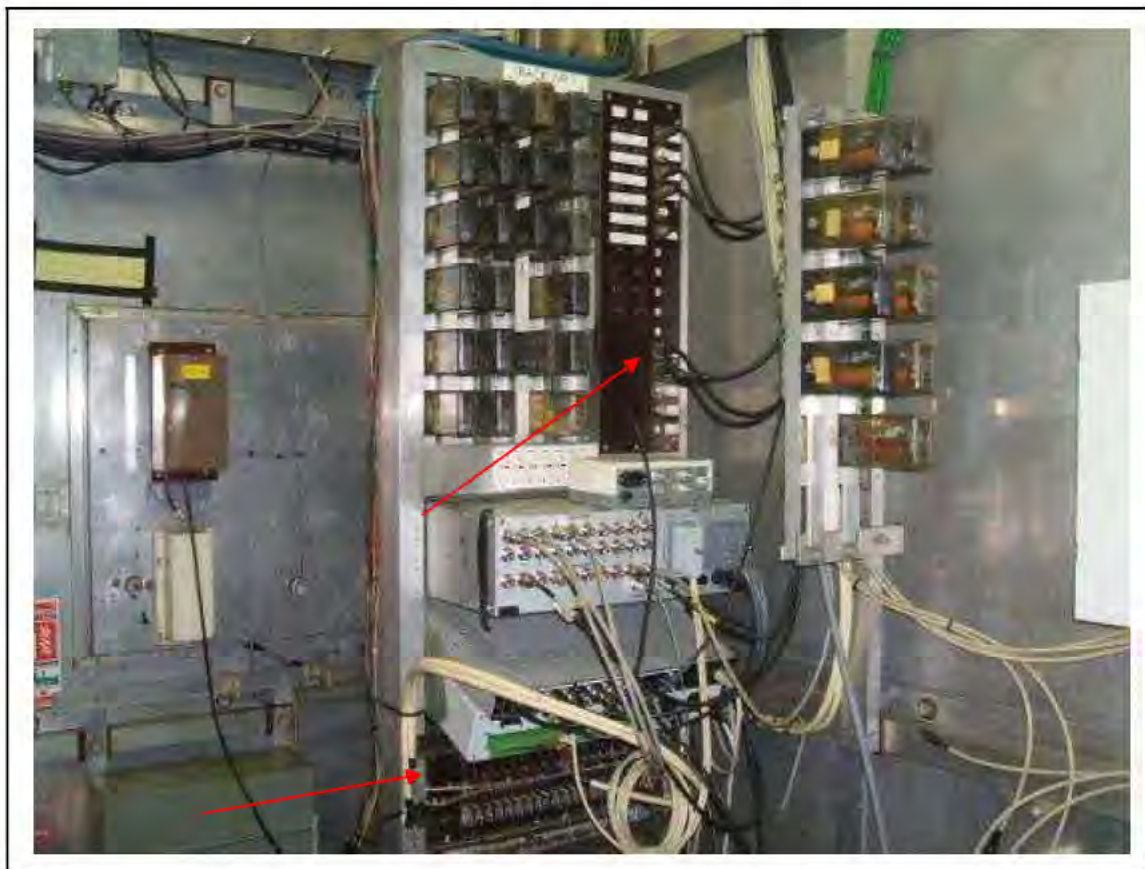
Siluminite boards strongly presumed to contain Chrysotile asbestos, Figure 176 - Material assessment rating: Very low

FIGURE 176: STRONGLY PRESUMED ASBESTOS IN SILUMINITE BOARDS IN RELAY ROOM , 3/712 - DESCRIPTION & RESULT OF ASSESSMENT (SAMPLE REF. SP1(25))

Sample Number	SP1(25)
Location	Relay Room , 3/712
Material Description	Siluminite boards
Material Comment	To relay rack no1
Quantity	2no, 50x10cm
Product Type	Composite
Current Condition	Good condition
Surface Treatment	Composite
Asbestos Type	Strongly Presumed Chrysotile
Material Assessment Rating	Very low
Accessibility	Low
Further Comment	Not applicable

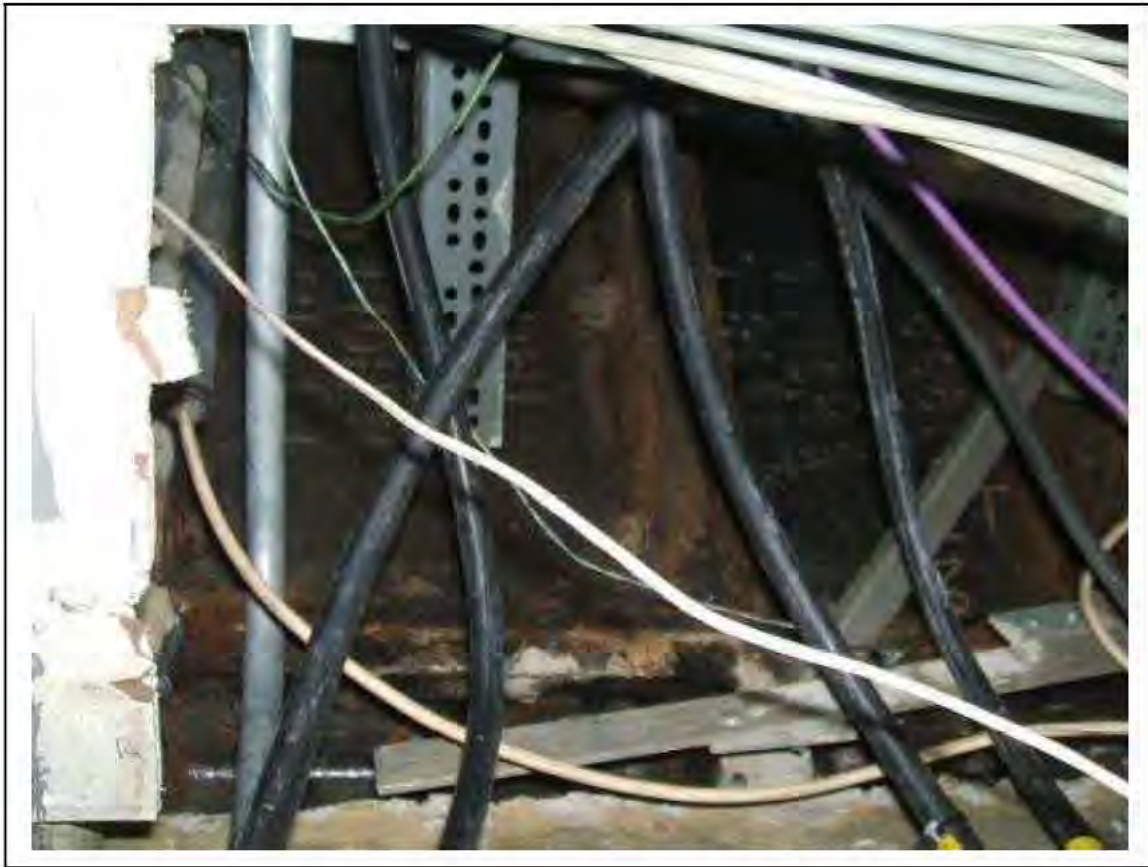
Tunnel ring joints strongly presumed to contain Amosite & Chrysotile asbestos, Figure 177 - Material assessment rating: Very low

FIGURE 177: STRONGLY PRESUMED ASBESTOS IN TUNNEL RING JOINTS IN CER, 3/731 - DESCRIPTION & RESULT OF ASSESSMENT (SAMPLE REF. SP1&2(2))

Sample Number	SP1&2(2)
Location	CER, 3/731
Material Description	Tunnel ring joints
Material Comment	Possible caulking, no access over equipment
Quantity	throughout
Product Type	Medium density
Current Condition	-
Surface Treatment	-
Asbestos Type	Strongly Presumed Amosite & Chrysotile
Material Assessment Rating	Very low
Accessibility	Low
Further Comment	Not applicable

Ref No.	Area Surveyed		Material Description	Quantity (m ²)	Product Type	Current Condition	Surface Treatment	Accessibility	Asbestos Type	Comments and Recommendations	Figure
	Location	Room/Plant No									
SP1&2(2)	CER	3/731	Tunnel ring joints	throughout	2	-	-	1	SP1&2	Possible caulking, no access over equipment	Figure 177
	CER	3/731	Supalux panel	-	-	-	-	-	-	To rear wall	-
SP1(26)	CER	3/731	Siluminite panel	20x20cm	1	0	0	1	SP1	-	Figure 178
K1(45)	CER	3/731	Braided cables	2no	2	1	1	2	K1	-	Figure 179
SP1(27)	CER	3/731	Possible siluminite strip	2x70cm	1	0	0	1	SP1	Behind earthing strip	Figure 180
	CER (New)	3/732	Supalux tiles	-	-	-	-	-	-	False ceiling	-
	CER (New)	3/732	Plaster on brickwork	-	-	-	-	-	-	Walls	-
	CER (New)	3/732	Concrete slab	-	-	-	-	-	-	Floor	-
	CER (New)	3/732	Plastic cables and metal conduits	-	-	-	-	-	-	Walls and ceiling	-
	CER (New)	3/732	Concrete slab	-	-	-	-	-	-	Ceiling above false ceiling	-

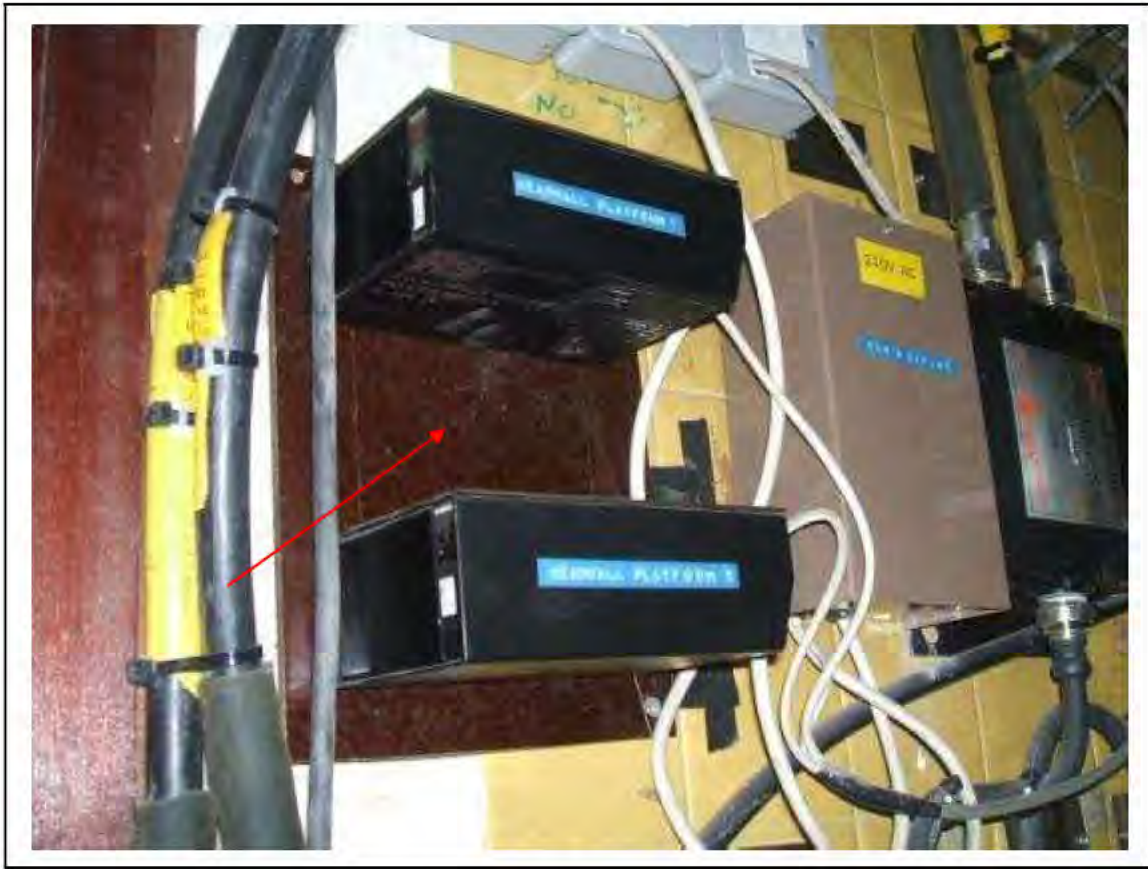
FIGURE 178: STRONGLY PRESUMED ASBESTOS IN SILUMINITE PANEL IN CER, 3/731 - DESCRIPTION & RESULT OF ASSESSMENT (SAMPLE REF. SP1(26))

Sample Number	SP1(26)
Location	CER, 3/731
Material Description	Siluminite panel
Material Comment	-
Quantity	20x20cm
Product Type	Composite
Current Condition	Good condition
Surface Treatment	Composite
Asbestos Type	Strongly Presumed Chrysotile
Material Assessment Rating	Very low
Accessibility	Low
Further Comment	Not applicable

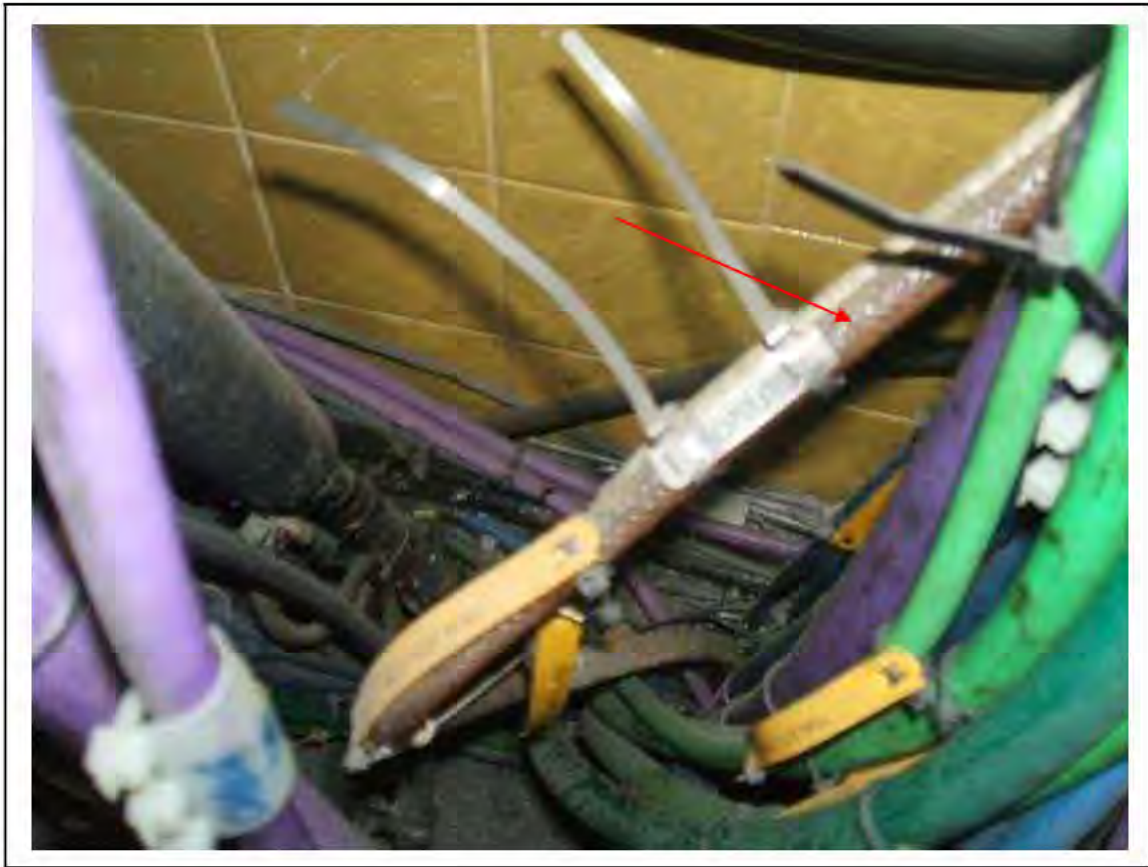
FIGURE 179: KNOWN ASBESTOS IN BRAIDED CABLES IN CER , 3/731 - DESCRIPTION & RESULT OF ASSESSMENT (SAMPLE REF. K1(45))

Sample Number	K1(45)
Location	CER , 3/731
Material Description	Braided cables
Material Comment	-
Quantity	2no
Product Type	Medium density
Current Condition	Slight damage
Surface Treatment	Encapsulated medium density
Asbestos Type	Known Chrysotile
Material Assessment Rating	Low
Accessibility	Medium
Further Comment	Not applicable

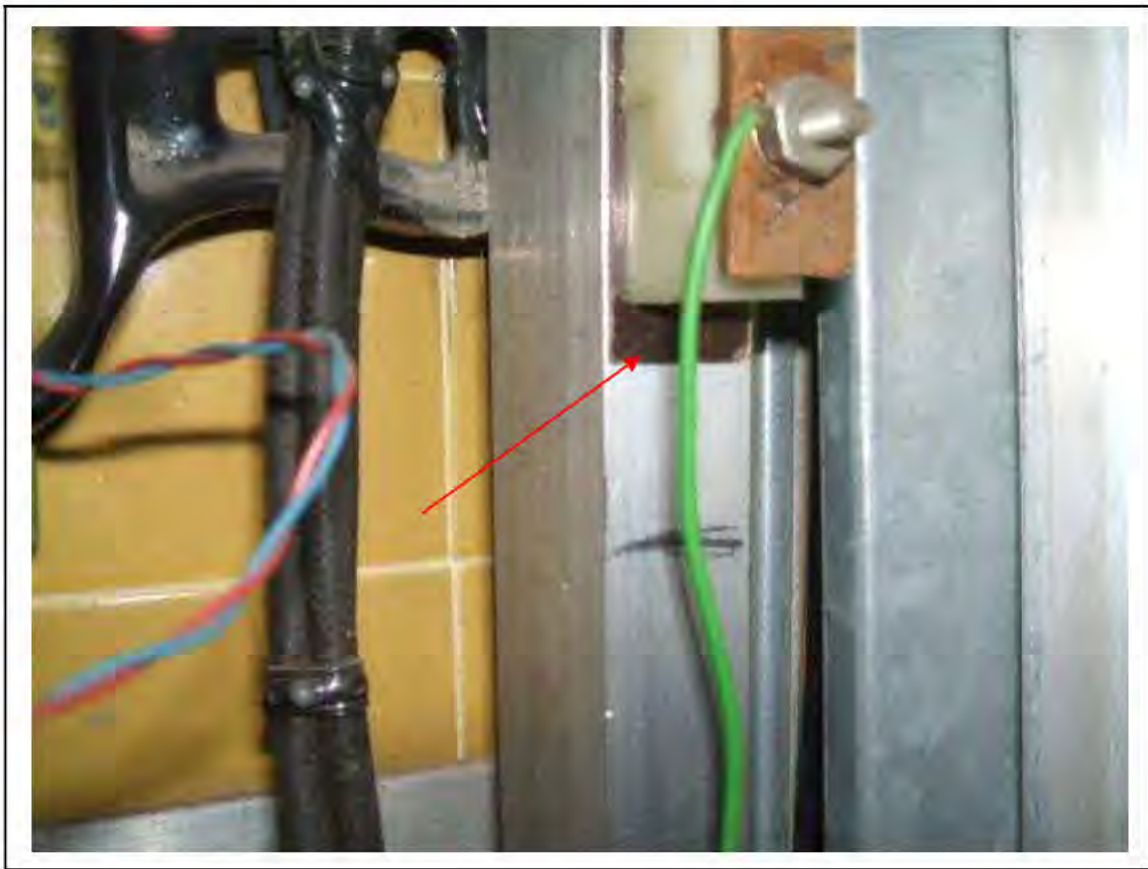
FIGURE 180: STRONGLY PRESUMED ASBESTOS IN SILUMINITE STRIP IN CER , 3/731 - DESCRIPTION & RESULT OF ASSESSMENT (SAMPLE REF. SP1(27))

Sample Number	SP1(27)
Location	CER , 3/731
Material Description	Possible siluminite strip
Material Comment	Behind earthing strip
Quantity	2x70cm
Product Type	Composite
Current Condition	Good condition
Surface Treatment	Composite
Asbestos Type	Strongly Presumed Chrysotile
Material Assessment Rating	Very low
Accessibility	Low
Further Comment	Not applicable

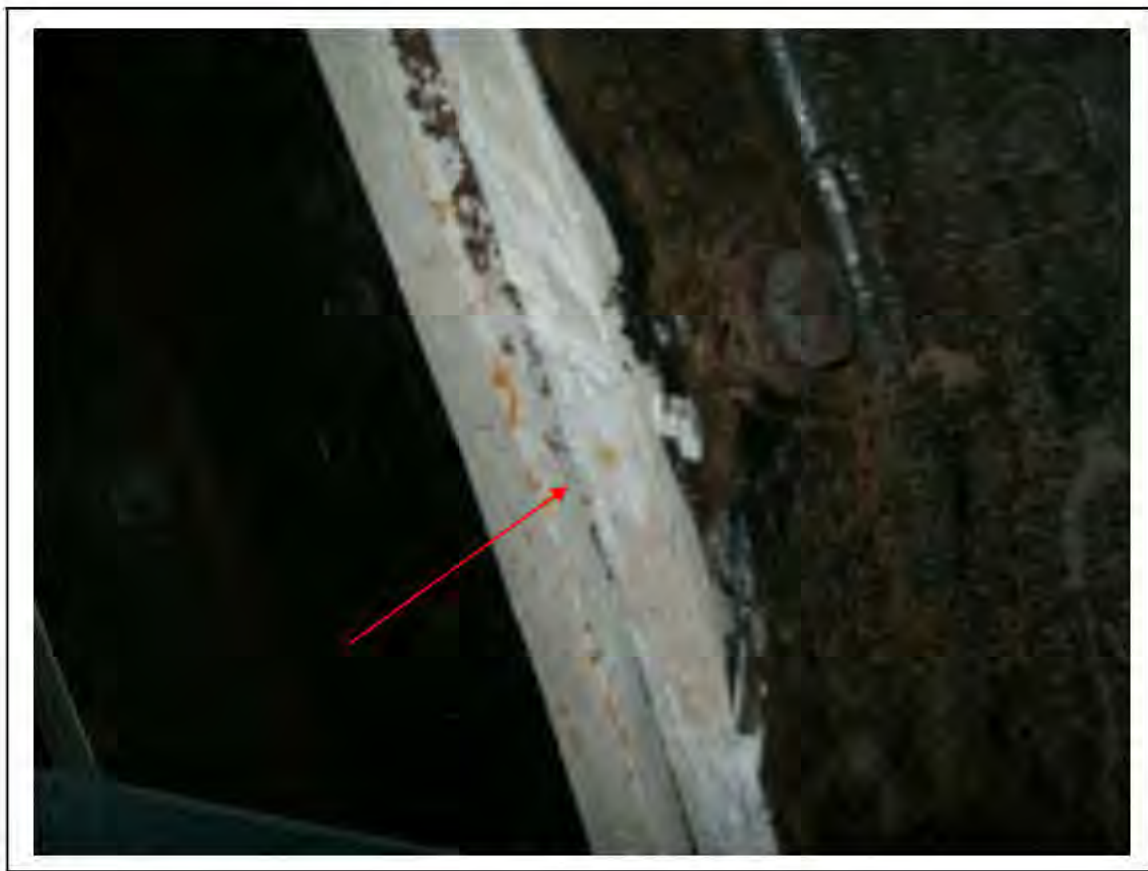
FIGURE 181: CONFIRMED ASBESTOS IN CAULKING IN OFFICE , 3/756 - DESCRIPTION & RESULT OF ASSESSMENT (SAMPLE REF. SAME AS 120445/150812/03)

Sample Number	Same as 120445/150812/03
Location	Office , 3/756
Material Description	Caulking
Material Comment	Tunnel ring flanges within false ceiling
Quantity	throughout
Product Type	Medium density
Current Condition	Slight damage
Surface Treatment	Encapsulated medium density
Asbestos Type	Amosite and Chrysotile
Material Assessment Rating	Medium
Accessibility	Low
Further Comment	Not applicable

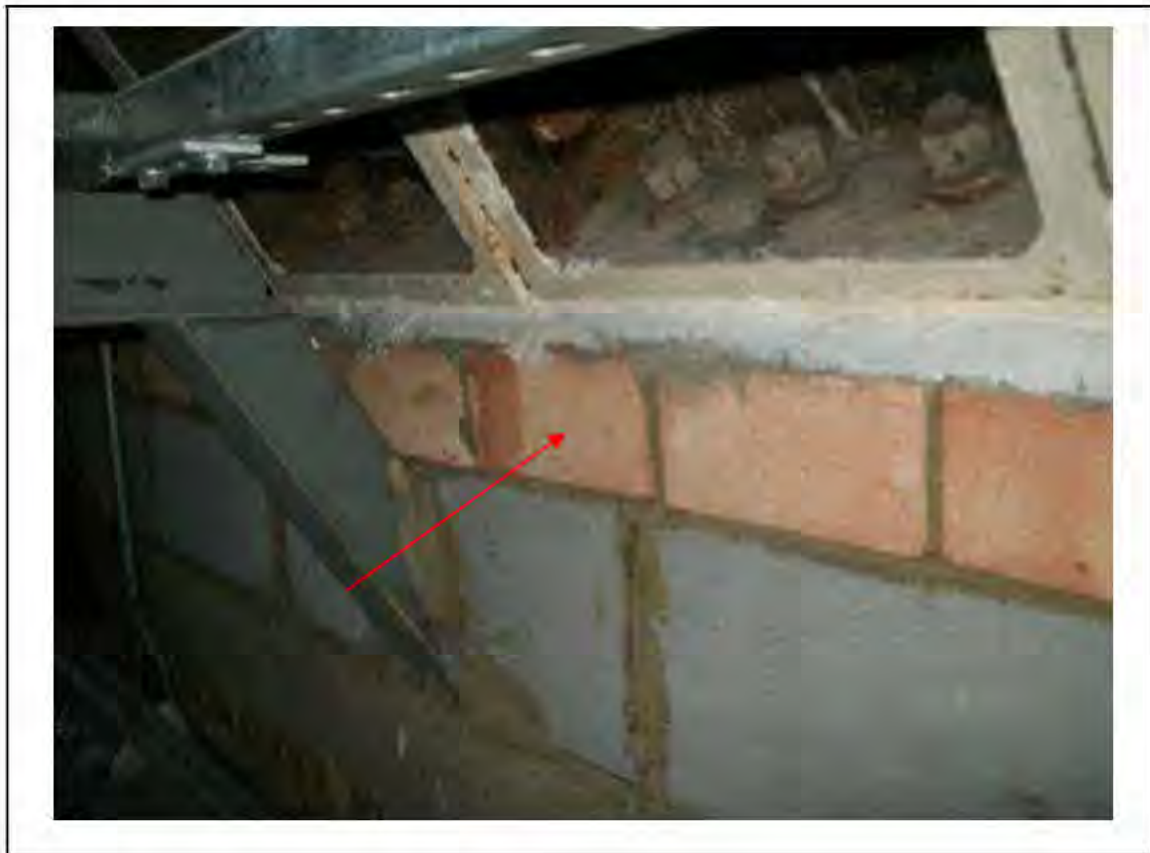
FIGURE 182: KNOWN ASBESTOS IN CELLACTITE, METAL CORRUGATED SHEETS IN OFFICE , 3/756 - DESCRIPTION & RESULT OF ASSESSMENT (SAMPLE REF. K1(46))

Cellactite, metal corrugated sheets known to contain Chrysotile asbestos, Figure 182 - Material assessment rating: Very low

Sample Number	K1(46)
Location	Office , 3/756
Material Description	Cellactite, metal corrugated sheets
Material Comment	Within wall cavities
Quantity	throughout
Product Type	Composite
Current Condition	-
Surface Treatment	Composite
Asbestos Type	Known Chrysotile
Material Assessment Rating	Very low
Accessibility	Very low
Further Comment	Not applicable

Ref No.	Area Surveyed		Material Description	Quantity (m ²)	Product Type	Current Condition	Surface Treatment	Accessibility	Asbestos Type	Comments and Recommendations	Figure
	Location	Room/Plant No									
	CER (New)	3/732	Rubber on wooden floor tiles	-	-	-	-	-	-	Raised floor	-
	CER	3/733	Supalux tiles	-	-	-	-	-	-	False ceiling	-
	CER	3/733	Plaster on brickwork	-	-	-	-	-	-	Walls	-
	CER	3/733	Plastic cables and metal conduits	-	-	-	-	-	-	To walls and ceiling	-
	CER	3/733	Concrete slab	-	-	-	-	-	-	Ceiling above false ceiling	-
	CER	3/733	Metal pipework	-	-	-	-	-	-	To walls	-
	CER	3/733	Concrete slab	-	-	-	-	-	-	Floor	-
	CER	3/733	New electrical equipment	-	-	-	-	-	-	Walls	-
	Office	3/756	Ceramic tiles on concrete slab	-	-	-	-	-	-	Floor	-
Same as 120445/15081 2/03	Office	3/756	Caulking	throughout	2	1	1	0	1&2	Tunnel ring flanges within false ceiling	Figure 181
K1(46)	Office	3/756	Cellacite, metal corrugated sheets	throughout	1	-	0	0	K1	Within wall cavities	Figure 182
