Hazardous Materials - TfL Engineering

Re-inspection Sign-Off for Brixton

Re-inspection Reference: V059/4RS-200403

Station	Brixton
Original Management Survey	R346601
Date of Original Management	31st August 2012
Re-inspection Reference:	V059-4RS-200403
Next Planned Re-inspection	Periodical re-inspection according to HM Management Plan

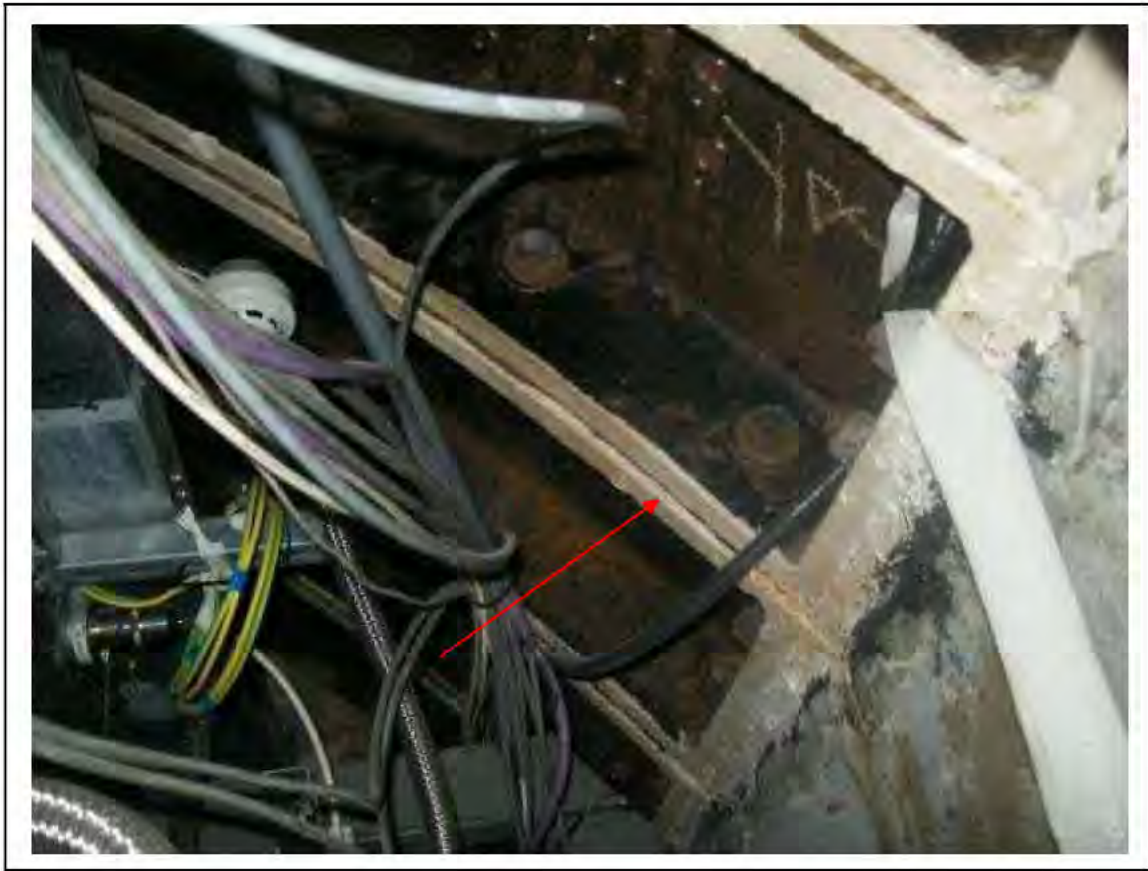
FIGURE 183: CONFIRMED ASBESTOS IN CAULKING IN PUMP ROOM, 3/771 - DESCRIPTION & RESULT OF ASSESSMENT (SAMPLE REF. SAME AS 120445/150812/03)

Caulking confirmed to contain Amosite and Chrysotile asbestos, Figure 183 - Material assessment rating: Low

Sample Number	Same as 120445/150812/03
Location	Pump Room, 3/771
Material Description	Caulking
Material Comment	Ceiling tunnel rings
Quantity	throughout
Product Type	Medium density
Current Condition	Slight damage
Surface Treatment	Encapsulated medium density
Asbestos Type	Amosite and Chrysotile
Material Assessment Rating	Low
Accessibility	Medium
Further Comment	Not applicable

Ref No.	Area Surveyed		Material Description	Quantity (m ²)	Product Type	Current Condition	Surface Treatment	Accessibility	Asbestos Type	Comments and Recommendations	Figure
	Location	Room/Plant No									
	Office	3/756	RSJ	-	-	-	-	-	-	Within false ceiling	-
	Office	3/756	Air conditioning ductwork, some with MMMF insulation	-	-	-	-	-	-	Within false ceiling	-
	Office	3/756	Metal pipes with MMMF insulation	-	-	-	-	-	-	To walls, ceiling and within false ceiling	-
	Office	3/756	Metal ceiling tiles	-	-	-	-	-	-	Within false ceiling	-
	Office	3/756	Supalux boxing	-	-	-	-	-	-	Wall	-
	Pump Room	3/771	Concrete slab	-	-	-	-	-	-	Floor	-
	Pump Room	3/771	Metal pipework, gaskets (rubber)	-	-	-	-	-	-	To walls and floor	-
	Pump Room	3/771	Air conditioning ducting some with MMMF insulation	-	-	-	-	-	-	To walls	-
	Pump Room	3/771	Concrete	-	-	-	-	-	-	Walls	-
	Pump Room	3/771	RSJ	-	-	-	-	-	-	Walls and ceiling	-
Same as 120445/15081 2/03	Pump Room	3/771	Caulking	throughout	2	1	1	2	1&2	Ceiling tunnel rings	Figure 183

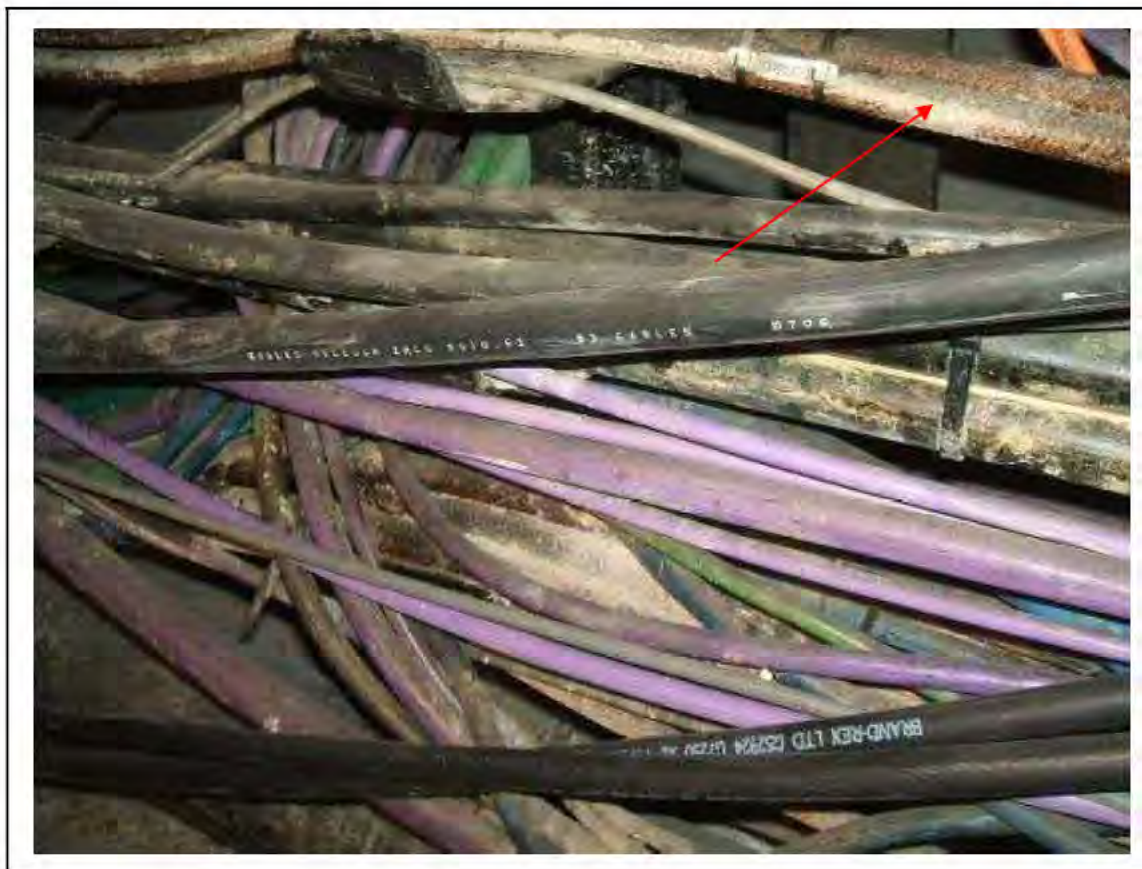
FIGURE 184: STRONGLY PRESUMED ASBESTOS IN BRAIDED CABLES IN CABLE SHAFT , 3/786 - DESCRIPTION & RESULT OF ASSESSMENT (SAMPLE REF. SP1(28))

Braided cables strongly presumed to contain Chrysotile asbestos, Figure 184 - Material assessment rating: Low

Sample Number	SP1(28)
Location	Cable Shaft , 3/786
Material Description	Braided cables
Material Comment	Wall 3
Quantity	5
Product Type	Medium density
Current Condition	Slight damage
Surface Treatment	Encapsulated medium density
Asbestos Type	Strongly Presumed Chrysotile
Material Assessment Rating	Low
Accessibility	Low
Further Comment	Not applicable

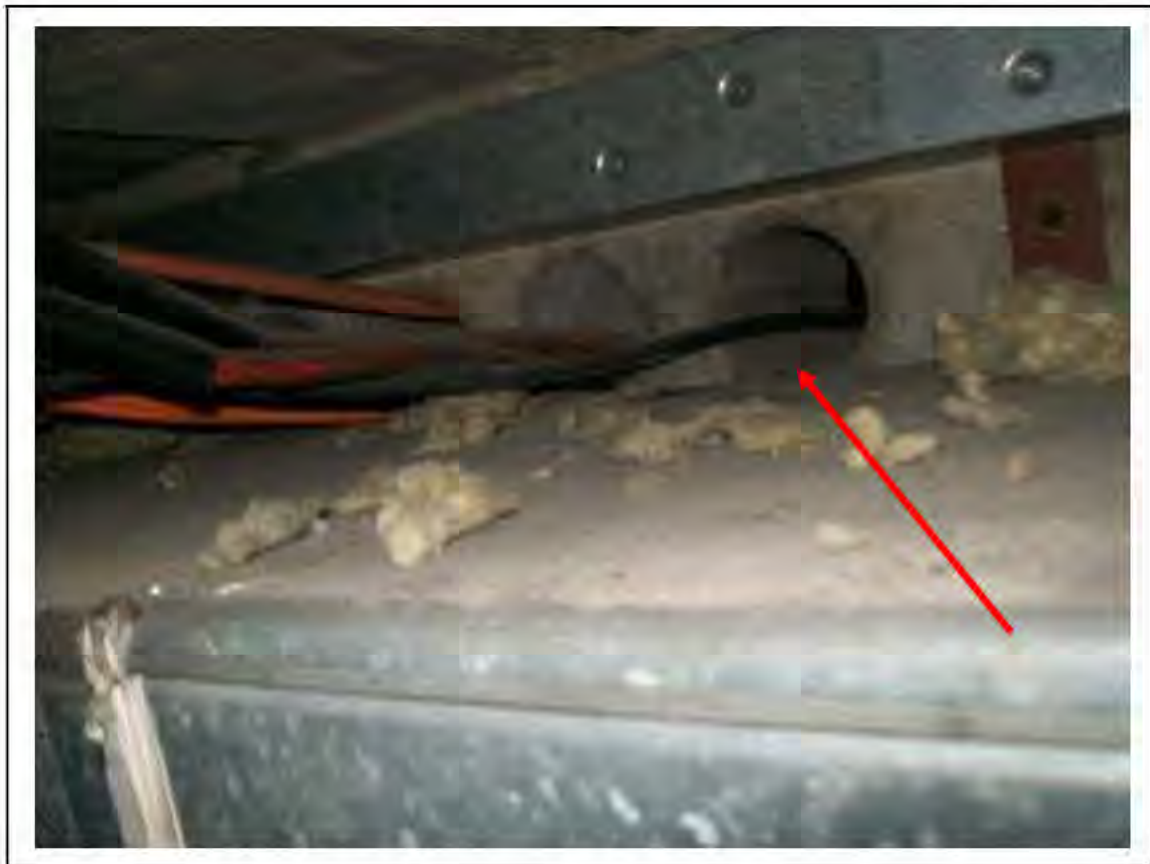
FIGURE 185: CONFIRMED ASBESTOS IN DUCTS TO DIVIDING WALL IN CABLE SHAFT, 3/786 - DESCRIPTION & RESULT OF ASSESSMENT (SAMPLE REF. SAME AS 120445/190812/01)

Ducts to dividing wall confirmed to contain Chrysotile asbestos, Figure 185 - Material assessment rating: Very low

Sample Number	Same as 120445/190812/01
Location	Cable Shaft, 3/786
Material Description	Ducts to dividing wall
Material Comment	Go into 3/787
Quantity	10no
Product Type	Composite
Current Condition	Good condition
Surface Treatment	Composite
Asbestos Type	Chrysotile
Material Assessment Rating	Very low
Accessibility	Low
Further Comment	Not applicable

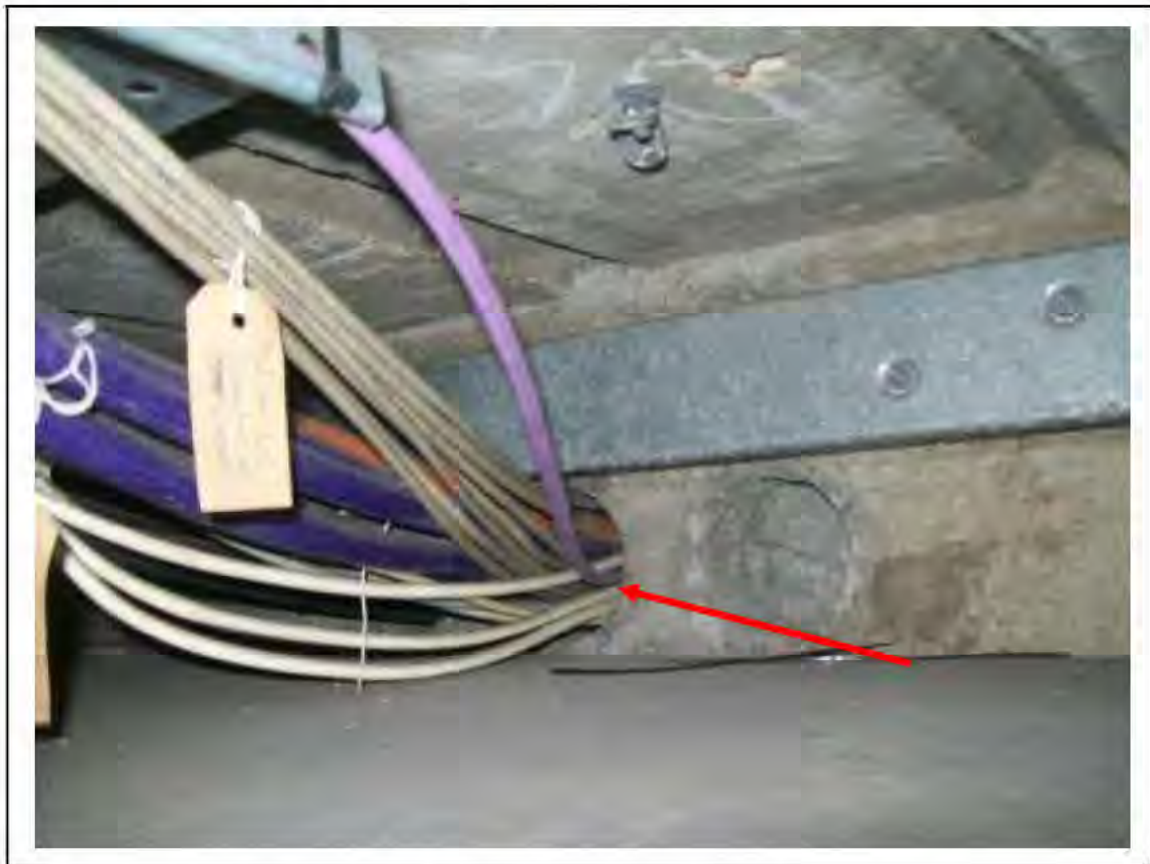
FIGURE 186: CONFIRMED ASBESTOS IN DUCT TO MID WALL IN CABLE SHAFT, 3/786 - DESCRIPTION & RESULT OF ASSESSMENT (SAMPLE REF. SAME AS 120445/190812/01)

Duct to middle wall confirmed to contain Chrysotile asbestos, Figure 186 - Material assessment rating: Very low

Sample Number	Same as 120445/190812/01
Location	Cable Shaft, 3/786
Material Description	Duct to mid wall
Material Comment	Go to 3/787
Quantity	10no
Product Type	Composite
Current Condition	Good condition
Surface Treatment	Composite
Asbestos Type	Chrysotile
Material Assessment Rating	Very low
Accessibility	Low
Further Comment	Not applicable

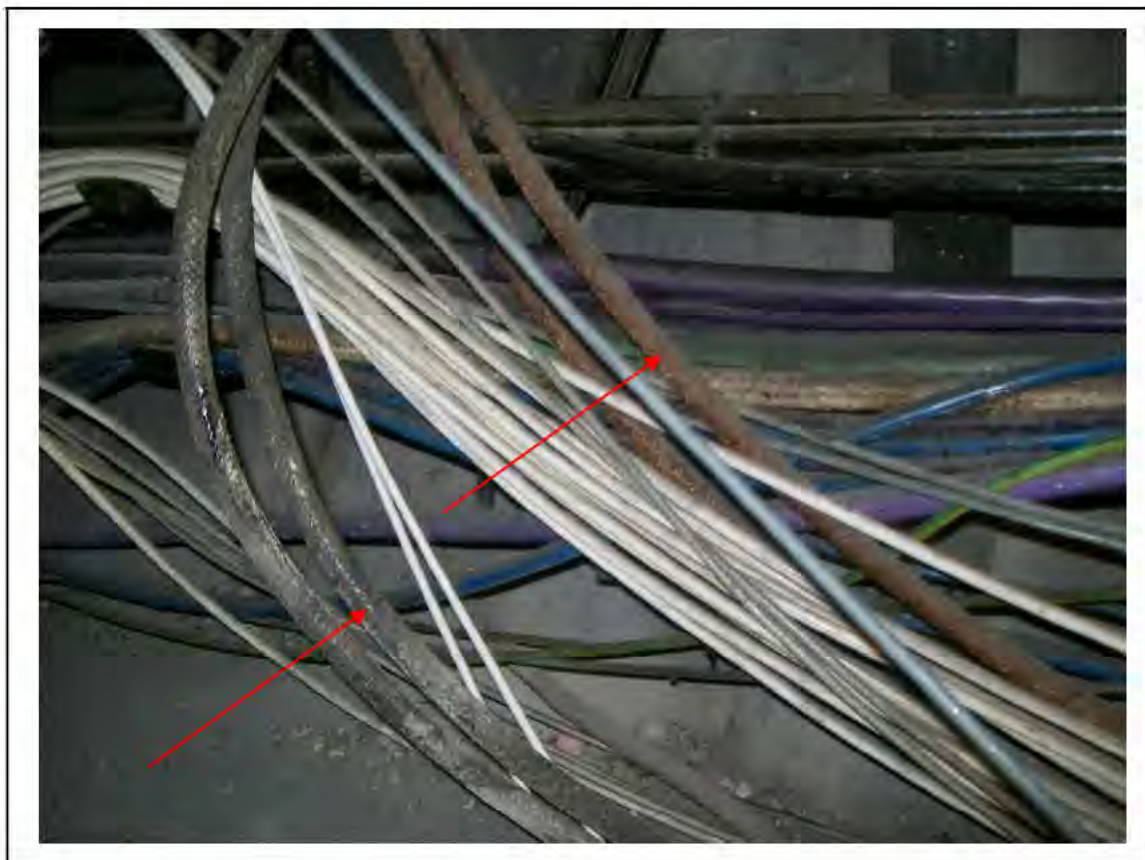
FIGURE 187: KNOWN ASBESTOS IN BRAIDED CABLES IN CABLE SHAFT , 3/786 & 3/787 - DESCRIPTION & RESULT OF ASSESSMENT (SAMPLE REF. K1(47))

Braided cables known to contain Chrysotile asbestos, Figure 187 - Material assessment rating: Low

Sample Number	K1(47)
Location	Cable Shaft , 3/786 & 3/787
Material Description	Braided cables
Material Comment	Running from LMC into cable room 3/786 within J hangers to cable run 3/787. Some cables are redundant , loose to floor, cut. Note: cables don't pass into inverts to both platforms
Quantity	throughout
Product Type	Medium density
Current Condition	Slight damage
Surface Treatment	Unencapsulated medium density
Asbestos Type	Known Chrysotile
Material Assessment Rating	Low
Accessibility	Low
Further Comment	Not applicable

Ref No.	Area Surveyed		Material Description	Quantity (m ²)	Product Type	Current Condition	Surface Treatment	Accessibility	Asbestos Type	Comments and Recommendations	Figure
	Location	Room/Plant No									
120445/130812/02	Cable Shaft	3/786	Bitumen ducts	10	-	-	-	-	0	Wall 3	-
SP1(28)	Cable Shaft	3/786	Braided cables	5	2	1	1	1	SP1	Wall 3	Figure 184
	Cable Shaft	3/786	Concrete	-	-	-	-	-	-	Floor, walls and ceiling	-
	Cable Shaft	3/786	Plastic cables and metal conduits	-	-	-	-	-	-	Throughout	-
	Cable Shaft	3/786	Metal air con	-	-	-	-	-	-	Throughout	-
	Cable Shaft	3/786	Metal pipes	-	-	-	-	-	-	Throughout	-
	Cable Shaft	3/786	Metal stairs	-	-	-	-	-	-	-	-
Same as 120445/190812/01	Cable Shaft	3/786	Ducts to dividing wall	10no	1	0	0	1	1	Go into 3/787	Figure 185
Same as 120445/190812/01	Cable Shaft	3/786	Duct to mid wall	10no	1	0	0	1	1	Go to 3/787	Figure 186
K1(47)	Cable Shaft	3/786 & 3/787	Braided cables	throughout	2	1	2	1	K1	Running from LMC into cable room 3/786 within J hangers to cable run 3/787. Some cables are redundant, loose to floor, cut. Note: cables don't pass into inverts to both platforms	Figure 187

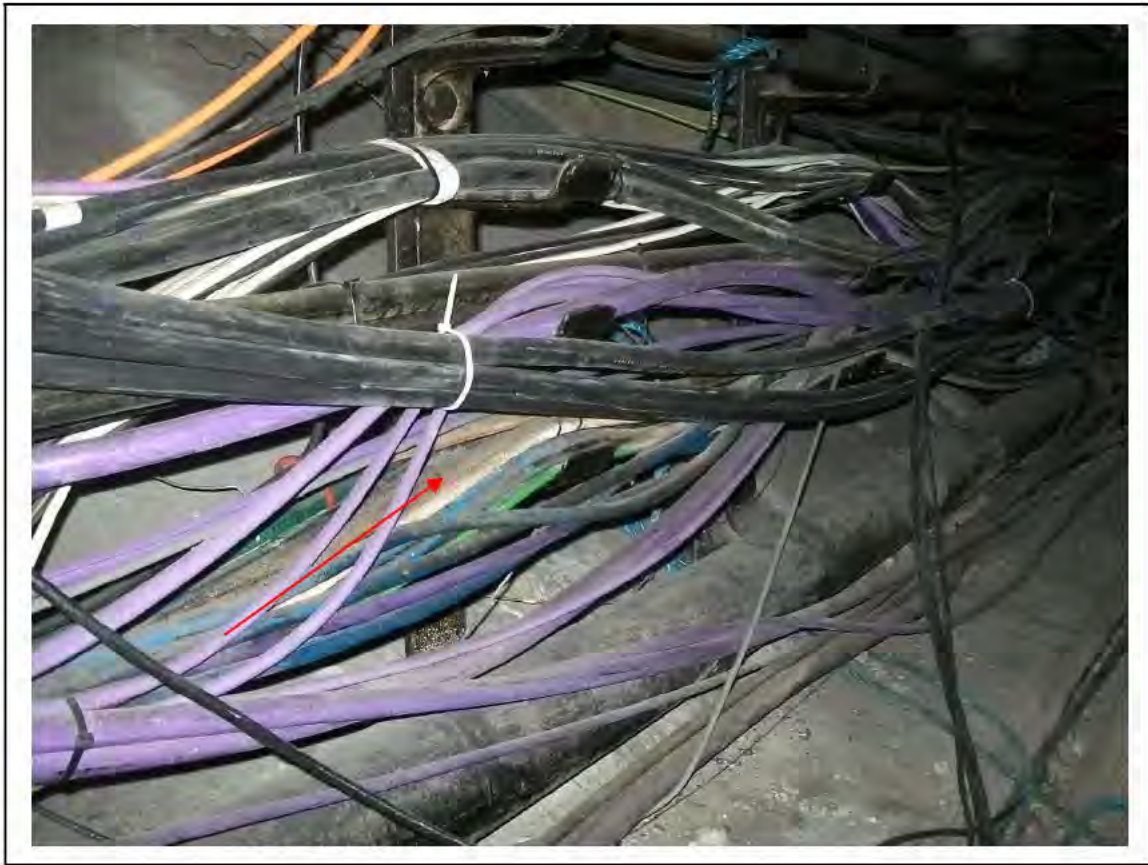
FIGURE 188: KNOWN ASBESTOS IN BRAIDED CABLES IN CABLE SHAFT , 3/787 - DESCRIPTION & RESULT OF ASSESSMENT (SAMPLE REF. K1(48))

Braided cables known to contain Chrysotile asbestos, Figure 188 - Material assessment rating: Low

Sample Number	K1(48)
Location	Cable Shaft , 3/787
Material Description	Braided cables
Material Comment	Wall 3
Quantity	2no
Product Type	Medium density
Current Condition	Slight damage
Surface Treatment	Unencapsulated medium density
Asbestos Type	Known Chrysotile
Material Assessment Rating	Low
Accessibility	Low
Further Comment	Not applicable

K1(48)	Cable Shaft	3/787	Braided cables	2no	2	1	2	1	K1	Wall 3	Figure 188

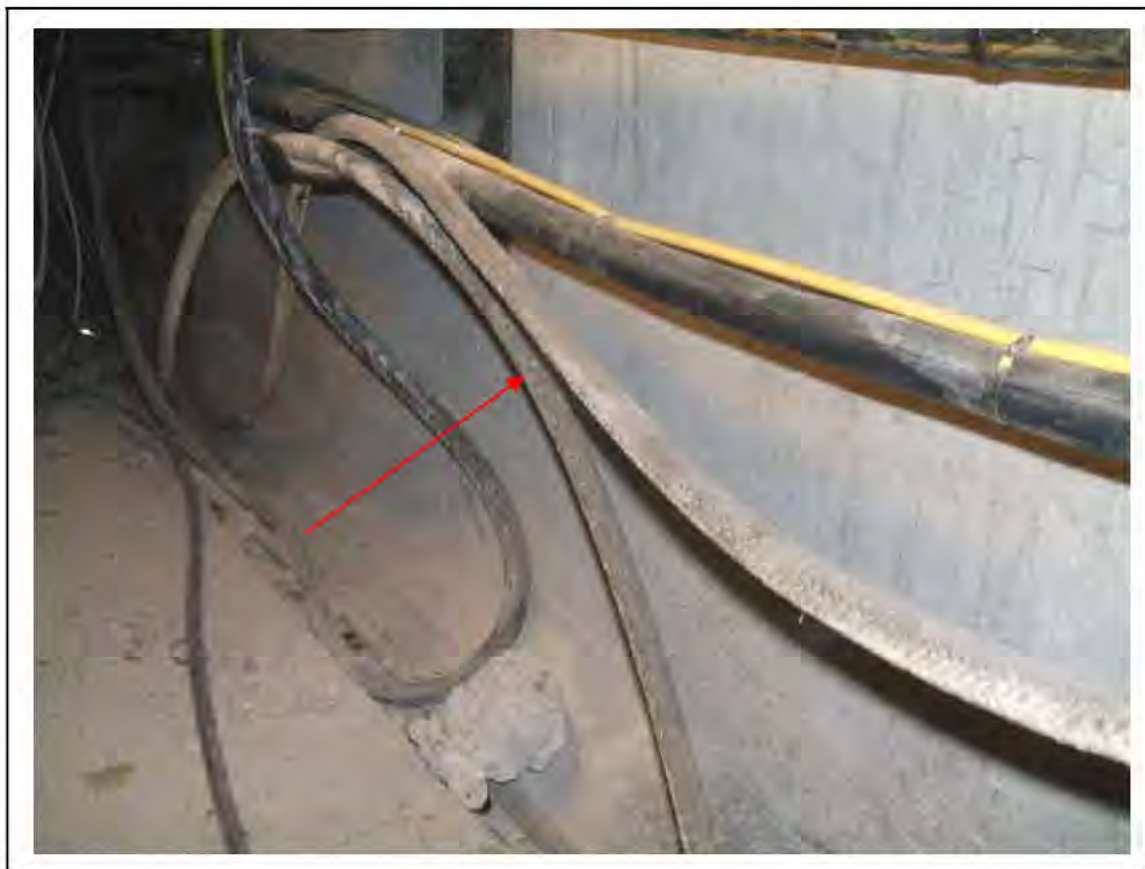
FIGURE 189: KNOWN ASBESTOS IN BRAIDED CABLES IN CABLE SHAFT , 3/787 - DESCRIPTION & RESULT OF ASSESSMENT (SAMPLE REF. K1(49))

Braided cables known to contain Chrysotile asbestos, Figure 189 - Material assessment rating: Low

Sample Number	K1(49)
Location	Cable Shaft , 3/787
Material Description	Braided cables
Material Comment	Wall 1, from cable duct running length
Quantity	5no
Product Type	Medium density
Current Condition	Slight damage
Surface Treatment	Unencapsulated medium density
Asbestos Type	Known Chrysotile
Material Assessment Rating	Low
Accessibility	Low
Further Comment	Not applicable

Ref No.	Area Surveyed		Material Description	Quantity (m ²)	Product Type	Current Condition	Surface Treatment	Accessibility	Asbestos Type	Comments and Recommendations	Figure
	Location	Room/Plant No									
K1(49)	Cable Shaft	3/787	Braided cables	5no	2	1	2	1	K1	Wall 1, from cable duct running length	Figure 189
	Cable Shaft	3/787	Cement duct	-	-	-	-	-	-	Throughout	-
	Cable Shaft	3/787	Concrete	-	-	-	-	-	-	Walls, floor and ceiling	-
	Cable Shaft	3/787	Plastic cables and metal conduits	-	-	-	-	-	-	Throughout	-
	Cable Shaft	3/787	Wood	-	-	-	-	-	-	Door and frame	-
	Cable Shaft	3/787	MMMF insulation debris	-	-	-	-	-	-	Floor throughout	-
	Cable Shaft	3/787	MMMF packing	-	-	-	-	-	-	Concrete ducts to ceiling	-
	Cable Shaft	3/787	Metal pipes	-	-	-	-	-	-	Throughout	-
	Cable Shaft	3/787	Metal steps	-	-	-	-	-	-	Ceiling	-
120445/19081 2/01	Cable Way	3/787	Mid wall ducts	10	1	0	0	1	1	Go to 3/786, opposite 3/202	Figure 190

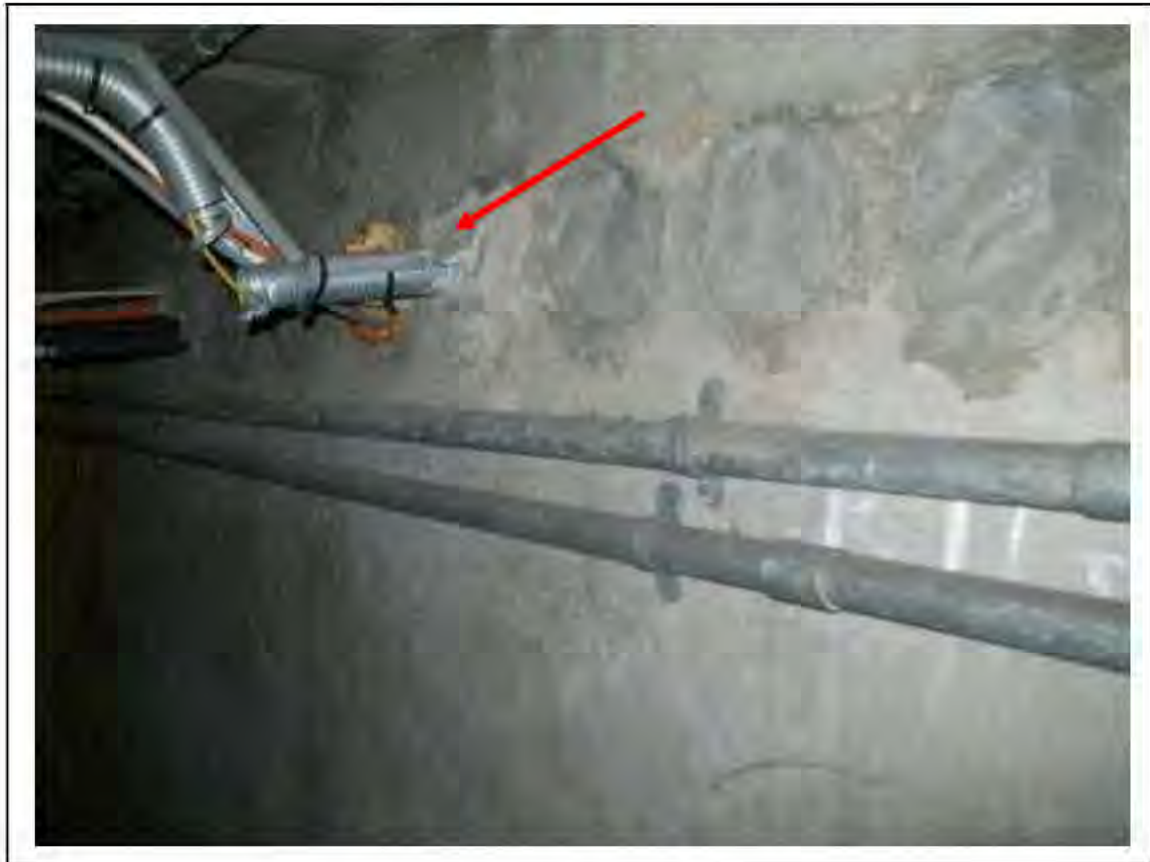
FIGURE 190: CONFIRMED ASBESTOS IN MID WALL DUCTS IN CABLE WAY, 3/787 - DESCRIPTION & RESULT OF ASSESSMENT (SAMPLE REF. 120445/190812/01)

Middle wall ducts known to contain Chrysotile asbestos, Figure 190 - Material assessment rating: Very low

Sample Number	120445/190812/01
Location	Cable Way, 3/787
Material Description	Mid wall ducts
Material Comment	Go to 3/786, opposite 3/202
Quantity	10
Product Type	Composite
Current Condition	Good condition
Surface Treatment	Composite
Asbestos Type	Known Chrysotile
Material Assessment Rating	Very low
Accessibility	Low
Further Comment	Not applicable

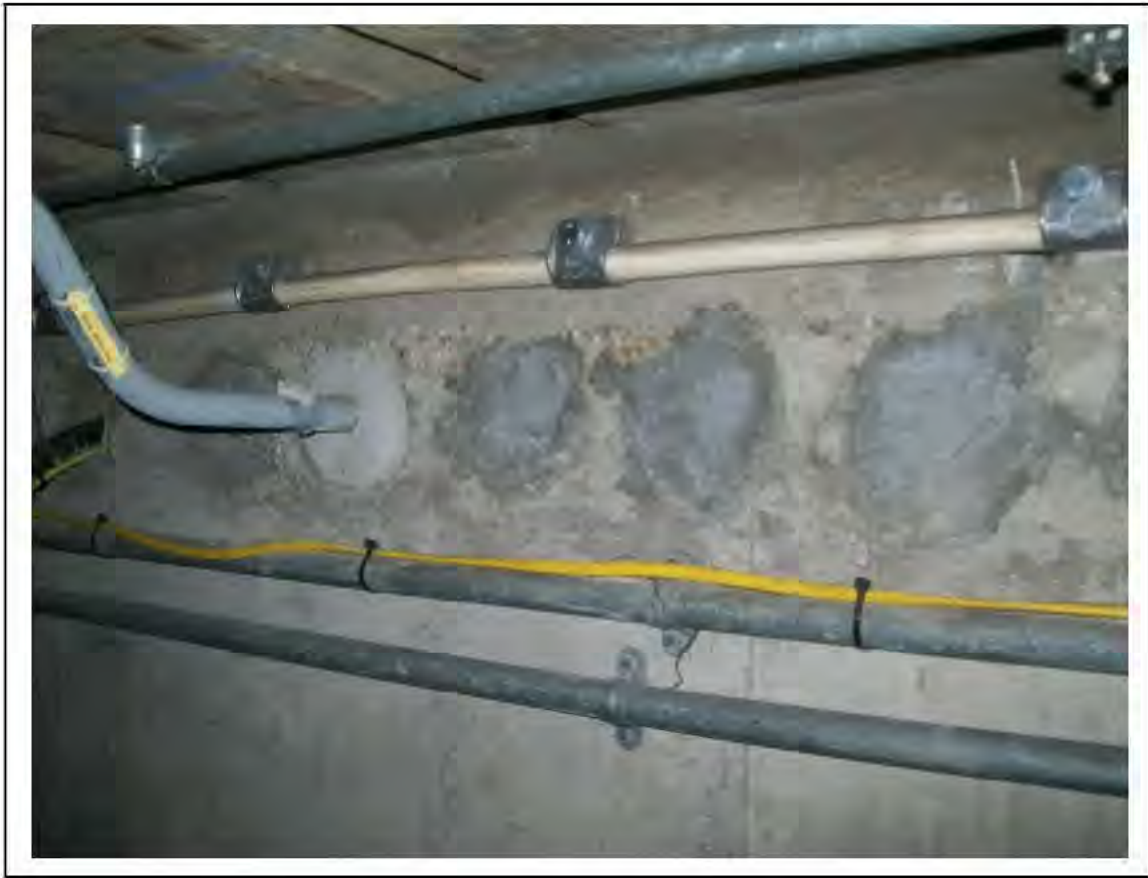
**FIGURE 191: KNOWN ASBESTOS IN MID WALL DUCTS IN CABLE WAY, 3/787
- DESCRIPTION & RESULT OF ASSESSMENT (SAMPLE REF.
SAME AS 120445/190812/01)**

Mid wall ducts known to contain Chrysotile asbestos, Figure 191 - Material assessment rating: Very low

Sample Number	Same as 120445/190812/01
Location	Cable Way, 3/787
Material Description	Mid wall ducts
Material Comment	Opposite to 3/203, run to 3/786 trough
Quantity	10
Product Type	Composite
Current Condition	Good condition
Surface Treatment	Composite
Asbestos Type	Known Chrysotile
Material Assessment Rating	Very low
Accessibility	Low
Further Comment	Not applicable

Same as 120445/19081 2/01	Cable Way	3/787	Mid wall ducts	10	1	0	0	1	K1	Opposite to 3/203, run to 3/786 trough	Figure 191
	Store Room	3/788	Concrete slab	-	-	-	-	-	-	Floor and walls	-

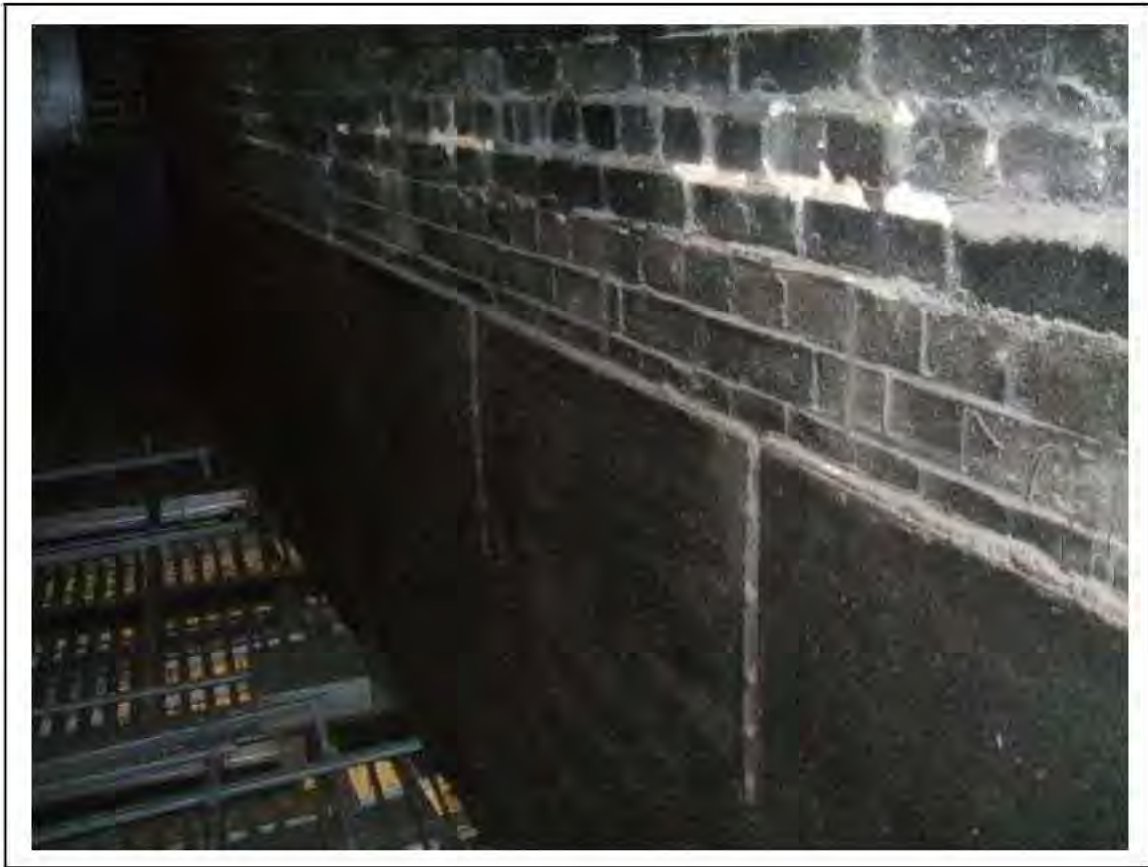
FIGURE 192: PRESUMED ASBESTOS BEHIND PANELS TO BEAM IN VENT SHAFT , 3/902 - DESCRIPTION & RESULT OF ASSESSMENT (SAMPLE REF. P1&2(57))

Possible asbestos behind panels to beam S11 presumed to contain Amosite & Chrysotile asbestos, Figure 192

Sample Number	P1&2(57)
Location	Vent Shaft , 3/902
Material Description	Possible asbestos behind panels to beam
Material Comment	Beam S11
Quantity	-
Product Type	-
Current Condition	-
Surface Treatment	-
Asbestos Type	Presumed Amosite & Chrysotile
Material Assessment Rating	-
Accessibility	-
Further Comment	Not applicable

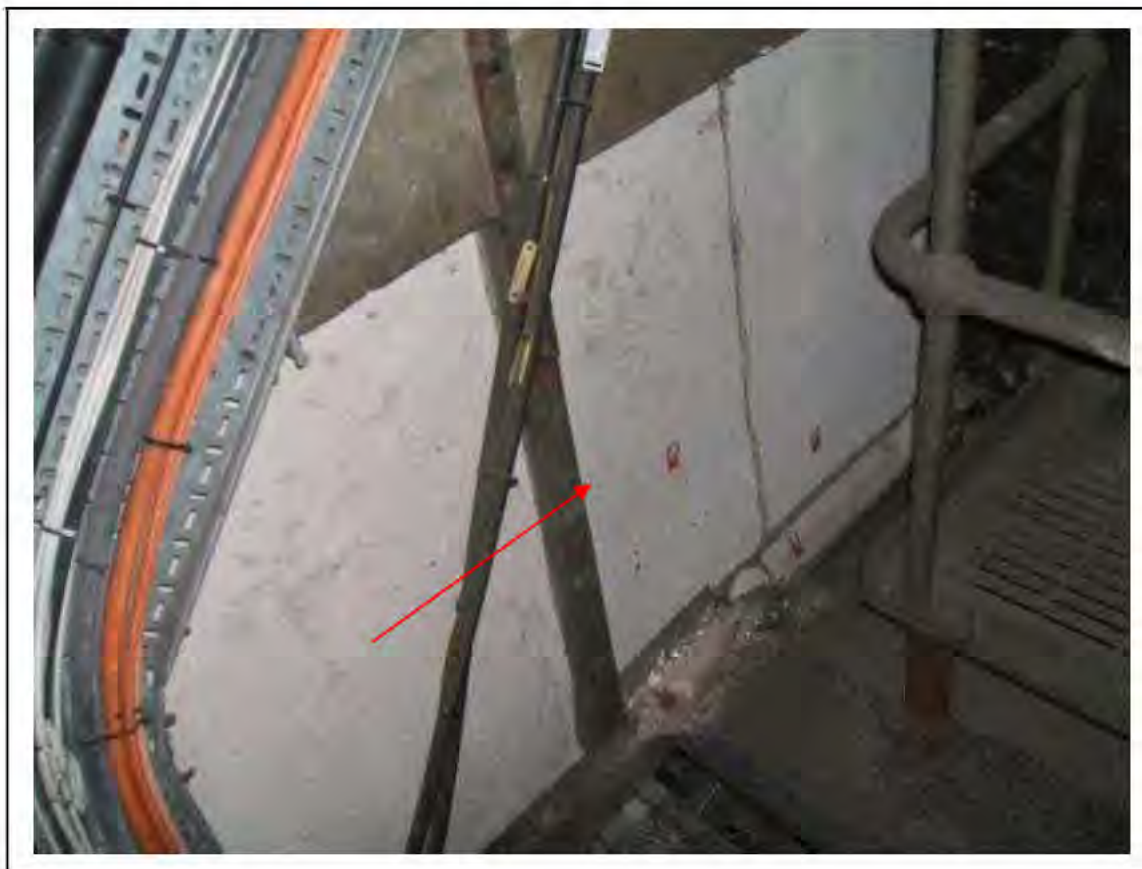
FIGURE 193: PRESUMED ASBESTOS IN RESIDUES BEHIND SUPALUX TO BEAM S10 IN VENT SHAFT , 3/902 - DESCRIPTION & RESULT OF ASSESSMENT (SAMPLE REF. P1&2(58))

Asbestos residues behind supalux to beam S10 presumed to contain Amosite & Chrysotile asbestos, Figure 193

Sample Number	P1&2(58)
Location	Vent Shaft , 3/902
Material Description	Asbestos residues behind supalux to beams
Material Comment	Beam S10, left hand side
Quantity	-
Product Type	-
Current Condition	-
Surface Treatment	-
Asbestos Type	Presumed Amosite & Chrysotile
Material Assessment Rating	-
Accessibility	-
Further Comment	Not applicable

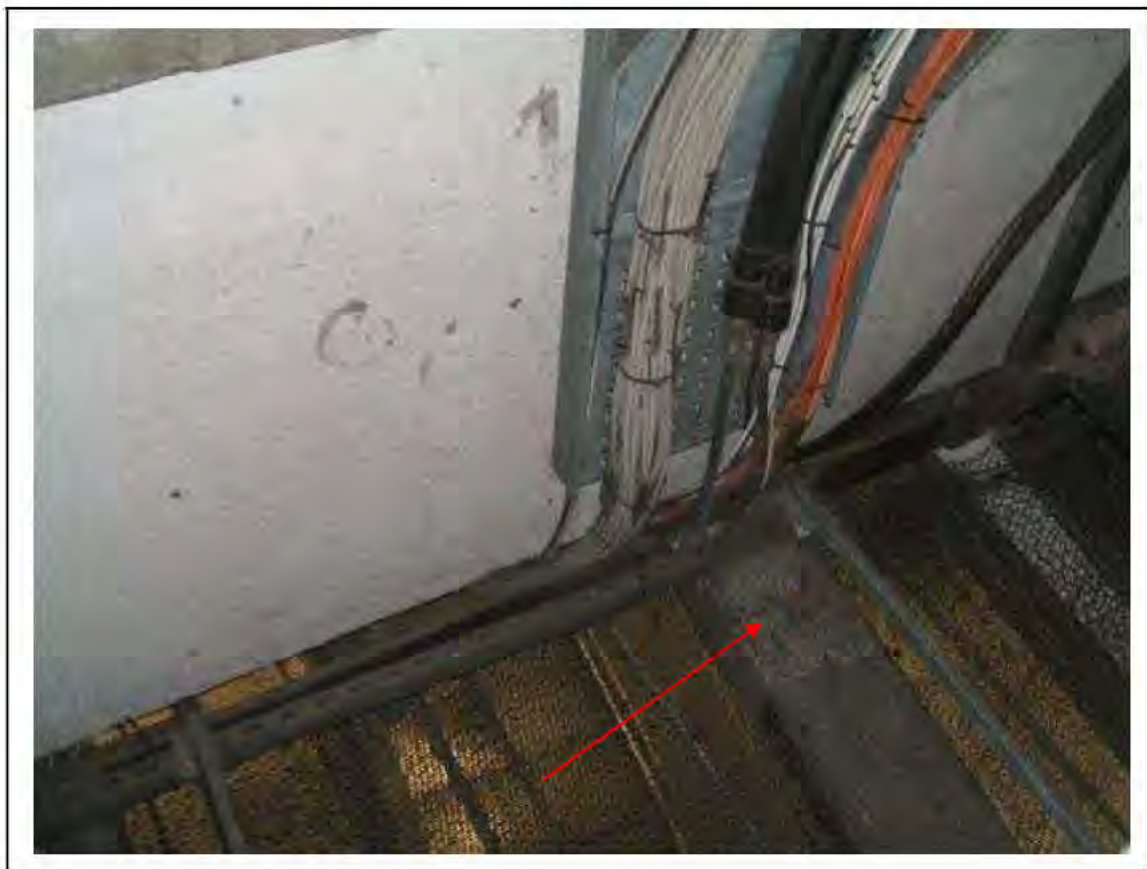
FIGURE 194: PRESUMED ASBESTOS IN RESIDUES TO LIGHTING BOXES IN VENT SHAFT , 3/902 - DESCRIPTION & RESULT OF ASSESSMENT (SAMPLE REF. P1&2(59))

Possible asbestos residues to lighting boxes by beam S10 presumed to contain Amosite & Chrysotile asbestos, Figure 194

Sample Number	P1&2(59)
Location	Vent Shaft , 3/902
Material Description	Possible asbestos residues to lighting boxes
Material Comment	Light boxes by beam S10
Quantity	-
Product Type	-
Current Condition	-
Surface Treatment	-
Asbestos Type	Presumed Amosite & Chrysotile
Material Assessment Rating	-
Accessibility	-
Further Comment	Not applicable

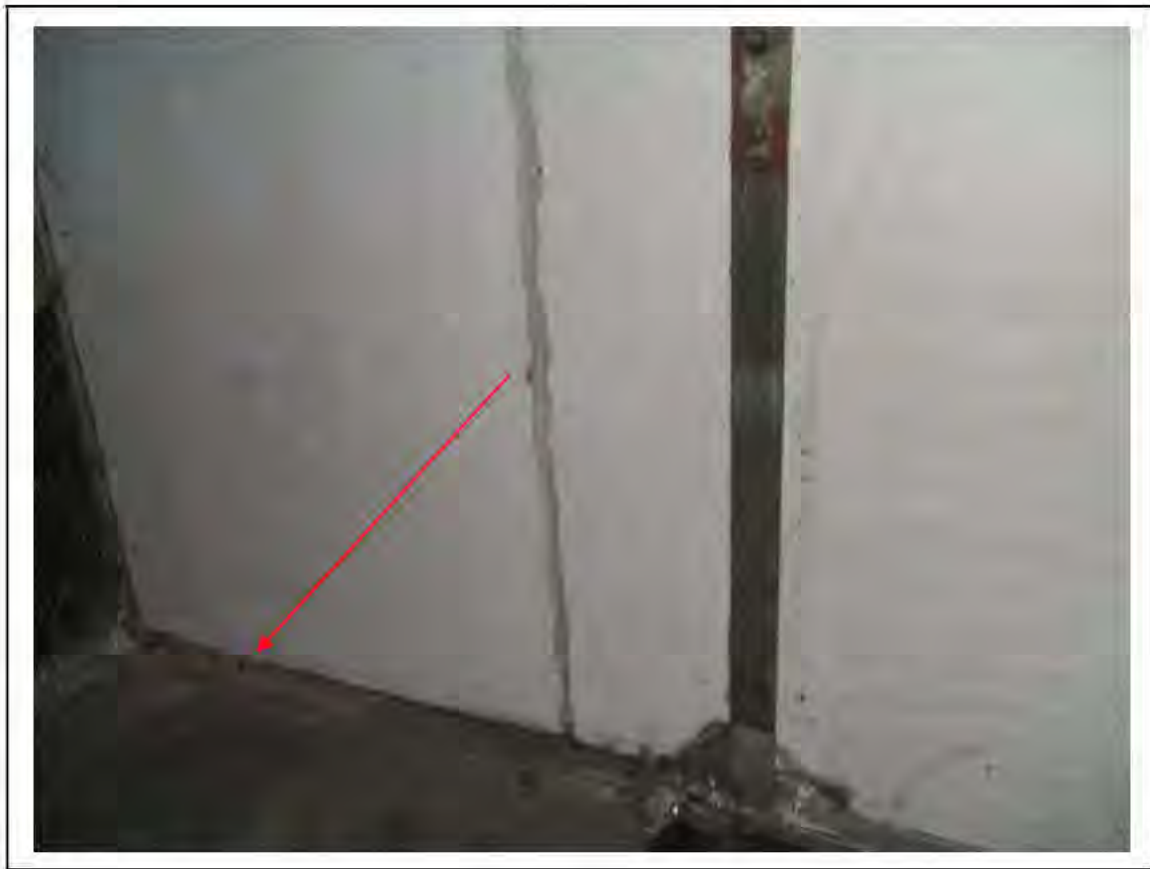
FIGURE 195: PRESUMED ASBESTOS IN RESIDUE BELOW SUPALUX ON BEAM IN VENT SHAFT , 3/902 - DESCRIPTION & RESULT OF ASSESSMENT (SAMPLE REF. P1&2(60))

Possible asbestos residue below supalux on beam S10 right hand side presumed to contain Amosite & Chrysotile asbestos, Figure 195

Sample Number	P1&2(60)
Location	Vent Shaft , 3/902
Material Description	Possible asbestos residue below supalux on beam
Material Comment	Beam S10, right hand side
Quantity	-
Product Type	-
Current Condition	-
Surface Treatment	-
Asbestos Type	Presumed Amosite & Chrysotile
Material Assessment Rating	-
Accessibility	-
Further Comment	Not applicable

Ref No.	Area Surveyed		Material Description	Quantity (m ²)	Product Type	Current Condition	Surface Treatment	Accessibility	Asbestos Type	Comments and Recommendations	Figure
	Location	Room/Plant No									
	Store Room	3/788	Metal panels	-	-	-	-	-	-	False ceiling	-
	Store Room	3/788	Concrete slab	-	-	-	-	-	-	Within false ceiling to ceiling	-
	Store Room	3/788	Plastic cables and metal conduits	-	-	-	-	-	-	Within false ceiling	-
	Store Room	3/788	Ceramic tiles on brickwork	-	-	-	-	-	-	Walls	-
	Store Room	3/788	New metal door	-	-	-	-	-	-	Door to wall 4	-
P1&2(57)	Vent Shaft	3/902	Possible asbestos behind panels to beam	-	-	-	-	-	P1&2	Beam S11	Figure 192
P1&2(58)	Vent Shaft	3/902	Asbestos residues behind supalux to beams	-	-	-	-	-	P1&2	Beam S10, left hand side	Figure 193
P1&2(59)	Vent Shaft	3/902	Possible asbestos residues to lighting boxes	-	-	-	-	-	P1&2	Light boxes by beam S10	Figure 194
P1&2(60)	Vent Shaft	3/902	Possible asbestos residue below supalux on beam	-	-	-	-	-	P1&2	Beam S10, right hand side	Figure 195
