Fatal accident involving the derailment of a tram at Sandilands Junction, Croydon

9 November 2016

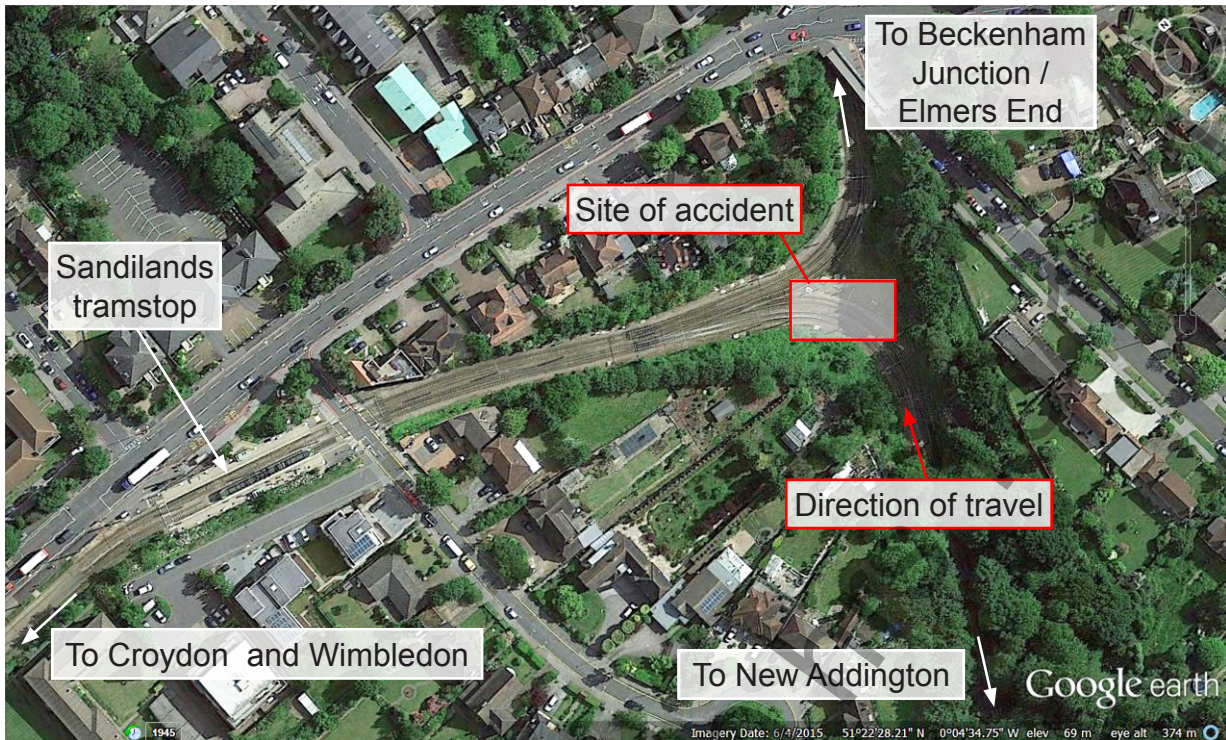
Figure 1: Google image showing area where accident occurred

- 1 At about 06:07 hrs on Wednesday 9 November 2016, a tram running between New Addington and Wimbledon derailed and overturned on a curve as it approached Sandilands Junction, in Croydon (figure 1). The tram travelled for a short distance on its side before stopping in the vicinity of the junction.
- 2 Seven people suffered fatal injuries in the accident. A further 51 people were taken to hospital, with eight of them suffering injuries described by the London Ambulance Service as “serious or life-threatening”.
- 3 The Rail Accident Investigation Branch’s (RAIB) initial review of the on-tram data recorder (OTDR) shows that the tram was travelling at a speed of approximately 70 km/h (43.5 mph) as it entered the curve, which had a maximum permitted speed of 20 km/h (12.5 mph).

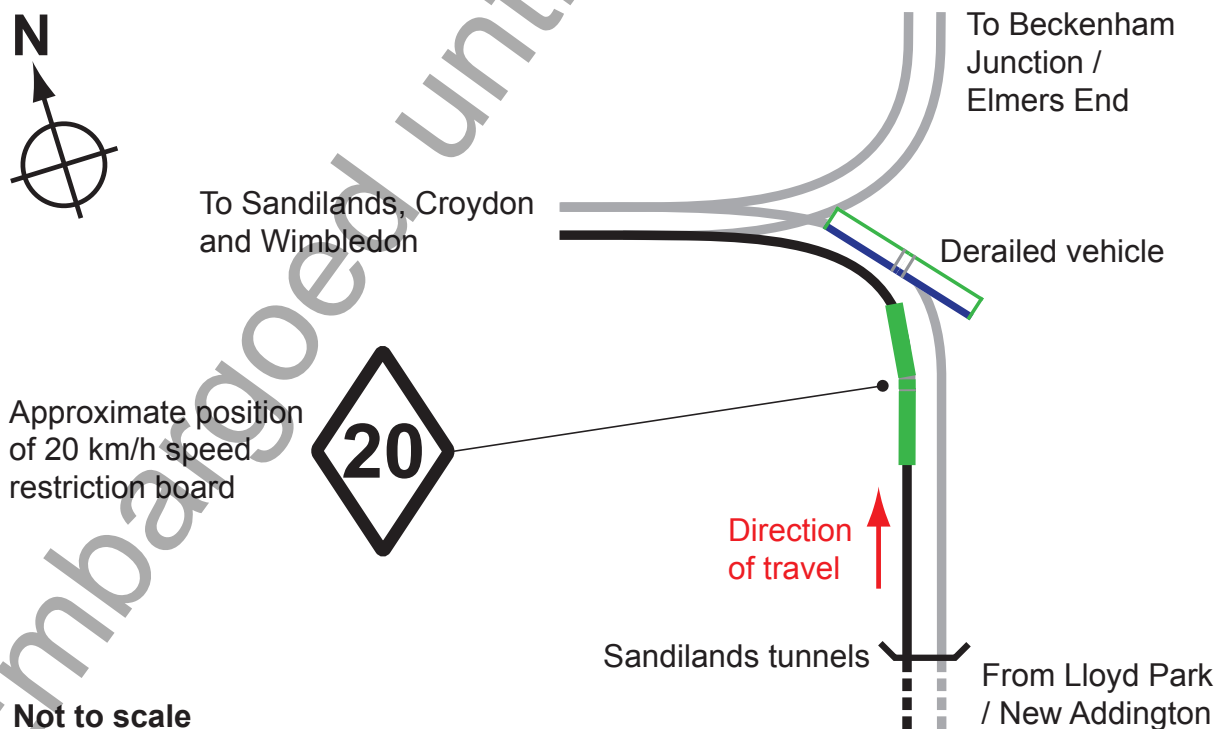
Figure 2: Diagram of accident location

- 12 The accident occurred at Sandilands Junction on the London Tramlink network in Croydon; the point at which the two easterly legs of the network from Beckenham Junction/Elmers End and New Addington converge (see figure 2).

- 13 The tram involved in the accident was running between Lloyd Park and Sandilands tram stops on the route from New Addington. After the Lloyd Park tram stop, the route runs in the open for about 900 metres, and then passes through Sandilands tunnels (comprised of three closely spaced tunnels with a total length of 512 metres), before emerging into a cutting approximately 100 metres before the left-hand curve on which the accident occurred. The curve has a radius of approximately 30 metres.

- 14 The tramway runs in its own dedicated corridor in this location (it does not change to street running until after Sandilands tram stop). The alignment through the tunnels on the approach to the curve is straight, and the track is on a gently falling gradient from the tunnel portal to the curve, before rising again through the junction.

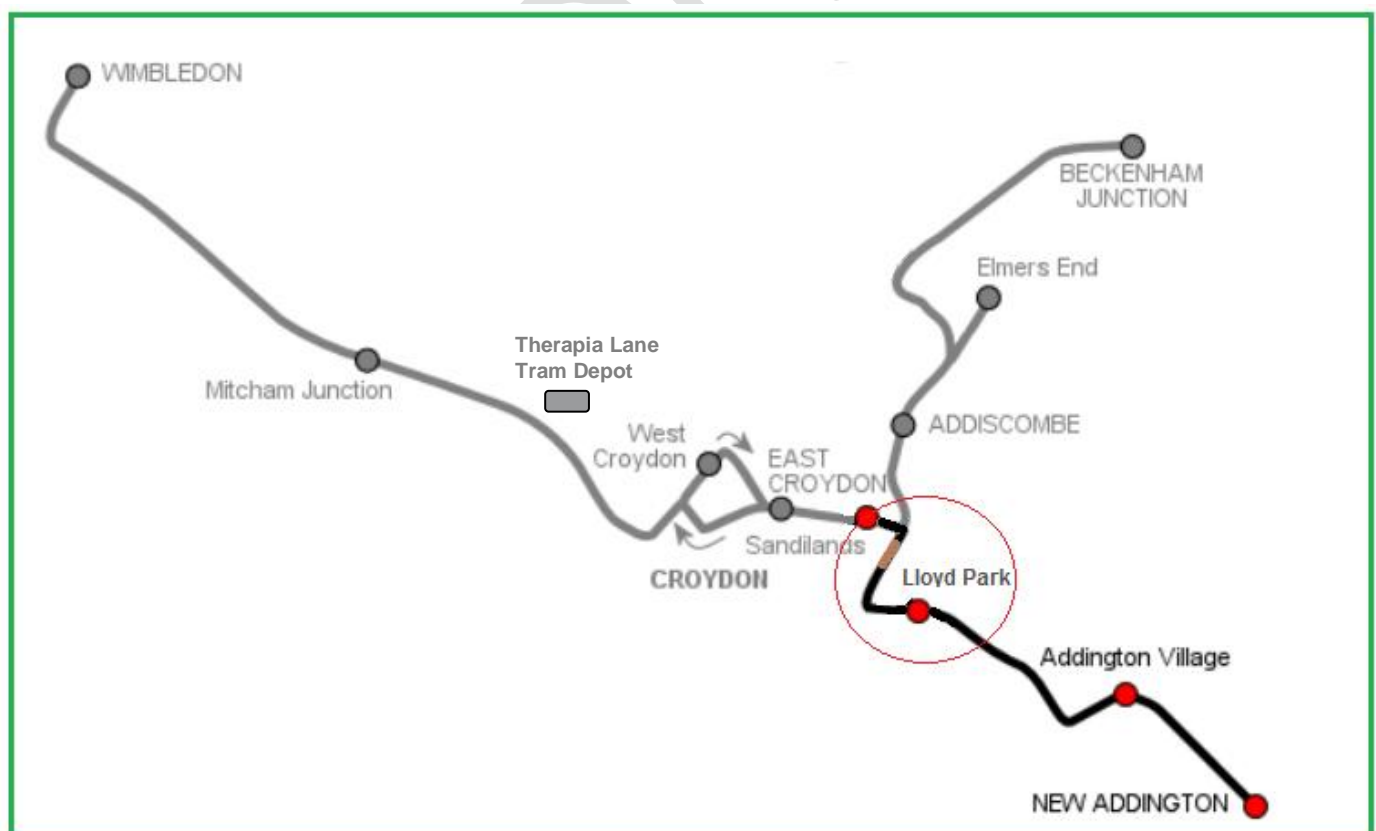
Figure 3 – LT Network highlighting Lloyd Park to Sandilands

The London Tram network is shown in Figure 3 with the critical Lloyd Park to Sandilands section highlighted. It includes a long largely straight section of the former Woodside and South Croydon Railway.

The tramway passes through three consecutive separate tunnels approaching the curve at Sandilands. At each end of the straight former railway sections there are small radius curves providing connections to the newer tramway alignments, both of which have 20km/h speed limits (see Figure 3 – LT Network highlighting Lloyd Park to Sandilands).

The track construction consists of S49 rail on Vortok fastened lightweight concrete sleepers and traction power is provided through the 750V DC overhead line equipment.

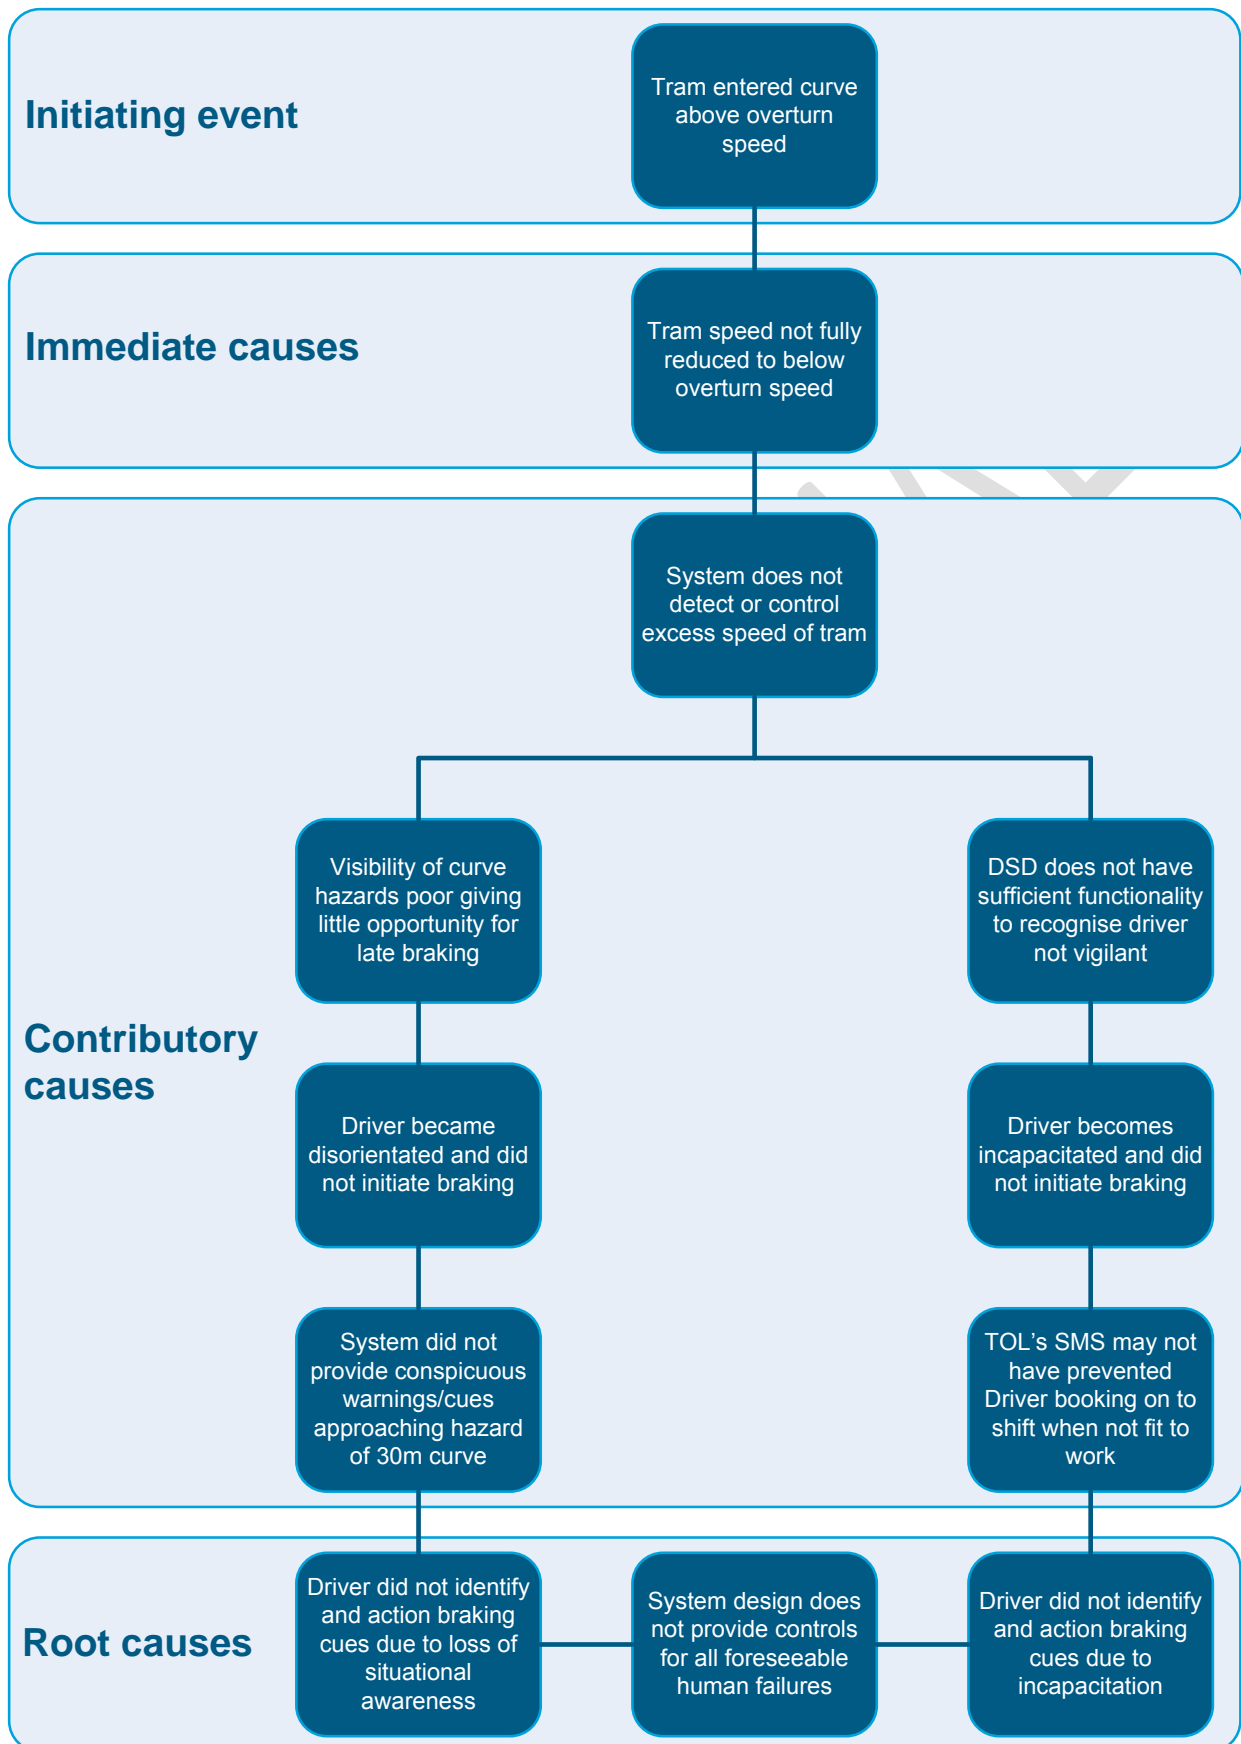
Figure 5 - Overview of Causal Chain

The causal chain (see Figure 5 - Overview of Causal Chain) is described as two possible contributory chains. Completion of investigations may enable one to be eliminated or identified as more probable than the other, to confirm one as the most likely causal chain. This report describes the initiating event and immediate cause as shared conclusions, and then discusses both the probable contributory and associated root causes in turn.
