## Environmental Visual Audit (EVA) – site visit report

Reason for EVA:	Collision data and resident complaints of speeding
Road name(s):	HITHER GREEN LANE AND TORRIDON ROAD (North of the A205) and COURTHILL ROAD (South of the A21)
Location type (station, underpass, road, etc.)	Roads
Nearest junction (s):	A205 South Circular junction with Hither Green Lane; and Torridon Road and A21 (Lewisham High Street) and Courthill Road
Borough:	LEWISHAM
Date of visit:	
Day of the week:	Choose an item.
Time (from and to, 24 hrs):	From:
Attendees: (incl. job title and organisation)	1.
	2.
	3.
	4.

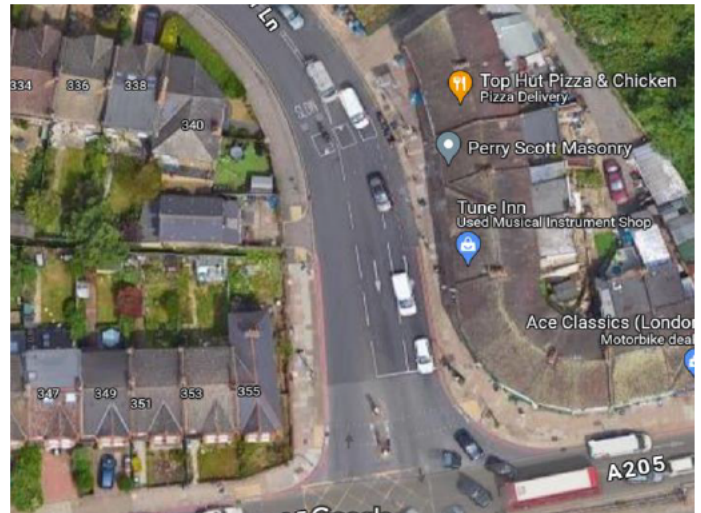
Photo 3 - Torridon Road from A205

- The main cause of this issue is the lack of entry treatments that signal a change in the road environment.
- Entry treatments are typically used to indicate that drivers are leaving a major road and entering an area of different character, such as a residential road.
- They can also mark the start of a series of traffic calming measures or the boundary of a 20 mph zone.

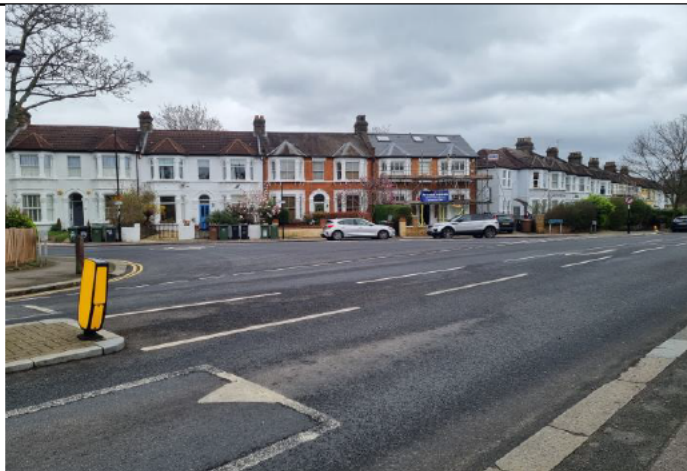
Photo 3 - Satellite view of Junction of Wellmeadow Road with Hither Green Lane

- Wide Junction: The junction's excessive width encourages vehicles to turn at higher speeds, posing a risk to pedestrians and other road users.
- Speeding Vehicles: Vehicles approaching the junction may exceed the 20 mph speed limit due to the wide turning area.
- Pedestrian Safety Concerns: The substantial crossing distance exposes pedestrians to potential hazards.
- Speed cushion design and kerbside parking impact. Speed cushion effectiveness is reduced.

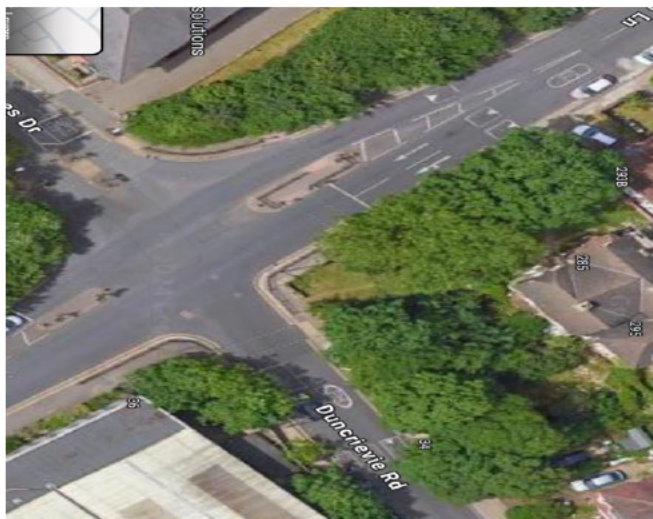
Map

- At the junction of Duncrevie Road and Hither Green Lane, the southbound carriageway splits into two lanes. This configuration and wide road width appears unnecessary and encourages cars to overtake or undertake at speed, including when setting off from the traffic lights and when other vehicles are obeying the speed limit.
- A significant number of pedestrians on the southside of the junction do not use the pedestrian crossing on the north side of the junction, instead crossing the carriage way in unsafe ways.

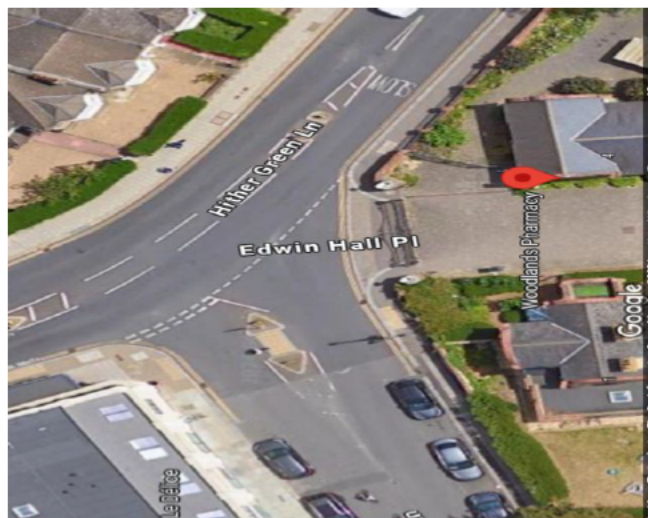
Photo 4 - Satellite View of Hither Green Lane / George Lane Junction

- Wide Junction: The junction's width encourages southbound vehicles to turn at higher speeds, posing a risk to pedestrians and other road users.
- Speeding Vehicles: northbound vehicles approaching the junction may exceed the 20 mph speed limit due to the wide turning area.
- Pedestrian Safety Concerns: The substantial crossing distance exposes pedestrians to potential hazards.
- The position of the pedestrian island poses a risk to pedestrians crossing where they are unable to observe traffic coming from behind (when facing south).
