**Jubilee line – Doors open on a train in service
between Finchley Rd and West Hampstead
stations**

1st September 2018

HSE Info Exchange Reference Number: 949522

Formal investigation report

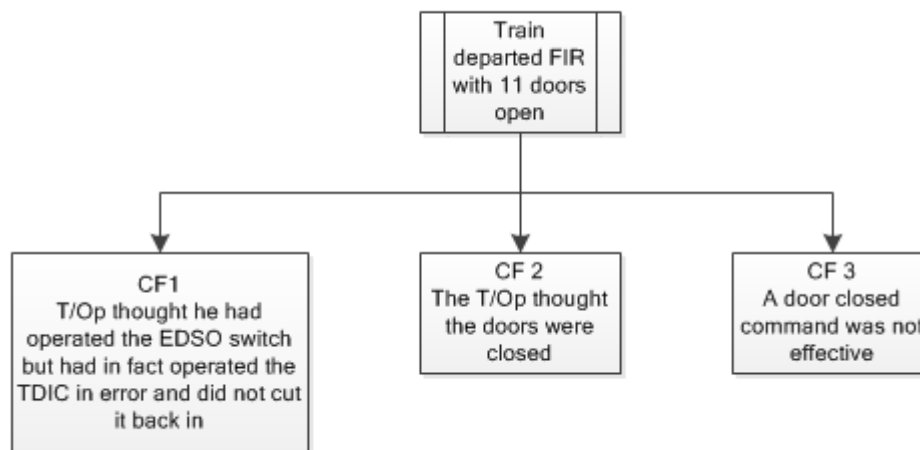
The FIR identified there were three causal factors; had any of these not been present the incident would not have occurred.

Figure 1 – The three causal factors

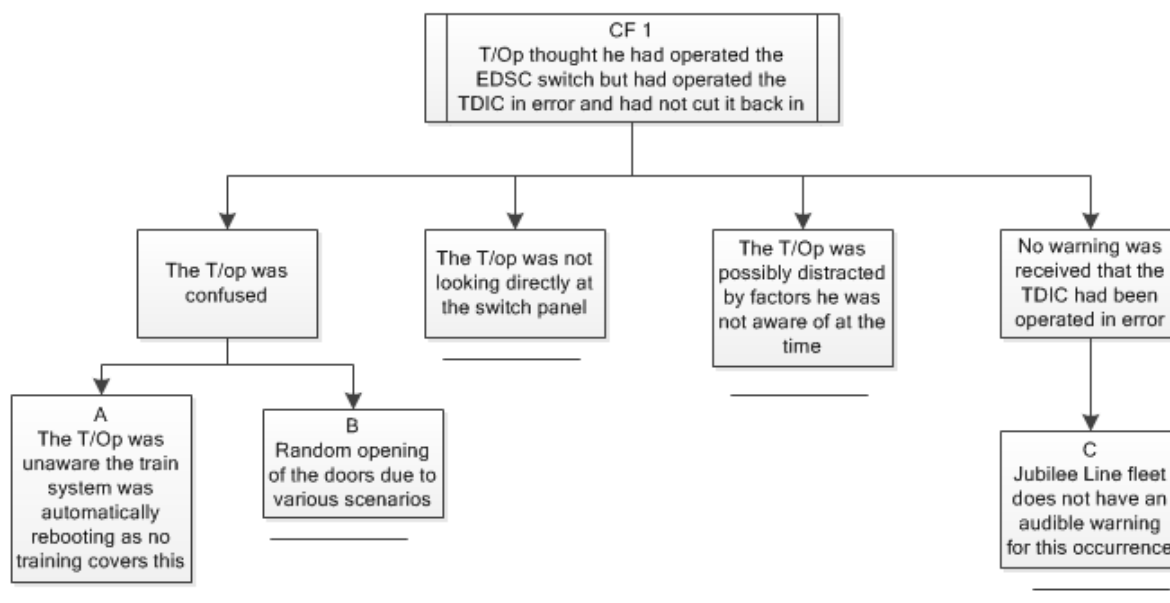
Root Causes

- A. The T/Op was unaware the train systems were automatically rebooting and were not in full communication with each other.
- B. Some but not all doors opening may have contributed to the confusion faced by the T/Op. There are three conditions that applied during this incident in terms of door operation:
 - o Some of the I I doors that did open did so as a result of passengers pressing the “open” buttons whilst the train had defaulted to “passenger open” status.

(*) As passenger mode had been withdrawn some years ago the door buttons were not subject to planned maintenance causing the above two conditions.

The defect scenario encountered by the T/Op during this incident is not covered in the Jubilee Line Defect Handling Guide and as per Defective in Service Instruction 99 the train should have been taken out of service.

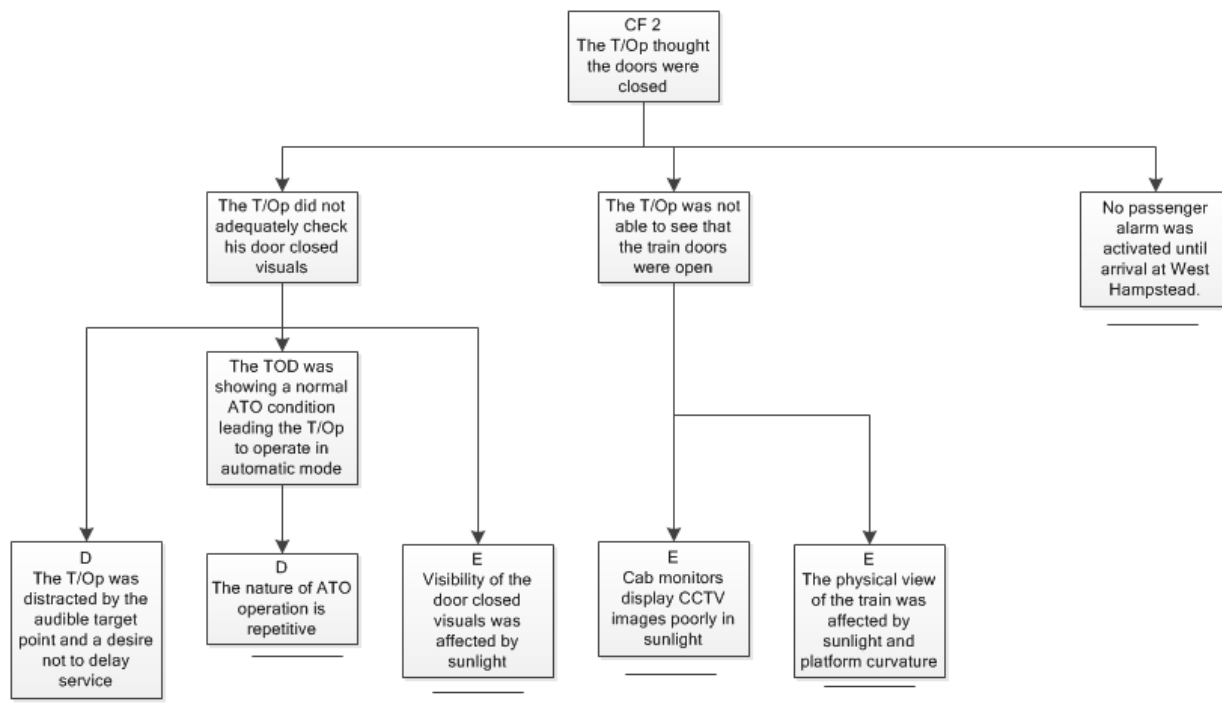
Root Causes

- D. The T/OP stated that ATO workload is very much a routine “Stop/Start/Stop” mode of operation. At the time of the incident the train was in an abnormal condition (TDIC operated) but the Train Operator Display (TOD) was showing a normal condition for ATO operation. The T/Op stated that whilst at Finchley Road platform he was distracted by the approaching ATO Target Point. It cannot be certain whether the Train Management System (TMS) screen would have shown an indication that the TDIC had been cut out as it has not proved possible to recreate the conditions of the fault. It is likely that the routine condition displayed on the TOD and the mundanity of the task, coupled with the audible warning that the ATO Target Point had been and the concern the T/Op had for not delaying the service reached led the T/Op to overlook the fact that he did not have his Door Closed Visual indications.

It was noted that the Door Closed Visual Indicators were brighter on the Jubilee Line fleet until a change effected around 2003 in response to complaints from T/Ops that they were distracting in tunnel sections. It was also noted that there are variations in the intensity of the illumination of the DCVIs on the current fleet. Three trains were utilised during the FIR site visit and some indicators were illuminated considerably brighter than others and one had a sticker over the lens. However, it must be reiterated that in all cases the illumination was severely affected by sunlight.

The FIR also noted that the visibility of the Outside Door Indicating Lights (ODILs), which identify open saloon doors by means of an orange light, were also affected by both sunlight and the recessed design. When viewing the ODILs from the CCTV monitors in the driving cab it was impossible to distinguish between the ODILs being illuminated and not. Further, by physically leaning out of the train it was only possible to see the first ODIL in the front saloon due to the recessed nature of the lights. In this incident the doors of the first saloon remained closed at the departure point at Finchley Road until detrainment commenced at West Hampstead, therefore the T/Op would have not had an indication that any doors were open from the ODILs.

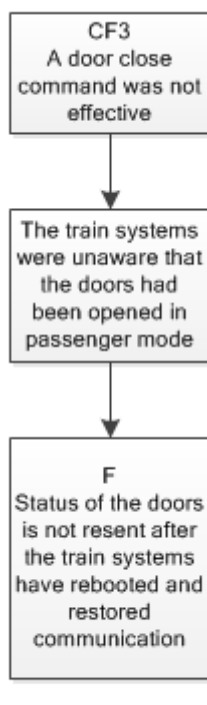
Root Cause

- F. Jubilee Fleet have confirmed that the train systems had rebooted by this point and also that the TMRTs are not programmed to resend the status of the doors to the train systems after communication is restored. Essentially, the TMRTs stopped communicating with the TMS preventing the T/Op from opening the doors. The system reverted to passenger mode as per the design. However, as this happened whilst the TMS was rebooting the TMRTs did not send information to the TMS that I I doors had been opened. When the T/Op pressed the door close buttons, the command was not actioned because the TMS believed the doors were still closed. Had the T/Op initiated his door open command I I seconds later when

communication was restored and then pressed the door close buttons the system would have acted on his command as he would have effectively re-cycled the doors. No indication is present on the TMS to indicate it is rebooting.
