Report No. 4RS-JP-161057-R524751

**MANAGEMENT ASBESTOS SURVEY
BOND STREET UNDERGROUND STATION**

Issue Date: 3rd January 2017

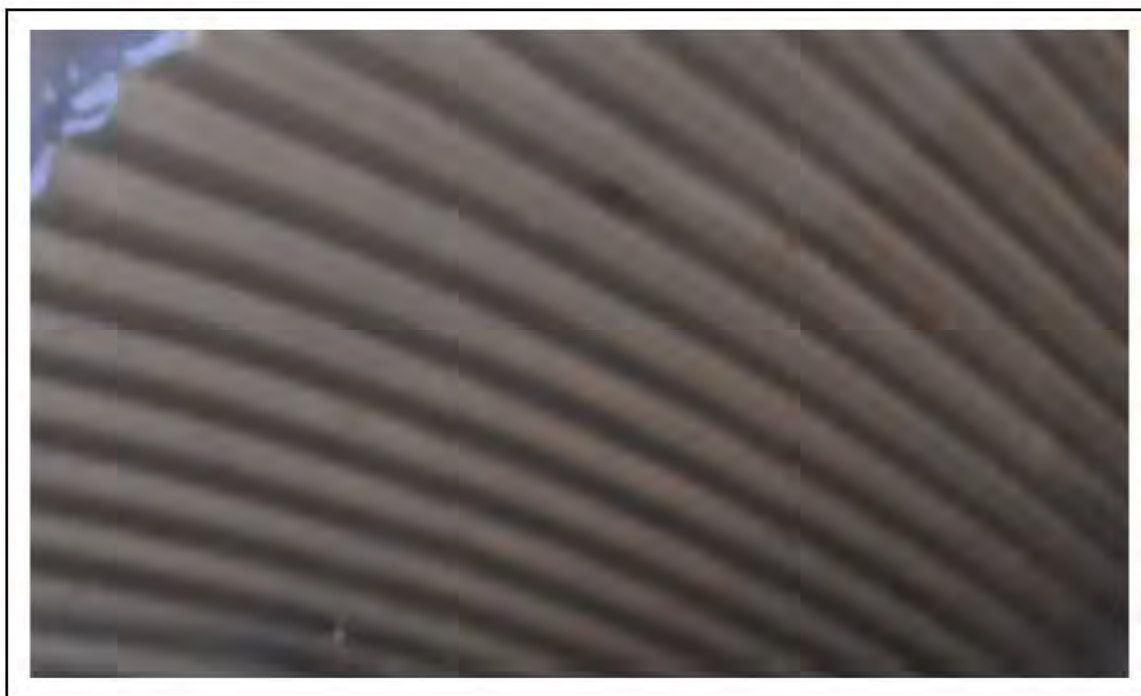
Cellactite confirmed to contain Chrysotile asbestos, Figure 3 - Material assessment rating: Very low

FIGURE 3: CONFIRMED ASBESTOS IN CELLACTITE IN UMC 1 & 2, 2/151 - DESCRIPTION & RESULT OF ASSESSMENT (SAMPLE REF. 110597/011011/01)

Sample Number	110597/011011/01
Location	UMC 1 & 2, 2/151
Material Description	Cellactite
Material Comment	To high level above top escalator no 1 to ceiling tiles (previously sampled) not accessible during 2016 Management Survey
Quantity	<1m ²
Product Type	Composite
Current Condition	Slight damage
Surface Treatment	Composite
Asbestos Type	Chrysotile
Material Assessment Rating	Very low
Accessibility	Low
Further Comment	Photo for illustration purposes only – not accessible during 2016 survey

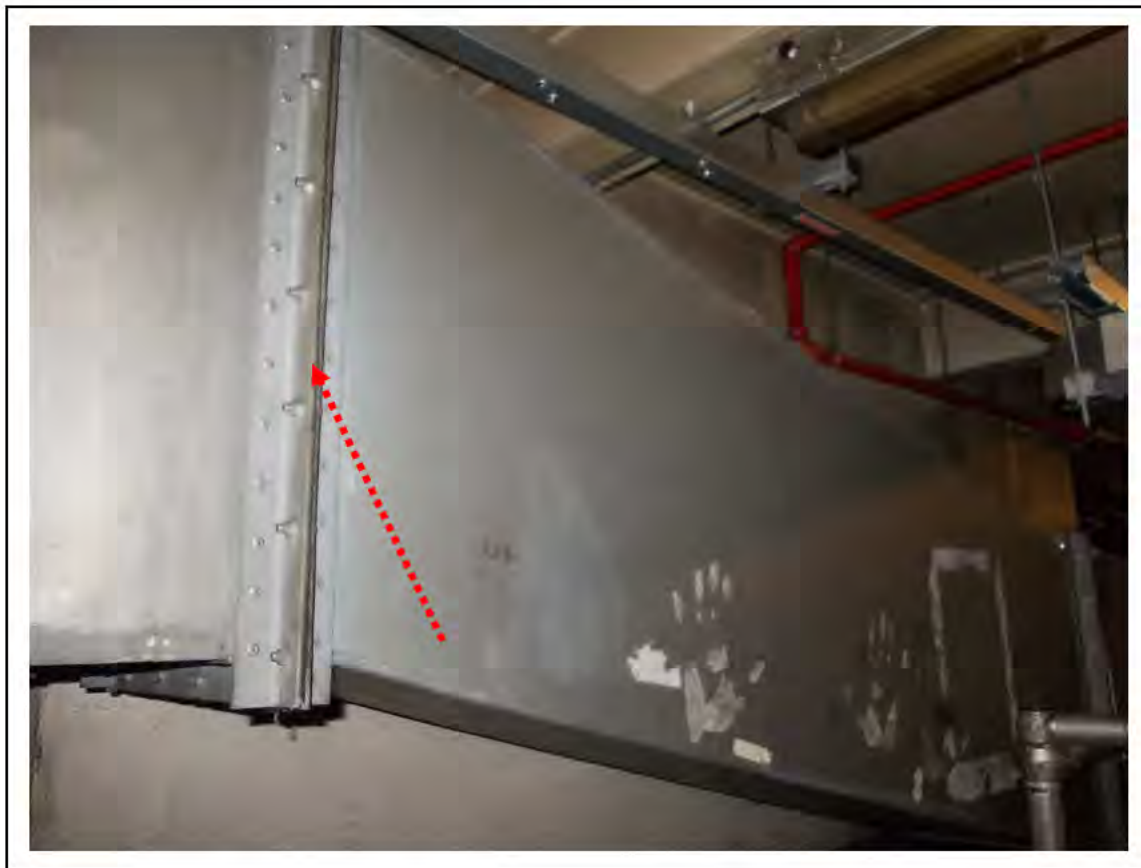
Mastic confirmed to contain Chrysotile asbestos, Figure 7 - Material assessment rating: Very low

FIGURE 7: CONFIRMED ASBESTOS IN MASTIC IN UMC 6, 7, 8, 2/152 - DESCRIPTION & RESULT OF ASSESSMENT (SAMPLE REF. 100675/251110/06)

Sample Number	100675/251110/06
Location	UMC 6,7,8, 2/152
Material Description	Mastic
Material Comment	To A/C ductwork flanges by room 2/664 (previously sampled)
Quantity	Throughout to joints and vent grills where present
Product Type	Composite
Current Condition	Good condition
Surface Treatment	Composite
Asbestos Type	Chrysotile
Material Assessment Rating	Very low
Accessibility	Medium
Further Comment	Not applicable

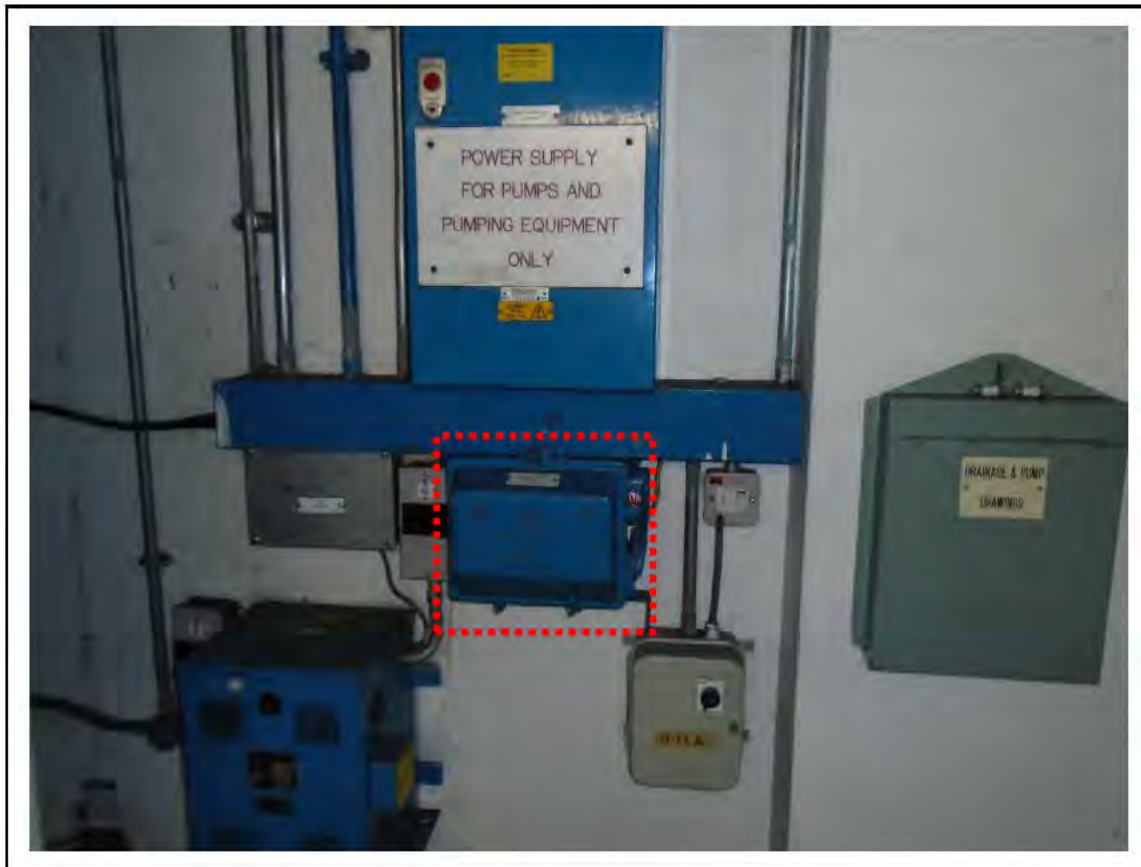
FIGURE 9: STRONGLY PRESUMED ASBESTOS IN MATERIALS WITHIN COMBINATION FUSE SWITCH IN PUMP ROOM, 3/771 - DESCRIPTION & RESULT OF ASSESSMENT (SAMPLE REF. SP1 (2))

Sample Number	SP1 (2)
Location	Pump Room, 3/771
Material Description	Materials within combination fuse switch
Material Comment	To wall 1
Quantity	1 no
Product Type	-
Current Condition	-
Surface Treatment	-
Asbestos Type	Strongly Presumed Chrysotile
Material Assessment Rating	-
Accessibility	-
Further Comment	Not applicable

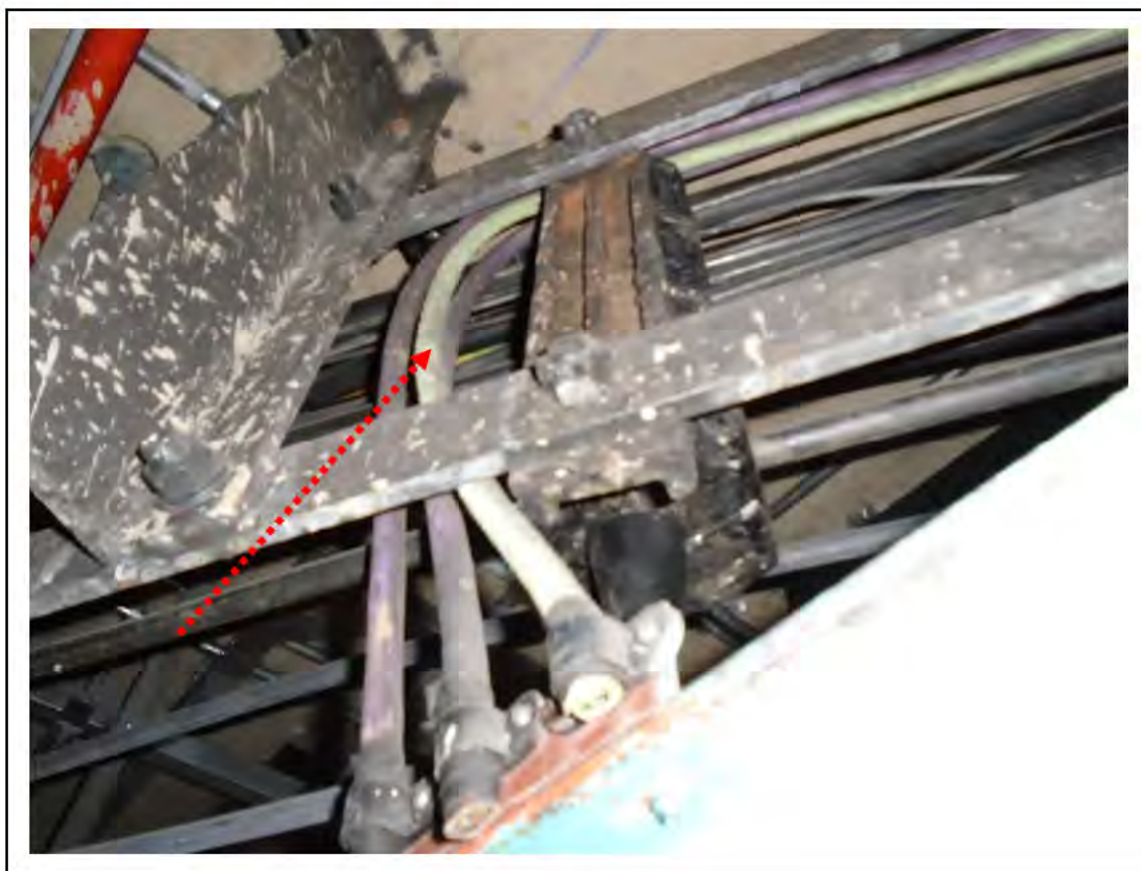
Woven cable insulation known to contain Chrysotile asbestos, Figure 25 - Material assessment rating: Low

FIGURE 25: KNOWN ASBESTOS IN WOVEN CABLE INSULATION IN LMC 3, 4, 5, 6/161 - DESCRIPTION & RESULT OF ASSESSMENT (SAMPLE REF. K1 (1))

Sample Number	K1 (1)
Location	LMC 3, 4, 5, 6/161
Material Description	Woven cable insulation
Material Comment	To J-Hanger no 1, cable cut inside chamber
Quantity	1 no x 25mm
Product Type	Medium density
Current Condition	Slight damage
Surface Treatment	Unencapsulated medium density
Asbestos Type	Known Chrysotile
Material Assessment Rating	Low
Accessibility	Low
Further Comment	Not applicable

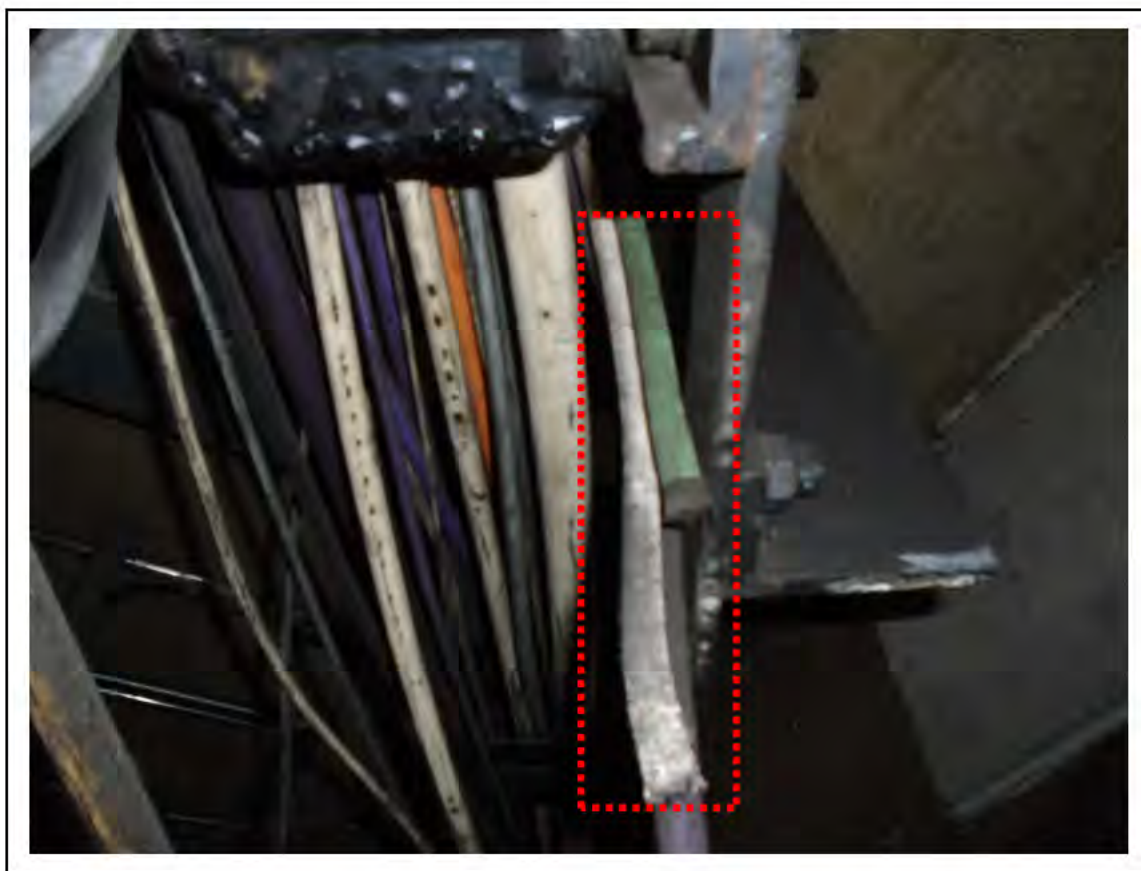
Woven cable insulation known to contain Chrysotile asbestos, Figure 26 - Material assessment rating: Low

FIGURE 26: KNOWN ASBESTOS IN WOVEN CABLE INSULATION IN LMC 3, 4, 5, 6/161 - DESCRIPTION & RESULT OF ASSESSMENT (SAMPLE REF. K1 (2))

Sample Number	K1 (2)
Location	LMC 3, 4, 5, 6/161
Material Description	Woven cable insulation
Material Comment	To J-Hanger no 2, cable cut inside chamber
Quantity	2 no x 25mm
Product Type	Medium density
Current Condition	Slight damage
Surface Treatment	Unencapsulated medium density
Asbestos Type	Known Chrysotile
Material Assessment Rating	Low
Accessibility	Low
Further Comment	Not applicable

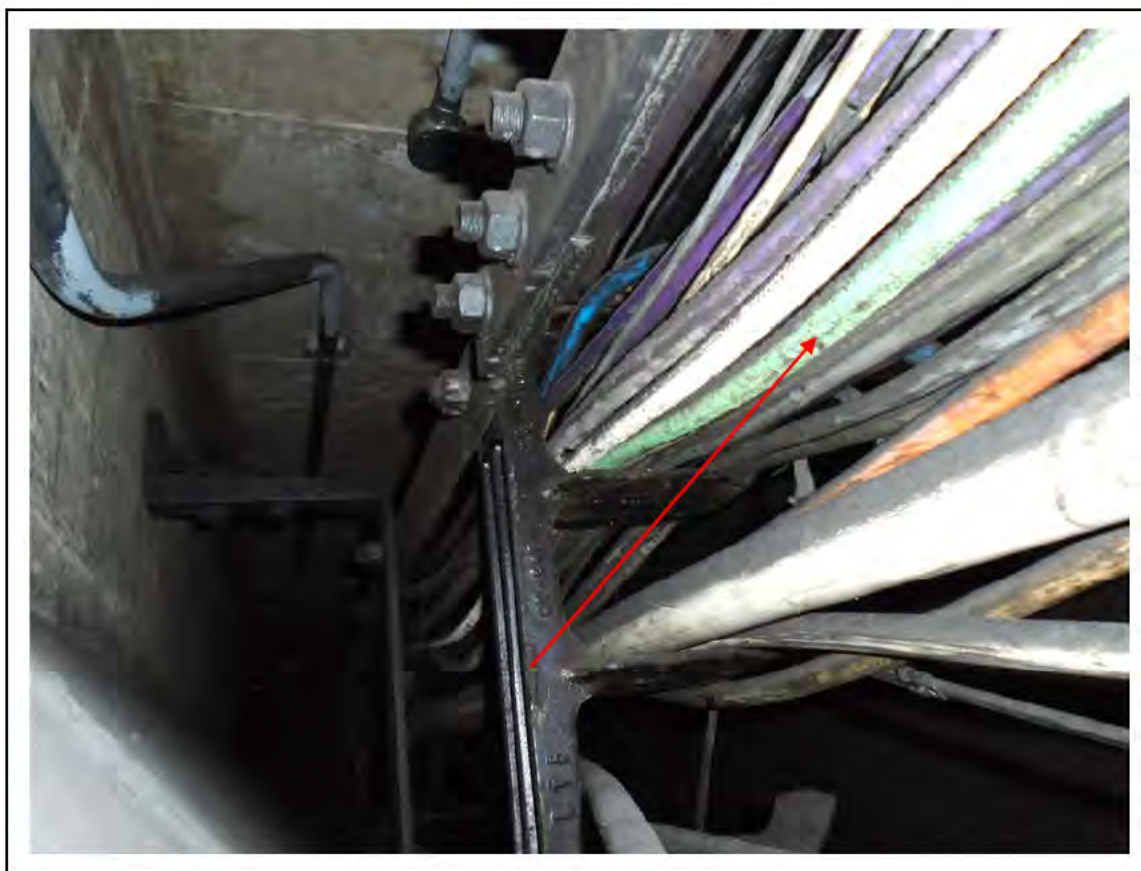
Woven cable insulation known to contain Chrysotile asbestos, Figure 28 - Material assessment rating: Low

FIGURE 28: KNOWN ASBESTOS IN WOVEN CABLE INSULATION IN LMC 3, 4, 5 CRAWLWAY, 6/161 - DESCRIPTION & RESULT OF ASSESSMENT (SAMPLE REF. K1 (3))

Sample Number	K1 (3)
Location	LMC 3, 4, 5 Crawlway, 6/161
Material Description	Woven cable insulation
Material Comment	To LHS crawl way - one cable crossing to right hand side crawl way approximately 10m from entrance, terminating at partition wall. One cable entering ducts approximately 6m from entrance, to left hand side wall.
Quantity	2 no x 25mm
Product Type	Medium density
Current Condition	Good condition
Surface Treatment	Unencapsulated medium density
Asbestos Type	Known Chrysotile
Material Assessment Rating	Low
Accessibility	Low
Further Comment	Not applicable

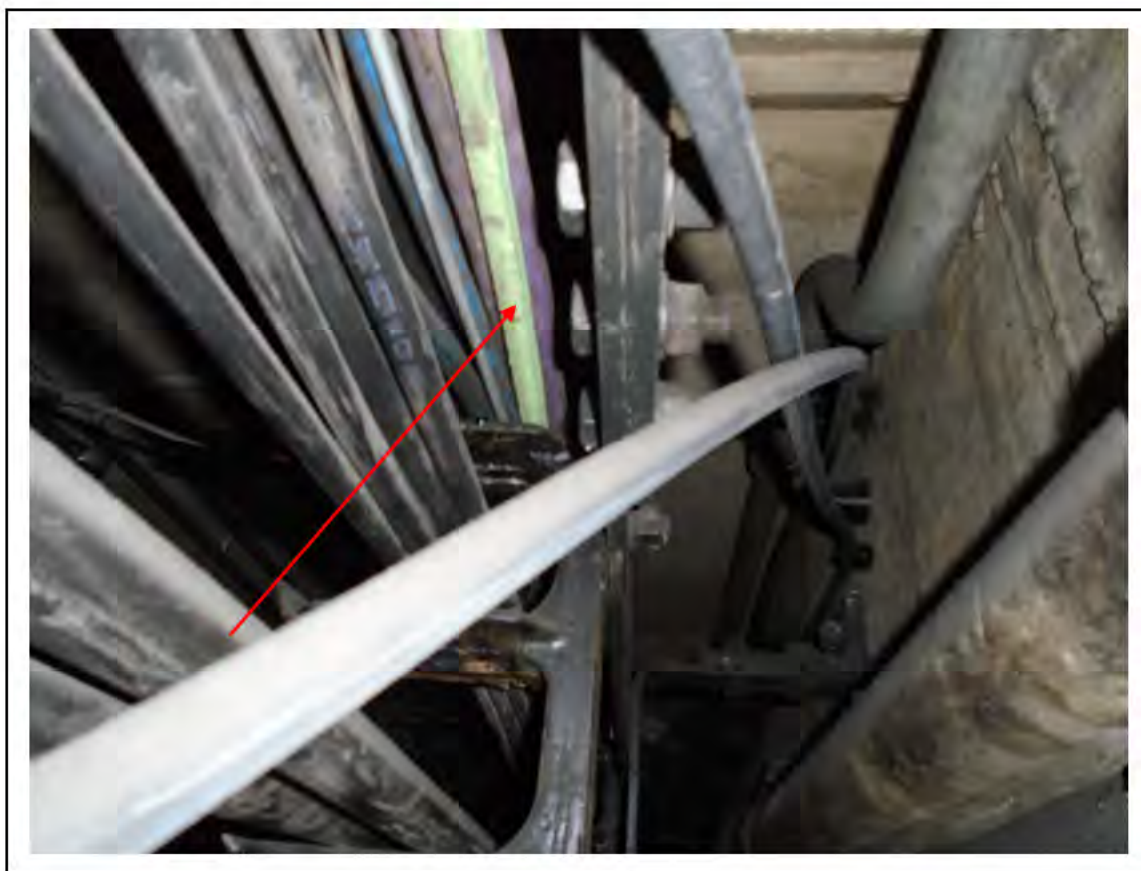
Woven cable insulation known to contain Chrysotile asbestos, Figure 29 - Material assessment rating: Low

FIGURE 29: KNOWN ASBESTOS IN WOVEN CABLE INSULATION IN LMC 3, 4, 5 CRAWLWAY, 6/161 - DESCRIPTION & RESULT OF ASSESSMENT (SAMPLE REF. K1 (4))

Sample Number	K1 (4)
Location	LMC 3, 4, 5 Crawlway, 6/161
Material Description	Woven cable insulation
Material Comment	To RHS crawl way - entering ducts to right hand side wall approximately 10m from entrance
Quantity	1 no x 25mm
Product Type	Medium density
Current Condition	Good condition
Surface Treatment	Unencapsulated medium density
Asbestos Type	Known Chrysotile
Material Assessment Rating	Low
Accessibility	Low
Further Comment	Not applicable

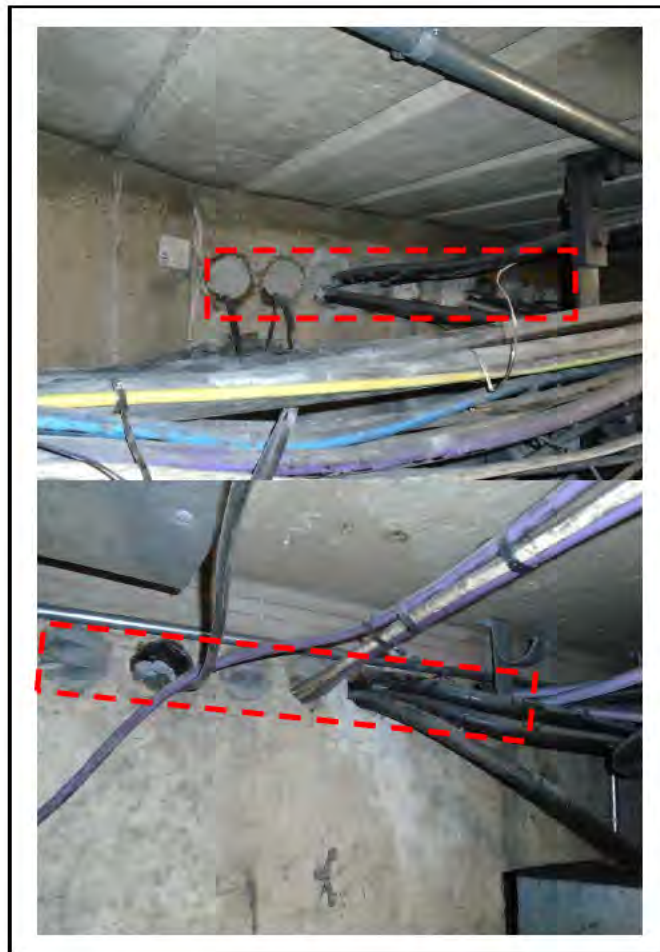
Bitumen ducts confirmed to contain Chrysotile asbestos, Figure 30 - Material assessment rating: Very low

FIGURE 30: CONFIRMED ASBESTOS IN BITUMEN DUCTS IN LMC 3, 4, 5 CRAWLWAY, 6/161 - DESCRIPTION & RESULT OF ASSESSMENT (SAMPLE REF. 161144/190916/01-10 & 12-18)

Sample Number	161144/190916/01-10 & 12-18
Location	LMC 3, 4, 5 Crawlway, 6/161
Material Description	Bitumen ducts
Material Comment	All ducts within crawl ways
Quantity	60 no
Product Type	Composite
Current Condition	Slight damage
Surface Treatment	Composite
Asbestos Type	Chrysotile
Material Assessment Rating	Very low
Accessibility	Low
Further Comment	Not applicable

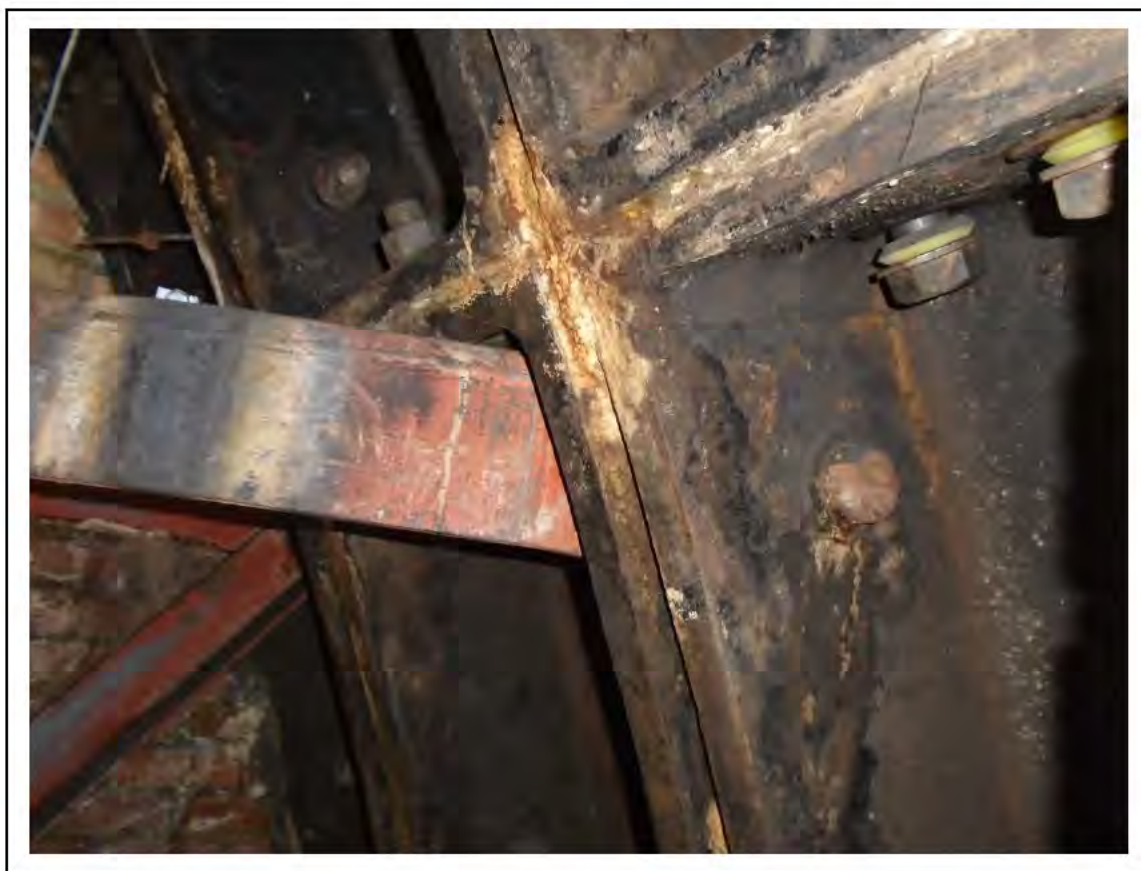
FIGURE 32: CONFIRMED ASBESTOS IN TUNNEL RING CAULKING IN STORE, 4/572 - DESCRIPTION & RESULT OF ASSESSMENT (SAMPLE REF. 100558/131010/4)

Sample Number	100558/131010/4
Location	Store, 4/572
Material Description	Tunnel ring caulking
Material Comment	To cast iron tunnel ring joints (previously sampled)
Quantity	Throughout to all tunnel ring joints present
Product Type	Highly friable
Current Condition	Slight damage
Surface Treatment	Treated highly friable
Asbestos Type	Amosite & Chrysotile
Material Assessment Rating	Medium
Accessibility	Low
Further Comment	Not applicable

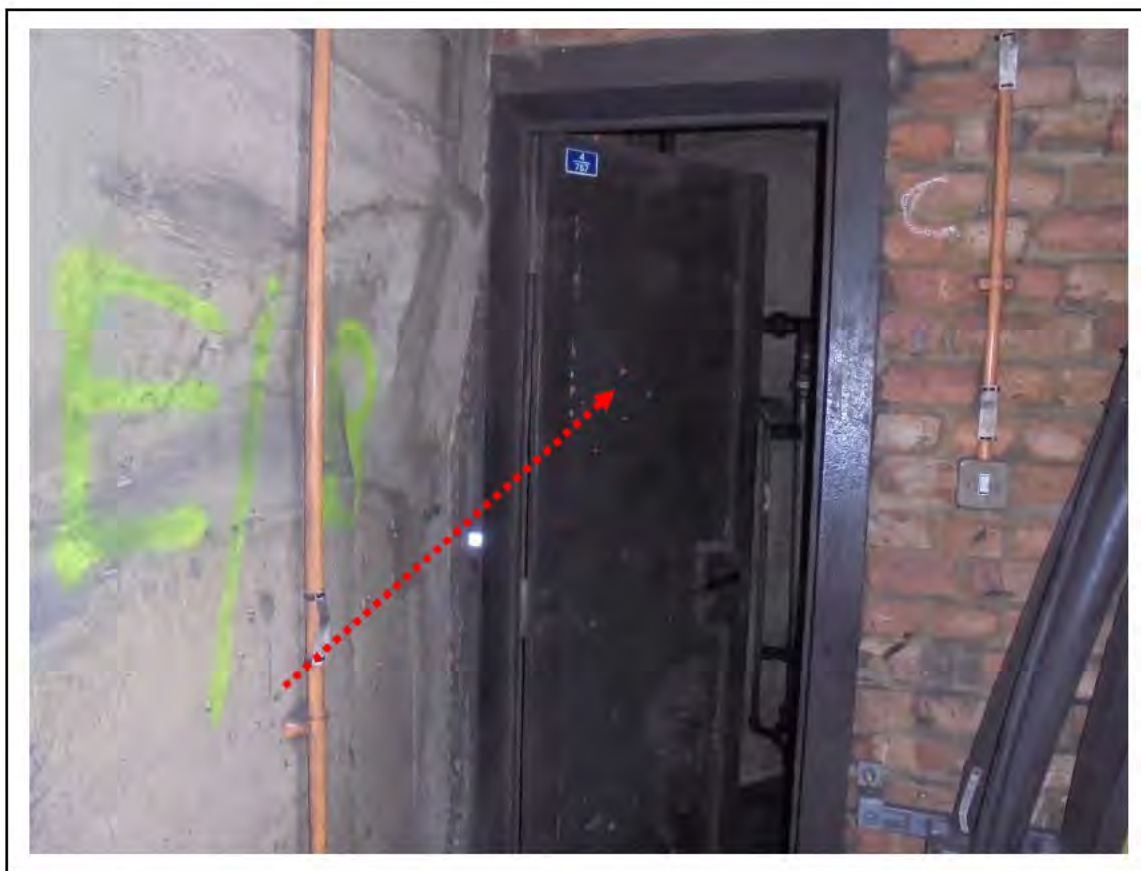
FIGURE 34: CONFIRMED ASBESTOS IN DURASTEEL PANEL IN CABLE TUNNEL, 4/786 - DESCRIPTION & RESULT OF ASSESSMENT (SAMPLE REF. ECS 76821)

Sample Number	ECS 76821
Location	Cable Tunnel, 4/786
Material Description	Durasteel panel
Material Comment	To cable tunnel door, previously sampled
Quantity	1 no x 2m ²
Product Type	Medium density
Current Condition	Good condition
Surface Treatment	Unencapsulated medium density
Asbestos Type	Amosite & Chrysotile
Material Assessment Rating	Low
Accessibility	Medium
Further Comment	Not applicable

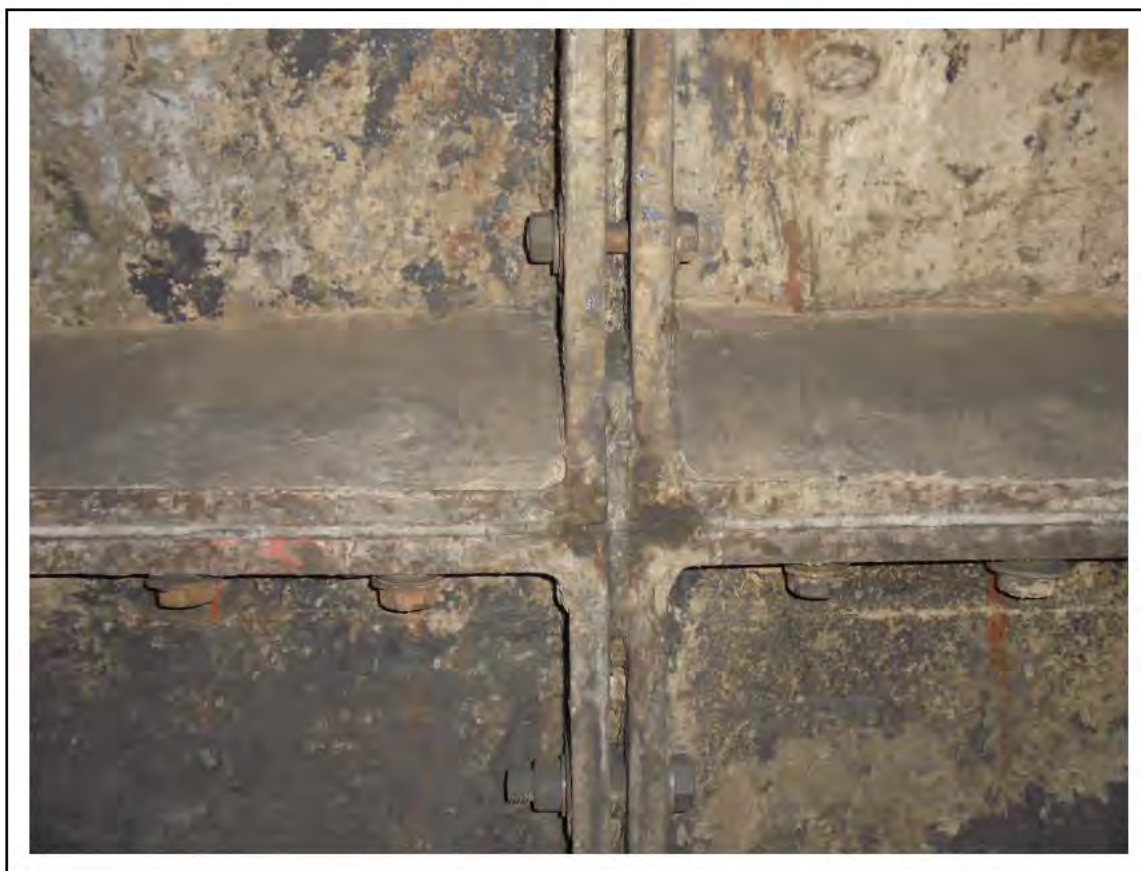
FIGURE 35: CONFIRMED ASBESTOS IN CAULKING IN CABLE TUNNEL, 4/786 - DESCRIPTION & RESULT OF ASSESSMENT (SAMPLE REF. ECS 85379)

Sample Number	ECS 85379
Location	Cable Tunnel, 4/786
Material Description	Caulking
Material Comment	To tunnel ring joints to walls/ ceiling throughout
Quantity	40m - Throughout to all tunnel ring joints present
Product Type	Highly friable
Current Condition	Moderate damage
Surface Treatment	Untreated highly friable
Asbestos Type	Amosite
Material Assessment Rating	High
Accessibility	Medium
Further Comment	Not applicable

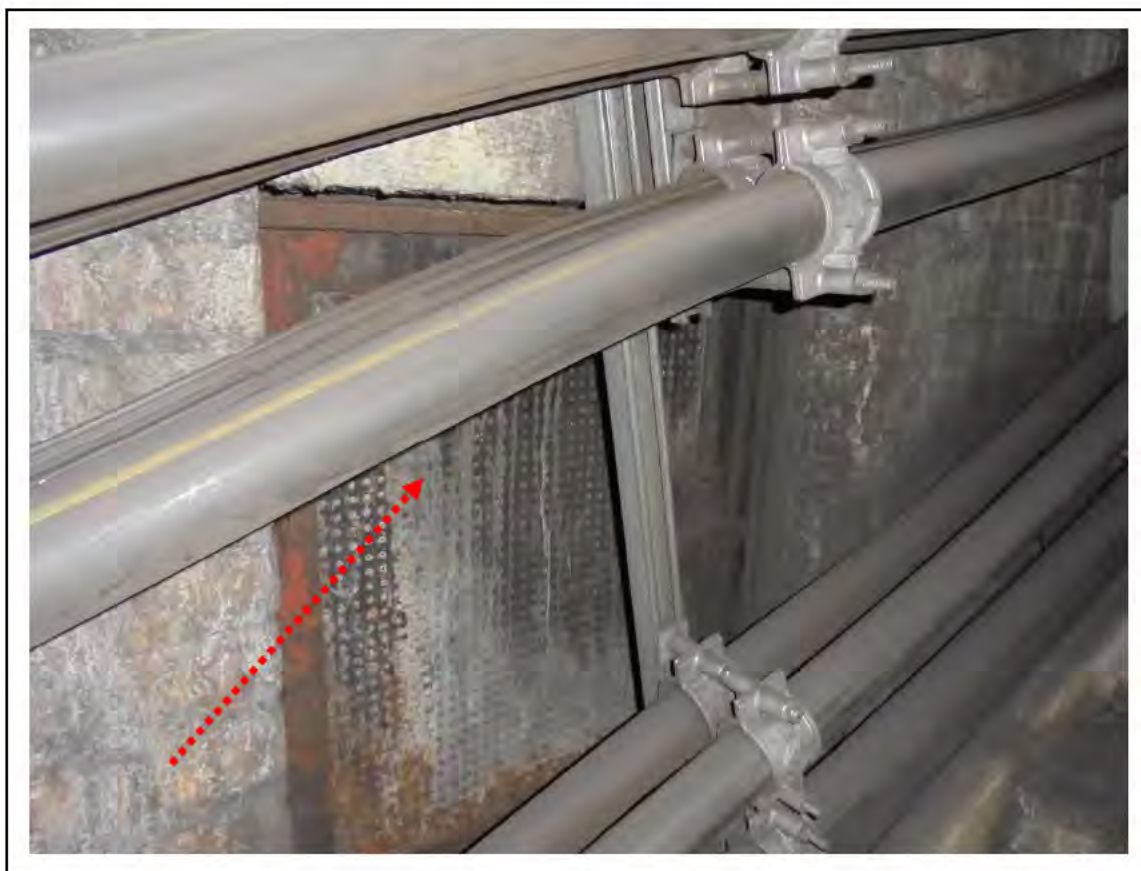
FIGURE 37: CONFIRMED ASBESTOS IN DURASTEEL PANEL IN CABLE TUNNEL, 4/786 - DESCRIPTION & RESULT OF ASSESSMENT (SAMPLE REF. AS 014003/18)

Sample Number	As 014003/18
Location	Cable Tunnel, 4/786
Material Description	Durasteel panel
Material Comment	To middle wall of cable run tunnels
Quantity	1m ²
Product Type	Medium density
Current Condition	Slight damage
Surface Treatment	Unencapsulated medium density
Asbestos Type	Amosite & Chrysotile
Material Assessment Rating	Medium
Accessibility	Low
Further Comment	Not applicable

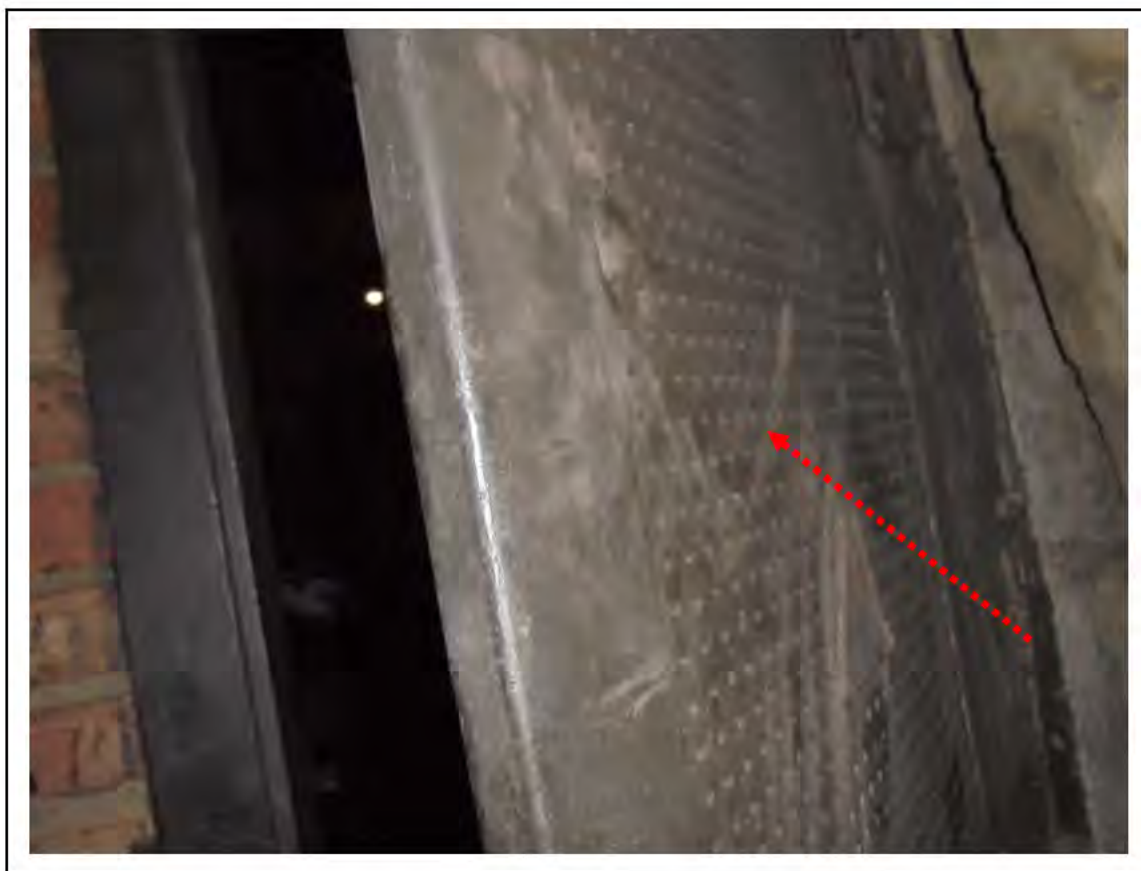
FIGURE 38: CONFIRMED ASBESTOS IN DURASTEEL PANEL IN CABLE TUNNEL, 4/787 - DESCRIPTION & RESULT OF ASSESSMENT (SAMPLE REF. ECS 76822)

Sample Number	ECS 76822
Location	Cable Tunnel, 4/787
Material Description	Durasteel panel
Material Comment	To cable tunnel door, previously sampled
Quantity	1 no x 2m ²
Product Type	Medium density
Current Condition	Good condition
Surface Treatment	Unencapsulated medium density
Asbestos Type	Amosite & Chrysotile
Material Assessment Rating	Low
Accessibility	Medium
Further Comment	Not applicable

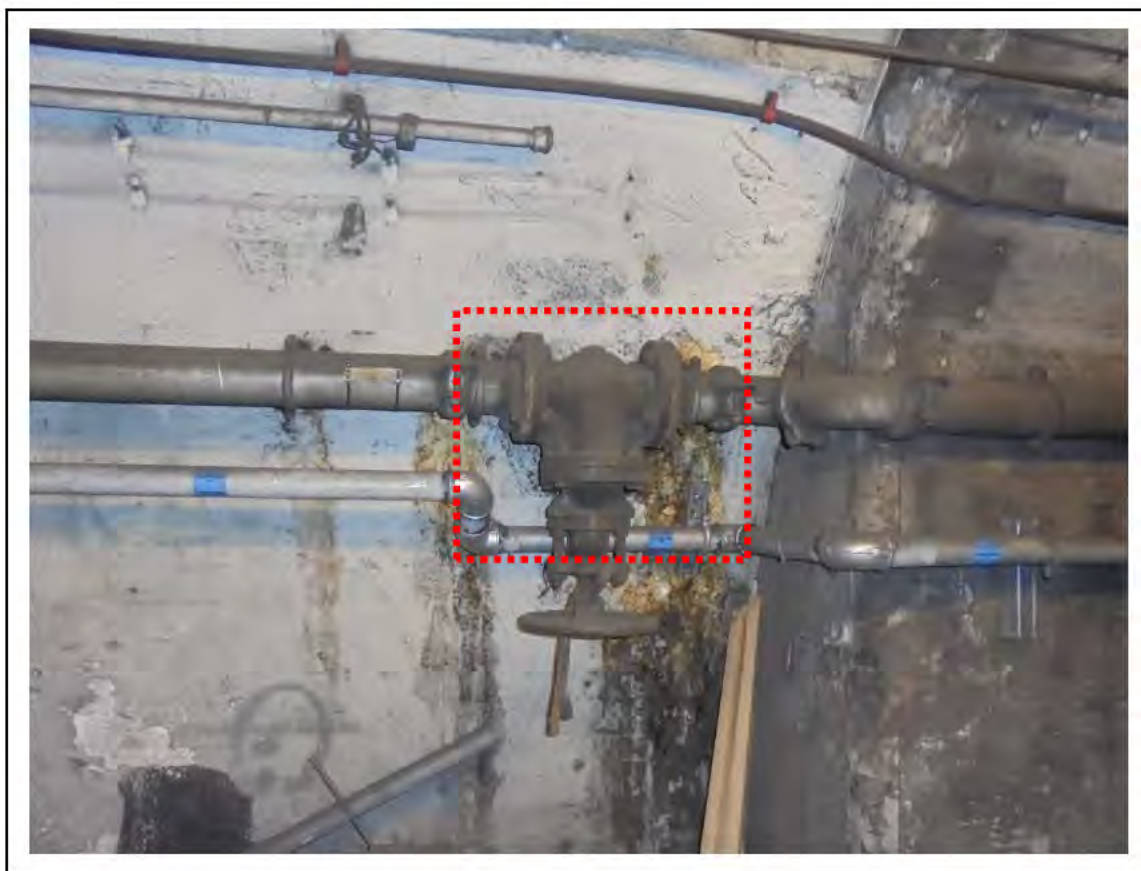
- 8.47 Vent Tunnel, 4/794
CAF gaskets confirmed to contain Chrysotile asbestos, Figure 44 - Material assessment rating: Low
- 8.48 SER, 4/711
Combination fuse switches strongly presumed to contain Chrysotile asbestos, Figure 45

FIGURE 44: CONFIRMED ASBESTOS IN CAF GASKETS IN VENT TUNNEL, 4/794 - DESCRIPTION & RESULT OF ASSESSMENT (SAMPLE REF. 100675/231110/4)

Sample Number	100675/231110/4
Location	Vent Tunnel, 4/794
Material Description	CAF gaskets
Material Comment	To pipework valve, previously sampled
Quantity	2 no
Product Type	Medium density
Current Condition	Slight damage
Surface Treatment	Unencapsulated medium density
Asbestos Type	Chrysotile
Material Assessment Rating	Low
Accessibility	Low
Further Comment	Not applicable

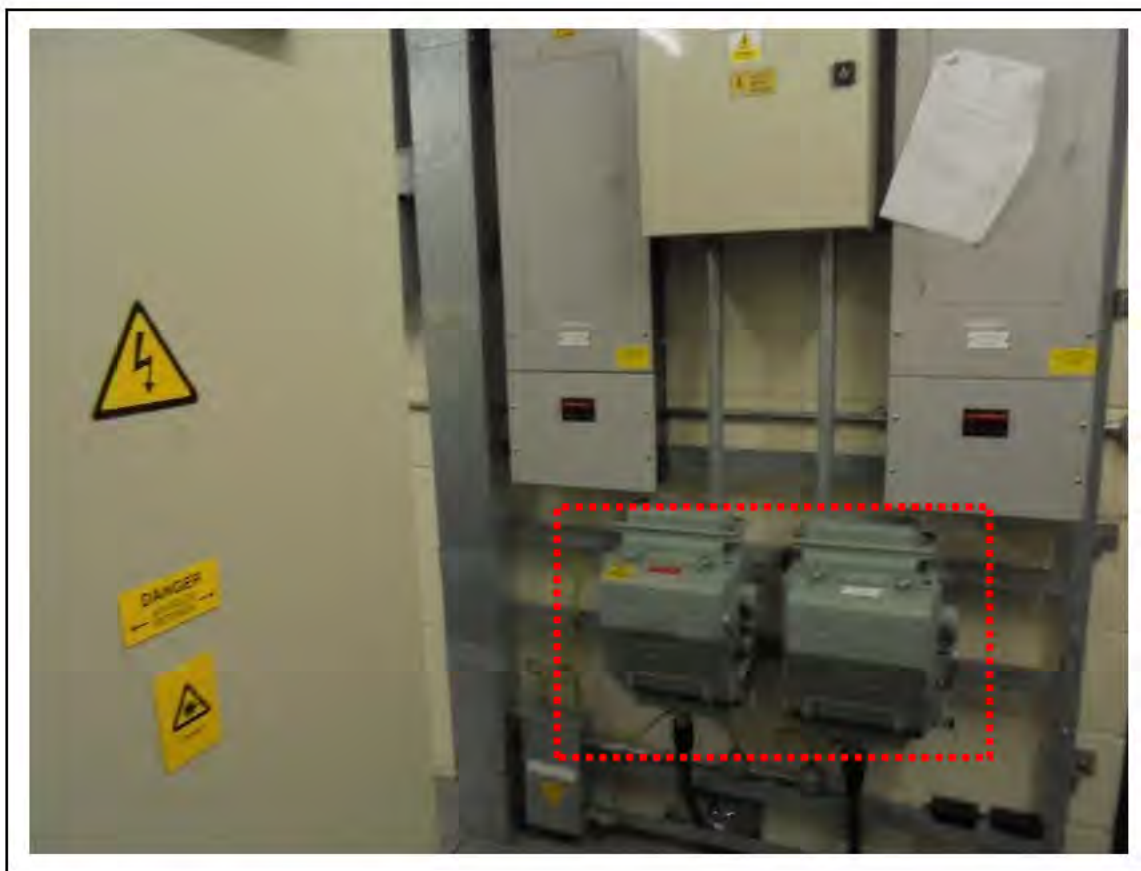
- 8.49 CER, 4/731
Combination fuse switches strongly presumed to contain Chrysotile asbestos, Figure 46
- 8.50 SER/CER, 4/762
Panels/ board presumed to contain Crocidolite asbestos, Figure 47

FIGURE 46: STRONGLY PRESUMED ASBESTOS IN COMBINATION FUSE SWITCHES IN CER, 4/731 - DESCRIPTION & RESULT OF ASSESSMENT (SAMPLE REF. SP1 (7))

Sample Number	SP1 (7)
Location	CER, 4/731
Material Description	Combination fuse switches
Material Comment	To wall 4, by door 4/733 - no isolation
Quantity	2 no
Product Type	-
Current Condition	-
Surface Treatment	-
Asbestos Type	Strongly Presumed Chrysotile
Material Assessment Rating	-
Accessibility	-
Further Comment	Not applicable

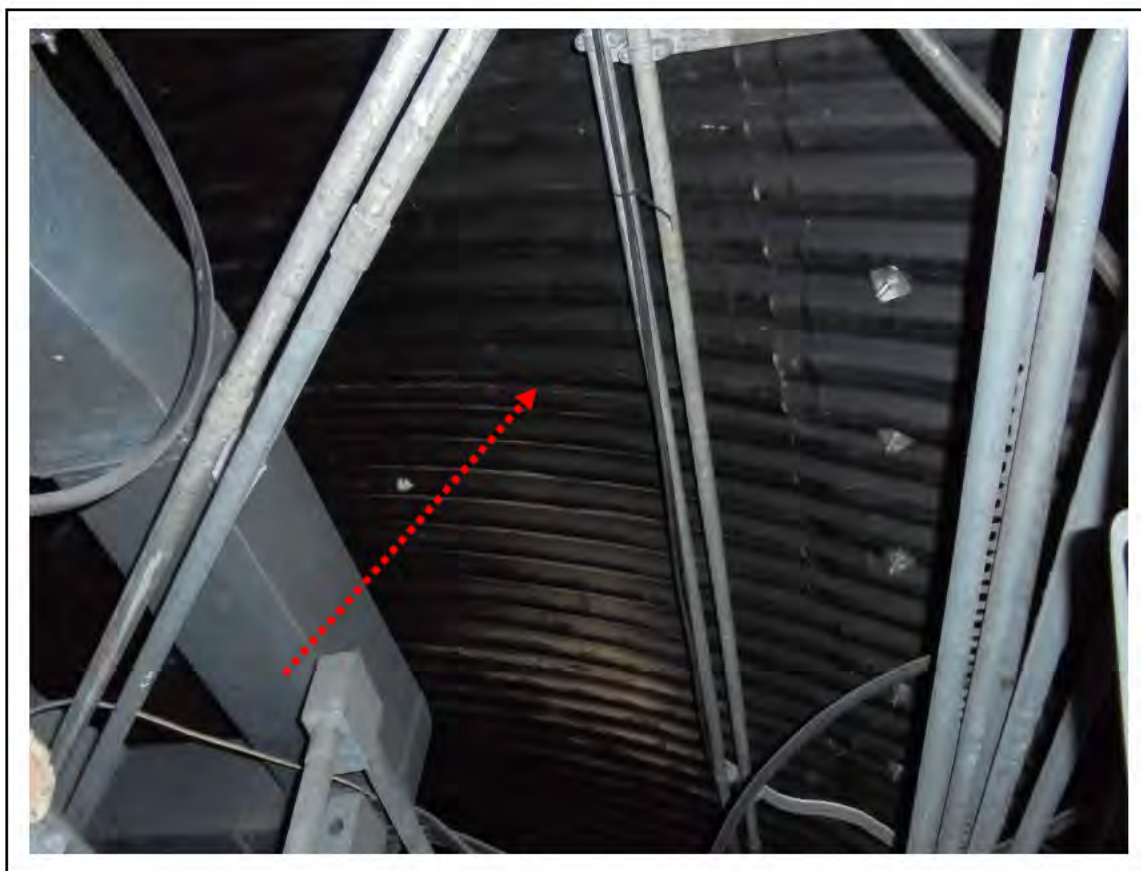
FIGURE 57: CONFIRMED ASBESTOS IN CELLACTITE SHEETING IN STORE, 6/406 - DESCRIPTION & RESULT OF ASSESSMENT (SAMPLE REF. ECS 85369)

- 8.61 Passage, 6/201
Caulking to tunnel rings known to contain Chrysotile asbestos, Figure 56 - Material assessment rating: Medium
- 8.62 Store, 6/406
Cellactite sheeting confirmed to contain Chrysotile asbestos, Figure 57 - Material assessment rating: Very low

Sample Number	ECS 85369
Location	Store, 6/406
Material Description	Cellactite sheeting
Material Comment	To ceiling within false ceiling, previously sampled
Quantity	40m ²
Product Type	Composite
Current Condition	Slight damage
Surface Treatment	Composite
Asbestos Type	Chrysotile
Material Assessment Rating	Very low
Accessibility	Low
Further Comment	Not applicable

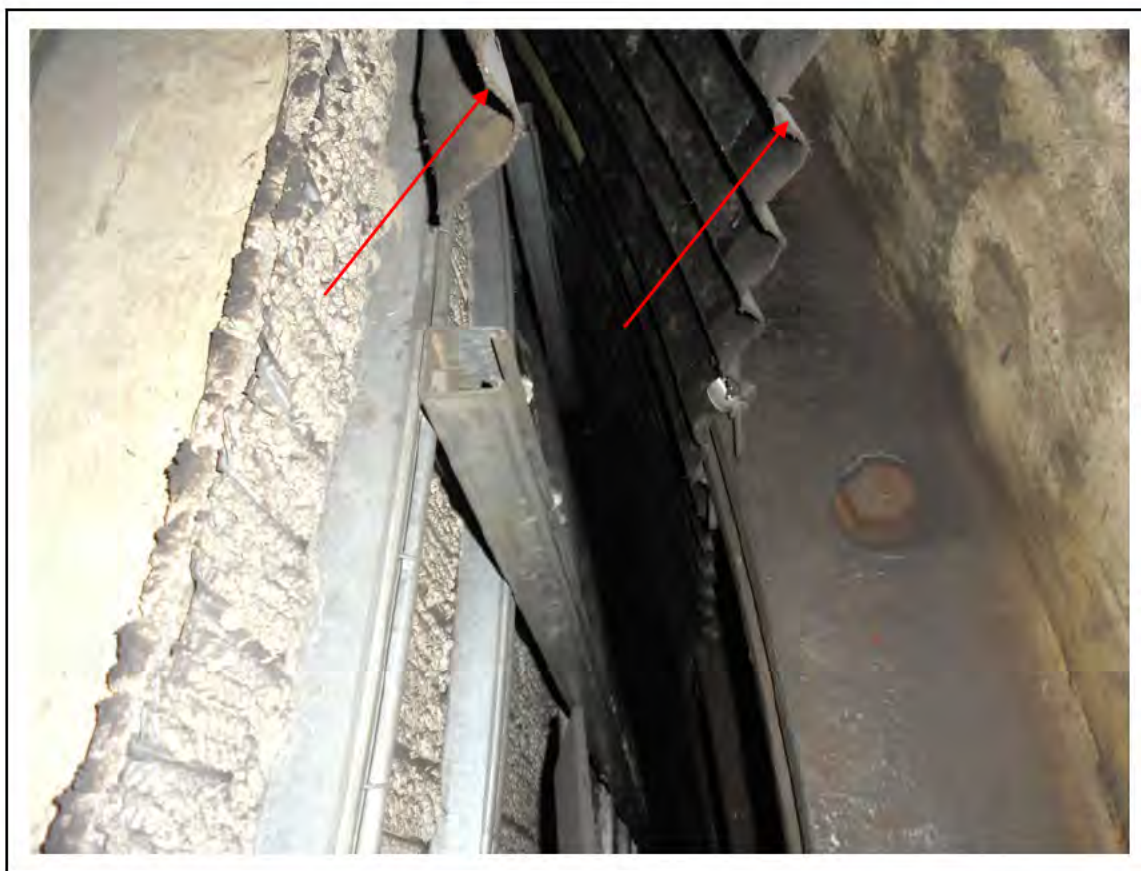
FIGURE 60: KNOWN ASBESTOS IN CELLACTITE SHEETING IN FLAMMABLE STORE, 6/901 - DESCRIPTION & RESULT OF ASSESSMENT (SAMPLE REF. K1 (8))

- 8.65 Flammable Store, 6/901
Cellactite sheeting known to contain Chrysotile asbestos, Figure 60 - Material assessment rating: Very low
- 8.66 Intermediate Concourse, 4/203
Tunnel ring caulking confirmed to contain Amosite asbestos, Figure 61 - Material assessment rating: Medium

Sample Number	K1 (8)
Location	Flammable Store, 6/901
Material Description	Cellactite sheeting
Material Comment	To cavity wall 4, either side of entrance door to high level
Quantity	Throughout, <5m ² visible
Product Type	Composite
Current Condition	Slight damage
Surface Treatment	Composite
Asbestos Type	Known Chrysotile
Material Assessment Rating	Very low
Accessibility	Low
Further Comment	Not applicable

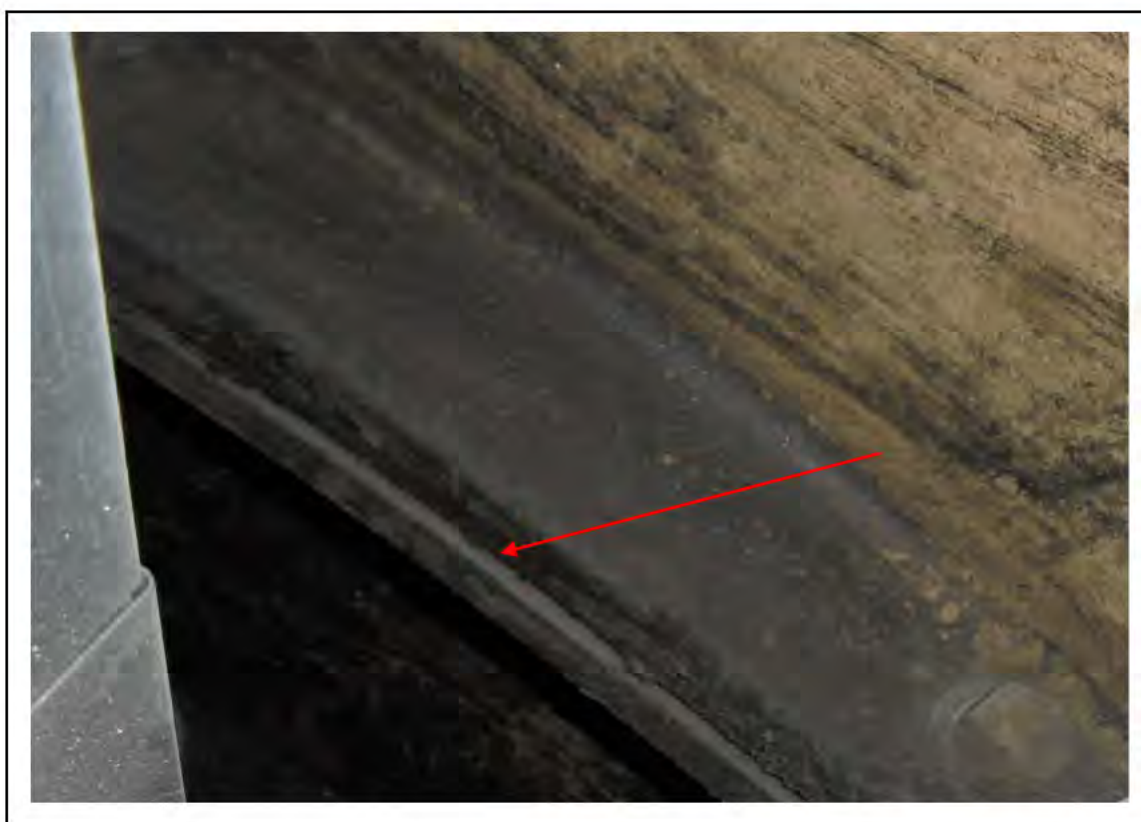
FIGURE 62: CONFIRMED ASBESTOS IN TUNNEL RING CAULKING IN OVERBRIDGE AND PASSAGE, 4/638 - DESCRIPTION & RESULT OF ASSESSMENT (SAMPLE REF. SAME AS ECS 85377)

- 8.67 Overbridge and Passage, 4/638
Tunnel ring caulking confirmed to contain Amosite asbestos, Figure 62 - Material assessment rating: Medium
- 8.68 Passage and Overbridge, 4/202 & 4/637
Cellactite sheeting confirmed to contain Chrysotile asbestos, Figure 63 - Material assessment rating: Very low

Sample Number	Same as ECS 85377
Location	Overbridge and Passage, 4/638
Material Description	Tunnel ring caulking
Material Comment	To tunnel ring flanges within false ceiling throughout passage
Quantity	100m throughout to all tunnel ring joints present
Product Type	Highly friable
Current Condition	Slight damage
Surface Treatment	Untreated highly friable
Asbestos Type	Amosite
Material Assessment Rating	Medium
Accessibility	Low
Further Comment	Not applicable

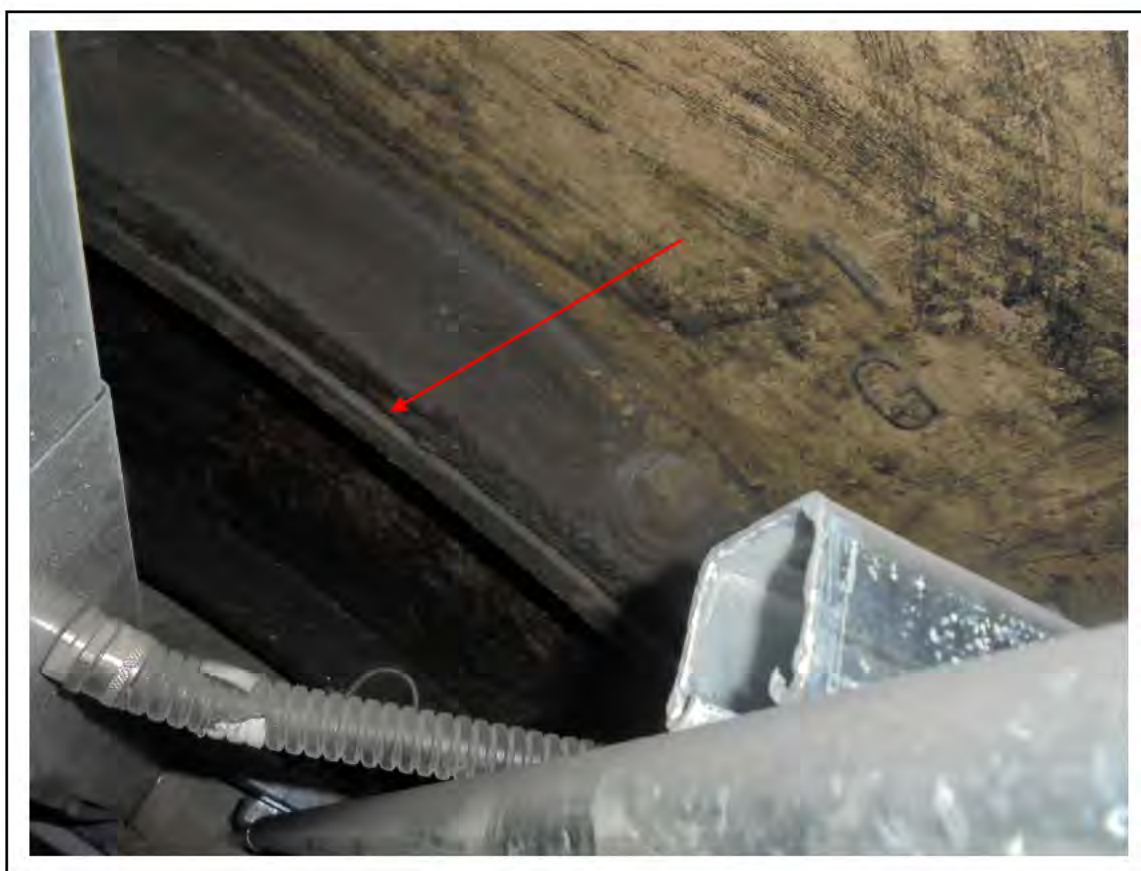
FIGURE 65: CONFIRMED ASBESTOS IN TUNNEL RING CAULKING IN PASSAGE AND OVERBRIDGE, 4/206 & 4/639 - DESCRIPTION & RESULT OF ASSESSMENT (SAMPLE REF. 100675/100211/01)

- 8.69 Passage, 4/205
Tunnel ring caulking confirmed to contain Amosite & Chrysotile asbestos, Figure 64 - Material assessment rating: Medium
- 8.70 Passage and Overbridge, 4/206 & 4/639
Tunnel ring caulking confirmed to contain Amosite & Chrysotile asbestos, Figure 65 - Material assessment rating: Medium

Sample Number	100675/100211/01
Location	Passage and Overbridge, 4/206 & 4/639
Material Description	Tunnel ring caulking
Material Comment	Throughout to flanges of tunnel rings (previously sampled)
Quantity	~60m throughout to all tunnel ring joints present
Product Type	Highly friable
Current Condition	Slight damage
Surface Treatment	Untreated highly friable
Asbestos Type	Amosite & Chrysotile
Material Assessment Rating	Medium
Accessibility	Low
Further Comment	Not applicable
