Report No. 4RS-JP-161057-R524751

**MANAGEMENT ASBESTOS SURVEY
BOND STREET UNDERGROUND STATION**

Issue Date: 3rd January 2017

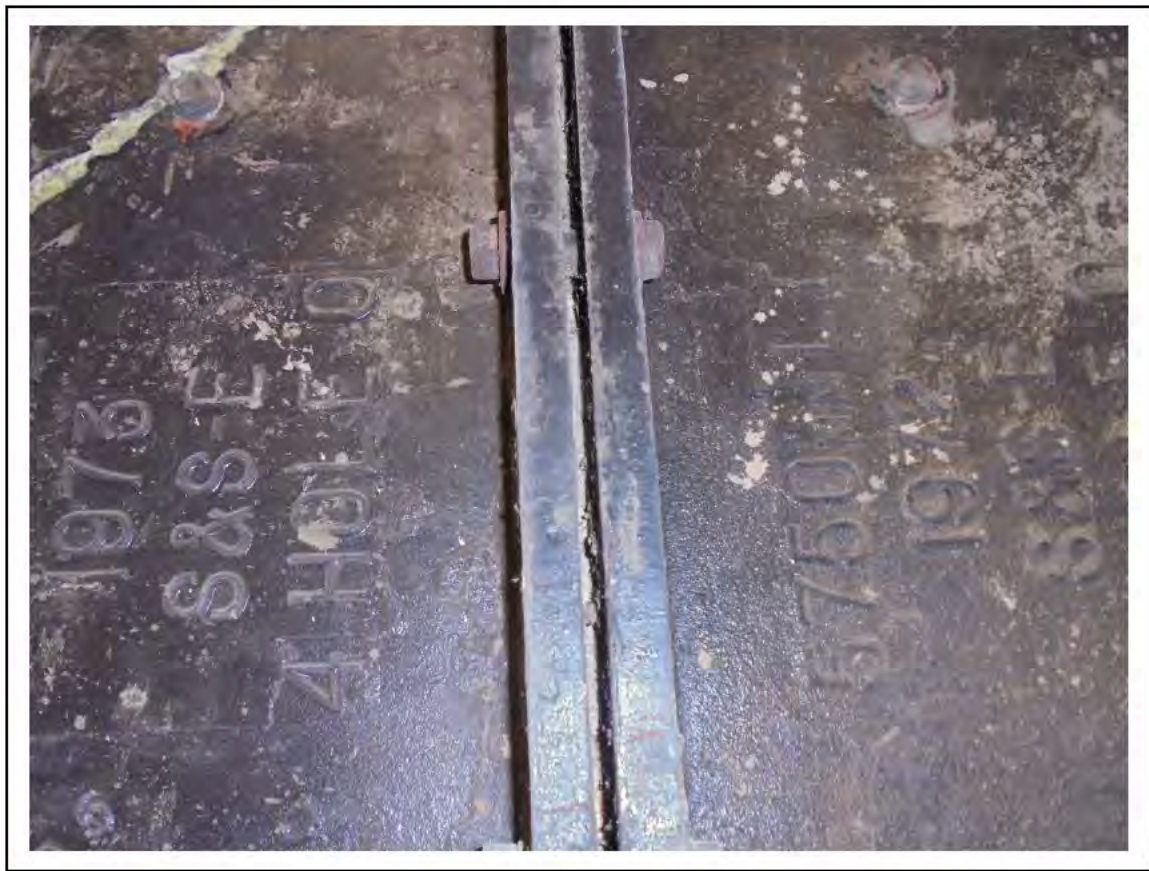
FIGURE 69: CONFIRMED ASBESTOS IN TUNNEL RING CAULKING IN PASSAGE, 4/204 - DESCRIPTION & RESULT OF ASSESSMENT (SAMPLE REF. 100675/231110/5)

- 8.74 Passage, 4/204
Tunnel ring caulking confirmed to contain Amosite & Chrysotile asbestos, Figure 69
- Material assessment rating: Medium
- 8.75 Circ Area, 4/093
Cellactite sheeting strongly presumed to contain Chrysotile asbestos, Figure 70

Sample Number	100675/231110/5
Location	Passage, 4/204
Material Description	Tunnel ring caulking
Material Comment	Throughout to tunnel ring flanges within false ceiling (previously sampled)
Quantity	Throughout to all tunnel ring joints present
Product Type	Highly friable
Current Condition	Slight damage
Surface Treatment	Untreated highly friable
Asbestos Type	Amosite & Chrysotile
Material Assessment Rating	Medium
Accessibility	Low
Further Comment	Not applicable

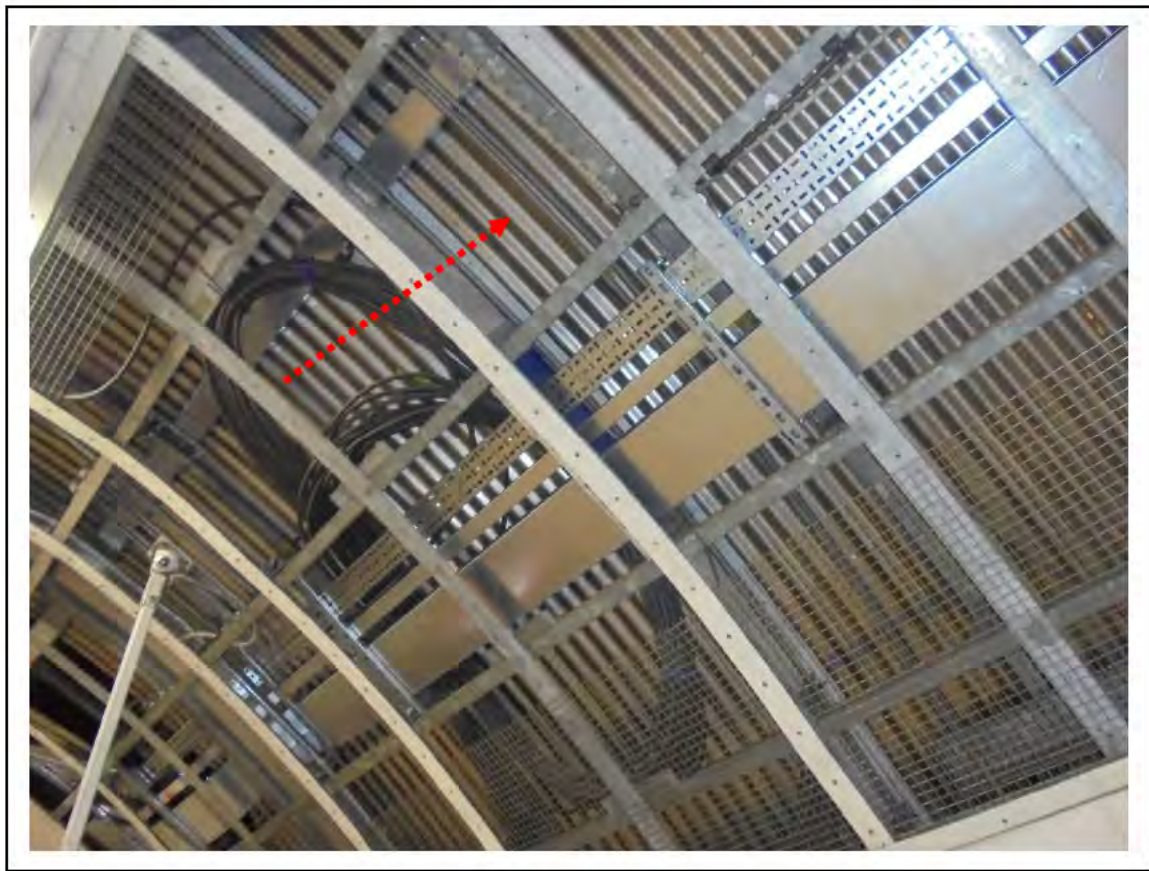
FIGURE 70: STRONGLY PRESUMED ASBESTOS IN CELLACTITE SHEETING IN CIRC AREA, 4/093 - DESCRIPTION & RESULT OF ASSESSMENT (SAMPLE REF. SP1 (9))

Sample Number	SP1 (9)
Location	Circ Area, 4/093
Material Description	Cellactite sheeting
Material Comment	Within wall cavities behind metal sheeting
Quantity	Throughout
Product Type	-
Current Condition	-
Surface Treatment	-
Asbestos Type	Strongly Presumed Chrysotile
Material Assessment Rating	-
Accessibility	-
Further Comment	Not applicable

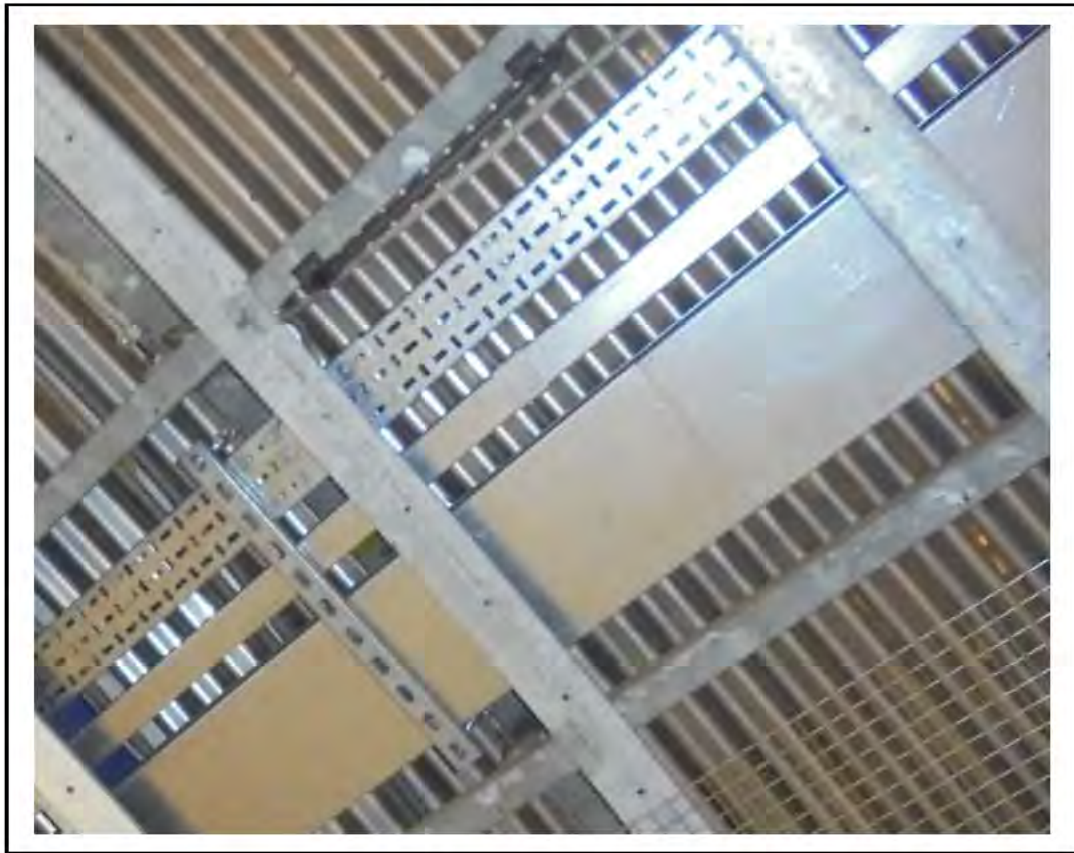
FIGURE 71: STRONGLY PRESUMED ASBESTOS IN CAULKING IN CIRC AREA, 4/093 - DESCRIPTION & RESULT OF ASSESSMENT (SAMPLE REF. SP1&2 (1))

- 8.76 Circ Area, 4/093
Caulking strongly presumed to contain Amosite & Chrysotile asbestos, Figure 71
- 8.77 Vent Shaft Entrance, 4/792
Caulking to cast iron tunnel rings confirmed to contain Amosite & Chrysotile asbestos, Figure 72 - Material assessment rating: Medium

Sample Number	SP1&2 (1)
Location	Circ Area, 4/093
Material Description	Caulking
Material Comment	To tunnel ring flanges behind metal sheeting
Quantity	Throughout
Product Type	-
Current Condition	-
Surface Treatment	-
Asbestos Type	Strongly Presumed Amosite & Chrysotile
Material Assessment Rating	-
Accessibility	-
Further Comment	Not applicable

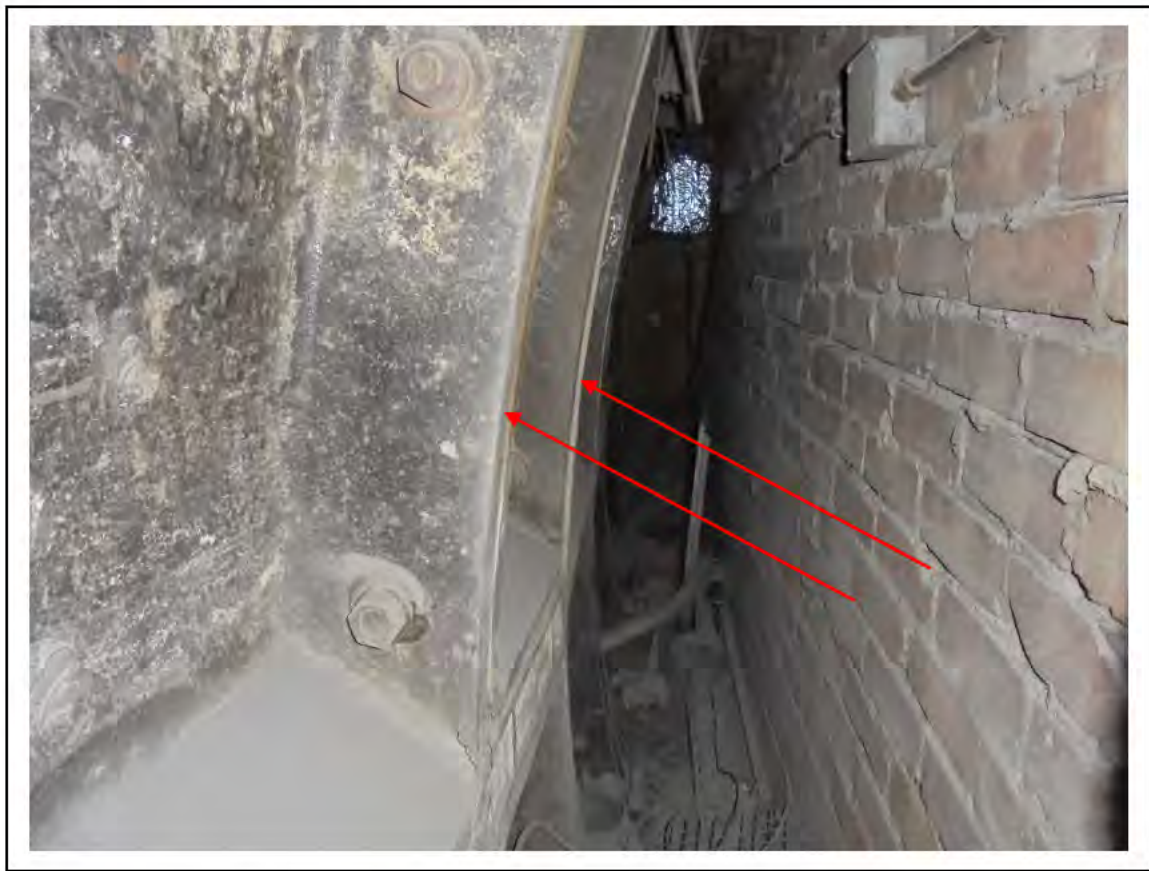
FIGURE 72: CONFIRMED ASBESTOS IN CAULKING TO CAST IRON TUNNEL RINGS IN VENT SHAFT ENTRANCE, 4/792 - DESCRIPTION & RESULT OF ASSESSMENT (SAMPLE REF. AS ECS 85389)

Sample Number	As ECS 85389
Location	Vent Shaft Entrance, 4/792
Material Description	Caulking to cast iron tunnel rings
Material Comment	To wall within cavity wall area
Quantity	~6m
Product Type	Highly friable
Current Condition	Slight damage
Surface Treatment	Untreated highly friable
Asbestos Type	Amosite & Chrysotile
Material Assessment Rating	Medium
Accessibility	Medium
Further Comment	Not applicable

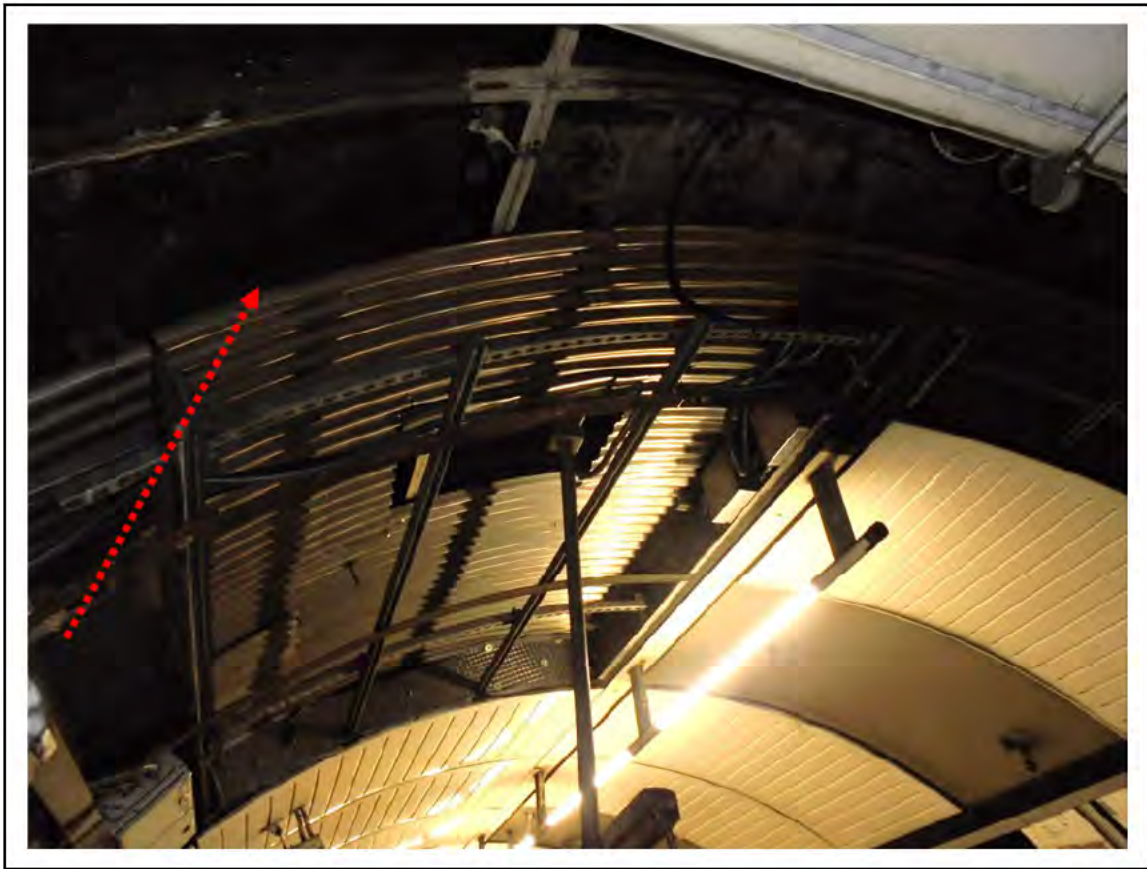
FIGURE 73: CONFIRMED ASBESTOS IN CELLACTITE IN PLATFORM 3, 6/261 - DESCRIPTION & RESULT OF ASSESSMENT (SAMPLE REF. ECS 85287 & 100946/210311/01)

- 8.80 Platform 3, 6/261
Cellactite confirmed to contain Chrysotile asbestos, Figure 73 - Material assessment rating: Very low
- 8.81 Platform 3, 6/261
Tunnel ring caulking confirmed to contain Amosite & Chrysotile asbestos, Figure 74

Sample Number	ECS 85287 & 100946/210311/01
Location	Platform 3, 6/261
Material Description	Cellactite
Material Comment	To cavity walls and ends of platforms. Presumed above track areas (previously sampled)
Quantity	Throughout platform and track areas ~500m ²
Product Type	Composite
Current Condition	Slight damage
Surface Treatment	Composite
Asbestos Type	Chrysotile
Material Assessment Rating	Very low
Accessibility	Low
Further Comment	Not applicable

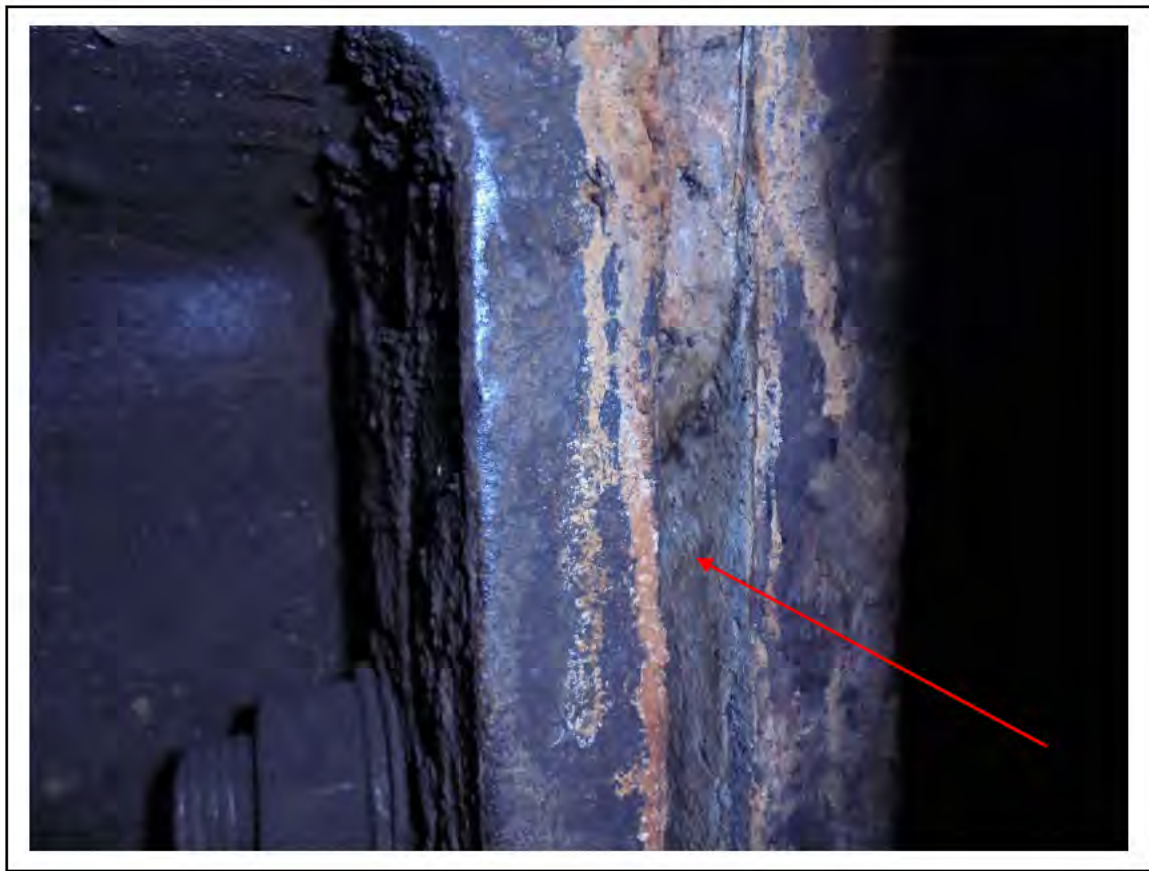
FIGURE 74: CONFIRMED ASBESTOS IN TUNNEL RING CAULKING IN PLATFORM 3, 6/261 - DESCRIPTION & RESULT OF ASSESSMENT (SAMPLE REF. 100946/210311/09)

Sample Number	100946/210311/09
Location	Platform 3, 6/261
Material Description	Tunnel ring caulking
Material Comment	To flanges throughout to cast iron tunnel ring walls (previously sampled)
Quantity	Throughout to all tunnel ring joints present
Product Type	Highly friable
Current Condition	Slight damage
Surface Treatment	Untreated highly friable
Asbestos Type	Amosite & Chrysotile
Material Assessment Rating	Medium
Accessibility	Low
Further Comment	Not applicable

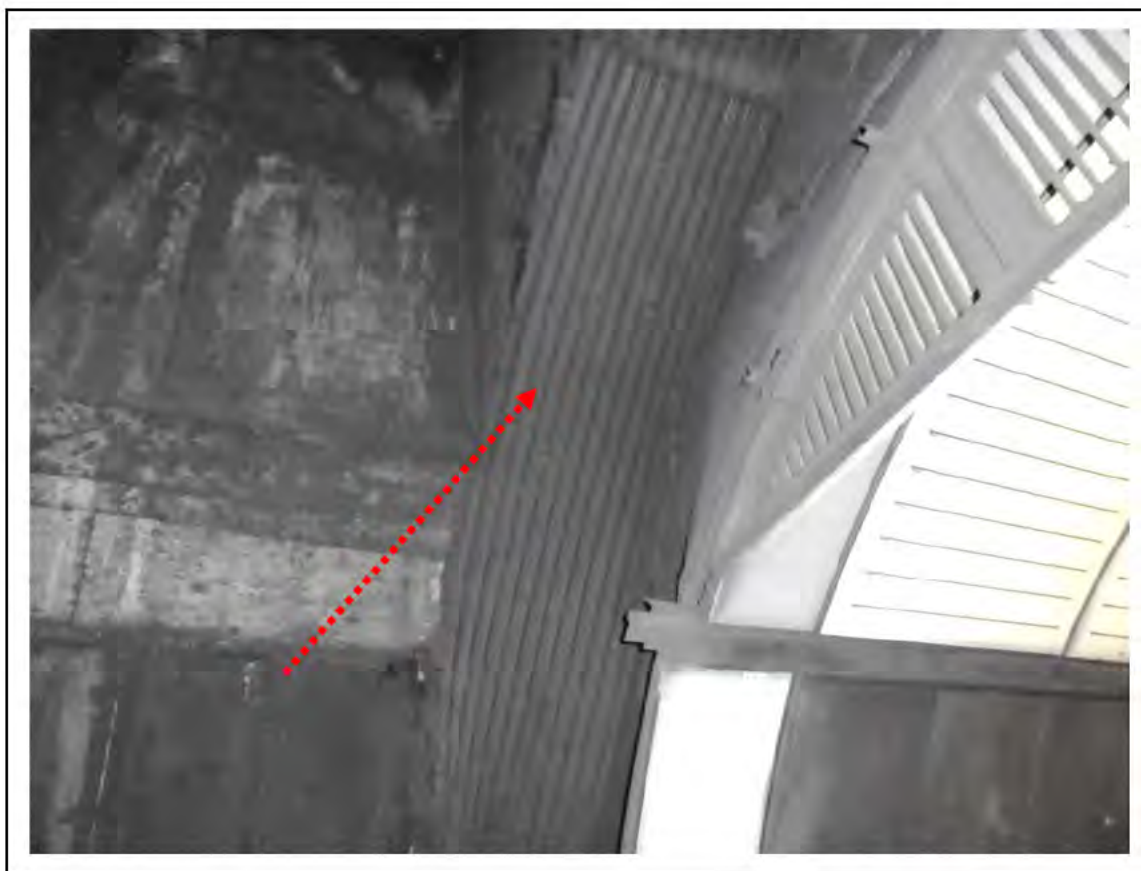
FIGURE 75: KNOWN ASBESTOS IN CELLACTITE IN PLATFORM 4, 6/262 - DESCRIPTION & RESULT OF ASSESSMENT (SAMPLE REF. K1 (10))

- Material assessment rating: Medium
- 8.82 Platform 4, 6/262
Cellactite known to contain Chrysotile asbestos, Figure 75 - Material assessment rating: Very low

Sample Number	K1 (10)
Location	Platform 4, 6/262
Material Description	Cellactite
Material Comment	Within cavity walls and above track - above metal sheets (previously sampled)
Quantity	Throughout platform and track areas, ~500m ²
Product Type	Composite
Current Condition	Slight damage
Surface Treatment	Composite
Asbestos Type	Known Chrysotile
Material Assessment Rating	Very low
Accessibility	Low
Further Comment	Not applicable

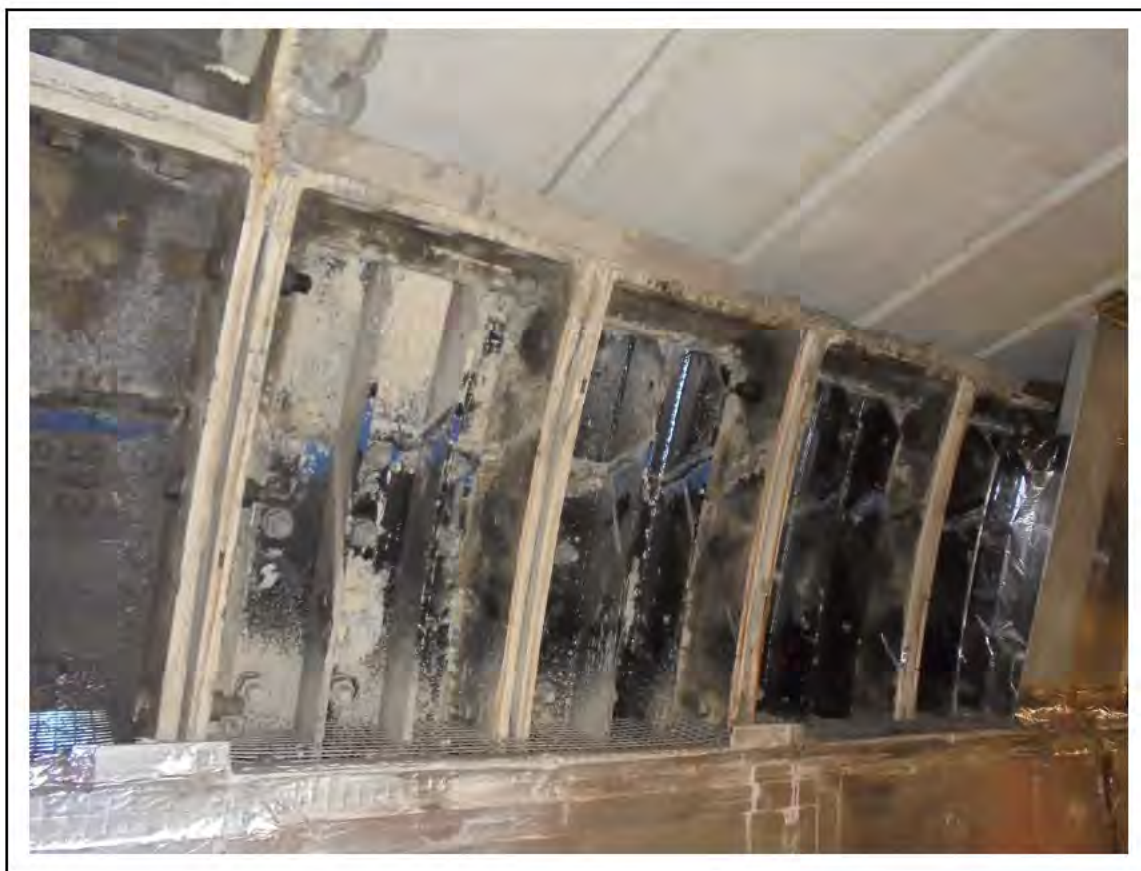
FIGURE 76: CONFIRMED ASBESTOS IN TUNNEL RING CAULKING IN PLATFORM 4, 6/262 - DESCRIPTION & RESULT OF ASSESSMENT (SAMPLE REF. 110103/150511/01 & 02)

- 8.83 Platform 4, 6/262
Tunnel ring caulking confirmed to contain Amosite & Chrysotile asbestos, Figure 76
- Material assessment rating: Medium
- 8.84 Platform 4, 6/262
Woven cable known to contain Chrysotile asbestos, Figure 77 - Material assessment rating: Very low

Sample Number	110103/150511/01 & 02
Location	Platform 4, 6/262
Material Description	Tunnel ring caulking
Material Comment	Throughout to tunnel wall/ring flanges along platform (previously sampled)
Quantity	Throughout to all tunnel ring joints present
Product Type	Highly friable
Current Condition	Slight damage
Surface Treatment	Untreated highly friable (partial encapsulation in sporadic areas)
Asbestos Type	Amosite & Chrysotile
Material Assessment Rating	Medium
Accessibility	Low
Further Comment	Not applicable

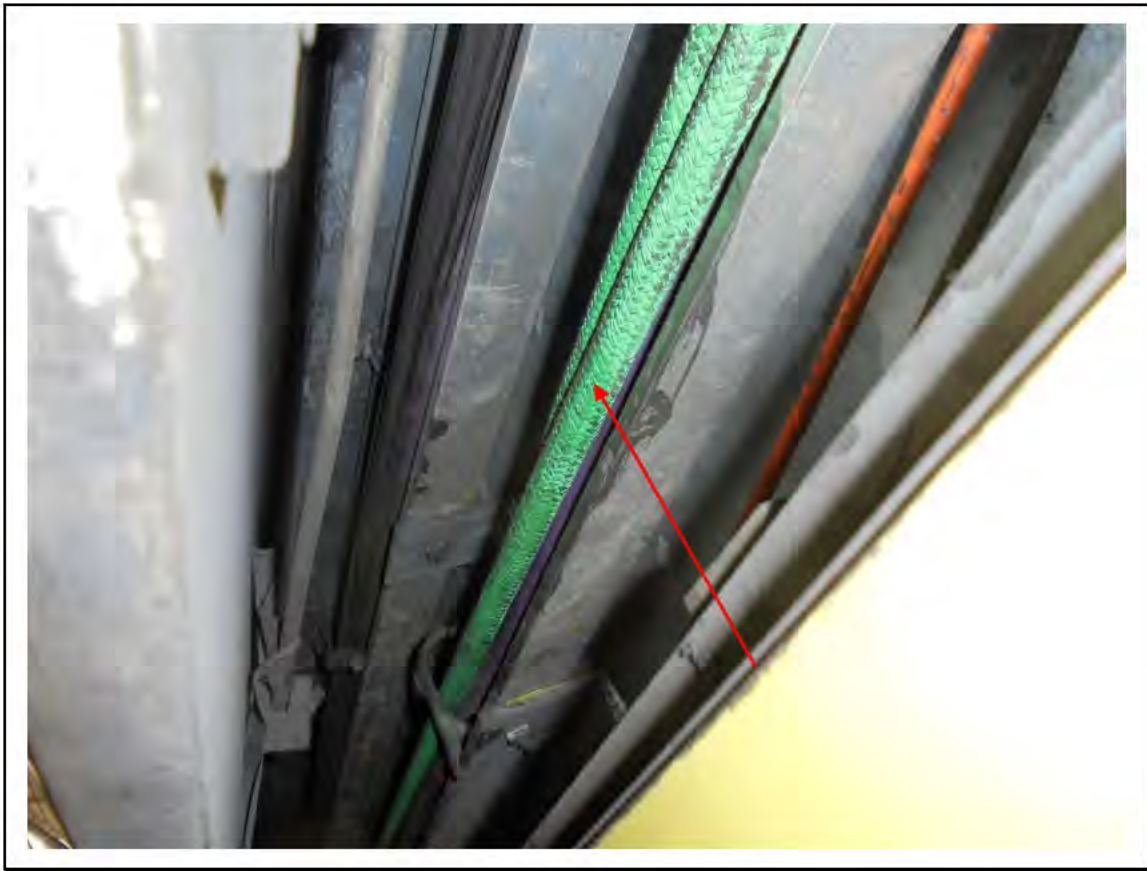
FIGURE 77: KNOWN ASBESTOS IN WOVEN CABLE IN PLATFORM 4, 6/262 - DESCRIPTION & RESULT OF ASSESSMENT (SAMPLE REF. K1 (9))

Sample Number	K1 (9)
Location	Platform 4, 6/262
Material Description	Woven cable
Material Comment	Within high level metal service panels to platform side wall - along platform
Quantity	~100m
Product Type	Medium density
Current Condition	Good condition
Surface Treatment	Encapsulated medium density
Asbestos Type	Known Chrysotile
Material Assessment Rating	Very low
Accessibility	Low
Further Comment	Not applicable

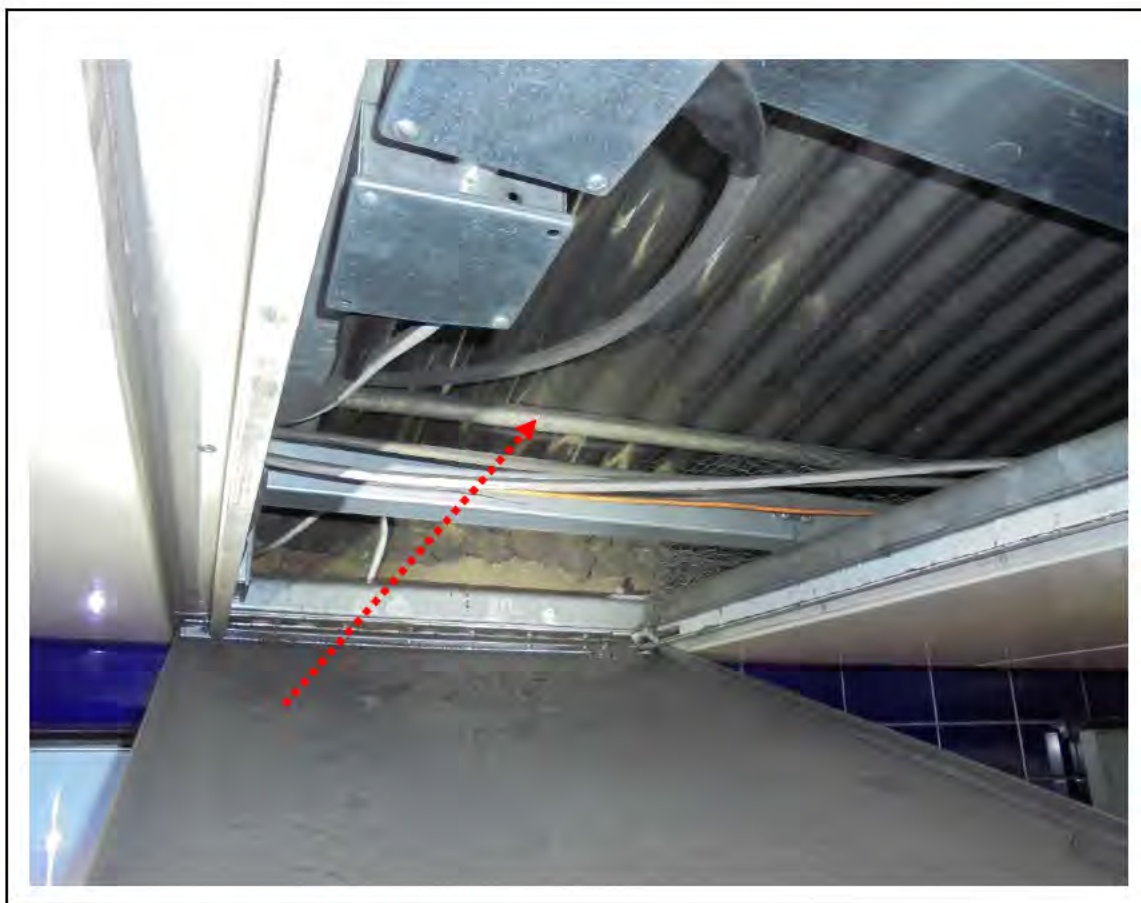
FIGURE 78: STRONGLY PRESUMED ASBESTOS IN CELLACTITE IN CIRC AREA AND PASSAGES, 6/081, 6/202 - 6/207 - DESCRIPTION & RESULT OF ASSESSMENT (SAMPLE REF. SP1 (10))

- 8.85 Circ Area and Passages, 6/081, 6/202 - 6/207
Cellactite strongly presumed to contain Chrysotile asbestos, Figure 78 - Material assessment rating: Very low

Sample Number	SP1 (10)
Location	Circ Area and Passages, 6/081, 6/202 - 6/207
Material Description	Cellactite
Material Comment	Above metal sheeting and/or within cavity walls
Quantity	Throughout/ partial
Product Type	Composite
Current Condition	Slight damage
Surface Treatment	Composite
Asbestos Type	Strongly Presumed Chrysotile
Material Assessment Rating	Very low
Accessibility	Low
Further Comment	Not applicable

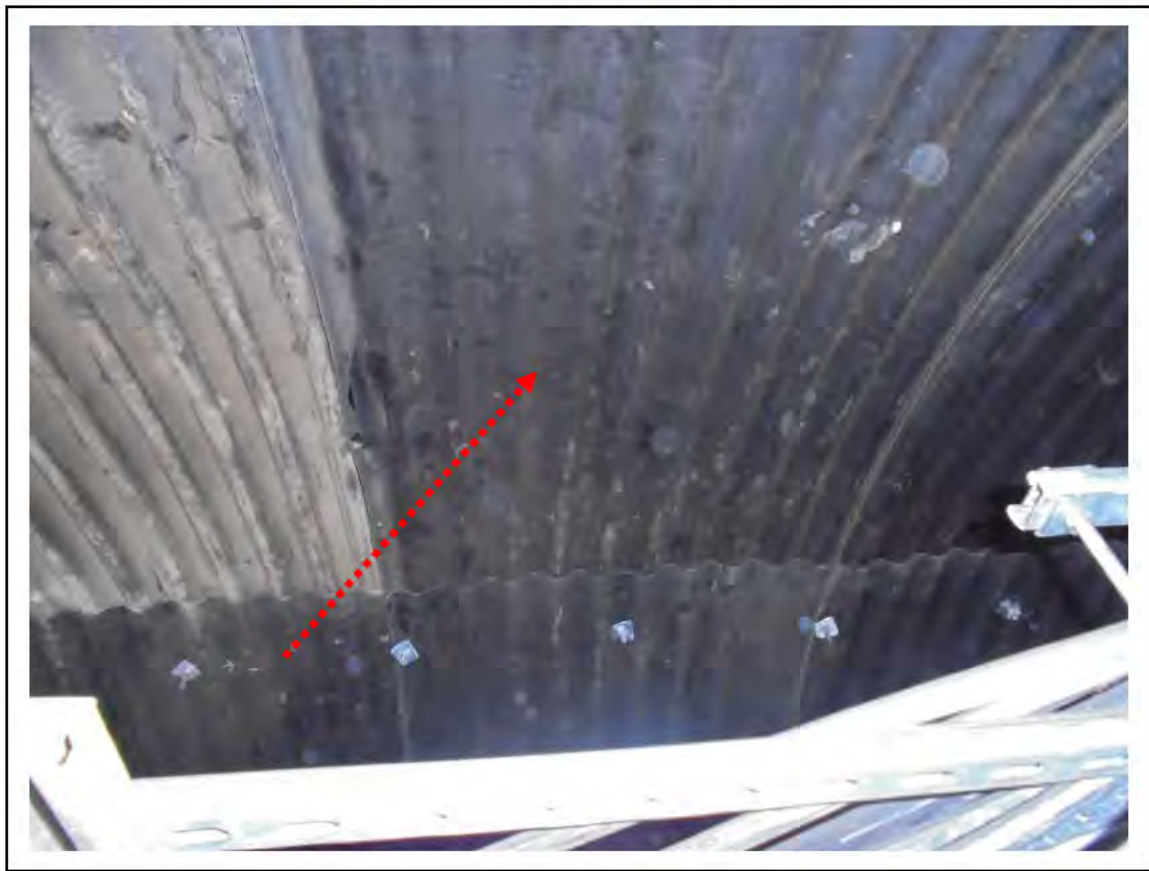
FIGURE 79: CONFIRMED ASBESTOS IN CELLACTITE SHEETING IN SWITCH ROOM, 5/661 - DESCRIPTION & RESULT OF ASSESSMENT (SAMPLE REF. ECS 85278)

- 8.89 Switch Room, 5/661
Cellactite sheeting confirmed to contain Chrysotile asbestos, Figure 79 - Material assessment rating: Very low
- 8.90 Relay Room, 5/712
Woven cable confirmed to contain Chrysotile asbestos, Figure 80 - Material assessment rating: Low

Sample Number	ECS 85278
Location	Switch Room, 5/661
Material Description	Cellactite sheeting
Material Comment	To ceiling within false ceiling throughout (previously sampled)
Quantity	15m ²
Product Type	Composite
Current Condition	Slight damage
Surface Treatment	Composite
Asbestos Type	Chrysotile
Material Assessment Rating	Very low
Accessibility	Low
Further Comment	Not applicable

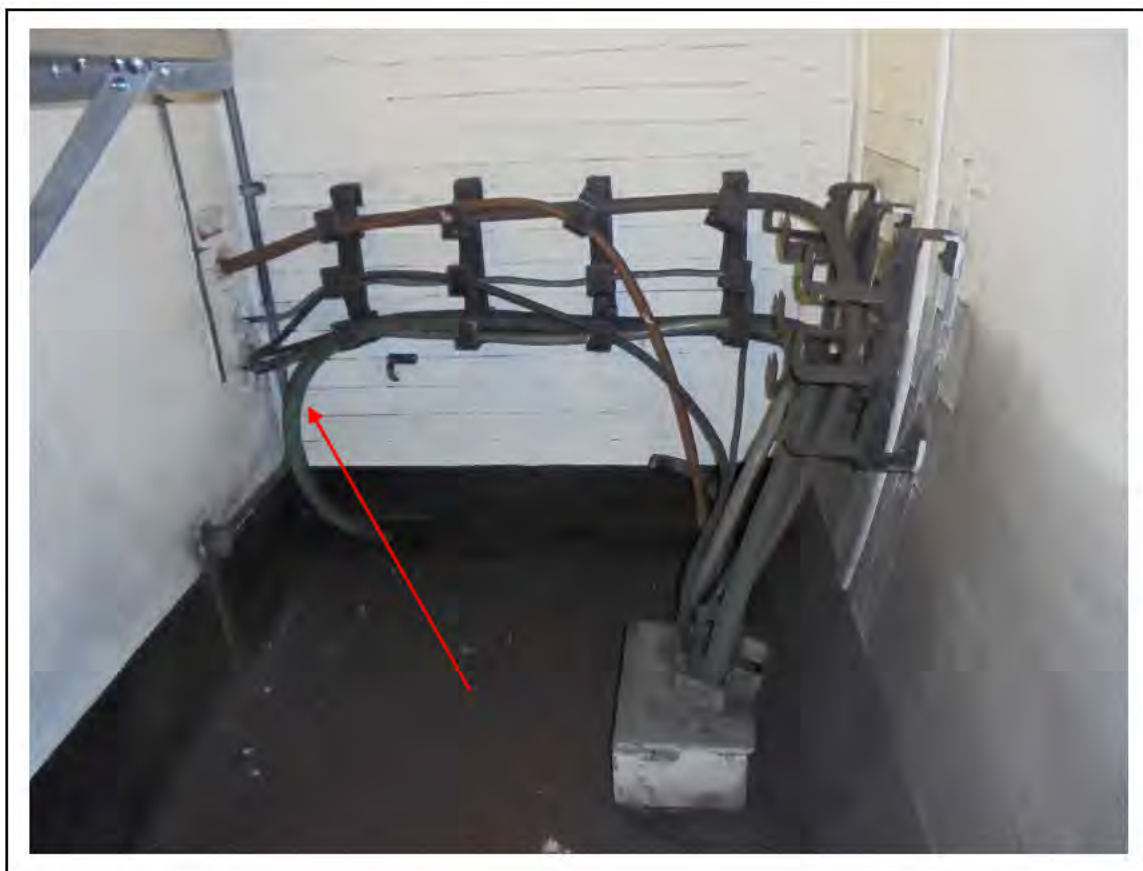
FIGURE 80: CONFIRMED ASBESTOS IN WOVEN CABLE IN RELAY ROOM, 5/712 - DESCRIPTION & RESULT OF ASSESSMENT (SAMPLE REF. ECS 85274)

Sample Number	ECS 85274
Location	Relay Room, 5/712
Material Description	Woven cable
Material Comment	To wall 1, to floor entering supalux boxing
Quantity	~3m
Product Type	Medium density
Current Condition	Slight damage
Surface Treatment	Unencapsulated medium density
Asbestos Type	Chrysotile
Material Assessment Rating	Low
Accessibility	Medium
Further Comment	Not applicable

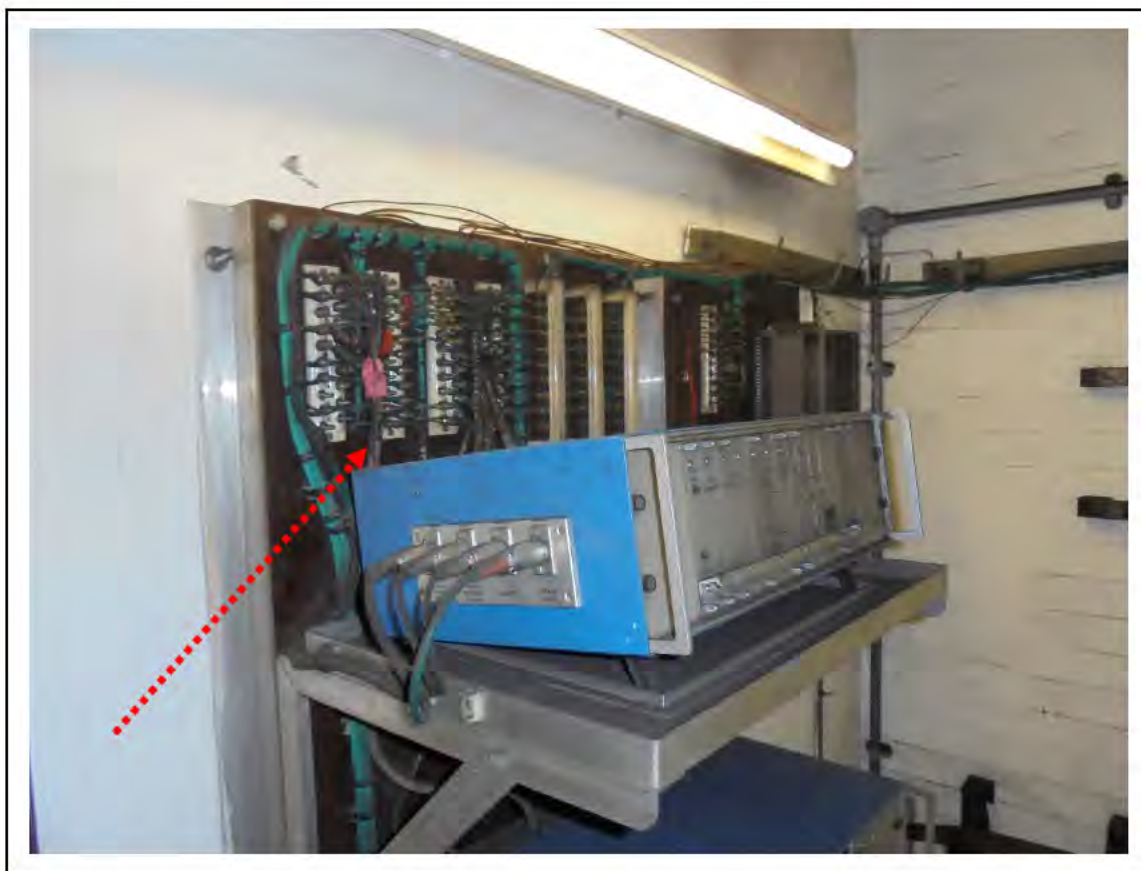
FIGURE 81: PRESUMED ASBESTOS IN BROWN COMPOSITE SILUMINITE BOARDS IN RELAY ROOM, 5/712 - DESCRIPTION & RESULT OF ASSESSMENT (SAMPLE REF. P1 (2))

- 8.91 Relay Room, 5/712
Brown composite siluminite boards presumed to contain Chrysotile asbestos, Figure 81 - Material assessment rating: Very low
- 8.92 Relay Room, 5/666
Black and brown composite panels presumed to contain Chrysotile asbestos, Figure 82 - Material assessment rating: Very low

Sample Number	P1 (2)
Location	Relay Room, 5/712
Material Description	Brown composite siluminite boards
Material Comment	To wall 4 by door to LHS no isolation for sample. Boards located to wall and below shelving units
Quantity	4 no x 1m ²
Product Type	Composite
Current Condition	Good condition
Surface Treatment	Composite
Asbestos Type	Presumed Chrysotile
Material Assessment Rating	Very low
Accessibility	Medium
Further Comment	Not applicable

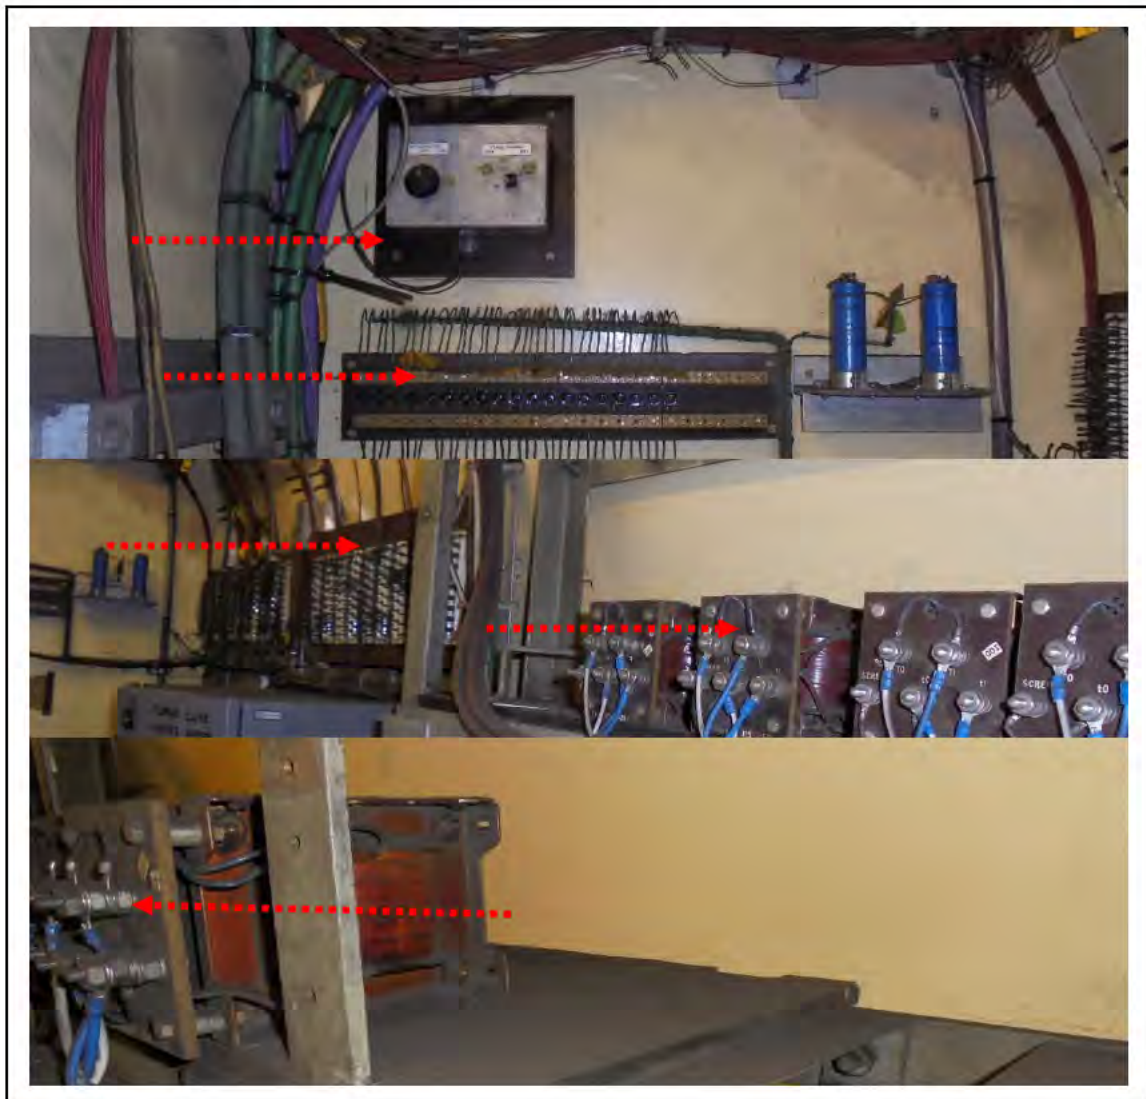
FIGURE 82: PRESUMED ASBESTOS IN BLACK AND BROWN COMPOSITE PANELS IN RELAY ROOM, 5/666 - DESCRIPTION & RESULT OF ASSESSMENT (SAMPLE REF. P1 (3))

Sample Number	P1 (3)
Location	Relay Room, 5/666
Material Description	Black and brown composite panels
Material Comment	To wall 2 and 1 at high level, no isolation for sample
Quantity	~8 no <0.5m ²
Product Type	Composite
Current Condition	Slight damage
Surface Treatment	Composite
Asbestos Type	Presumed Chrysotile
Material Assessment Rating	Very low
Accessibility	Medium
Further Comment	Not applicable

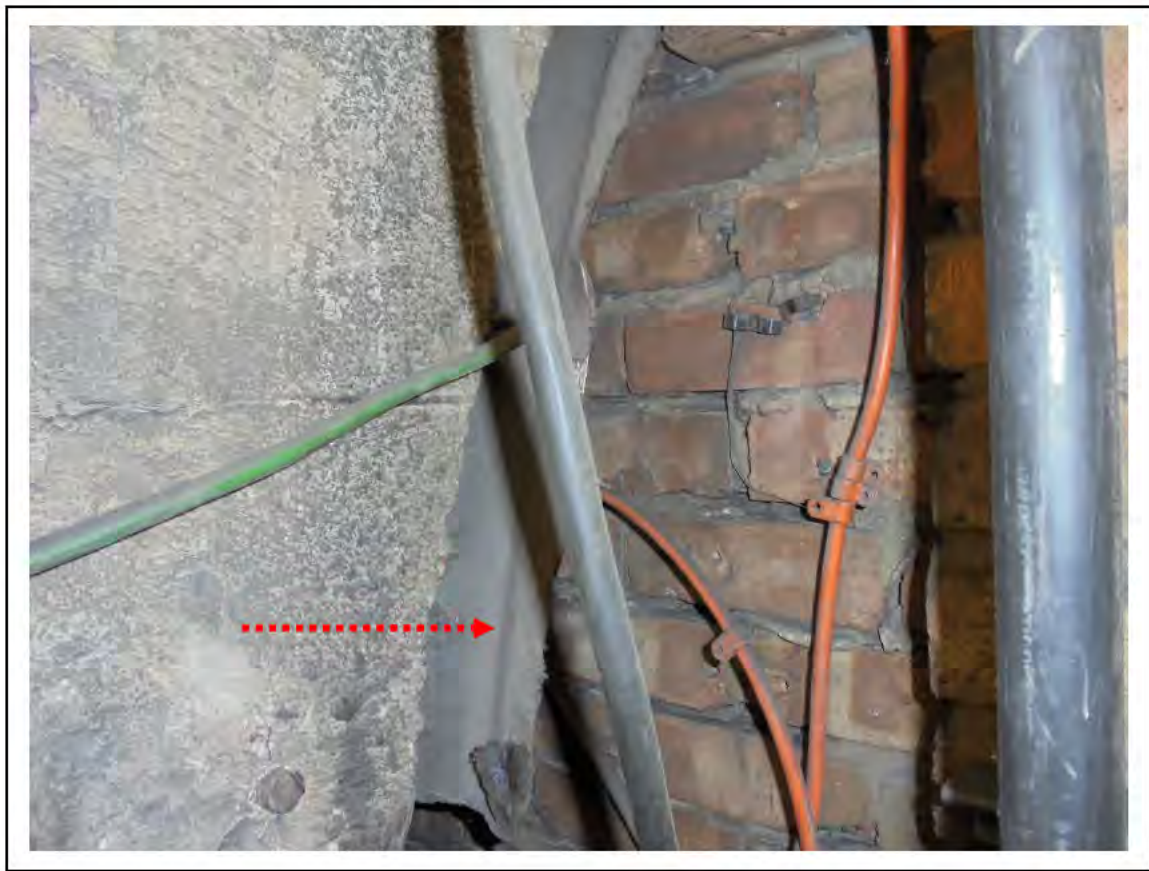
FIGURE 83: CONFIRMED ASBESTOS IN CELLACTITE SHEETING IN BOSTWICK GATE CHAMBER, 4/765 - DESCRIPTION & RESULT OF ASSESSMENT (SAMPLE REF. 161057/011216/01)

- 8.93 Relay Room, 5/666, CER, 5/731
No isolation to electricals throughout.
- 8.94 CER, 5/731
No access to floor cable/ service hatches.
- 8.95 Bostwick Gate Chamber, 4/765
Cellactite sheeting confirmed to contain Chrysotile asbestos, Figure 83 - Material assessment rating: Very low

Sample Number	161057/011216/01
Location	Bostwick Gate Chamber, 4/765
Material Description	Cellactite sheeting
Material Comment	Within cavity wall (corner of walls 2/3) and possibly above metal sheeting within cavity wall, wall 1 and ceiling above metal sheeting
Quantity	~12m ²
Product Type	Composite
Current Condition	Slight damage
Surface Treatment	Composite
Asbestos Type	Chrysotile
Material Assessment Rating	Very low
Accessibility	Low
Further Comment	Not applicable

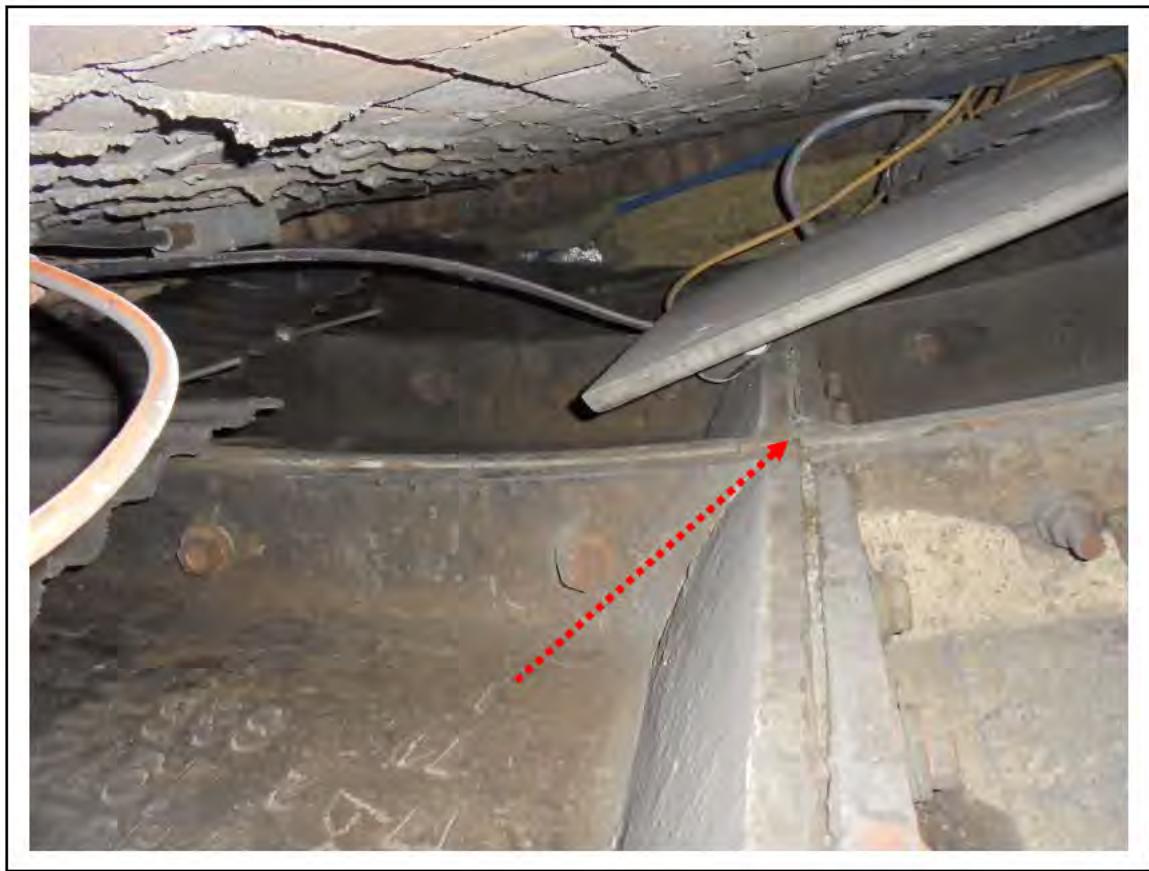
FIGURE 84: CONFIRMED ASBESTOS IN CAULKING IN BOSTWICK GATE CHAMBER, 4/765 - DESCRIPTION & RESULT OF ASSESSMENT (SAMPLE REF. SP1 & 2 (2))

Sample Number	SP1 & 2 (2)
Location	Bostwick Gate Chamber, 4/765
Material Description	Caulking
Material Comment	To tunnel ring flanges
Quantity	Throughout to all tunnel ring joints present
Product Type	Highly friable
Current Condition	Slight damage
Surface Treatment	Untreated highly friable
Asbestos Type	Amosite & Chrysotile
Material Assessment Rating	Medium
Accessibility	Medium
Further Comment	Not applicable

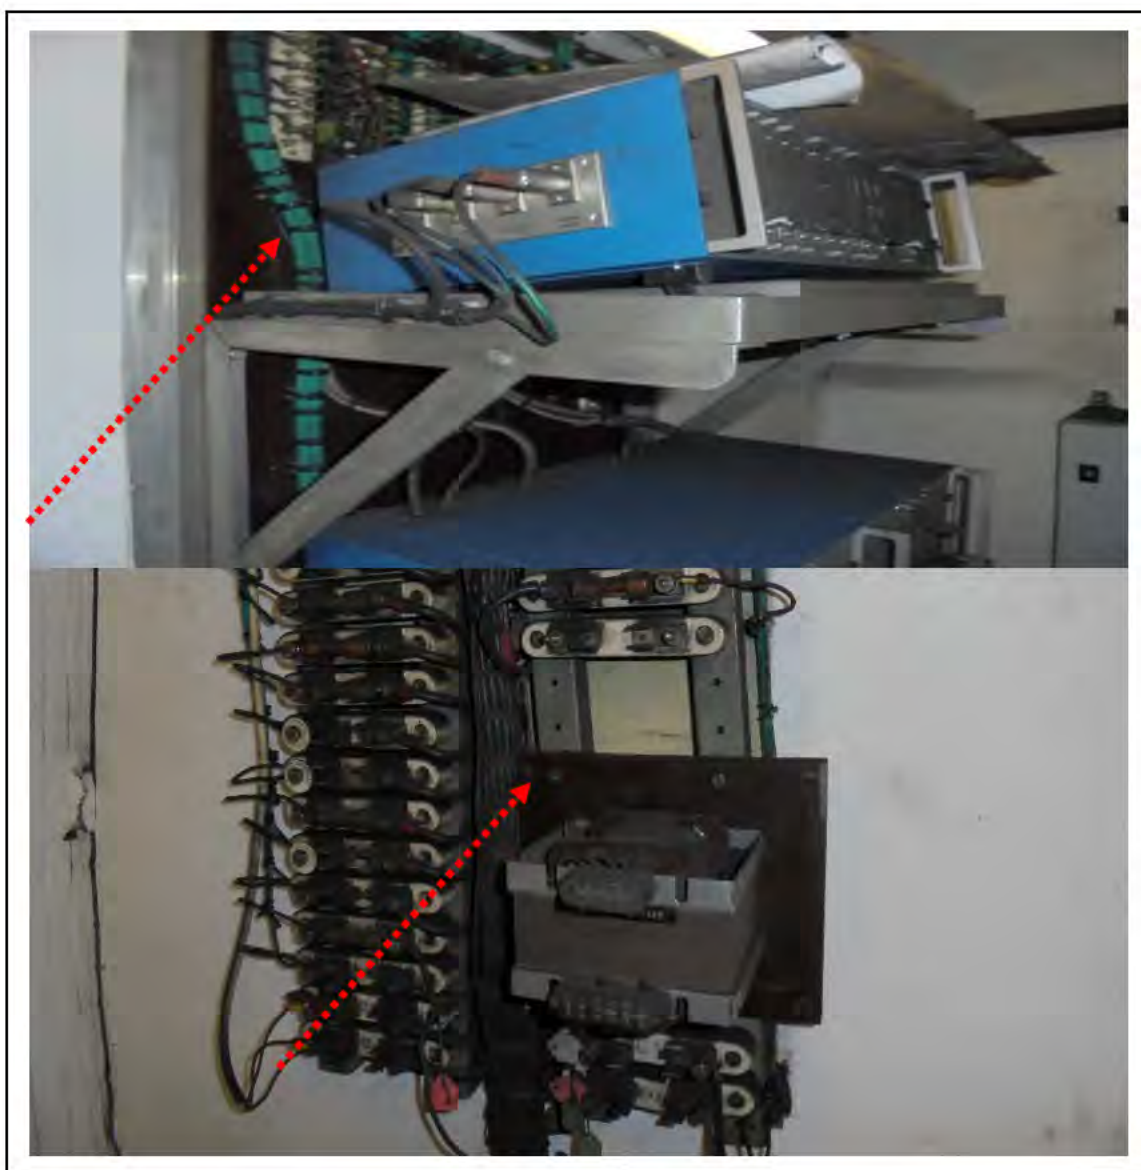
FIGURE 85: STRONGLY PRESUMED ASBESTOS IN SILUMINITE PANELS IN RELAY ROOM, 5/714 - DESCRIPTION & RESULT OF ASSESSMENT (SAMPLE REF. SP1 (11))

Sample Number	SP1 (11)
Location	Relay Room, 5/714
Material Description	Siluminite panels
Material Comment	To electrical equipment to wall 4 and 1 no to wall 3. Backing boards and below shelf units
Quantity	5 no x <1m ²
Product Type	Composite
Current Condition	Good condition
Surface Treatment	Composite
Asbestos Type	Strongly Presumed Chrysotile
Material Assessment Rating	Very low
Accessibility	Medium
Further Comment	Not applicable

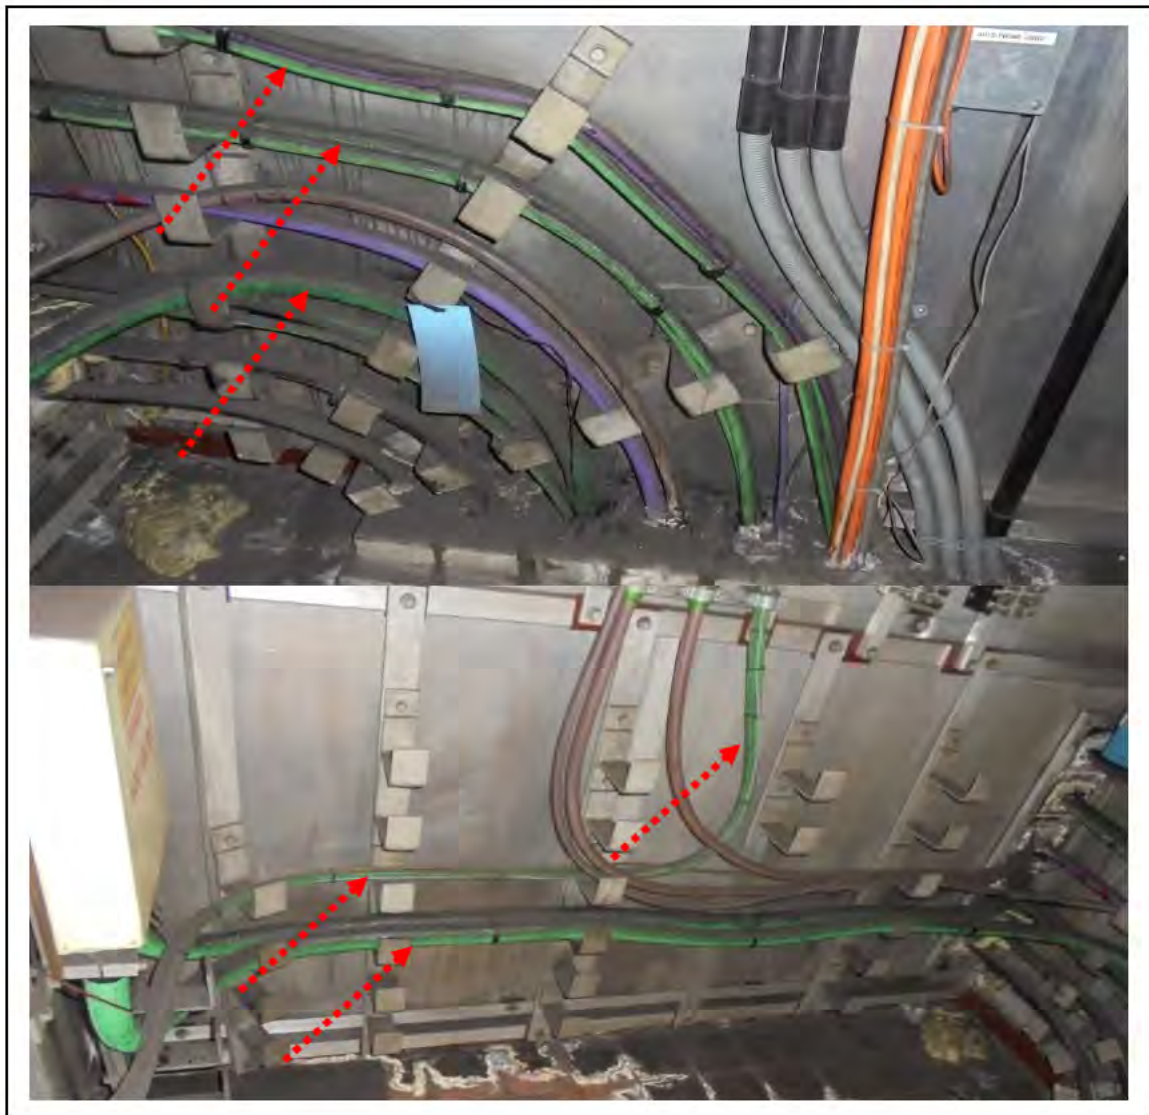
FIGURE 86: KNOWN ASBESTOS IN WOVEN CABLE INSULATION IN CER, 6/712 - DESCRIPTION & RESULT OF ASSESSMENT (SAMPLE REF. K1 (10A))

Sample Number	K1 (10a)
Location	CER, 6/712
Material Description	Woven cable insulation
Material Comment	2 no x 10mm diameter cable, 3 no x 10mm diameter cable, 1 no x 10mm diameter cable, 4 no x 20mm diameter cable
Quantity	10 no
Product Type	Medium density
Current Condition	Good condition
Surface Treatment	Encapsulated medium density
Asbestos Type	Known Chrysotile
Material Assessment Rating	Very low
Accessibility	Low
Further Comment	Not applicable
