Report No. 4RS-JP-161057-R524751

**MANAGEMENT ASBESTOS SURVEY
BOND STREET UNDERGROUND STATION**

Issue Date: 3rd January 2017

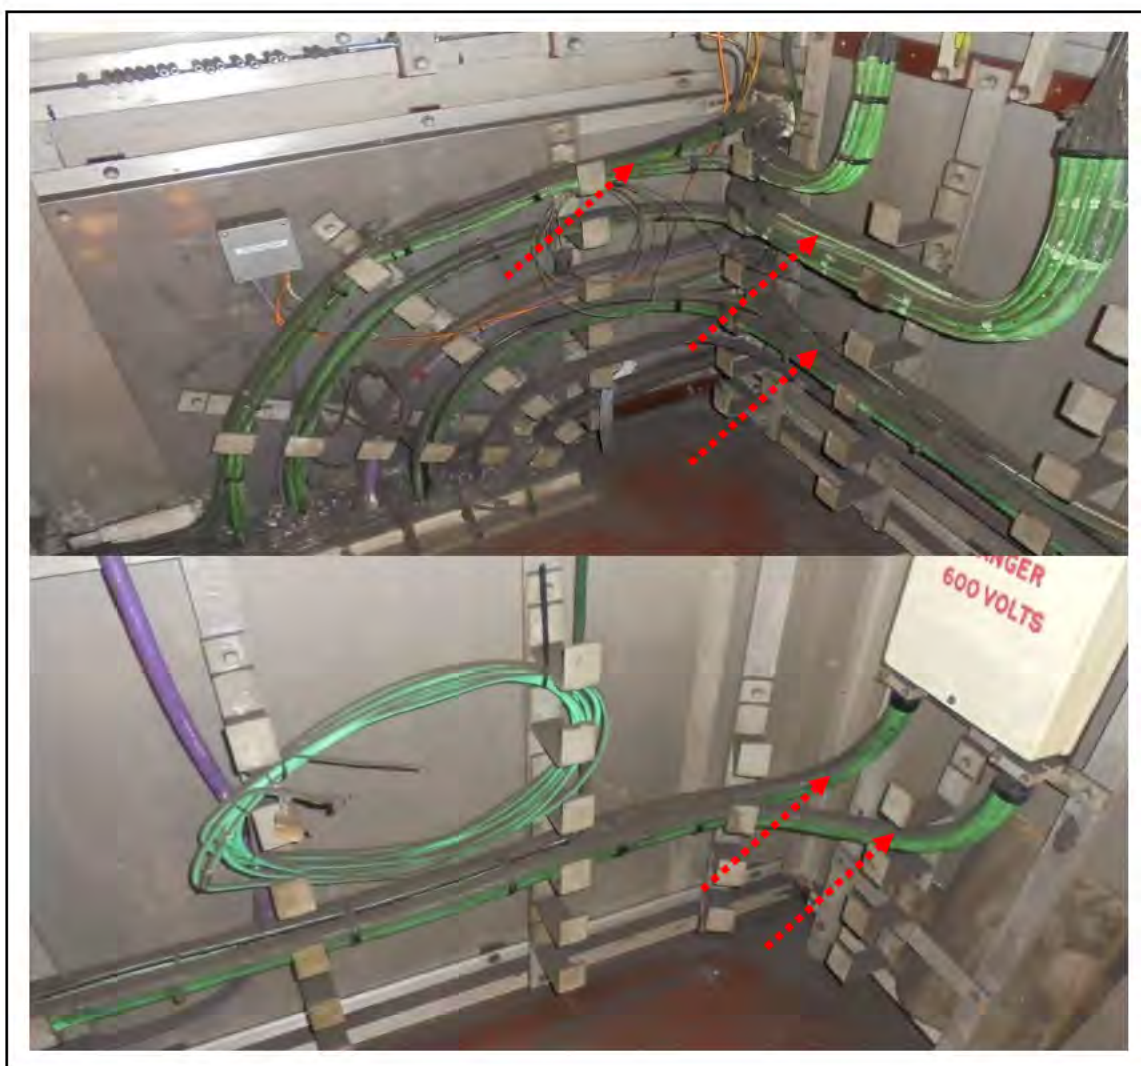
FIGURE 87: KNOWN ASBESTOS IN WOVEN CABLE INSULATION IN RELAY ROOM, 6/715 - DESCRIPTION & RESULT OF ASSESSMENT (SAMPLE REF. K1 (11))

Sample Number	K1 (11)
Location	Relay Room, 6/715
Material Description	Woven cable insulation
Material Comment	To walls 1, 2 and 3 at low level. 3 no x 10mm diameter cable, 2 no x 40mm diameter cable, 5 no x 15mm diameter cable, 25 no x 10mm diameter cable, 2 no x 10mm diameter cable, 1 no x 10mm diameter cable (white), 2 no x 20mm diameter cable
Quantity	37no
Product Type	Medium density
Current Condition	Good condition
Surface Treatment	Encapsulated medium density
Asbestos Type	Known Chrysotile
Material Assessment Rating	Very low
Accessibility	Medium
Further Comment	Not applicable

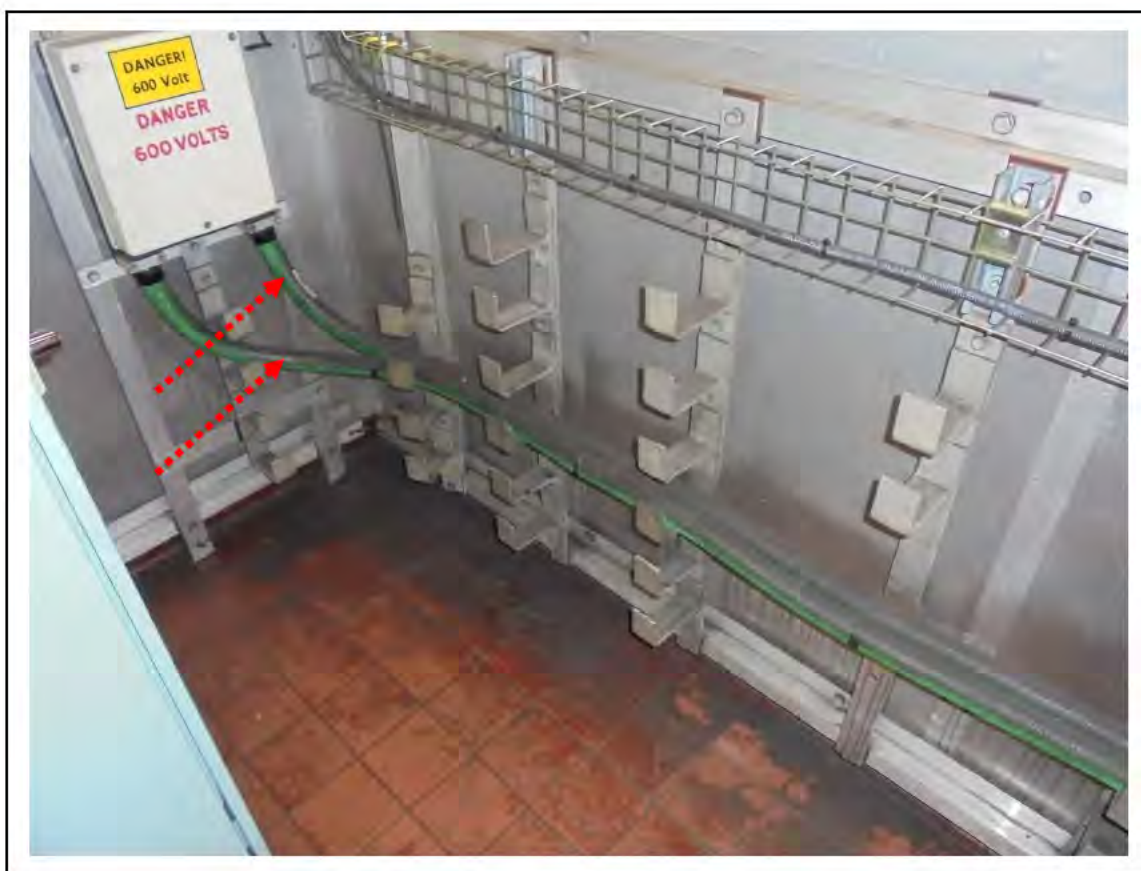
FIGURE 88: KNOWN ASBESTOS IN WOVEN CABLE INSULATION IN CER, 6/714 - DESCRIPTION & RESULT OF ASSESSMENT (SAMPLE REF. K1 (12))

Sample Number	K1 (12)
Location	CER, 6/714
Material Description	Woven cable insulation
Material Comment	2 no x 40mm diameter cable, 9 no x 10mm diameter cable, 2 no x 20mm diameter cable, 2 no x 15mm diameter cable to low level , walls 1, 2 & 3
Quantity	15 no
Product Type	Medium density
Current Condition	Good condition
Surface Treatment	Encapsulated medium density
Asbestos Type	Known Chrysotile
Material Assessment Rating	Very low
Accessibility	Low
Further Comment	Not applicable

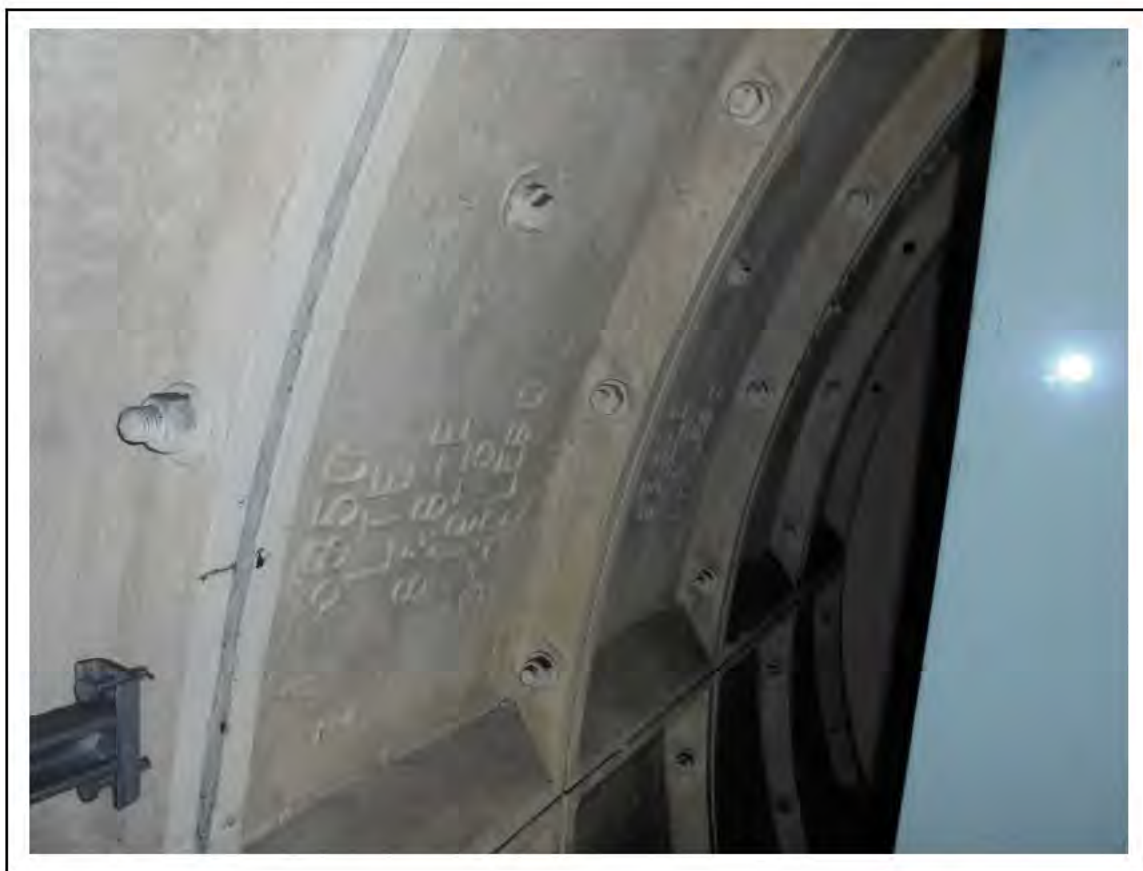
FIGURE 89: CONFIRMED ASBESTOS IN CAULKING IN SWITCH CUPBOARD E10, 6/663 - DESCRIPTION & RESULT OF ASSESSMENT (SAMPLE REF. ECS 85356)

Sample Number	ECS 85356
Location	Switch Cupboard E10, 6/663
Material Description	Caulking
Material Comment	To tunnel ring flanges/ joints throughout to walls/ ceiling
Quantity	Throughout to all tunnel ring joints present
Product Type	Highly friable
Current Condition	Slight damage
Surface Treatment	Untreated highly friable
Asbestos Type	Amosite & Chrysotile
Material Assessment Rating	Medium
Accessibility	Low
Further Comment	Not applicable

ECS 85356	Switch Cupboard E10	6/663	Caulking	Throughout	3	1	3	1	1&2	To tunnel ring flanges/ joints throughout to walls/ ceiling	Figure 89
	Switch Cupboard E10	6/663	Timber door and framework	-	-	-	-	-	-	Throughout	-
	Switch Cupboard E10	6/663	New lighting	-	-	-	-	-	-	Throughout	-
	Switch Cupboard E10	6/663	MMMf insulation firestop and mastic - new	-	-	-	-	-	-	Throughout	-

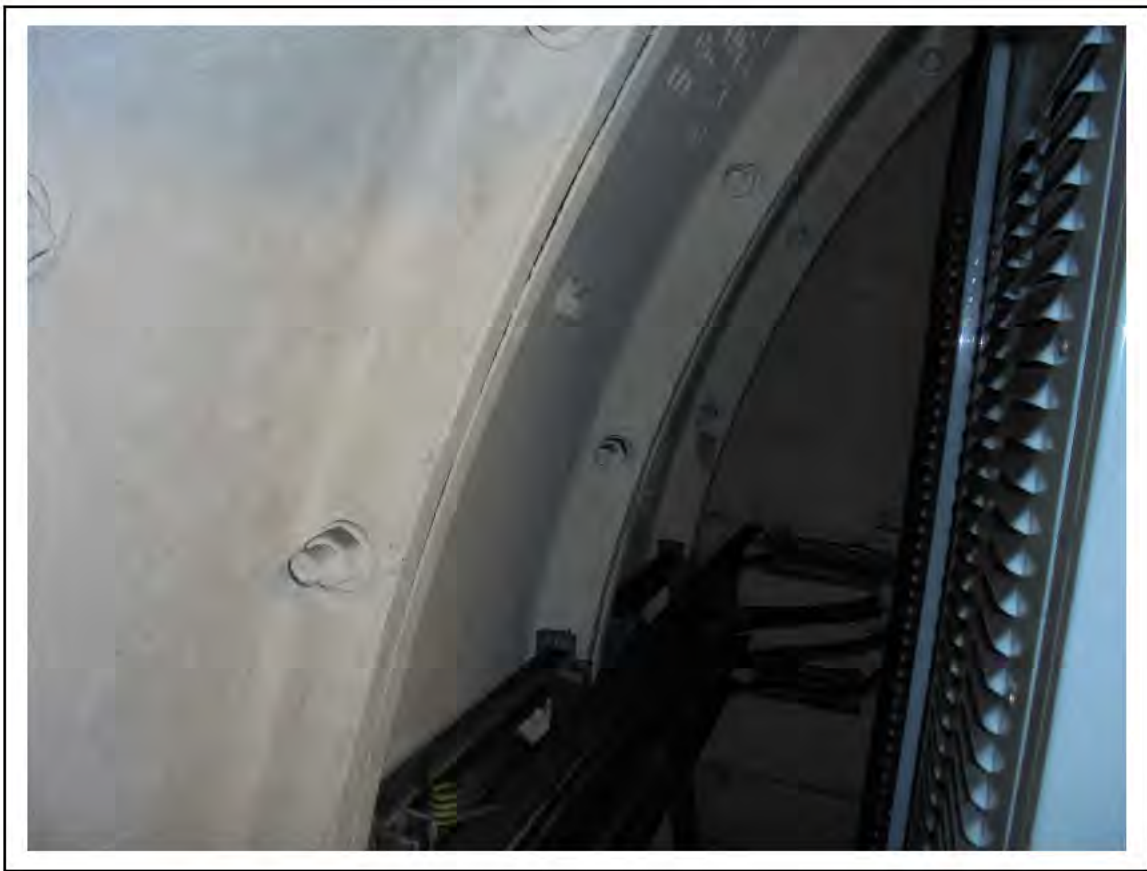
FIGURE 90: CONFIRMED ASBESTOS IN CAULKING IN SWITCH CUPBOARD E9, 6/662 - DESCRIPTION & RESULT OF ASSESSMENT (SAMPLE REF. ECS 85356)

Sample Number	ECS 85356
Location	Switch Cupboard E9, 6/662
Material Description	Caulking
Material Comment	To tunnel ring flanges/ joints throughout to walls/ ceiling
Quantity	Throughout to all tunnel ring joints present
Product Type	Highly friable
Current Condition	Slight damage
Surface Treatment	Untreated highly friable
Asbestos Type	Amosite & Chrysotile
Material Assessment Rating	Medium
Accessibility	Low
Further Comment	Not applicable

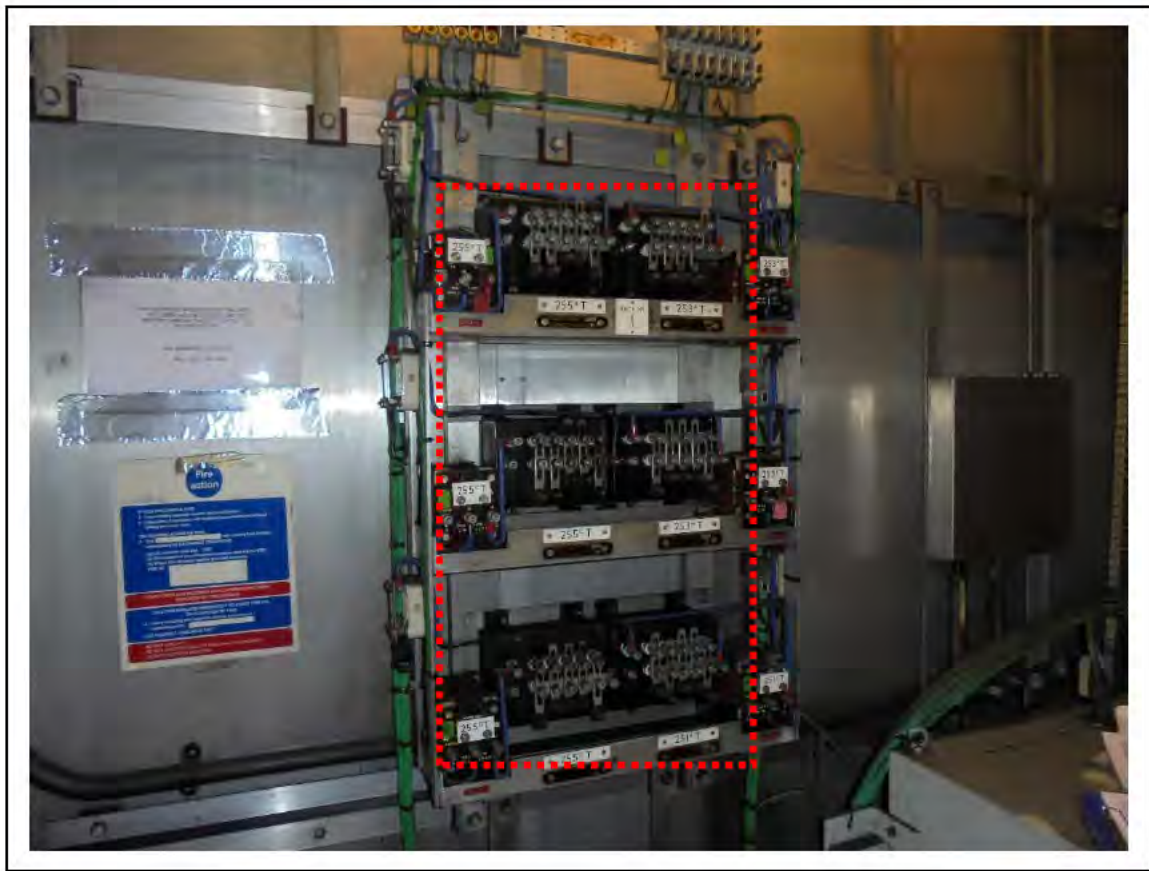
Old siluminite backing panels strongly presumed to contain Chrysotile asbestos, Figure 91 - Material assessment rating: Very low

FIGURE 91: STRONGLY PRESUMED ASBESTOS IN OLD SILUMINITE BACKING PANELS IN RELAY ROOM, 6/711 - DESCRIPTION & RESULT OF ASSESSMENT (SAMPLE REF. SP1 (12))

Sample Number	SP1 (12)
Location	Relay Room, 6/711
Material Description	Old siluminite backing panels
Material Comment	Throughout to live electrical track circuit equipment, to wall 1
Quantity	Throughout
Product Type	Composite
Current Condition	Good condition
Surface Treatment	Composite
Asbestos Type	Strongly Presumed Chrysotile
Material Assessment Rating	Very low
Accessibility	Medium
Further Comment	Not applicable

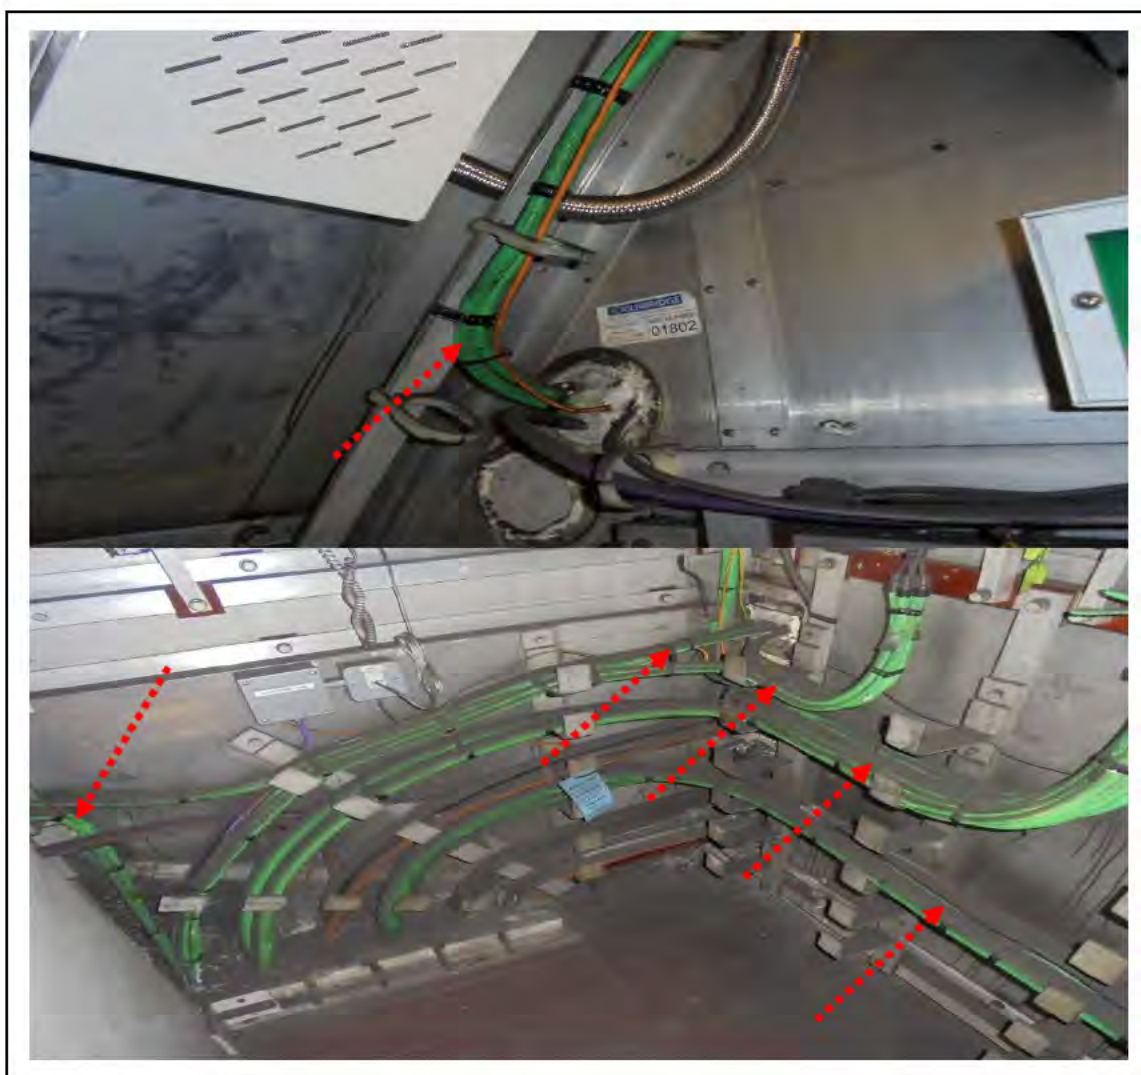
Woven cable insulation known to contain Chrysotile asbestos, Figure 92 - Material assessment rating: Very low

FIGURE 92: KNOWN ASBESTOS IN WOVEN CABLE INSULATION IN RELAY ROOM, 6/711 - DESCRIPTION & RESULT OF ASSESSMENT (SAMPLE REF. K1 (13))

Sample Number	K1 (13)
Location	Relay Room, 6/711
Material Description	Woven cable insulation
Material Comment	2 no x 40mm diameter cable, 1 no x 15mm diameter cable, 25 no x 10mm diameter cable, 2 no x 20mm diameter cable, 2 no x 10mm diameter cable running to platform via wall 4, high level
Quantity	32 no
Product Type	Medium density
Current Condition	Good condition
Surface Treatment	Encapsulated medium density
Asbestos Type	Known Chrysotile
Material Assessment Rating	Very low
Accessibility	Medium
Further Comment	Not applicable

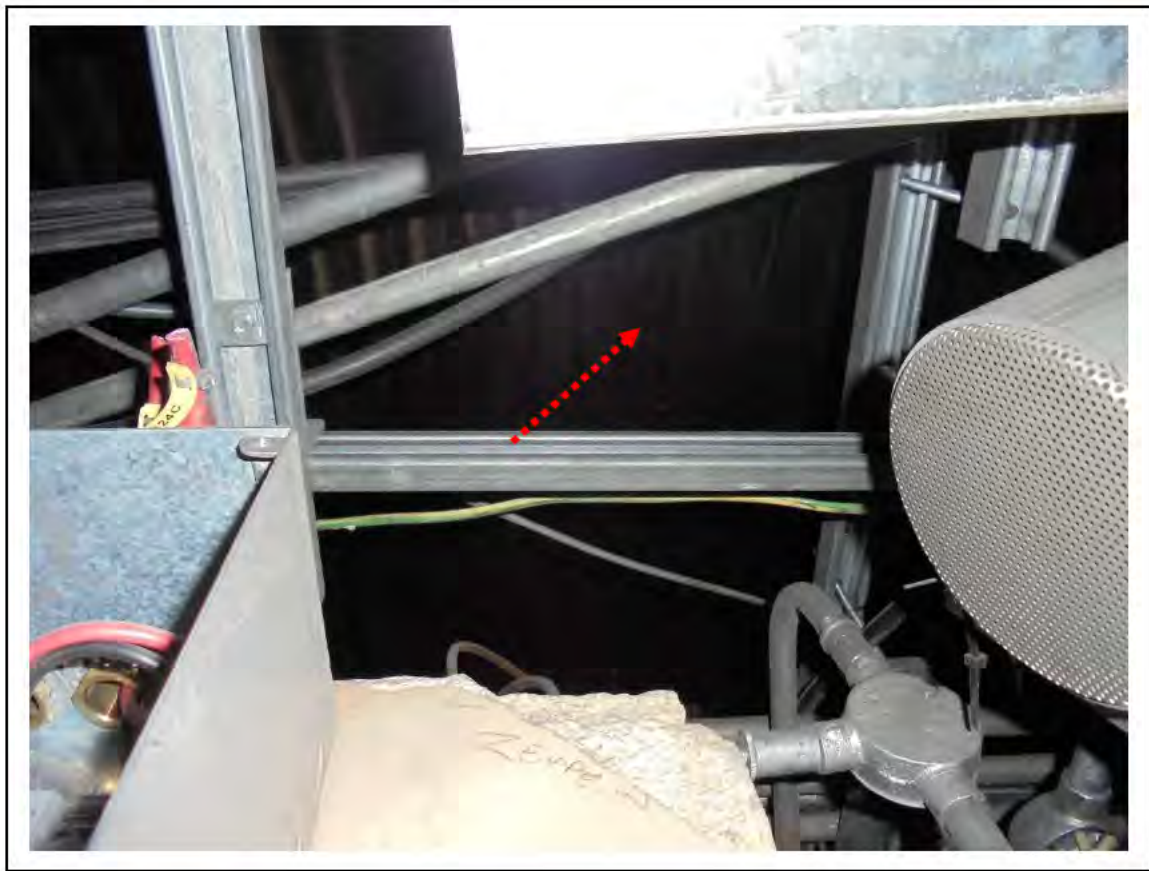
Cellactite known to contain Chrysotile asbestos, Figure 93 - Material assessment rating: Very low

FIGURE 93: KNOWN ASBESTOS IN CELLACTITE IN CER, 6/661 - DESCRIPTION & RESULT OF ASSESSMENT (SAMPLE REF. K1 (14))

Sample Number	K1 (14)
Location	CER, 6/661
Material Description	Cellactite
Material Comment	Throughout to ceiling above false ceiling
Quantity	~12m ²
Product Type	Composite
Current Condition	Slight damage
Surface Treatment	Composite
Asbestos Type	Known Chrysotile
Material Assessment Rating	Very low
Accessibility	Low
Further Comment	Not applicable

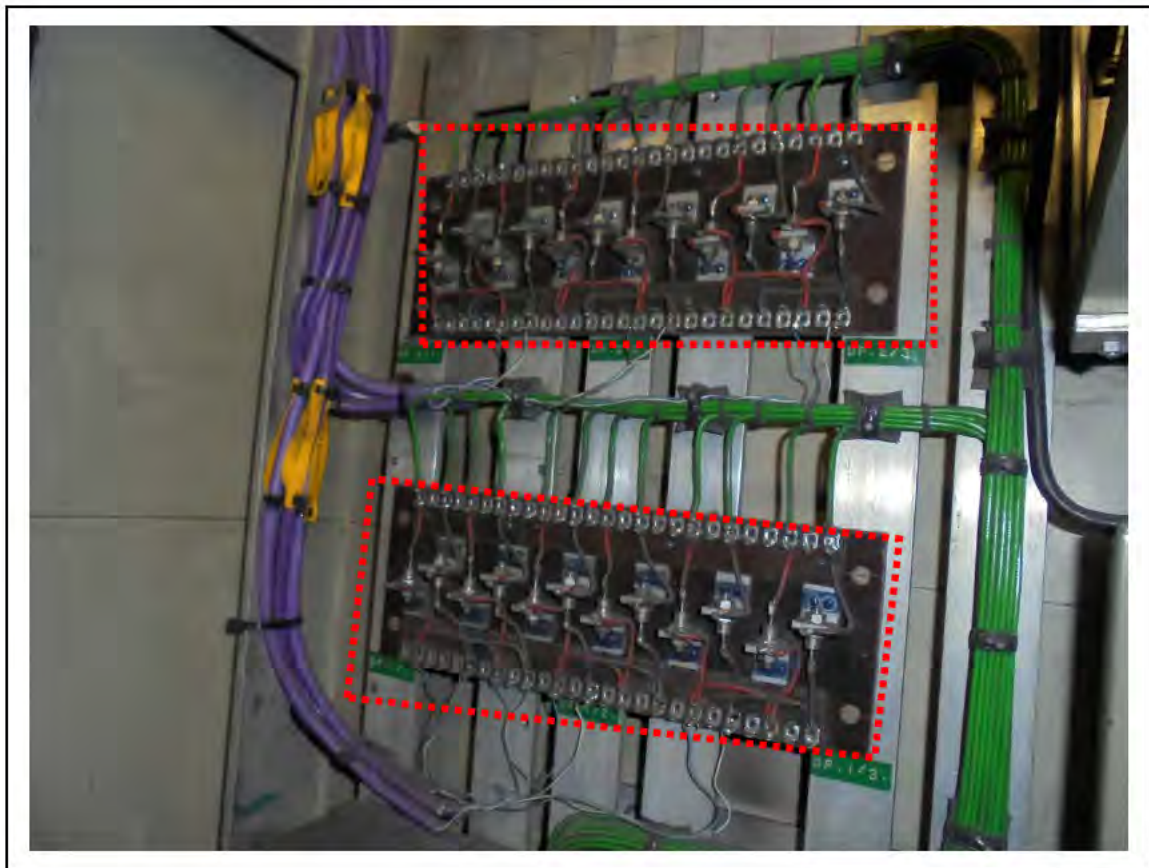
Brown composite backing boards strongly presumed to contain Chrysotile asbestos, Figure 94 - Material assessment rating: Very low

FIGURE 94: STRONGLY PRESUMED ASBESTOS IN BROWN COMPOSITE BACKING BOARDS IN CER, 6/661 - DESCRIPTION & RESULT OF ASSESSMENT (SAMPLE REF. SP1 (13))

Sample Number	SP1 (13)
Location	CER, 6/661
Material Description	Brown composite backing boards
Material Comment	To wall 4, electrical / relay equipment
Quantity	2 no
Product Type	Composite
Current Condition	Good condition
Surface Treatment	Composite
Asbestos Type	Strongly Presumed Chrysotile
Material Assessment Rating	Very low
Accessibility	Low
Further Comment	Not applicable

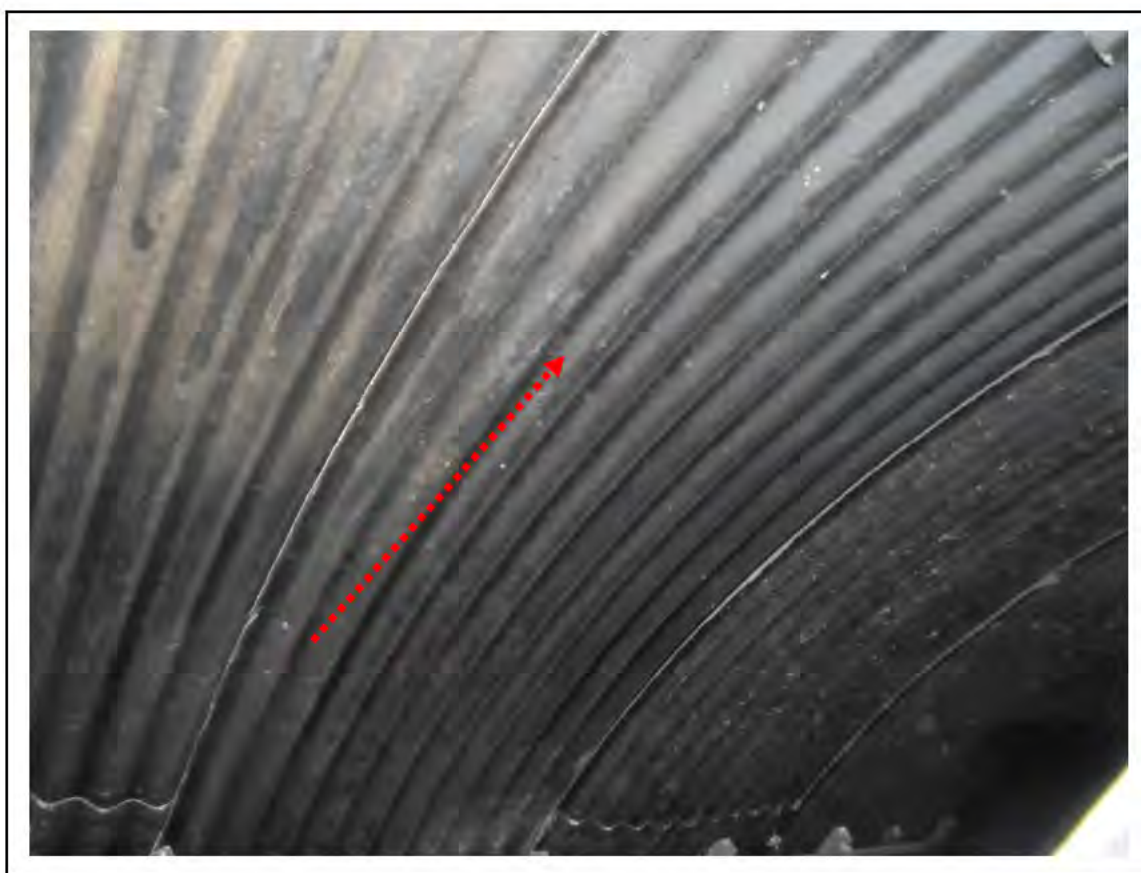
Cellactite sheeting known to contain Chrysotile asbestos, Figure 95 - Material assessment rating: Very low

FIGURE 95: KNOWN ASBESTOS IN CELLACTITE SHEETING IN SWITCH ROOM E5, 6/665 - DESCRIPTION & RESULT OF ASSESSMENT (SAMPLE REF. K1 (15))

Sample Number	K1 (15)
Location	Switch Room E5, 6/665
Material Description	Cellactite sheeting
Material Comment	To ceiling above false ceiling throughout
Quantity	40m ²
Product Type	Composite
Current Condition	Slight damage
Surface Treatment	Composite
Asbestos Type	Known Chrysotile
Material Assessment Rating	Very low
Accessibility	Low
Further Comment	Not applicable
