From: Kelly Darren
Sent: 02 June 2020 11:54
To: Storer Richard
Cc: Forrest Jim; Venn Daniel
Subject: Kempton Court CCTV Survey
Attachments: PJ00366135_Socotec UK Limited_51 Durward Street_New Install (1).pdf; drainage sketch - mark up.pdf

Project Name: PJ00366135_Socotec UK Limited_51 Durvward Street_New Install

Project Description: CCTV survey - New Installation

This report is issued as part of C512-BBM-A-ITP-D061_WS106-50227, inspection number 5.9, showing conditions of the existing drainage within BBMV construction site boundaries in Kempton Court private car park on the completion.

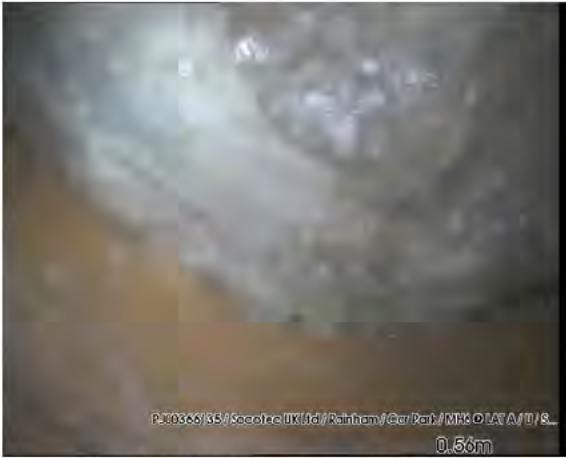
200317_1202G-Survey.jpg, 00:00:18, 0.56 m
Finish node type, other special chamber, reference number:
LAT A, REDUNDANT OR CAPPED

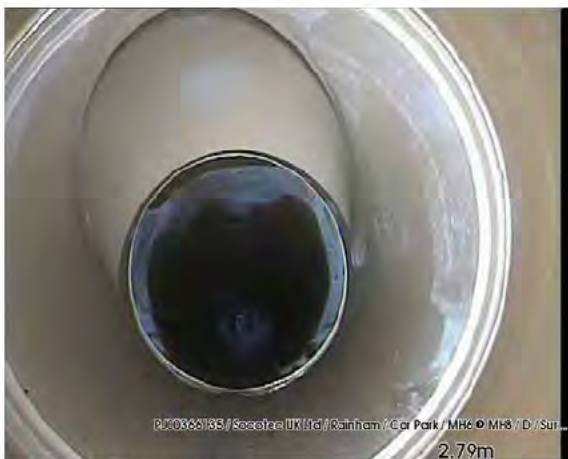
200317_1232B-Survey.jpg, 00:00:11, 2.79 m
Junction, at 11 o'clock, diameter: 150 mm

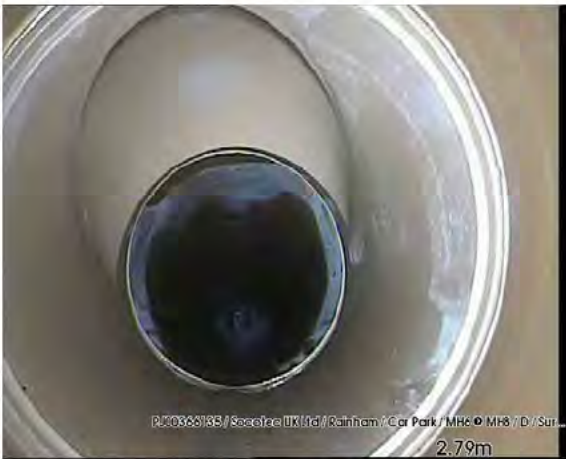
200317_1232B-Survey.jpg, 00:00:11, 2.79 m
 Junction, at 11 o'clock, diameter: 150 mm

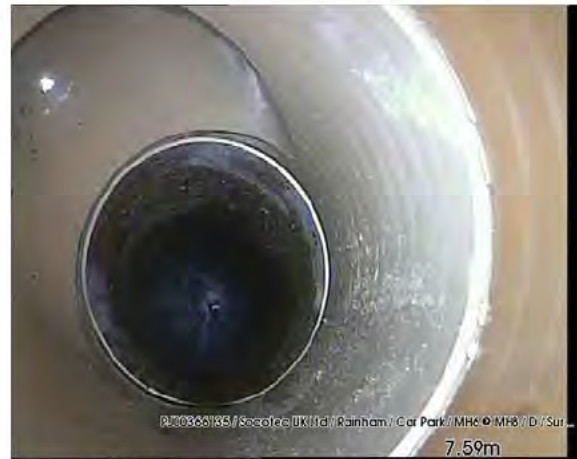
200317_1232C-Survey.jpg, 00:00:25, 7.59 m
 Junction, at 10 o'clock, diameter: 150 mm

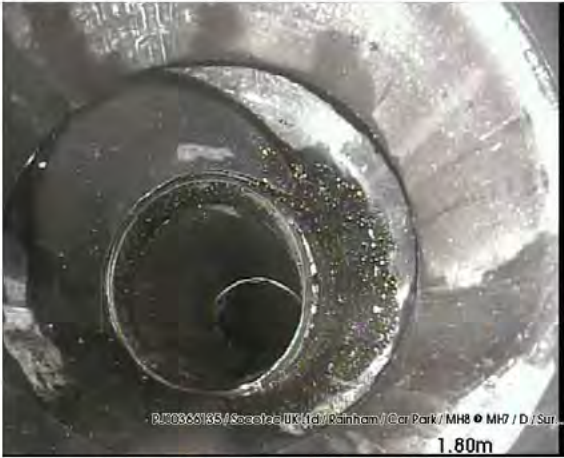
200317_1336D-Survey.jpg, 00:00:25, 1.80 m
 Junction, at 10 o'clock, diameter: 150 mm

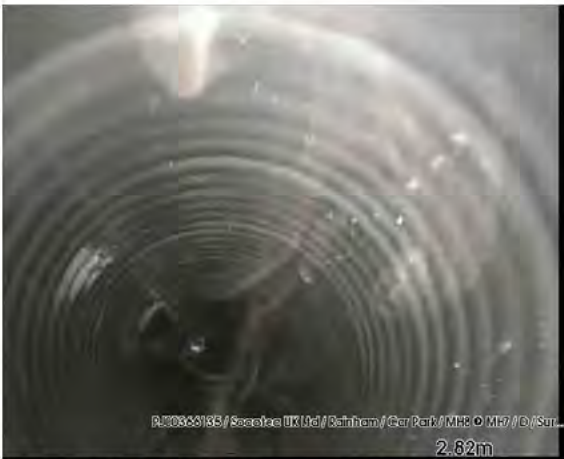
200317_1337B-Survey.jpg, 00:00:34, 2.86 m
 Line deviates down

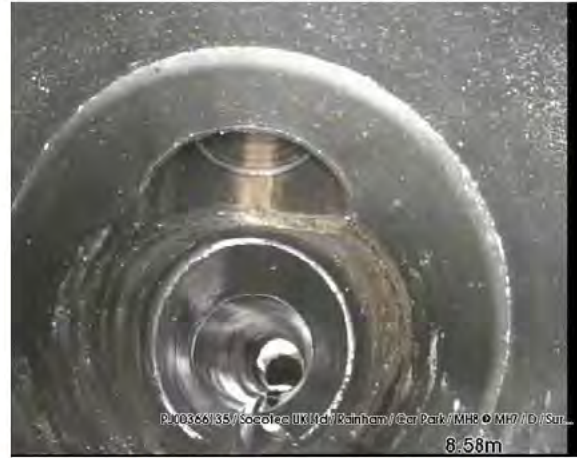
200317_1338A-Survey.jpg, 00:00:54, 8.58 m
 Junction, at 12 o'clock, diameter: 100 mm

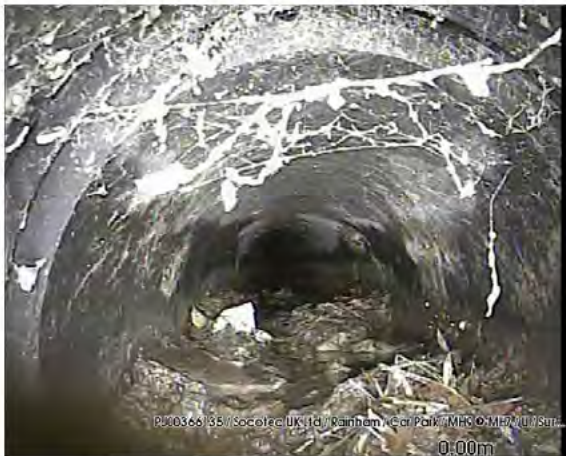
Section	PLR	Grade	Description
7	MH7X	4	Settled deposits, fine, 40% % cross-sectional area loss
8	MH9X	3	Multiple defects
13	GY06X	3	Settled deposits, fine, 10% % cross-sectional area loss
14	GY08X	3	Settled deposits, fine, 10% % cross-sectional area loss
16	GY07X	3	Settled deposits, fine, 10% % cross-sectional area loss

200317_1436A-Survey.jpg, 00:00:09, 0.00 m
 Settled deposits, fine, 40% % cross-sectional area loss

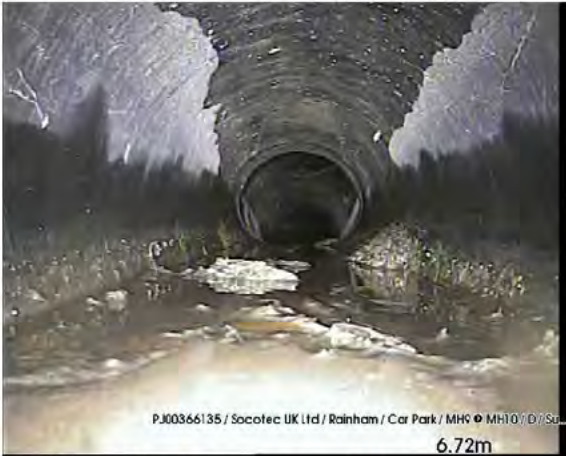
200317_1441B-Survey.jpg, 00:00:52, 6.72 m
 Settled deposits, coarse, 10% % cross-sectional area loss

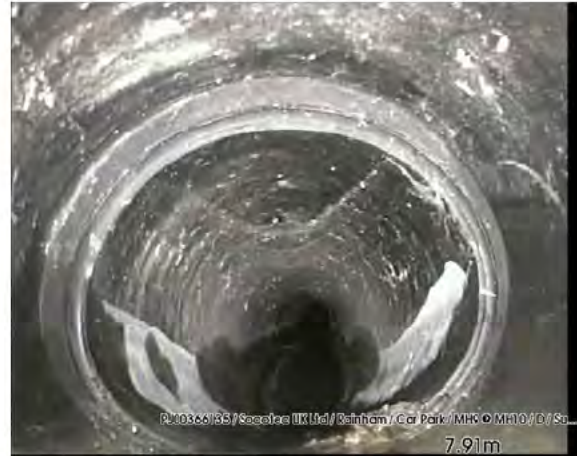
200317_1442A-Survey.jpg, 00:01:29, 7.91 m
 Deformed drain or sewer, 20% %

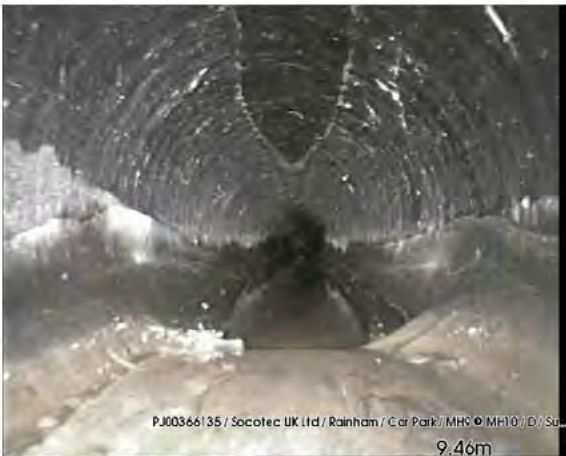
200317_1442B-Survey.jpg, 00:02:05, 9.46 m
 Deformed drain or sewer, 10% %

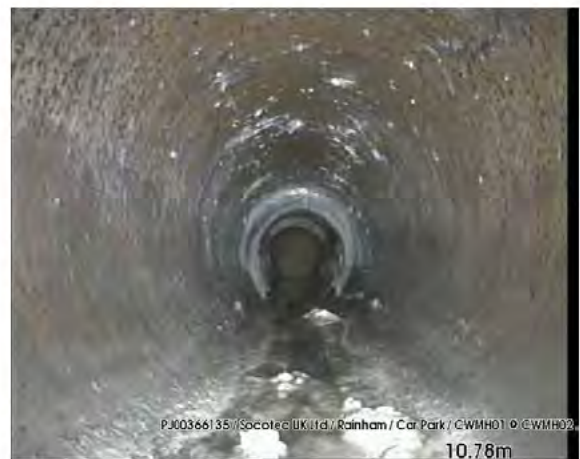
200317_1457A-Survey.jpg, 00:00:35, 6.97 m
 Line deviates down

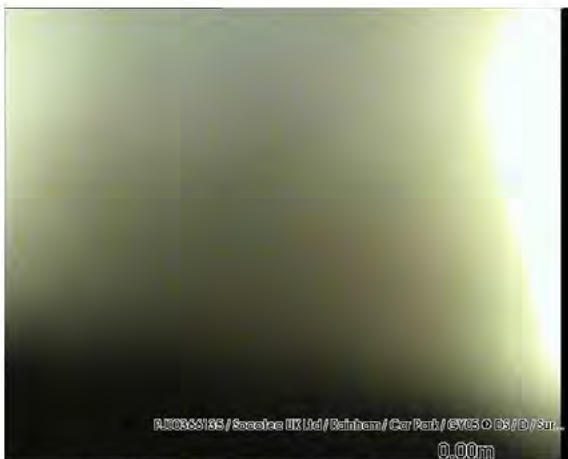
200318_1202E-Survey.jpg, 00:00:04, 0.00 m
 General remark, belly in pipe

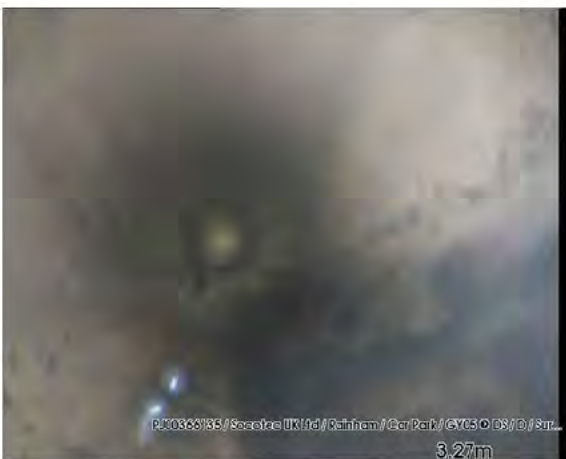
200318_1203B-Survey.jpg, 00:00:33, 3.27 m
 Material changes Vitrified clay pipe @REM

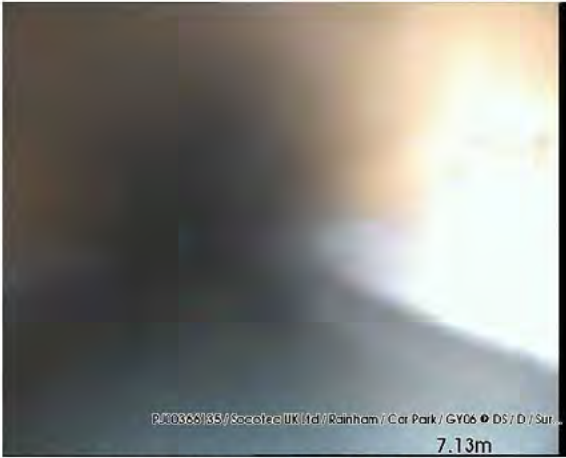
200318_1355B-Survey.jpg, 00:00:42, 7.13 m
 Settled deposits, fine, 10% % cross-sectional area loss

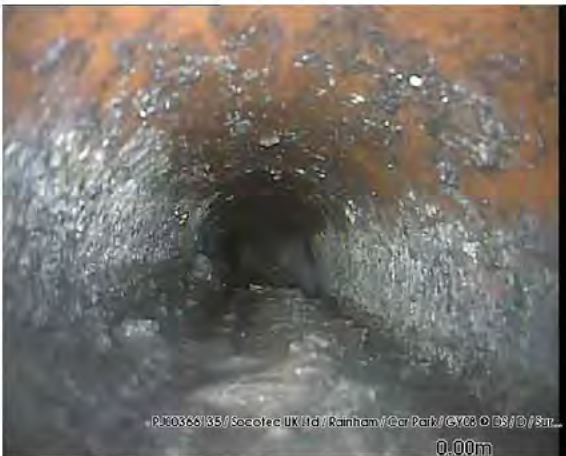
200318_1411A-Survey.jpg, 00:00:04, 0.00 m
 Settled deposits, fine, 10% % cross-sectional area loss

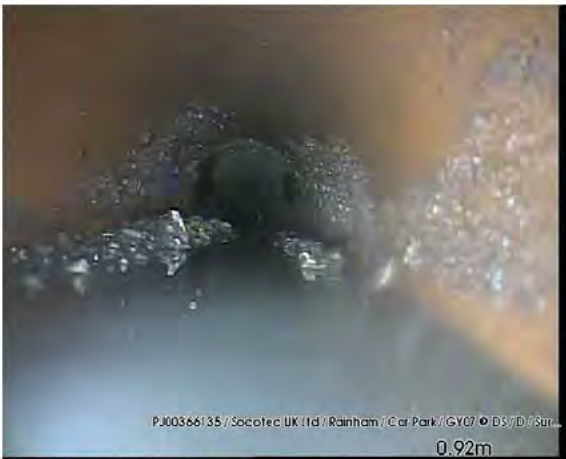
200318_1432E-Survey.jpg, 00:00:14, 0.92 m
 Settled deposits, fine, 10% % cross-sectional area loss

Section	PLR	Grade	Description
7	MH7X	4	Settled deposits, fine, 40% % cross-sectional area loss
8	MH9X	3	Multiple defects
13	GY06X	3	Settled deposits, fine, 10% % cross-sectional area loss
14	GY08X	3	Settled deposits, fine, 10% % cross-sectional area loss
16	GY07X	3	Settled deposits, fine, 10% % cross-sectional area loss

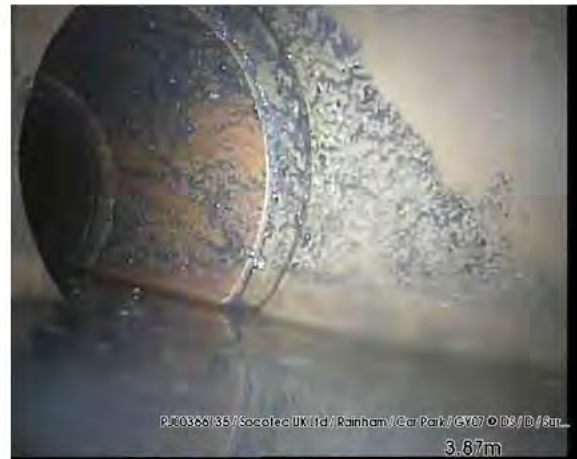
200318_1433A-Survey.jpg, 00:00:39, 3.87 m
 Finish node type, other special chamber, reference number:
 DS, reached

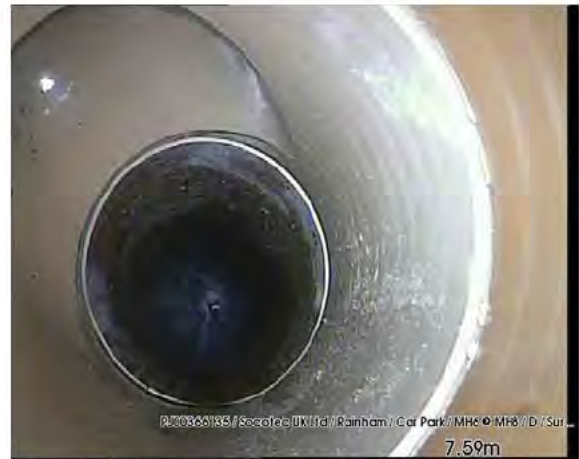
200317_1232C-Survey.jpg, 00:00:25, 7.59 m
 Junction, at 10 o'clock, diameter: 150 mm

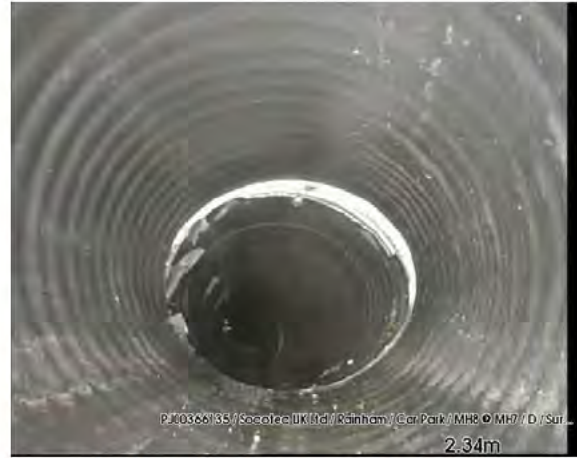
200317_1337A-Survey.jpg, 00:00:30, 2.34 m
 Deformed drain or sewer, 40% %

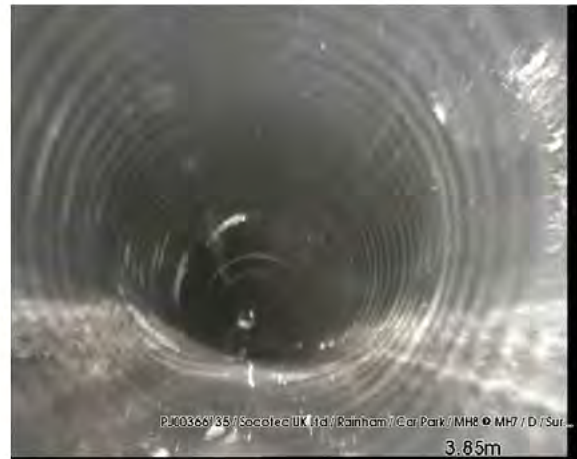
200317_1337C-Survey.jpg, 00:00:38, 3.85 m
 Deformed drain or sewer, 30% %

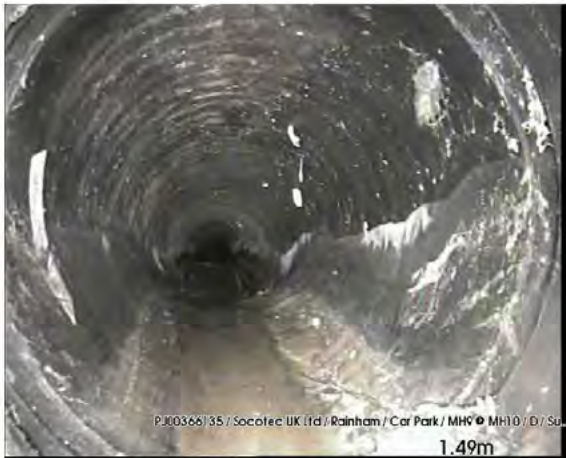
200317_1440C-Survey.jpg, 00:00:19, 1.49 m
 Material changes Polyvinyl chloride @REM

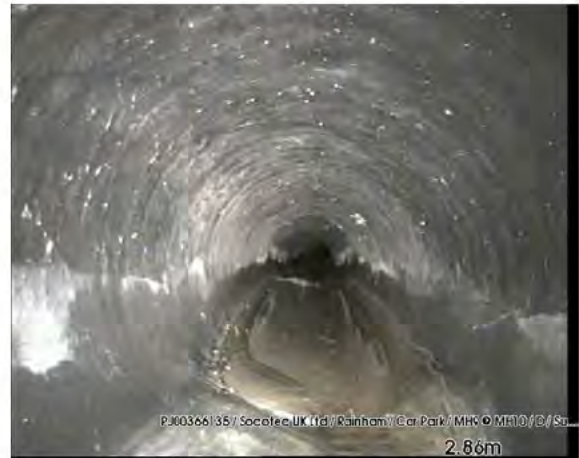
200317_1440D-Survey.jpg, 00:00:26, 2.86 m
 Line deviates down

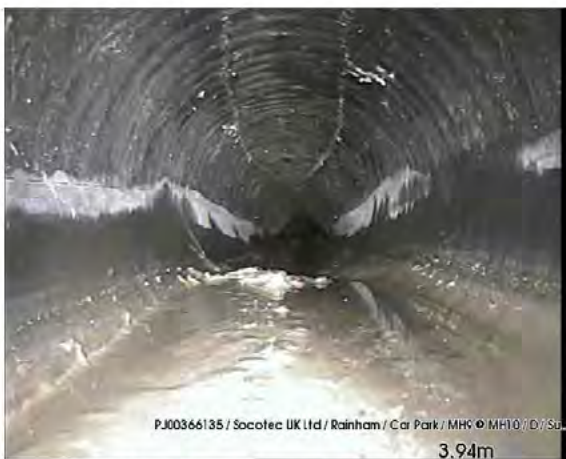
200317_1440E-Survey.jpg, 00:00:32, 3.94 m
 Settled deposits, fine, 10% % cross-sectional area loss

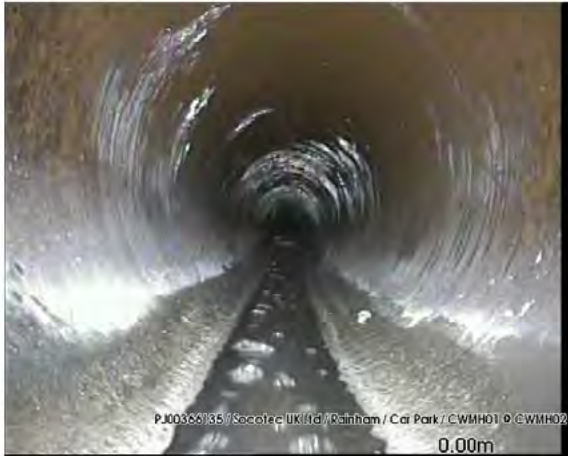
200317_1456C-Survey.jpg, 00:00:00, 0.00 m
 Start node type, manhole, reference number: CWMH01

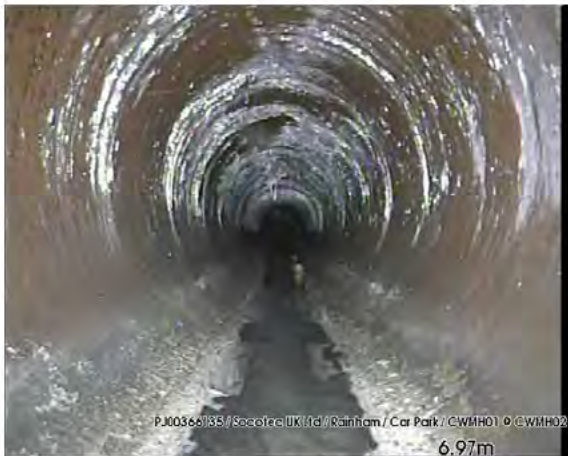
200317_1457A-Survey.jpg, 00:00:35, 6.97 m
 Line deviates down

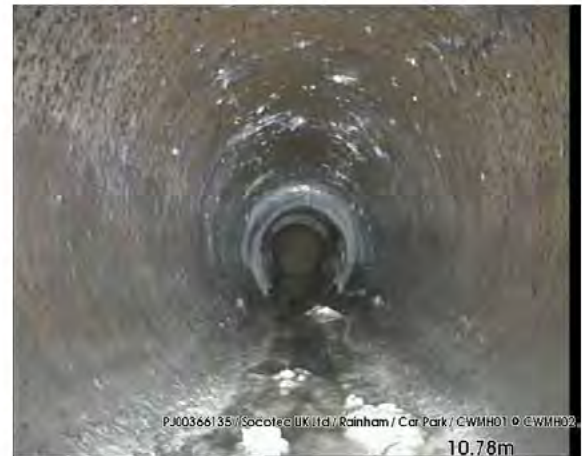
200317_1457B-Survey.jpg, 00:00:51, 10.78 m
 Line deviates down

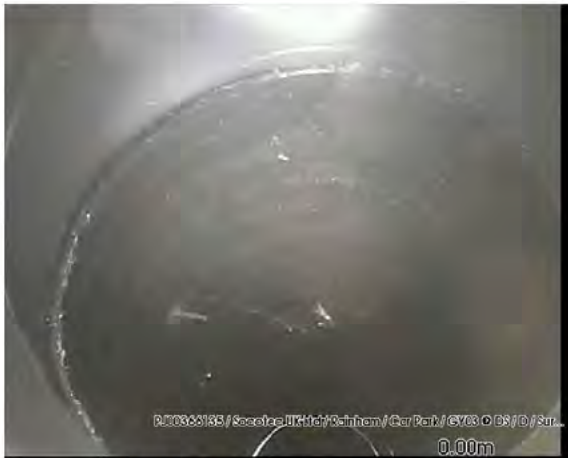
200318_1135C-Survey.jpg, 00:00:00, 0.00 m
 Start node type, gully, reference number: GY03

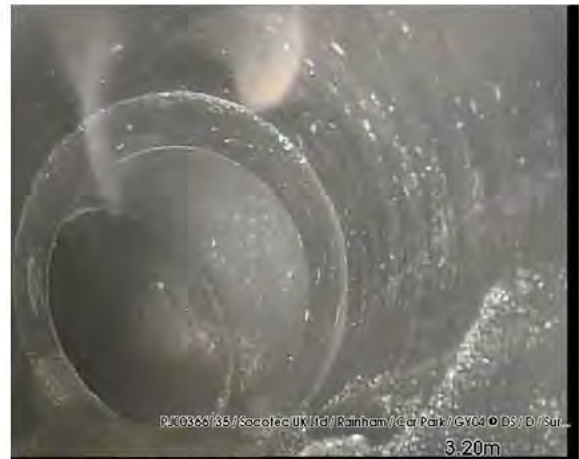
200318_1145B-Survey.jpg, 00:00:24, 3.20 m
 Line deviates left

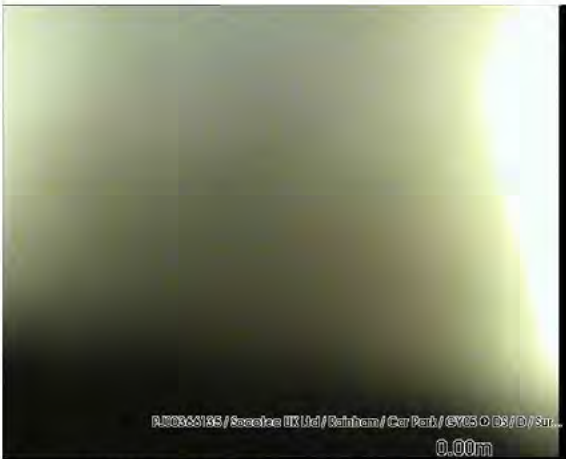
200318_1202E-Survey.jpg, 00:00:04, 0.00 m
 General remark, belly in pipe

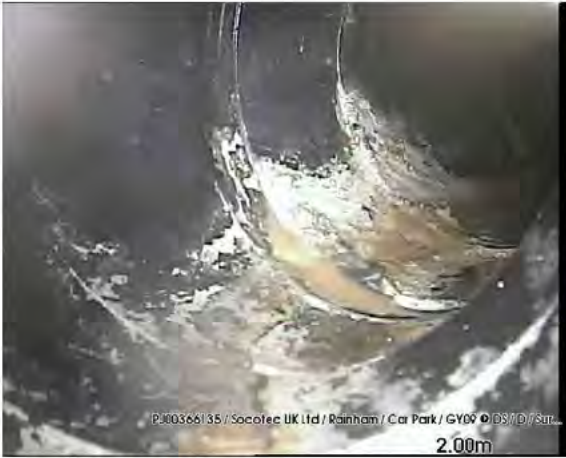
200318_1418E-Survey.jpg, 00:00:22, 2.00 m
Line deviates right
