# Formal Investigation Report – Passenger Fatality

## Waterloo Station – Bakerloo Line platform 3

26<sup>th</sup> May 2020

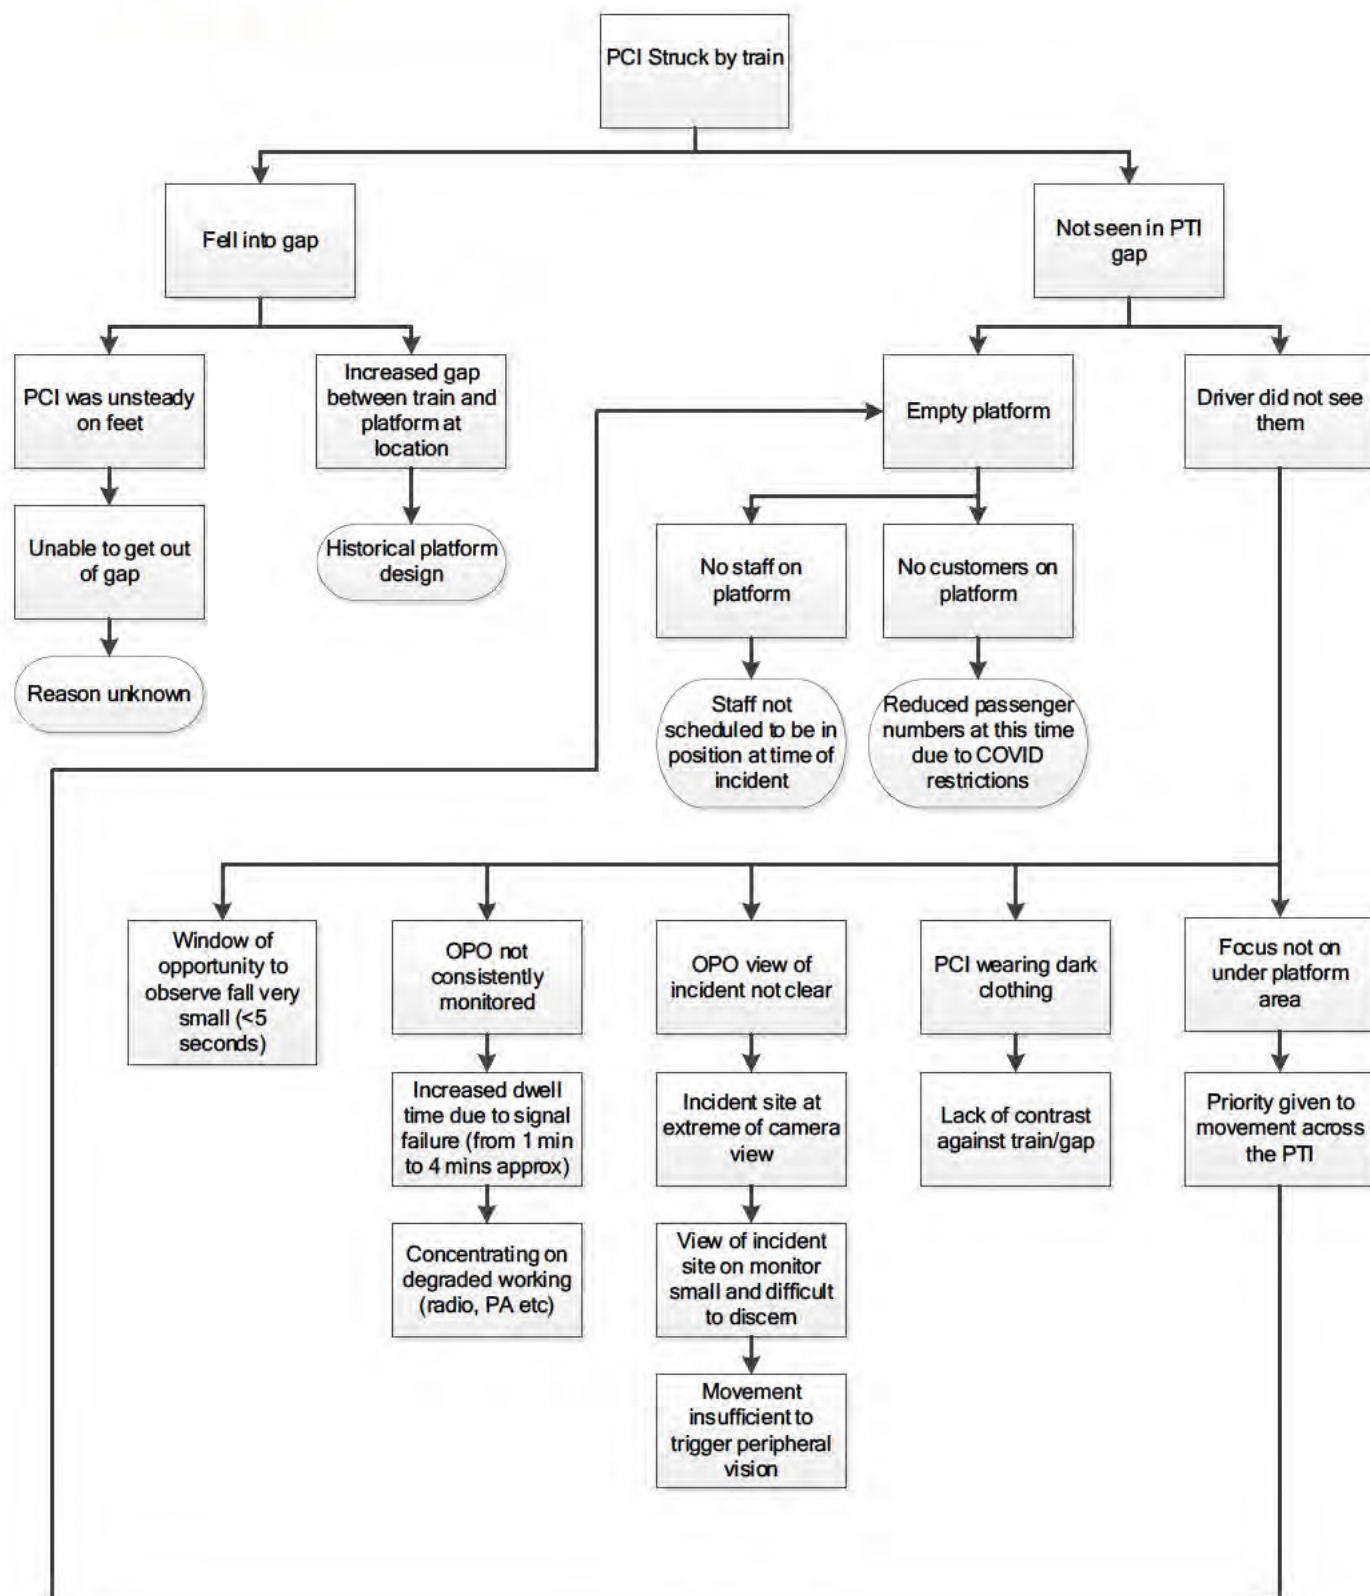
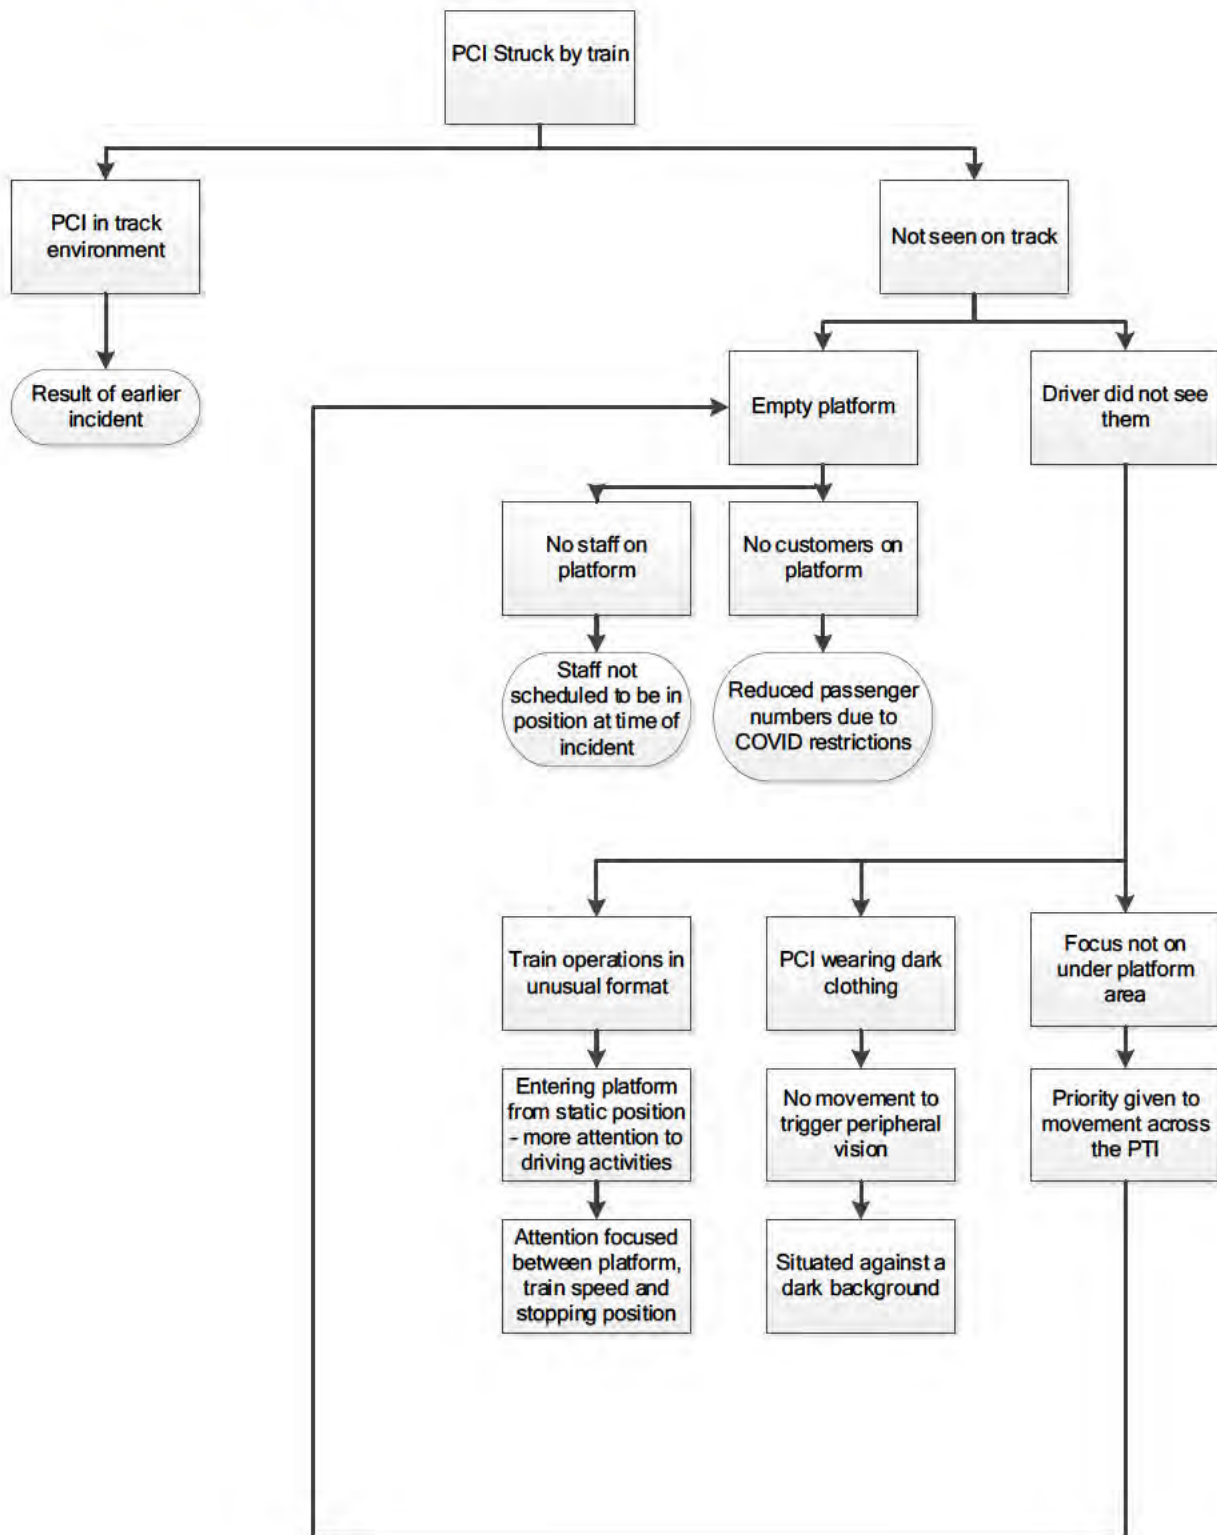
### 14.1 Train 210

This formal investigation identified that train 210 departed the platform with a male passenger in the gap between the train and the platform. The train had been delayed by a signal failure and it was during this delay with the train held in the platform that the passenger disembarked from the train.
