## Near Miss with Track Worker

### Langley Station

Sunday 16<sup>th</sup> February 2020

HSE Info Exchange Reference Number: 117371

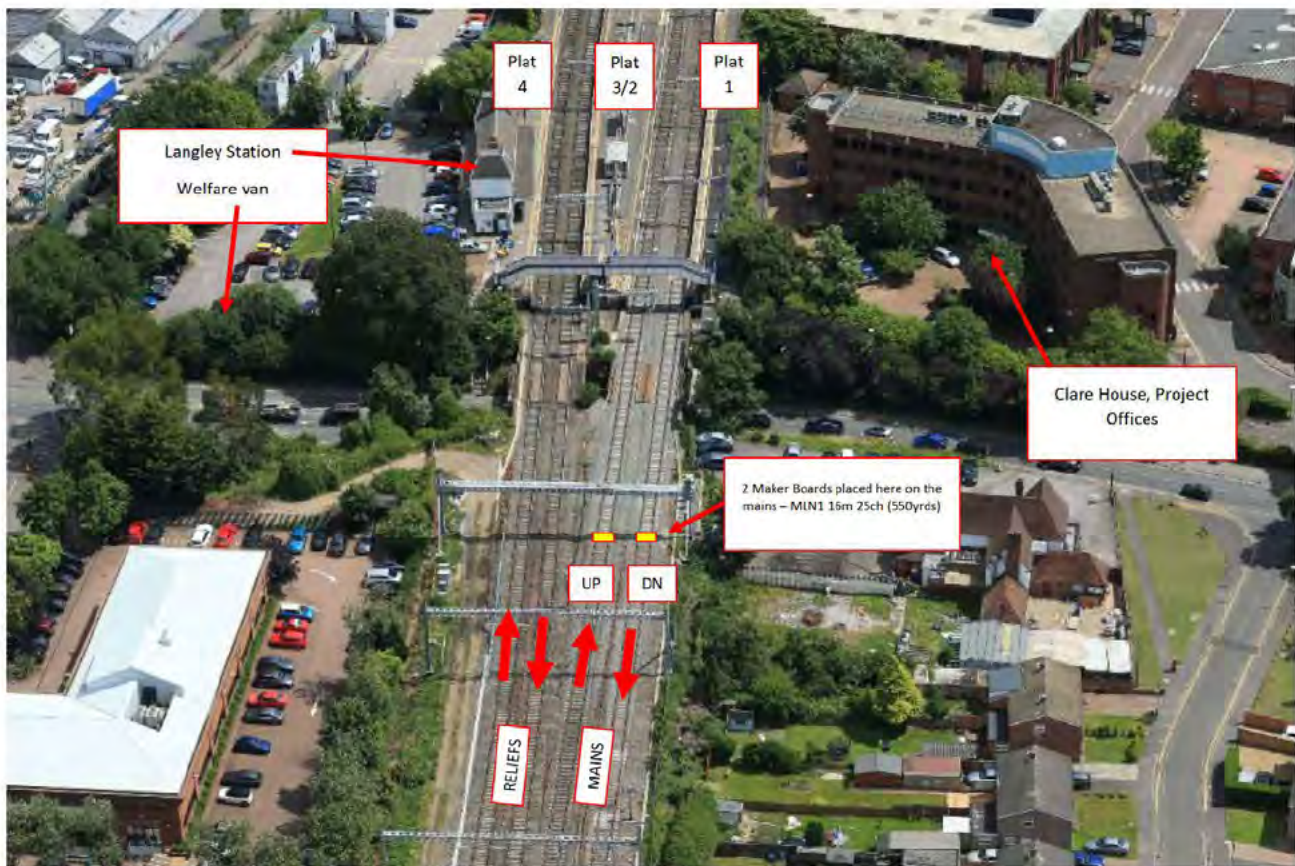
The incident took place on the main lines at 16m 00 chain (Paddington to Reading) at Langley Station, Station Road, Langley, Berkshire, SL3 6DB.

Fig No. 01: Langley Station complex showing Mains and Relief lines

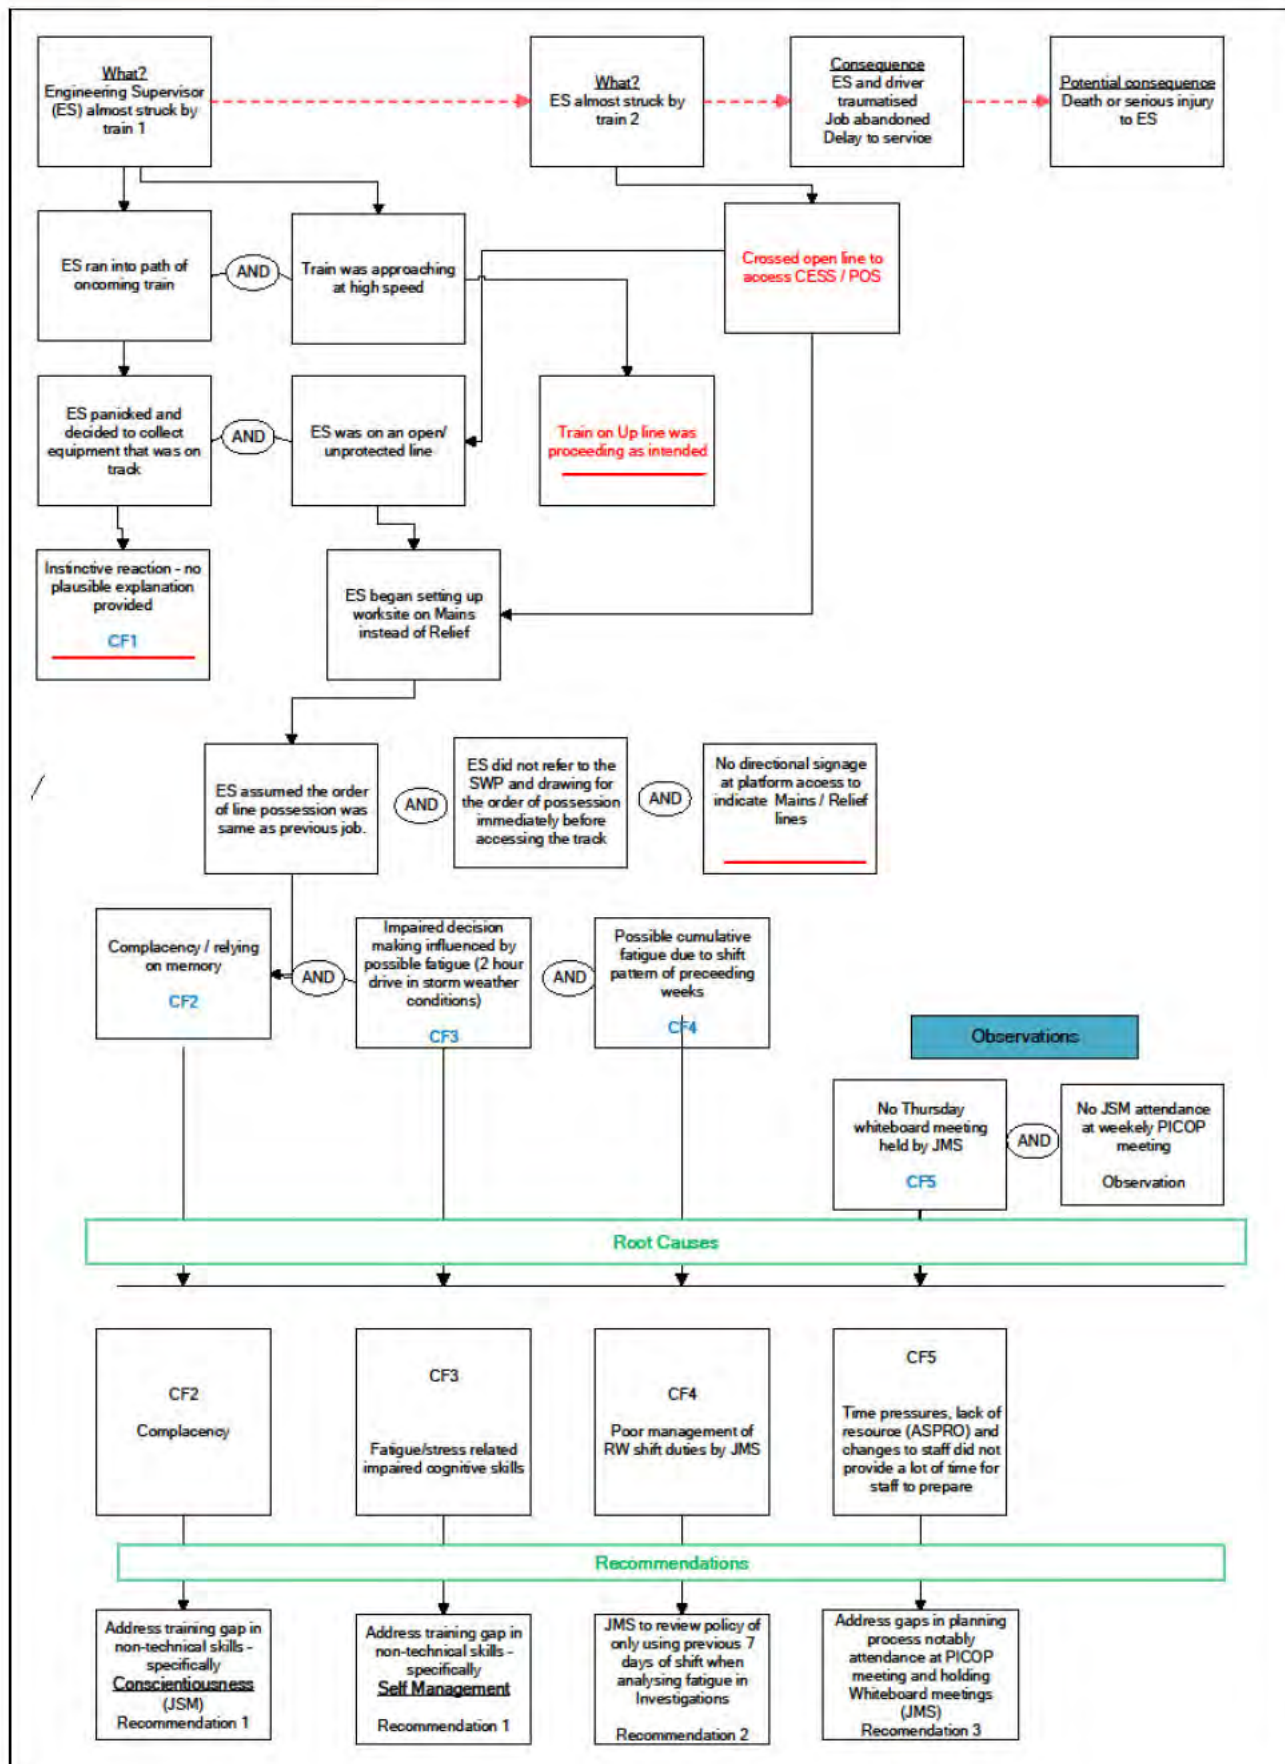
## 15 Root Cause Analysis

It is evident from the voice recordings of the statement from the ASPRO COSS on the evening and the conversation between the PICOP and ES; that ES knew it was the Relief line that was the first possession to be taken on the night. ES noted, during a phone conversation with [REDACTED] investigator on 25<sup>th</sup> February, that when he went to set out the boards that for some reason, he felt that he was setting the site out exactly as he did on 26<sup>th</sup> January, when the Main line was taken first.
