Formal Incident Investigation

Fracture of the longitudinal beam on the 96 tube stock

Stratford Market Depot

17th October 2019

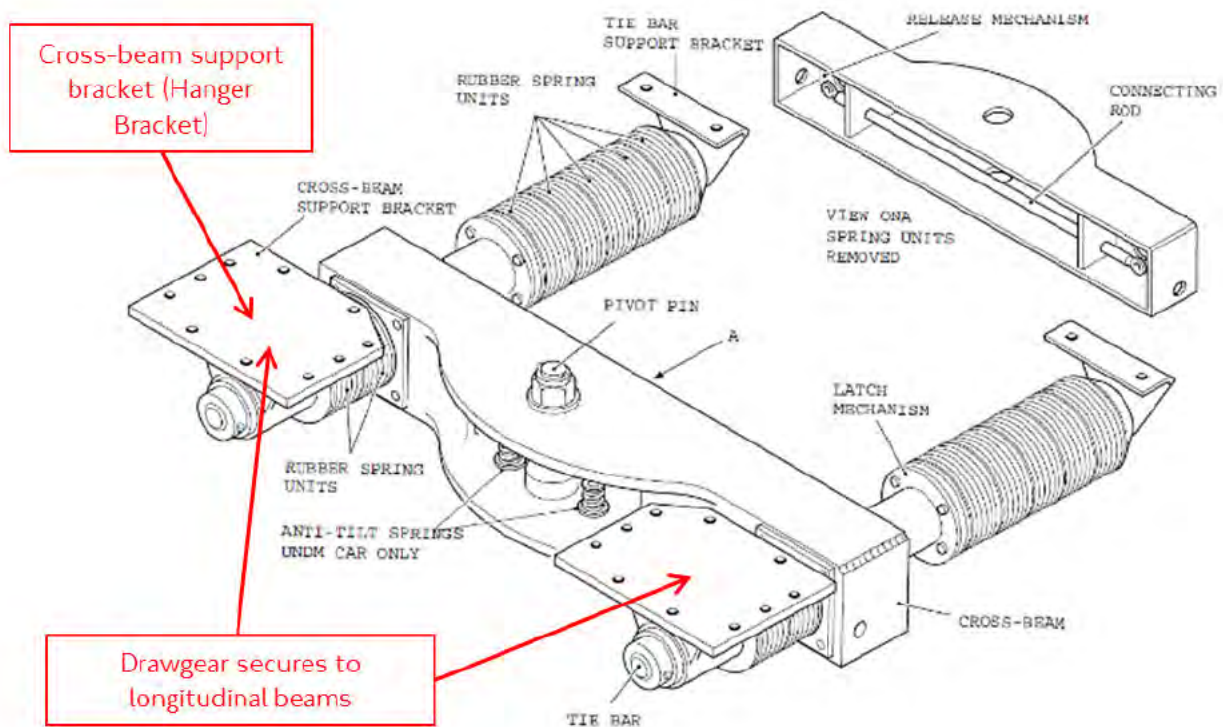
Figure 4: Drawgear general assembly view

21. On the 22nd October 2019, following disassembly and inspection of the drawgear, a number of M16 bolt fixings within the crossbeam support bracket (see Figure 4) were found to have failed. This prompted a review by TfL Rolling Stock Engineers that resulted in the decision to also stop Category 2 trains from running.

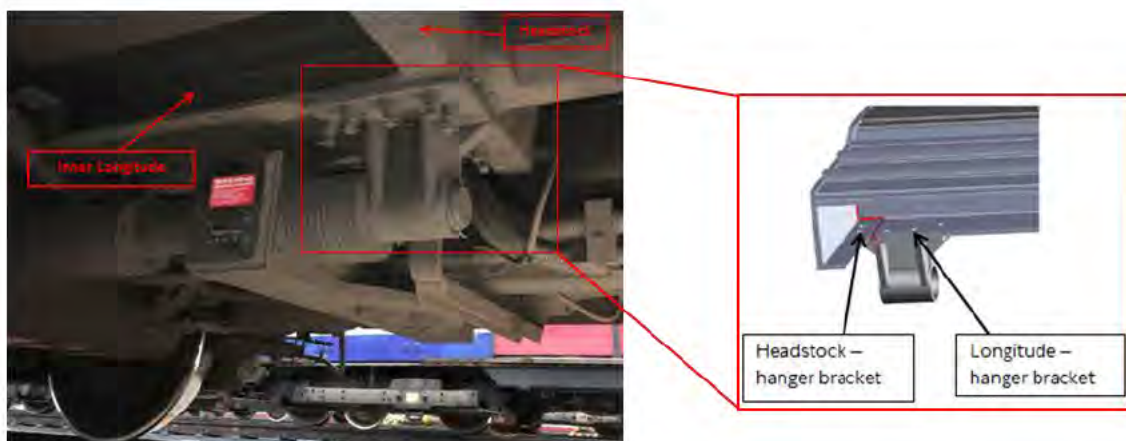
Figure 18: Hanger bracket attaching to headstock and longitudinal beam

Strain gauges were attached to the longitudinal beams on the A end of unit 96685 (ST) which was identified as being intact. A total of 12 gauges (gauge 1 to 12) were attached to the A end of the car on positions around the drawgear bracket as these were the locations where most of the fractures were found.

From stress ranges gathered during the test run and the subsequent fatigue life calculated, it can be concluded that fracture initiation and propagation is mainly a result of the high cyclic stresses on the longitudinal beam as a result of the buff and draw loads transferred through the drawbar and hanger bracket. In some positions on the longitudinal beams these stresses lead to a fatigue life which is much less than the expected operational life of 40 years with some having a fatigue life of less than 10 years. It is also clear that the fatigue life on different ends of a carriage are different because of the variance in loading.

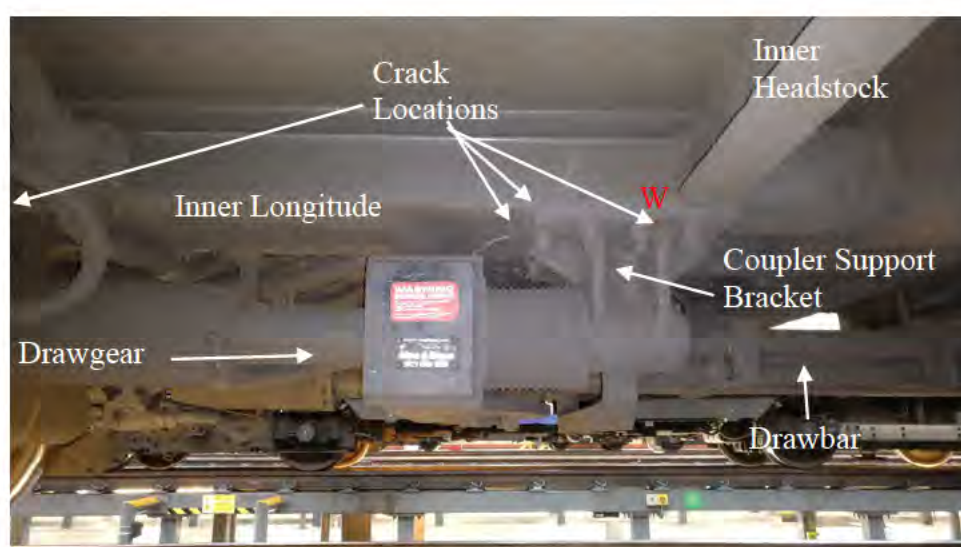
Figure 2, 96TS Coupler assembly and carbody structural arrangement

The inner longitude is an extruded aluminium I beam which is welded in position at either end and to the floor extrusion. At one end it is connected to the aluminium inner headstock via a horizontal weld, (Position W). This weld is situated directly across the bolted interface of the coupler support bracket. Longitudinal acceleration and braking forces are transferred from the coupler through the drawgear (which comprises rubber elements to dampen the force input) and into the carbody via the coupler support brackets. Figure 2

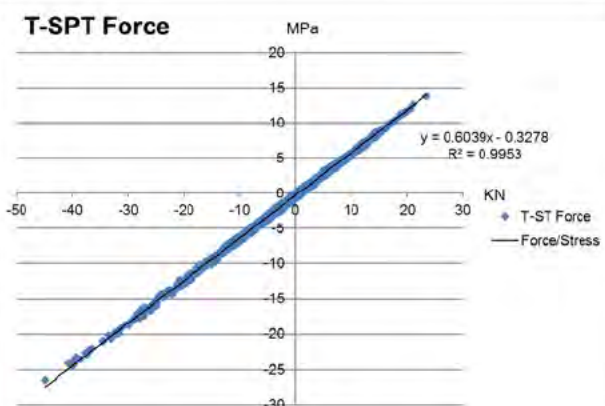
Table 5: Parent metal proof reserve factors against loadcases

As part of the investigation strain gauge tests were completed which also measured the coupler forces. The relationship between force and stress was shown to be linear (Table 5) and therefore the intermediate end longitudines' ability to meet the proof load requirements can be calculated. The table below details derived stresses against a given force at crack initiation point A. This shows the longitude would pass at 400kN compressive but would fail the 500kN tensile loadcase with a reserve of 0.86

350	Coupler Release (Intercar)	211	1.22	
400	Proof compressive	241	1.07	
500	Proof tensile	301	0.86

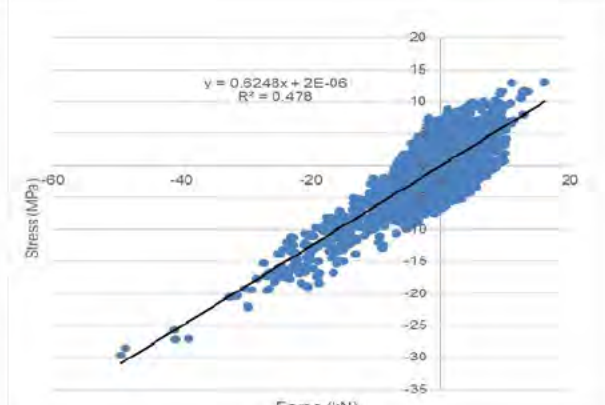
Table 6: HAZ proof reserve factors against loadcases

The exercise was repeated for a gauge positioned at the weld connection between the longitude to the tertiary headstock (crack location D). (The wider data spread is believed to be due to the gauge's position near the tertiary headstock and is therefore also affected by passenger loading). As can be seen the HAZ did not meet any of the proof loadcases in agreement with the carbody static test results in 1995, Table 6.

350	Coupler release (Intercar)	218	0.59	
400	Proof compressive	249	0.52	
500	Proof tensile	312	0.41

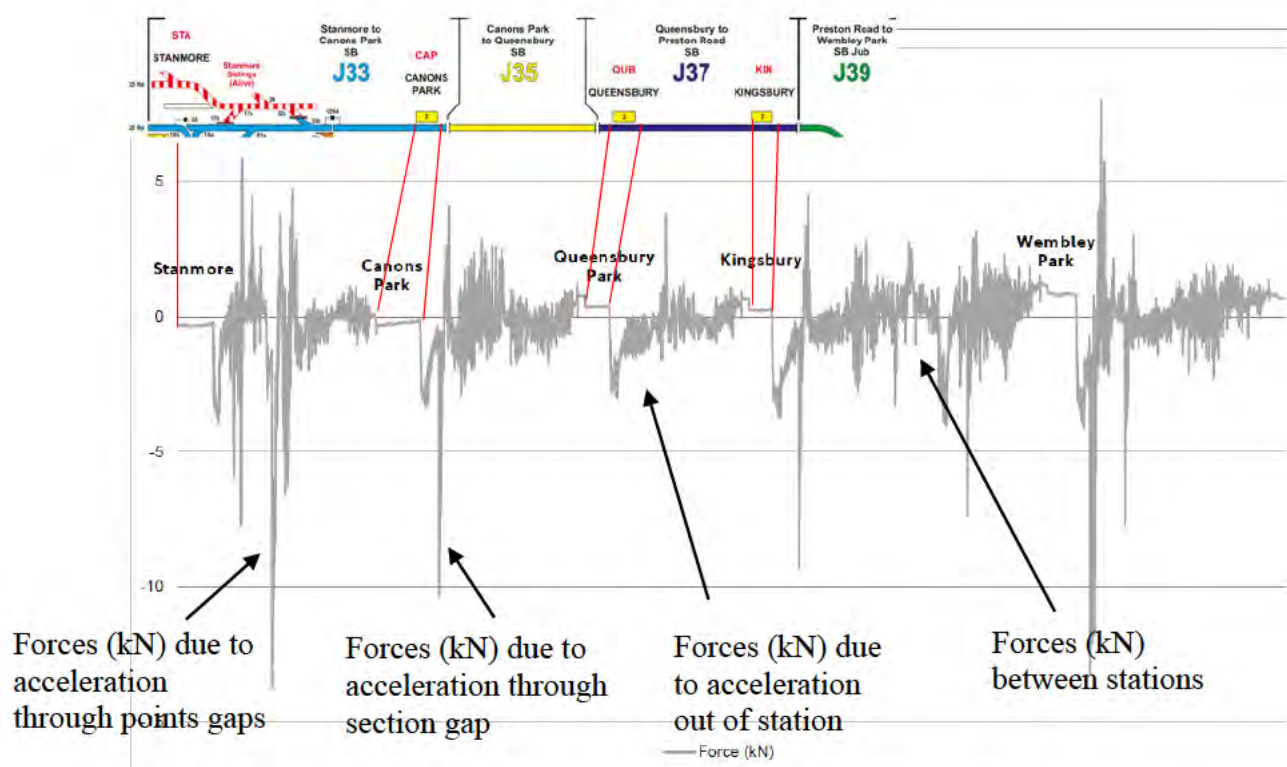
Figure 11: Coupler force(kN) between Stanmore and Wembley Park stations

The fatigue damage accrual is solely driven by these same traction and braking forces distributed through the couplers under varying conditions, Figure 11. Negative forces are generally due to acceleration and positive due to braking, although as can be seen large inputs often result in load reversals due to the following motor car becoming gapped and a rapid reversal of load through the coupler.

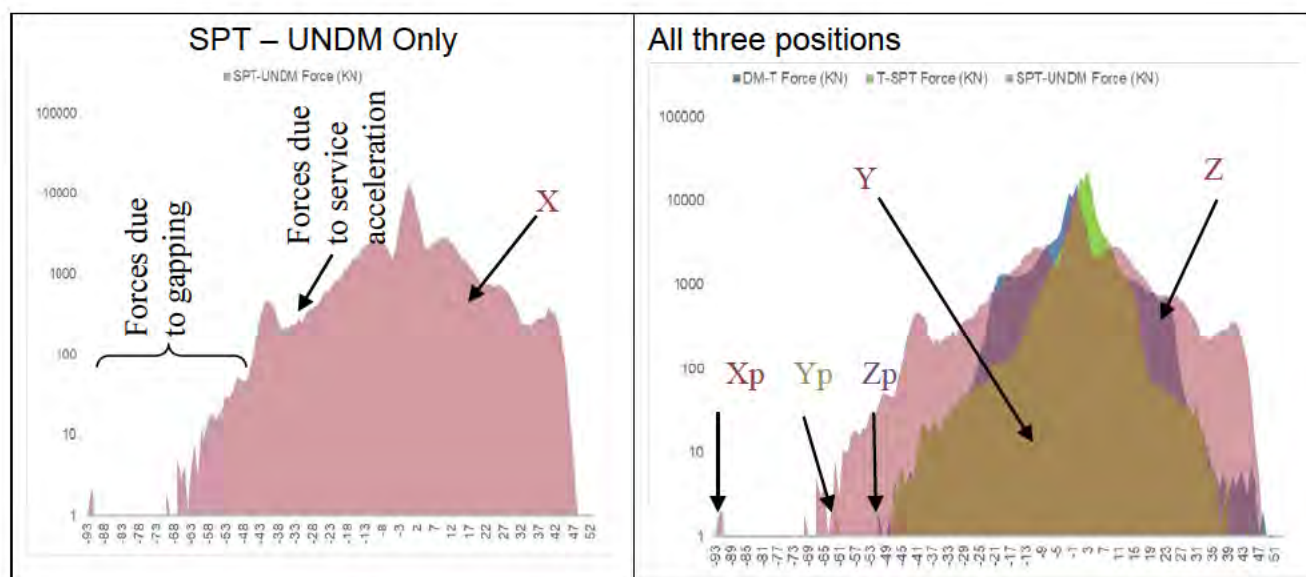
Figure 12: Histogram of coupler forces against number of cycles

The coupler force cycles for an ATO test in passenger service have been plotted as a histogram against the number of cycles to show the coupler force characteristics at the SpT – UNDM (Marked X), the SpT – T (Y) and T – DM (Z). As can be seen the SpT -UNDM has significantly higher forces and a greater number of cycles at higher magnitude which are driving the fatigue damage and increased crack formation, Figure 12.
