## PROPOSED LONDON UNDERGROUND (NORTHERN LINE EXTENSION) ORDER

PROOF OF EVIDENCE

Jonathan R A Gammon Engineering

**DOCUMENT TFL2/B**

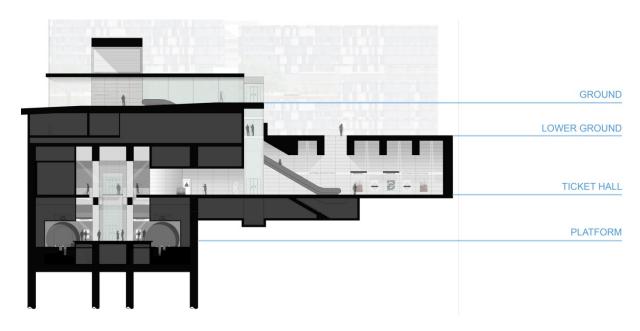
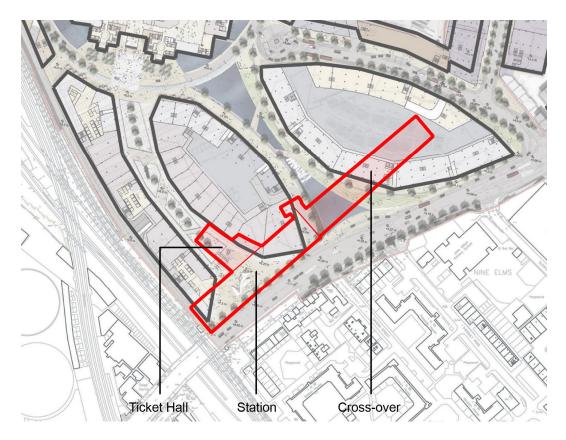
Figure 8 Battersea Station-Configuration - Sheet 1

Section showing sequence of spaces from entrance to platform

Ground level plan showing station and cross-over in outline within the completed master plan

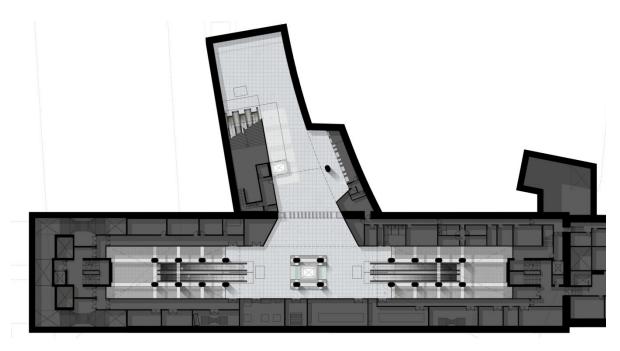
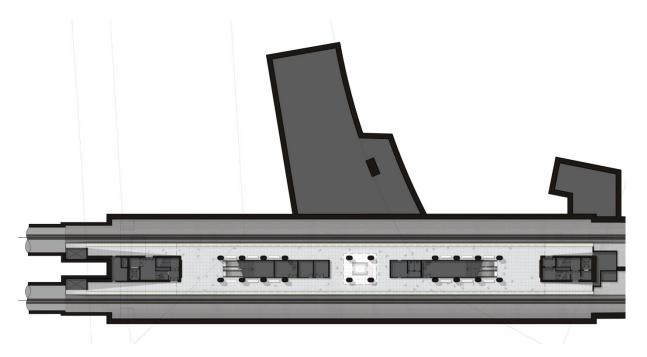
Figure 9 Battersea Station-Configuration - Sheet 2

Ticket hall & upper concourse plan

Platform level plan at Battersea Station

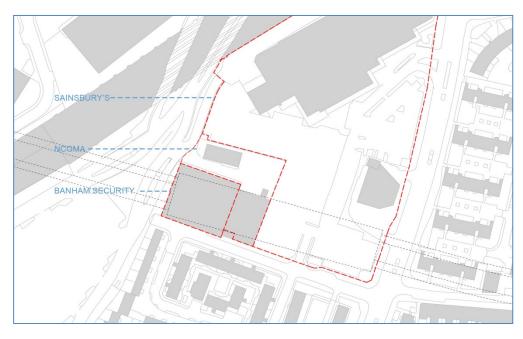
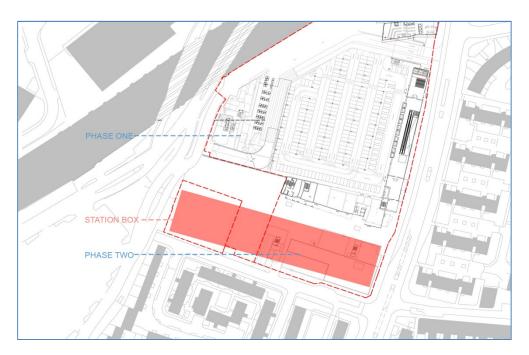
Figure 28 Nine Elms Plans Configuration – Sheet 1

Existing site layout at Nine Elms

Approved Sainsbury's scheme showing phases 1 & 2

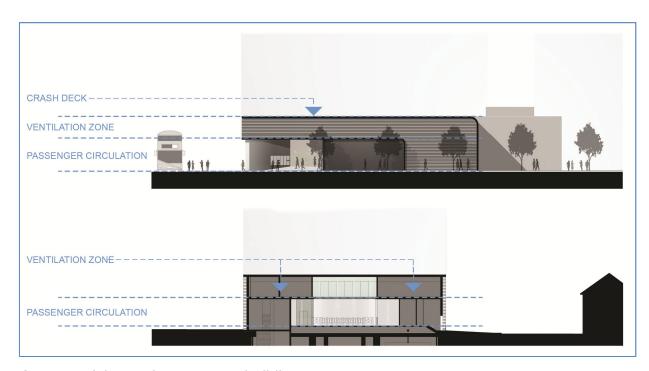
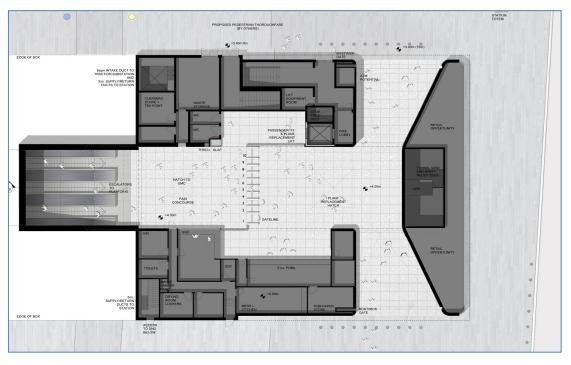
Figure 29 Nine Elms Plans Configuration – Sheet 2

Aspects of the station entrance building

Ticket hall ground level plan
