Airborne transmission and ventilation

SET: 3 March 2021
For information no
action required.

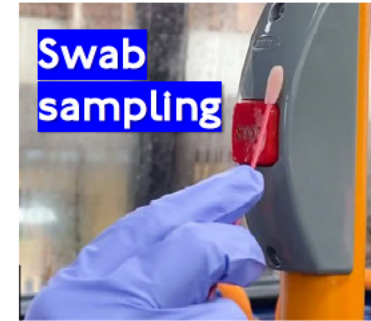
- Researcher travels from Waterloo to Euston on Northern Line, then Euston to Paddington on 205 bus
- Takes swab samples at hard surfaces e.g. grab handles
- Takes air samples, sampling 300L/minute of air (on average someone exercising hard breathes less than 100L/minute so this is a large sample volume)
- Extremely sensitive lab tests are used to give the best chance of detecting any virus

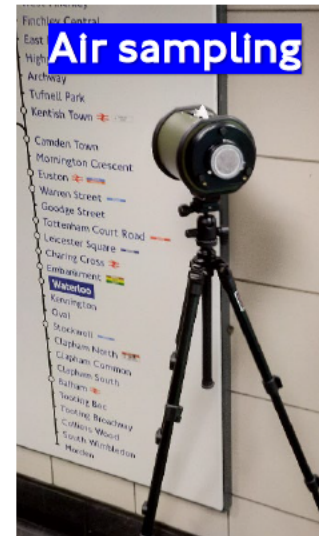
More information on sampling methodology
