Referenced Document(s):  
Off-track Inspections  
W0135 and W0125**OFF-TRACK AND FENCING INSPECTIONS**

**Section 1 : Inspection details**

Inspection Type PM6	Sheet No. 1 of 1	Inspection Work Order No.	54724109 DLW013
Inspector's name [REDACTED]	District Line Southfields – Wimbledon		Date 15/05/2020

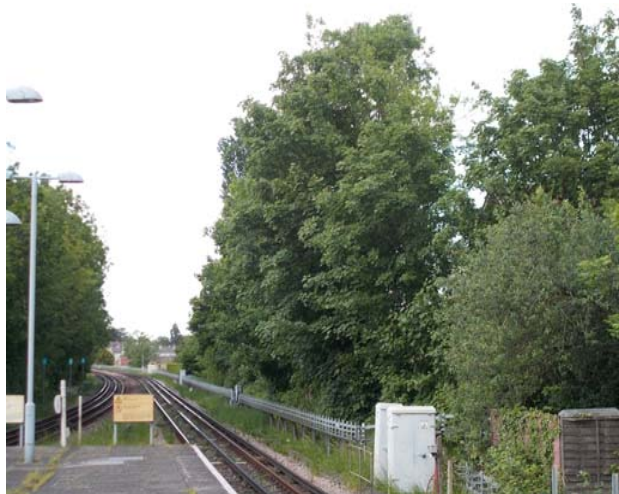
**12/05/2020: Reduce trees, Ideally fell and treat stumps. Priority 2.**

BRS & Road	<b>D164</b>	Road:	<b>WB</b>
From Station	<b>East Putney</b>		
To Station	<b>Southfields</b>		
Line	<b>District</b>	Line Type	<b>LOCAL</b>
Meterage	<b>1360</b>	Distance	<b>33</b>
Slope	<b>G</b>	Legal Status	
DistBldg:	<b>1</b>	DistTrack:	<b>5</b>

OwnerID:	<b>DISTRICT</b>		
HeightM:	<b>10</b>		
MaxTrunkDiameter:	<b>0.2</b>		
AssetOnID:	<b>GR</b>		
BatValue:			
LeanID:			
FellDate:			
Ivy	<input type="checkbox"/>	Dead	<input type="checkbox"/>
DfDis:		DfCdb:	
DfDwd:		WildlifeAffecting	<input type="checkbox"/>
DominantSpeciesID:	<b>Sycamore</b>		
SubDominantSpeciesID:			
OtherSpecies:			
EffectingSignals	<input type="checkbox"/>	OverhangingCrun	<input type="checkbox"/>
Area:	<b>98</b>		
Site Area Reference:	<b>SA3205</b>		
Vegetation Sensitivity:

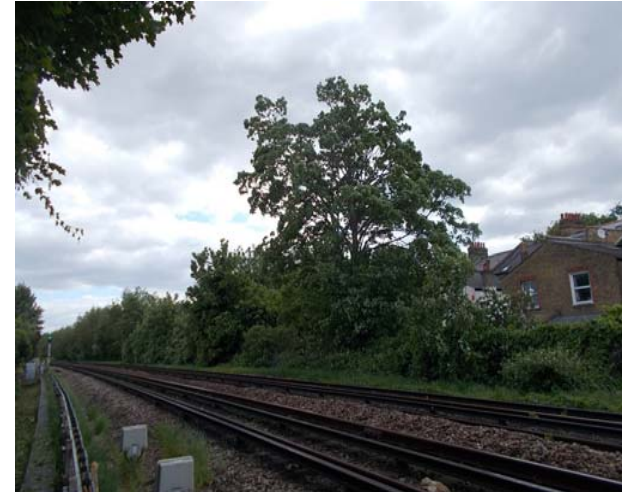
13/05/2020: Third party tree overhanging track, reduce. Priority 2

BRS	<b>D166</b>	Road:	<b>EB</b>
From Station	<b>Wimbledon Park</b>		
To Station	<b>Southfields</b>		
Line	<b>District</b>	Line Type	<b>LOCAL</b>
Meterage	<b>0902</b>	Distance	<b>0</b>
Slope	<b>E</b>	Legal Status	
DistBldg:	<b>9999</b>	DistTrack:	<b>6</b>

OwnerID:	<b>3rd Party</b>
AssetOnID:	<b>GR</b>
CommonNameTree:	<b>Sycamore</b>
HeightM:	<b>13</b>
SpreadM:	<b>12</b>
TrunkDiameter:	<b>0.45</b>
NoStems:	<b>1</b>
Ivy:	<input type="checkbox"/> Dead: <input type="checkbox"/>
DfCav:	DfCdb:
DfDcy:	DfDis:
DfDwd:	DfHrt:
DfPol:	DfWfk:
OverhangingCrun:	<input checked="" type="checkbox"/> EffectingSignals: <input type="checkbox"/>
LeanID:	
FellDate:	
Site Area Reference:	<b>SA3077</b>
Vegetation Sensitivity:

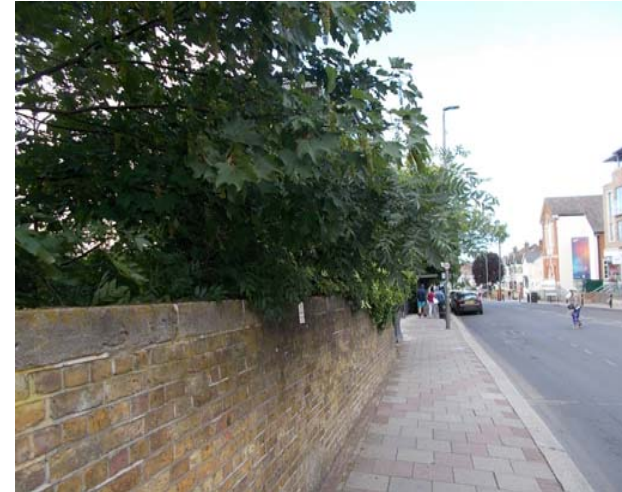
IdentifiedWorksNumber: **NWST2129D165**

13/05/2020: Cut back vegetation to wall, as encroaching path. Priority 1

BRS **D165** Road: **WB**

Min. Width: **3**

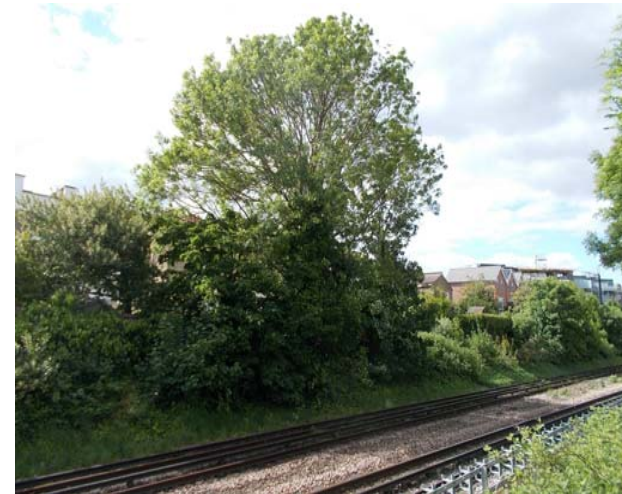
**13/05/2020: Cut ivy, ideally fell and treat stumps. Priority 2**

BRS	<b>D166</b>	Road:	<b>EB</b>
From Station	<b>Wimbledon Park</b>		
To Station	<b>Southfields</b>		
Line	<b>District</b>	Line Type	<b>LOCAL</b>
Meterage	<b>1098</b>	Distance	<b>0</b>
Slope	<b>C</b>	Legal Status	
DistBldg:	<b>19</b>	DistTrack:	<b>4.5</b>

OwnerID:	<b>DISTRICT</b>
AssetOnID:	<b>GR</b>
CommonNameTree:	<b>Ash</b>
HeightM:	<b>14</b>
SpreadM:	<b>11</b>
TrunkDiameter:	<b>0.3</b>
NoStems:	<b>2</b>
Ivy:	<input checked="" type="checkbox"/> Dead: <input type="checkbox"/>
DfCav:	DfCdb:
DfDcy:	DfDis:
DfDwd:	DfHrt:
DfPol:	DfWfk: <b>3</b>
OverhangingCrun:	<input type="checkbox"/> EffectingSignals: <input type="checkbox"/>
LeanID:	
FellDate:	
Site Area Reference:	<b>SA3078</b>
Vegetation Sensitivity:

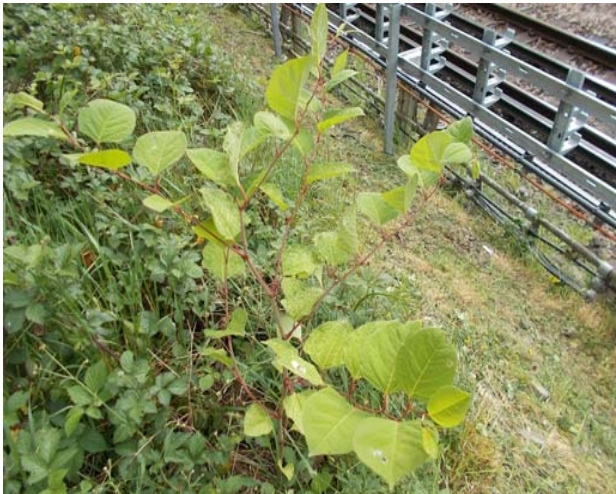
IdentifiedWorksNumber:	CSP600D166
RefNo:	CSP600
Spray	<input type="checkbox"/>
VisitsPerYear:	3
CutDown	<input type="checkbox"/>
ReseedSpecialMix	<input type="checkbox"/>
ReplantingRequired	<input type="checkbox"/>
WorkPackageID:	
Vegetation Sensitivity:

13/05/2020: Treat Japanese Knotweed. Priority 1

BRS	D166	Road	WB
From Station	Southfields		
To Station	Wimbledon Park		
Line	District	Line Type	LOCAL
Start Meterage	0180	Distance	31
Slope	C	Legal Status

OwnerID:	DISTRICT
Area:	200
SpeciesID:	Japanese Knotweed
Encroaching	<input type="checkbox"/>

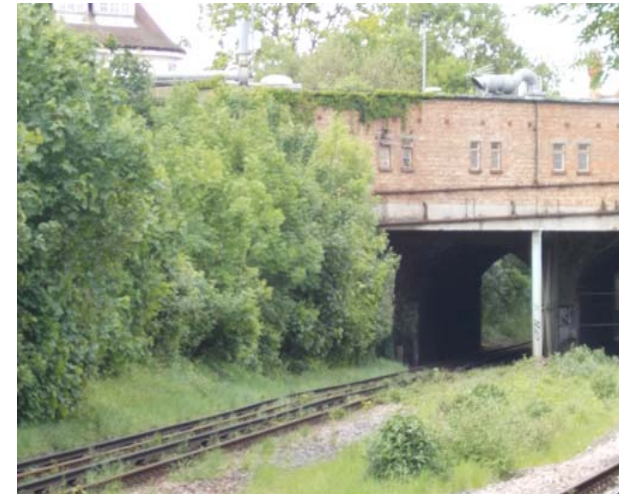
**13/05/2020: Cut back from track at approx 100-1250m, as touching passing trains. Priority P**

BRS & Road	<b>D166</b>	Road:	<b>EB</b>
From Station	<b>Wimbledon Park</b>		
To Station	<b>Southfields</b>		
Line	<b>District</b>	Line Type	<b>LOCAL</b>
Meterage	<b>1090</b>	Distance	<b>143</b>
Slope	<b>C</b>	Legal Status	
DistBldg:	<b>5</b>	DistTrack:	<b>2</b>

OwnerID:	<b>DISTRICT</b>	
HeightM:	<b>11</b>	
MaxTrunkDiameter:	<b>0.25</b>	
AssetOnID:	<b>GR</b>	
BatValue:		
LeanID:		
FellDate:		
Ivy	<input type="checkbox"/>	Dead <input type="checkbox"/>
DfDis:		DfCdb: <input type="checkbox"/>
DfDwd:		WildlifeAffecting <input type="checkbox"/>
DominantSpeciesID:	<b>Ash</b>	
SubDominantSpeciesID:	<b>Field Maple</b>	
OtherSpecies:	<b>Hawthorn, Sycamore</b>	
EffectingSignals	<input type="checkbox"/>	OverhangingCrun <input type="checkbox"/>
Area:	<b>468</b>	
Site Area Reference:	<b>SA3078</b>	
Vegetation Sensitivity:

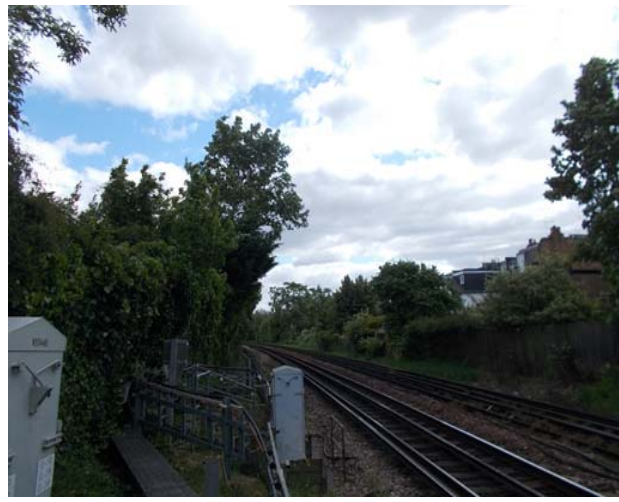
**13/05/2020: Third party tree overhanging track, reduce. Priority 2**

BRS	<b>D166</b>	Road:	<b>WB</b>
From Station	<b>Southfields</b>		
To Station	<b>Wimbledon Park</b>		
Line	<b>District</b>	Line Type	<b>LOCAL</b>
Meterage	<b>0327</b>	Distance	<b>0</b>
Slope	<b>G</b>	Legal Status	
DistBldg:	<b>10</b>	DistTrack:	<b>6</b>

OwnerID:	<b>3rd Party</b>
AssetOnID:	<b>GR</b>
CommonNameTree:	<b>Sycamore</b>
HeightM:	<b>13</b>
SpreadM:	<b>12</b>
TrunkDiameter:	<b>0.25</b>
NoStems:	<b>3</b>
Ivy:	<input type="checkbox"/> Dead: <input type="checkbox"/>
DfCav:	DfCdb:
DfDcy:	DfDis:
DfDwd:	DfHrt:
DfPol:	DfWfk:
OverhangingCrun:	<input checked="" type="checkbox"/> EffectingSignals: <input type="checkbox"/>
LeanID:	
FellDate:	
Site Area Reference:	<b>SA3079</b>
Vegetation Sensitivity:

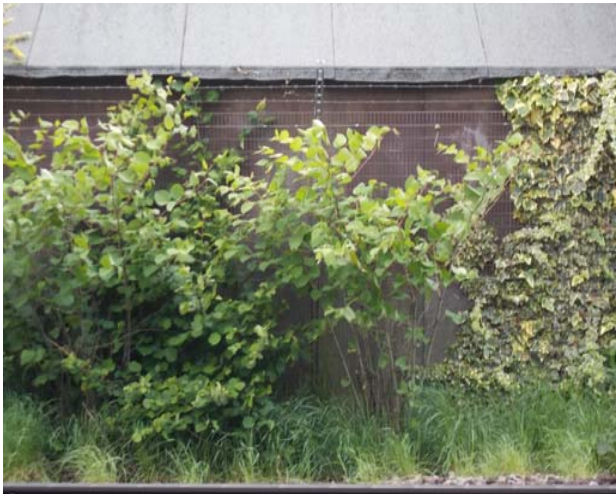
IdentifiedWorksNumber:	CSP7347D166
RefNo:	CSP7347
Spray	<input type="checkbox"/>
VisitsPerYear:	
CutDown	<input type="checkbox"/>
ReseedSpecialMix	<input type="checkbox"/>
ReplantingRequired	<input type="checkbox"/>
WorkPackageID:	
Vegetation Sensitivity:

13/05/2020: Treat Japanese Knotweed. Priority 1

BRS	D166	Road	EB
From Station	Wimbledon Park		
To Station	Southfields		
Line	District	Line Type	LOCAL
Start Meterage	0985	Distance	4
Slope	G	Legal Status

OwnerID:	DISTRICT
Area:	2
SpeciesID:	Japanese Knotweed
Encroaching	<input type="checkbox"/>
