ITEMS TO BEWARE OF

The following items are known to be in the locations of your works noted within section 1.2, these items should remain undisturbed during the works described in section 1.4, however if you do need to disturb any of these items please contact the Hazardous Materials Unit for further advice and guidance:

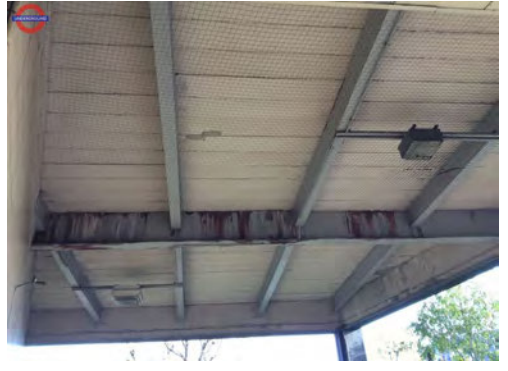
Reference:	24442

Description:	Asbestos: No Access: Presumed D229-00: Station Building - Hatton Cross Stn Start(m): Not Specified Finish(m): Not Specified	
Hazard Area:	Void	
Comments:	Entrance Exterior - Above Entrance Canopies - No Access	
Reference:	24443

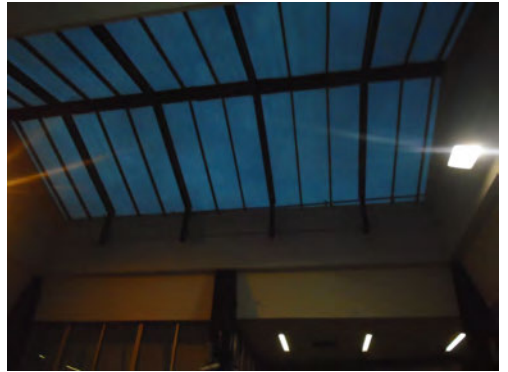
Description:	Asbestos: Strongly Presumed D229-00: Station Building - Hatton Cross Stn Start(m): Not Specified Finish(m): Not Specified	
Hazard Area:	Glazing Rope	
Comments:	Stairs Entrance Exterior - Potential Chrysotile gaskets within Glazing Rope	
Reference:	45281

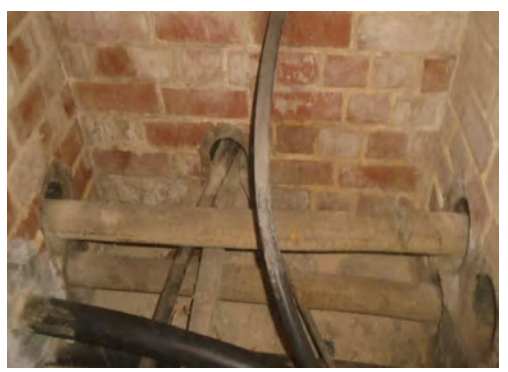
Description:	Asbestos: Known D229-00-1/001: Booking Hall - Station Building - Hatton Cross Stn Start(m): Not Specified Finish(m): Not Specified	
Hazard Area:	Cable Sheath	
Comments:	Cable pit by waiting area adjacent to shop 1/451 - 2x white braided cables (within 3 no walls?)

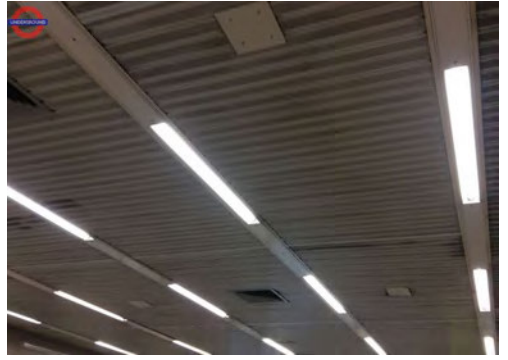
Reference:	24445

Description:	Asbestos: No Access: Presumed D229-00-1/001/CLG-01: Ceiling: Suspended - 1 - Booking Hall - Station Building - Hatton Cross Stn Start(m): Not Specified Finish(m): Not Specified	
Hazard Area:	Void	
Comments:	Void above false ceiling	
Reference:	24444

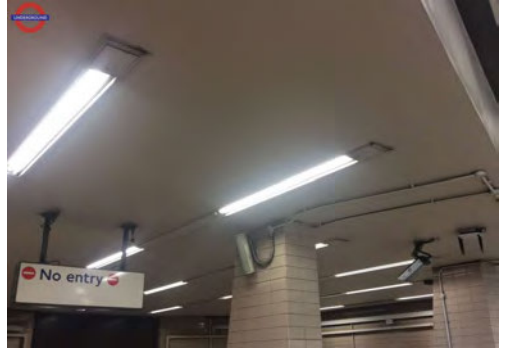
Description:	Asbestos: No Access: Presumed D229-00-1/201/CLG-01: Ceiling: Solid - 1 - Circulation Area - Station Building - Hatton Cross Stn Start(m): Not Specified Finish(m): Not Specified	
Hazard Area:	Void	
Comments:	No Access above Plasterboard Ceiling	
Reference:	24520

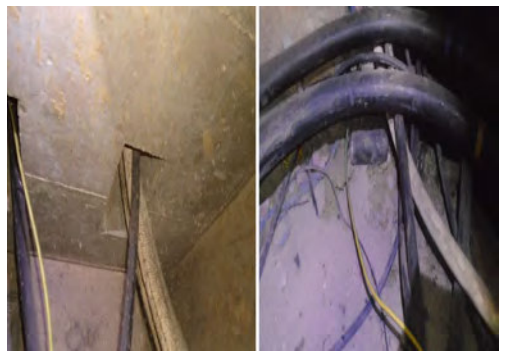
Description:	Asbestos: Known D229-00-1/661: Switch Room - Station Building - Hatton Cross Stn Start(m): Not Specified Finish(m): Not Specified	
Hazard Area:	Cable: Sheath	
Comments:	Cable Pit - 2x White braided cables running from external wall (bus stop side) along walls (loose to floor) and into electrical main sector box

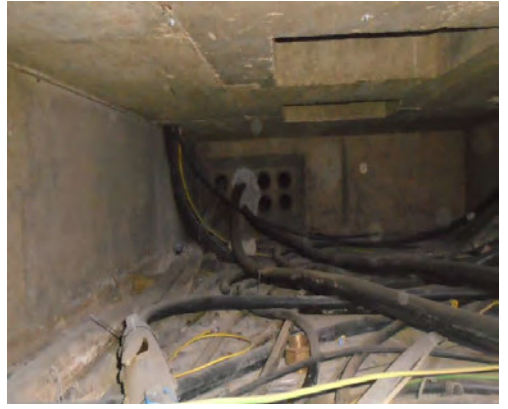
Reference:	45282

Description:	Asbestos: Known D229-00-1/661: Switch Room - Station Building - Hatton Cross Stn Start(m): Not Specified Finish(m): Not Specified	
Hazard Area:	Cable Ducts: Bitumen	
Comments:	Cable Pit - 8x cable ducts to external wall(bus stop side) in cable pit	
Reference:	25286

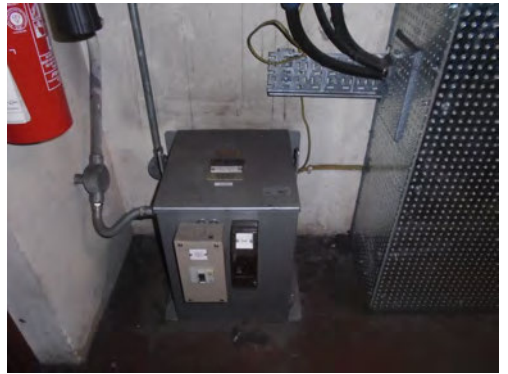
Description:	Asbestos: Presumed D229-00-1/661/WAL-001: Wall: Internal - 1 - Switch Room - Station Building - Hatton Cross Stn Start(m): Not Specified Finish(m): Not Specified	
Hazard Area:	Other Electrical Boxes	
Comments:	1 x Transformer Boxes No electrician on site during 2020 re-inspection to open boxes for inspection - therefore cannot score material within.	
Reference:	24529

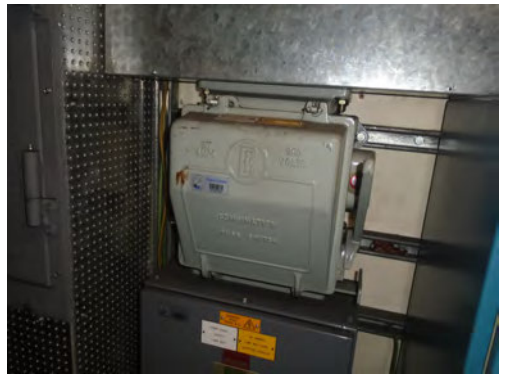
Description:	Asbestos: Presumed D229-00-1/661/WAL-001: Wall: Internal - 1 - Switch Room - Station Building - Hatton Cross Stn Start(m): Not Specified Finish(m): Not Specified	
Hazard Area:	Isolator Switches	
Comments:	1x 60amp Combination switch box

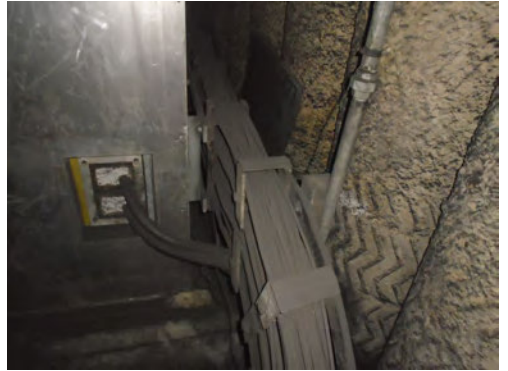
Reference:	24618

Description:	Asbestos: Known D229-00-2/081: Lobby - Station Building - Hatton Cross Stn Start(m): Not Specified Finish(m): Not Specified	
Hazard Area:	Cable: Sheath	
Comments:	10 x 15mm cable entry via invert runs along RHS relay room - j hanger no. 1	
Reference:	24612

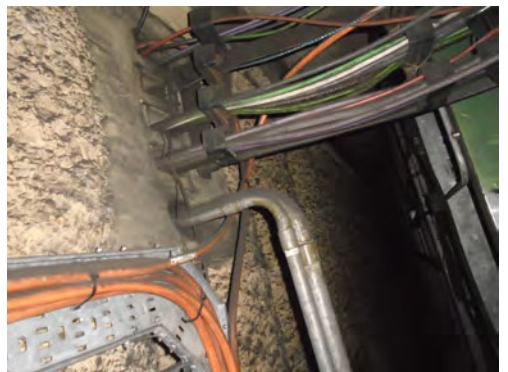
Description:	Asbestos: Known D229-00-2/081: Lobby - Station Building - Hatton Cross Stn Start(m): Not Specified Finish(m): Not Specified	
Hazard Area:	Cable: Sheath	
Comments:	4x30mm cable, entry from invert - exit: LHS of relay room into relay room, j hanger no. 2	
Reference:	24613

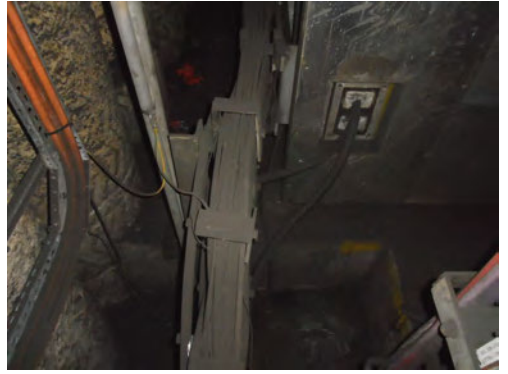
Reference:	24614

Description:	Asbestos: Known D229-00-2/081: Lobby - Station Building - Hatton Cross Stn Start(m): Not Specified Finish(m): Not Specified	
Hazard Area:	Cable: Sheath	
Comments:	1x 30mm cable entry from invert, exit LHS of relay room into relay room, j hanger no. 3	
Reference:	24608

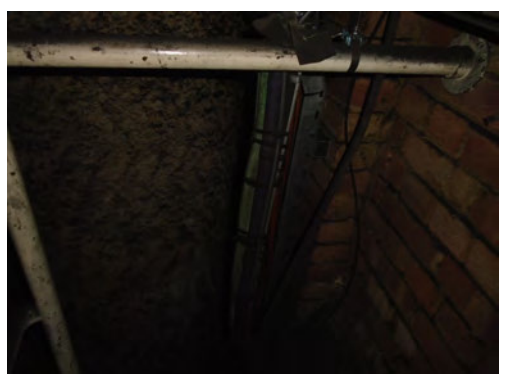
Description:	Asbestos: Known D229-00-2/081: Lobby - Station Building - Hatton Cross Stn Start(m): Not Specified Finish(m): Not Specified	
Hazard Area:	Cable: Sheath	
Comments:	3x15mm cable entry via invert runs along RHS relay room - j hanger no. 3

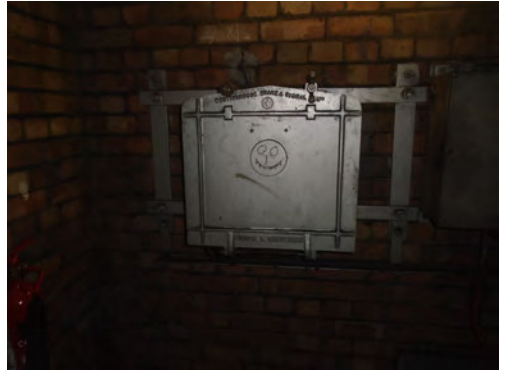
Reference:	24605

Description:	Asbestos: Presumed D229-00-2/081/WAL-001: Wall: Internal - 1 - Lobby - Station Building - Hatton Cross Stn Start(m): Not Specified Finish(m): Not Specified	
Hazard Area:	Westing house Boxes	
Comments:	1 x Westinghouse Box - Insulation within	
Reference:	24610

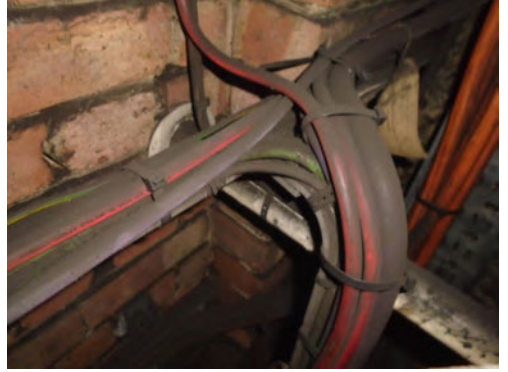
Description:	Asbestos: Known D229-00-2/081/WAL-002: Wall: Internal - 2 - Lobby - Station Building - Hatton Cross Stn Start(m): Not Specified Finish(m): Not Specified	
Hazard Area:	Cable: Sheath	
Comments:	1 x15mm cable - enters room via platform signal box wall 2 - drops into invert	
Reference:	24609

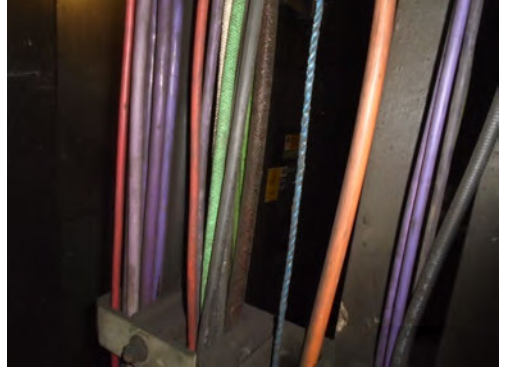
Description:	Asbestos: Known D229-00-2/081/WAL-003: Wall: Internal - 3 - Lobby - Station Building - Hatton Cross Stn Start(m): Not Specified Finish(m): Not Specified	
Hazard Area:	Cable: Sheath	
Comments:	1x20mm cable enters room via invert to high level, exits through concrete ducts to wall 3 to trackside

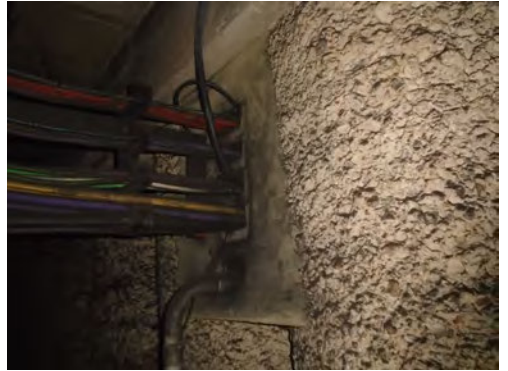
Reference:	24617

Description:	Asbestos: Known D229-00-2/081/WAL-005: Wall: Internal - 5 - Lobby - Station Building - Hatton Cross Stn Start(m): Not Specified Finish(m): Not Specified	
Hazard Area:	Cable: Sheath	
Comments:	1x20mm cable entry through invert to high level, exit through concrete duct wall 5 to trackside	
Reference:	25373

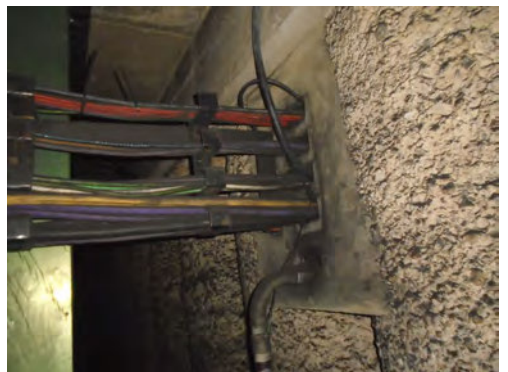
Description:	Asbestos: Known D229-00-2/081/WAL-005: Wall: Internal - 5 - Lobby - Station Building - Hatton Cross Stn Start(m): Not Specified Finish(m): Not Specified	
Hazard Area:	Cable: Sheath	
Comments:	4x15mm cable entry through invert to high level, exit through concrete duct wall 5 to trackside	
Reference:	24616

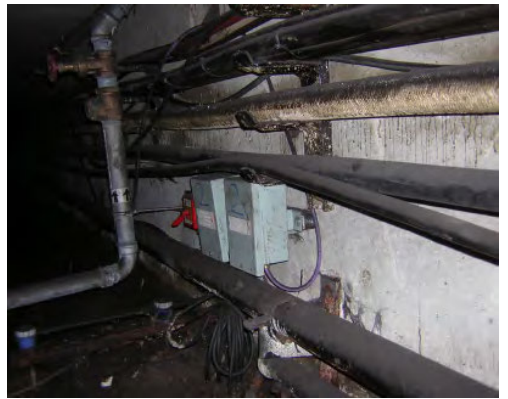
Reference:	24695

Description:	Asbestos: Presumed D229-00-2/261: Platform 1 - Westbound Local - Station Building - Hatton Cross Stn Start(m): Not Specified Finish(m): Not Specified	
Hazard Area:	Other Electrical Boxes	
Comments:	Platform 1 Invert - possible ACM inside 2 electrical boxes on the track wall

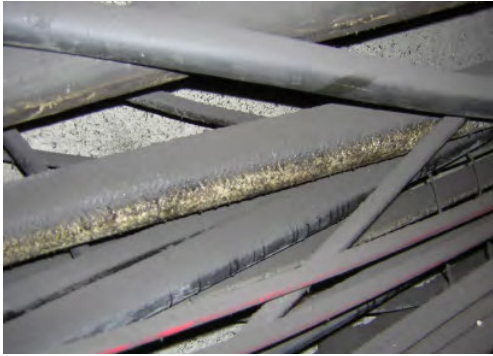
Description:	Asbestos: Strongly Presumed D229-00-2/261: Platform 1 - Westbound Local - Station Building - Hatton Cross Stn Start(m): Not Specified Finish(m): Not Specified	
Hazard Area:	Cable: Sheath	
Comments:	Platform 1 Invert - 1x Braided cable - trackside wall on 3rd from top j hanger	
Reference:	24694

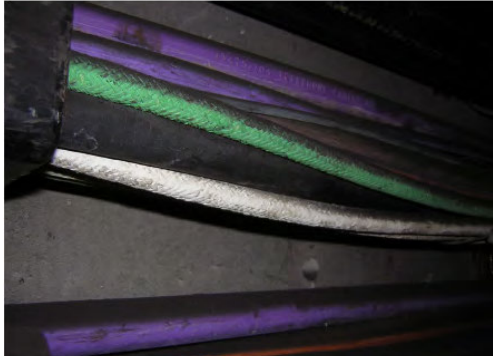
Description:	Asbestos: Strongly Presumed D229-00-2/261: Platform 1 - Westbound Local - Station Building - Hatton Cross Stn Start(m): Not Specified Finish(m): Not Specified	
Hazard Area:	Cable: Sheath	
Comments:	Platform 1 Invert - 5x Braided cables on platform side wall - green and white cables	
Reference:	24687	
Description:	Asbestos: Strongly Presumed D229-00-2/261: Platform 1 - Westbound Local - Station Building - Hatton Cross Stn Start(m): Not Specified Finish(m): Not Specified	
Hazard Area:	Cable Duct: Other	
Comments:	Concourse Invert (hatch near 2/081) - 1 x cable sleeve filled in - 6m from entrance

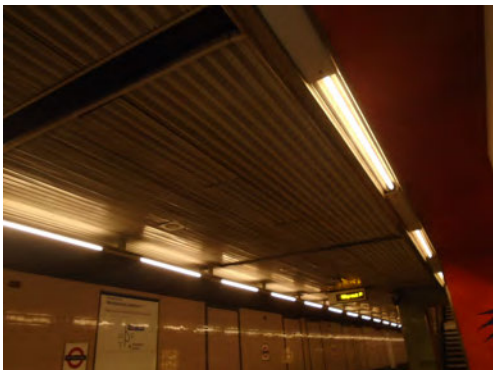
Description:	Asbestos: Strongly Presumed D229-00-2/261/CLG-01: Ceiling: Suspended - 1 - Platform 1 - Station Building - Hatton Cross Stn Start(m): Not Specified Finish(m): Not Specified	
Hazard Area:	Cable: Sheath	
Comments:	2 x braided cables in access hatch

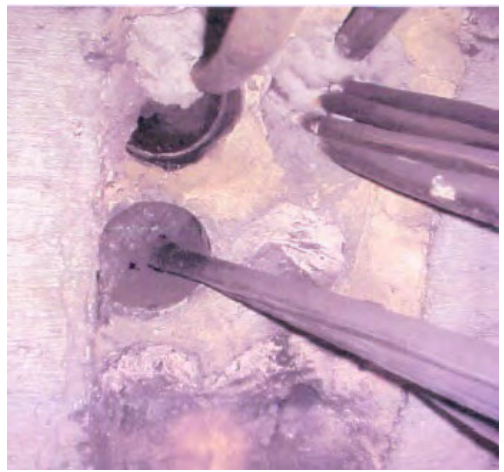
Description:	Asbestos: Known D229-00-2/262: Platform 2 - Eastbound Local - Station Building - Hatton Cross Stn Start(m): Not Specified Finish(m): Not Specified	
Hazard Area:	Cable Duct: Other	
Comments:	Platform 2 - Invert 6 x cable sleeves - Head wall - Chrysotile	
Reference:	24416

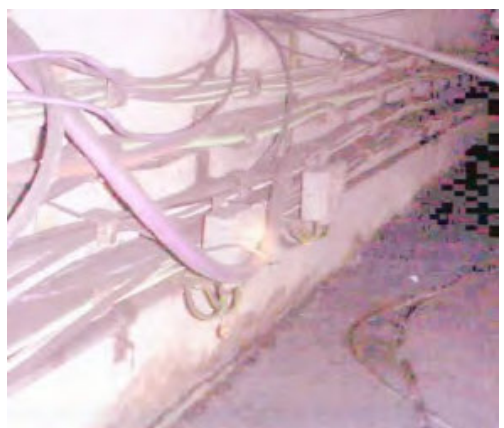
Description:	Asbestos: Presumed D229-00-2/262: Platform 2 - Eastbound Local - Station Building - Hatton Cross Stn Start(m): Not Specified Finish(m): Not Specified	
Hazard Area:	Westing house Boxes	
Comments:	Components within 2 x Small Westinghouse boxes

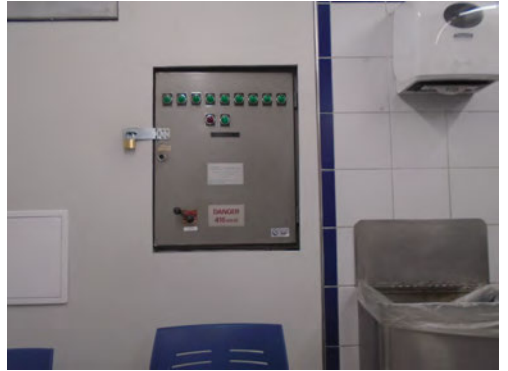
Description:	Asbestos: Presumed D229-00-2/331/CLG-01: Ceiling: Solid - 1 - Mess Room - Station Building - Hatton Cross Stn Start(m): Not Specified Finish(m): Not Specified	
Hazard Area:	Control Panels	
Comments:	Control panel 1 no to wall 2 behind locker	
Reference:	44290

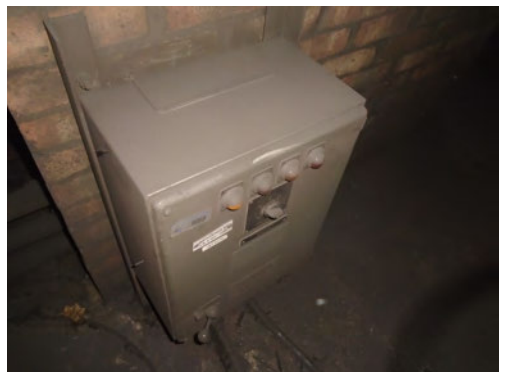
Description:	Asbestos: Presumed D229-00-2/414: Yard - Station Building - Hatton Cross Stn Start(m): Not Specified Finish(m): Not Specified	
Hazard Area:	Control Panels	
Comments:	Fan Control panel 1 no to low wall in front of metal platform	
Reference:	25382

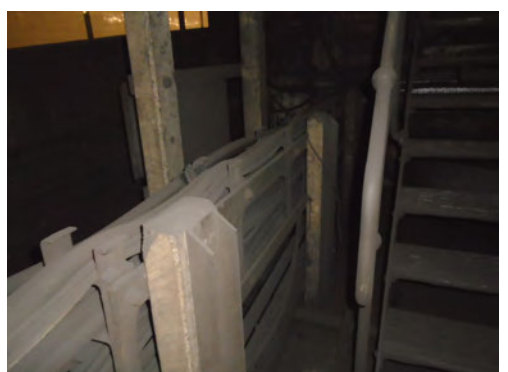
Description:	Asbestos: Strongly Presumed D229-00-2/414: Yard - Station Building - Hatton Cross Stn Start(m): Not Specified Finish(m): Not Specified	
Hazard Area:	Cable: Sheath	
Comments:	Cable Run WB - 7 x braided cables

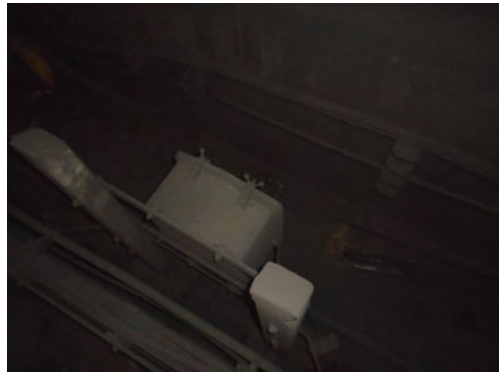
Description:	Asbestos: Strongly Presumed D229-00-2/414: Yard - Station Building - Hatton Cross Stn Start(m): Not Specified Finish(m): Not Specified	
Hazard Area:	Westing house Boxes	
Comments:	Wall by Invert EB side - Westinghouse Box & 2 x Green 40mmØ Cables	
Reference:	24796

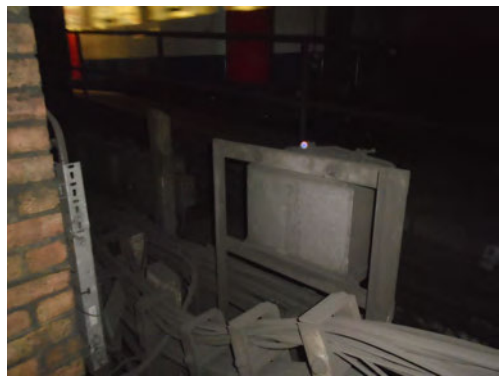
Description:	Asbestos: Strongly Presumed D229-00-2/414: Yard - Station Building - Hatton Cross Stn Start(m): Not Specified Finish(m): Not Specified	
Hazard Area:	Rope Seals	
Comments:	Trackside Wall WB - 4 x Westinghouse Boxes	
Reference:	24795

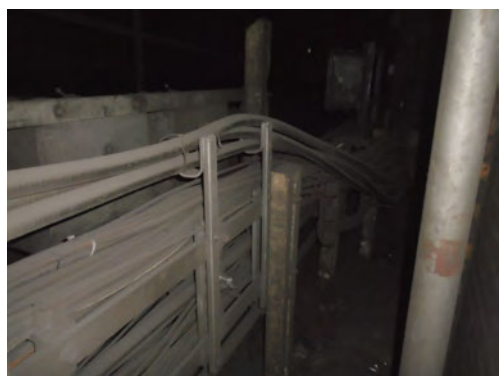
Description:	Asbestos: Strongly Presumed D229-00-2/414: Yard - Station Building - Hatton Cross Stn Start(m): Not Specified Finish(m): Not Specified	
Hazard Area:	Cable: Sheath	
Comments:	Trackside Wall WB - 2 x braided cables

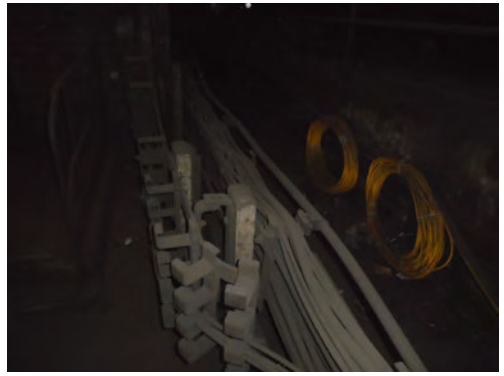
Description:	Asbestos: Strongly Presumed D229-00-2/414: Yard - Station Building - Hatton Cross Stn Start(m): Not Specified Finish(m): Not Specified	
Hazard Area:	Cable: Sheath	
Comments:	Cable Run EB - 14 x cables	
Reference:	24713

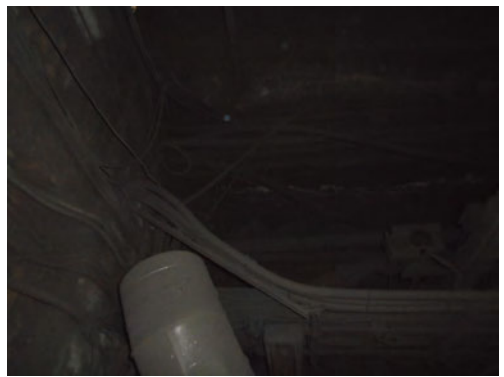
Description:	Asbestos: Strongly Presumed D229-00-2/414: Yard - Station Building - Hatton Cross Stn Start(m): Not Specified Finish(m): Not Specified	
Hazard Area:	Cable Duct: Other	
Comments:	Wall to Invert WB side - 6 x cable sleeves in each - Encapsulated - no access	
Reference:	24712

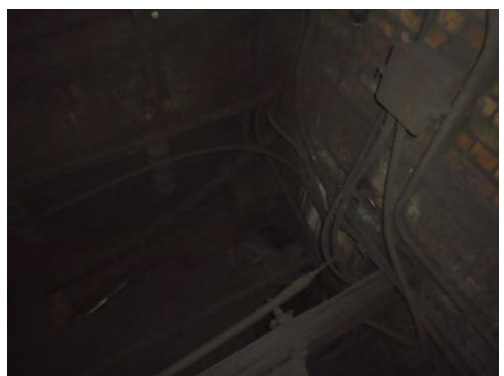
Description:	Asbestos: Strongly Presumed D229-00-2/414: Yard - Station Building - Hatton Cross Stn Start(m): Not Specified Finish(m): Not Specified	
Hazard Area:	Cable Duct: Other	
Comments:	Wall to Invert EB side - 6 x cable sleeves in each - Encapsulated - no access

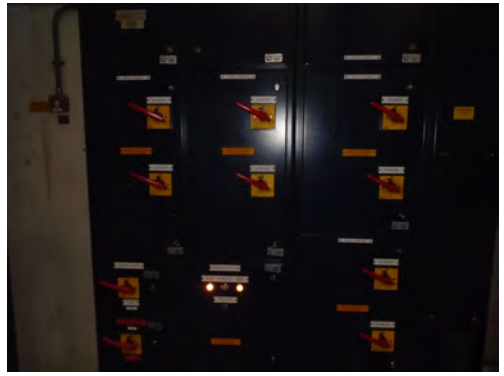
Description:	Asbestos: Presumed D229-00-2/661/WAL-002: Wall: Internal - 2 - Switch Room - Station Building - Hatton Cross Stn Start(m): Not Specified Finish(m): Not Specified	
Hazard Area:	Other Electrical Boxes	
Comments:	Automatic change over box	
Reference:	24679

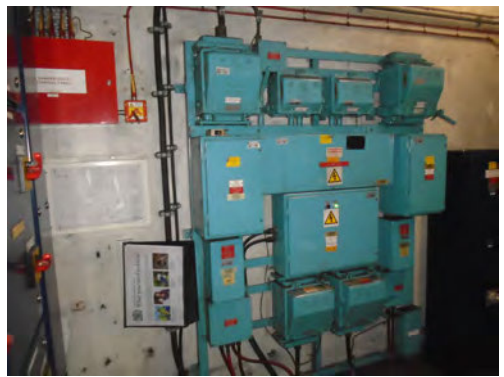
Description:	Asbestos: Strongly Presumed D229-00-2/661/WAL-002: Wall: Internal - 2 - Switch Room - Station Building - Hatton Cross Stn Start(m): Not Specified Finish(m): Not Specified	
Hazard Area:	Isolator Switches	
Comments:	Switch boxes Insulation within 4 x 60amp, 2 x30amp	
Reference:	24808

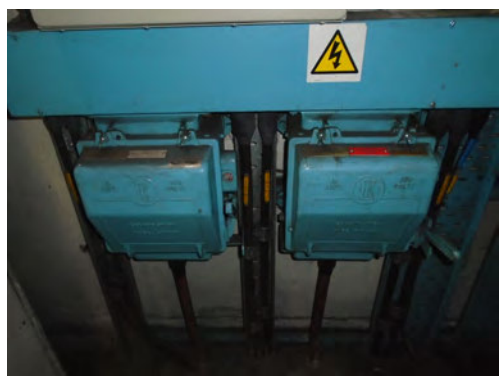
Description:	Asbestos: Strongly Presumed D229-00-2/661/WAL-004: Wall: Internal - 4 - Switch Room - Station Building - Hatton Cross Stn Start(m): Not Specified Finish(m): Not Specified	
Hazard Area:	Isolator Switches	
Comments:	Switch boxes Insulation within - 2x 60amp

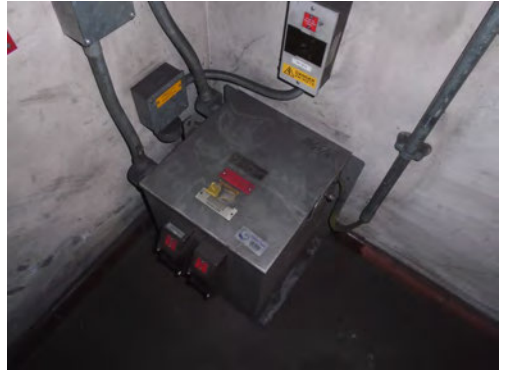
Description:	Asbestos: Presumed D229-00-2/662/WAL-001: Wall: Internal - 1 - Switch Room - Station Building - Hatton Cross Stn Start(m): Not Specified Finish(m): Not Specified	
Hazard Area:	Other Electrical Boxes	
Comments:	1 x Transformer Box on floor	
Reference:	25392

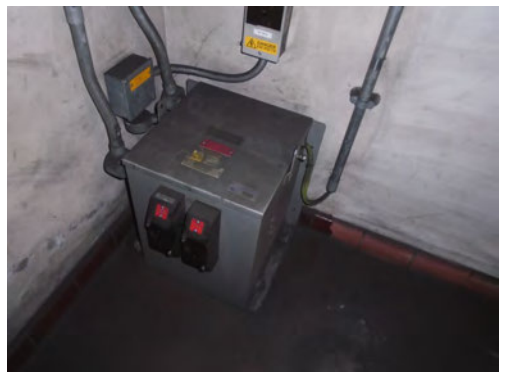
Description:	Asbestos: Presumed D229-00-2/662/WAL-002: Wall: Internal - 2 - Switch Room - Station Building - Hatton Cross Stn Start(m): Not Specified Finish(m): Not Specified	
Hazard Area:	Other Electrical Boxes	
Comments:	1x 8KVA transformer on the floor wall 2 and 3	
Reference:	44289

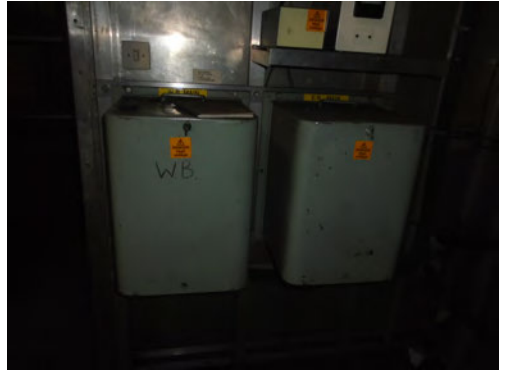
Description:	Asbestos: Presumed D229-00-2/712: Relay Room - Station Building - Hatton Cross Stn Start(m): Not Specified Finish(m): Not Specified	
Hazard Area:	Other Electrical Boxes	
Comments:	2 x Circuit Breakers	
Reference:	24814

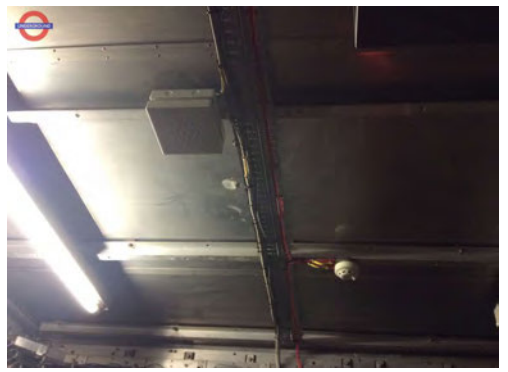
Description:	Asbestos: No Access: Presumed D229-00-2/712/CLG-01: Ceiling: Solid - 1 - Relay Room - Station Building - Hatton Cross Stn Start(m): Not Specified Finish(m): Not Specified	
Hazard Area:	Void	
Comments:	No access behind Metal Cladding	
Reference:	24815

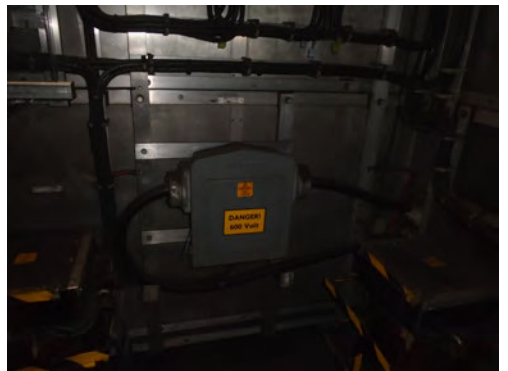
Description:	Asbestos: Strongly Presumed D229-00-2/712/WAL-001: Wall: Internal - 1 - Relay Room - Station Building - Hatton Cross Stn Start(m): Not Specified Finish(m): Not Specified	
Hazard Area:	Westing house Boxes	
Comments:	Westinghouse Joint Boxes

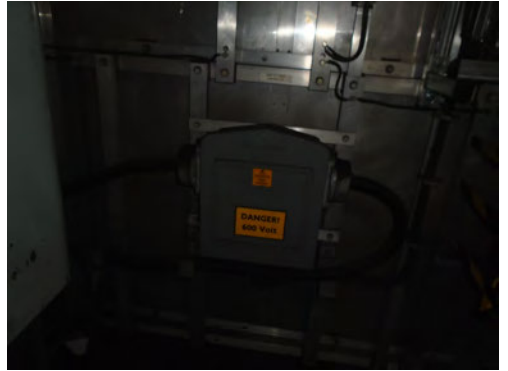
Reference:	25469

Description:	Asbestos: Strongly Presumed D229-00-2/712/WAL-003: Wall: Internal - 3 - Relay Room - Station Building - Hatton Cross Stn Start(m): Not Specified Finish(m): Not Specified	
Hazard Area:	Westing house Boxes	
Comments:	Westinghouse Joint Boxes	
Reference:	24903

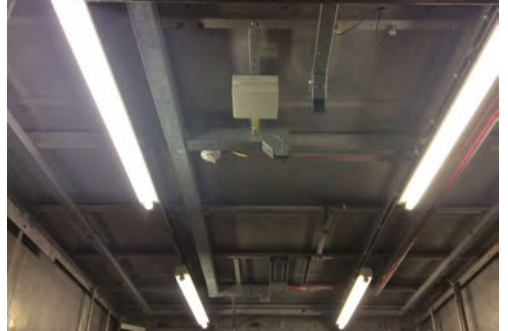
Description:	Asbestos: No Access: Presumed D229-00-2/731/CLG-01: Ceiling: Solid - 1 - CER - Station Building - Hatton Cross Stn Start(m): Not Specified Finish(m): Not Specified	
Hazard Area:	Void	
Comments:	No Access behind Metal Cladding

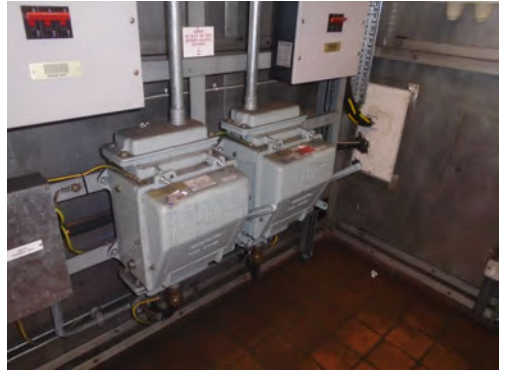
Reference:	24904

Description:	Asbestos: Strongly Presumed D229-00-2/731/WAL-003: Wall: Internal - 3 - CER - Station Building - Hatton Cross Stn Start(m): Not Specified Finish(m): Not Specified	
Hazard Area:	Isolator Switches	
Comments:	Switch Boxes - Insulation within 2 x 60amp	
Reference:	24681
