Driver behaviour at continuous footways research

Report
March 2018

Transport for London

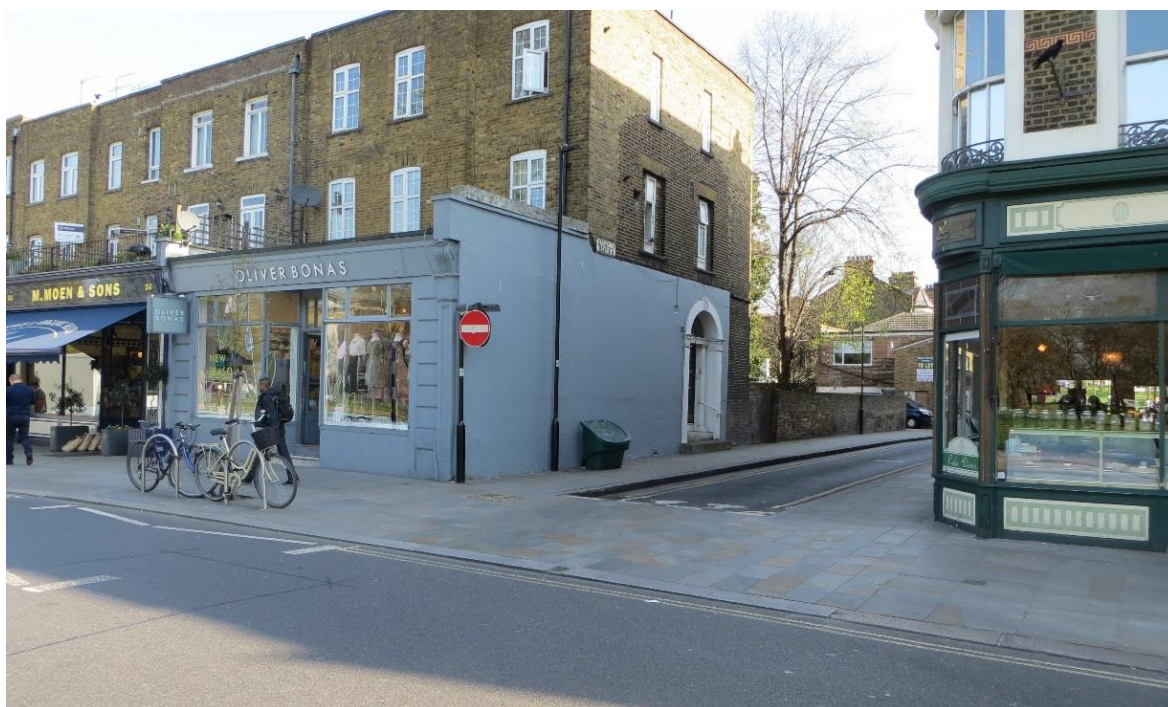
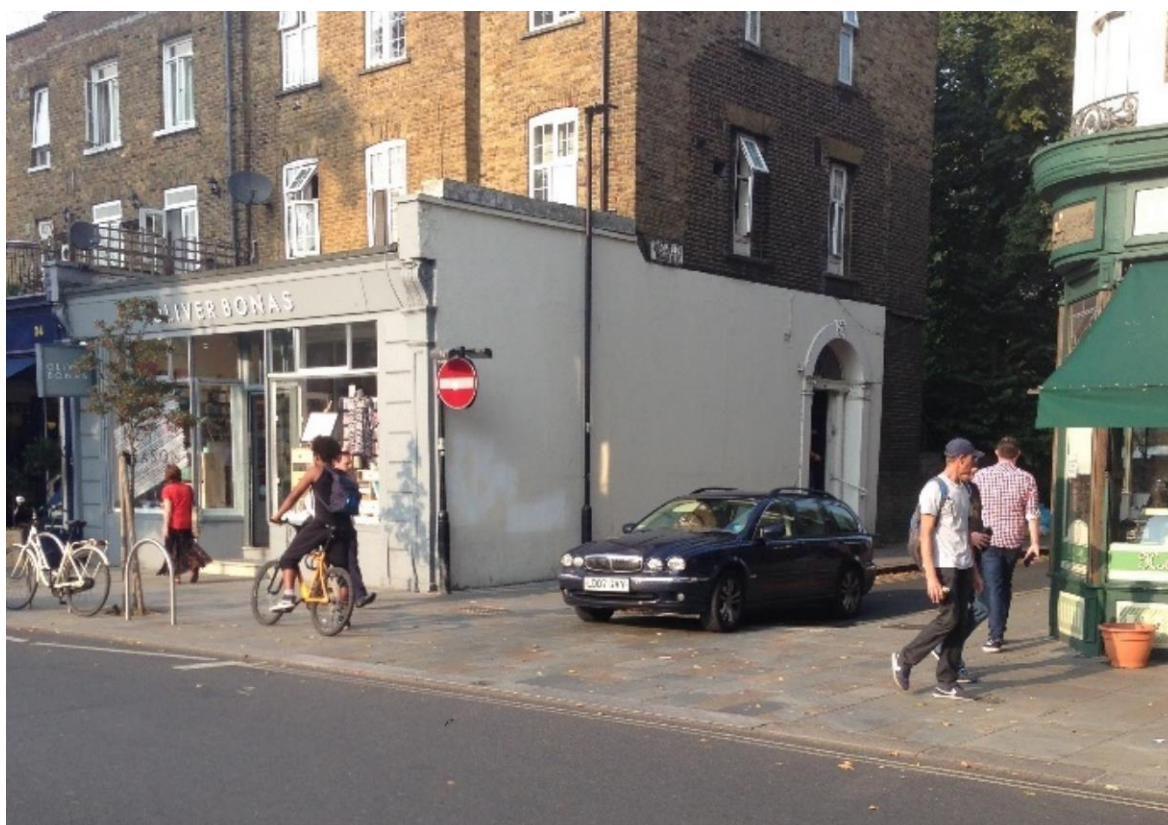
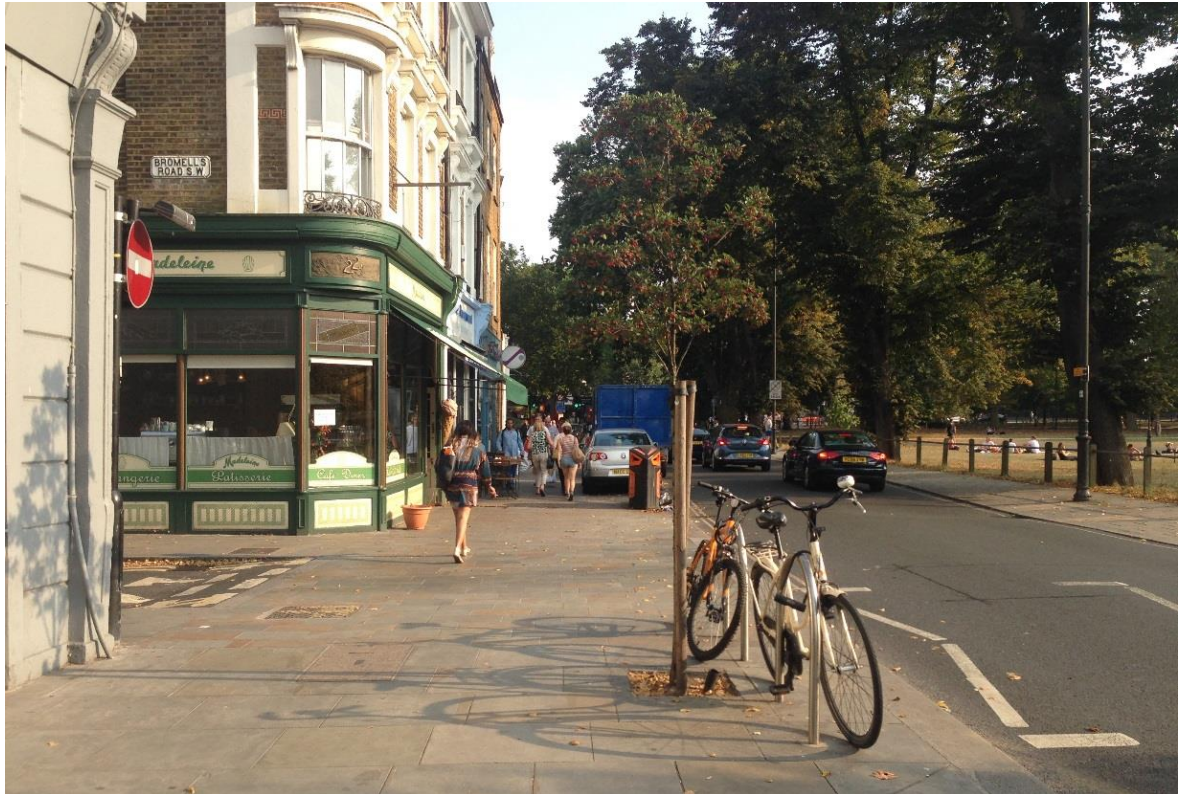
Figure 1.1: A continuous footway treatment in Clapham, south London

- 1.3 The design intent is to prioritise pedestrian movement along the continuous footway; drivers are expected to modify their behaviour accordingly. At the time of this research, continuous footways are still relatively rare in London; examples can be found in Clapham Old Town and in Waltham Forest as part of the mini-Holland scheme.

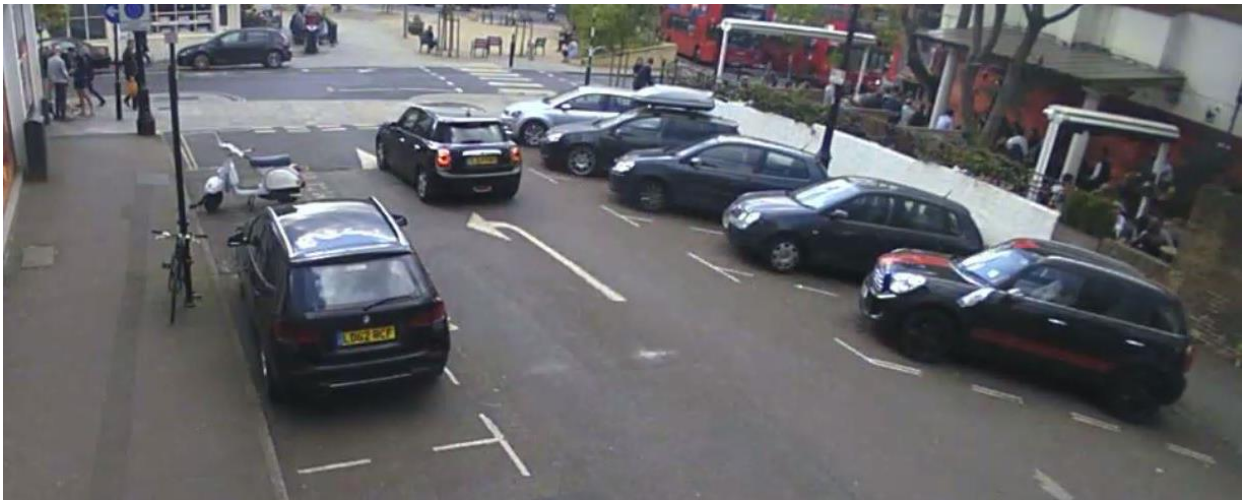
A vehicle approaches the junction, while a pedestrian with an orange carrier bag walks towards the junction mouth.

The vehicle proceeds to stop on the continuous footway, the pedestrian is at the junction edge and diverts to walk behind the stopped vehicle.

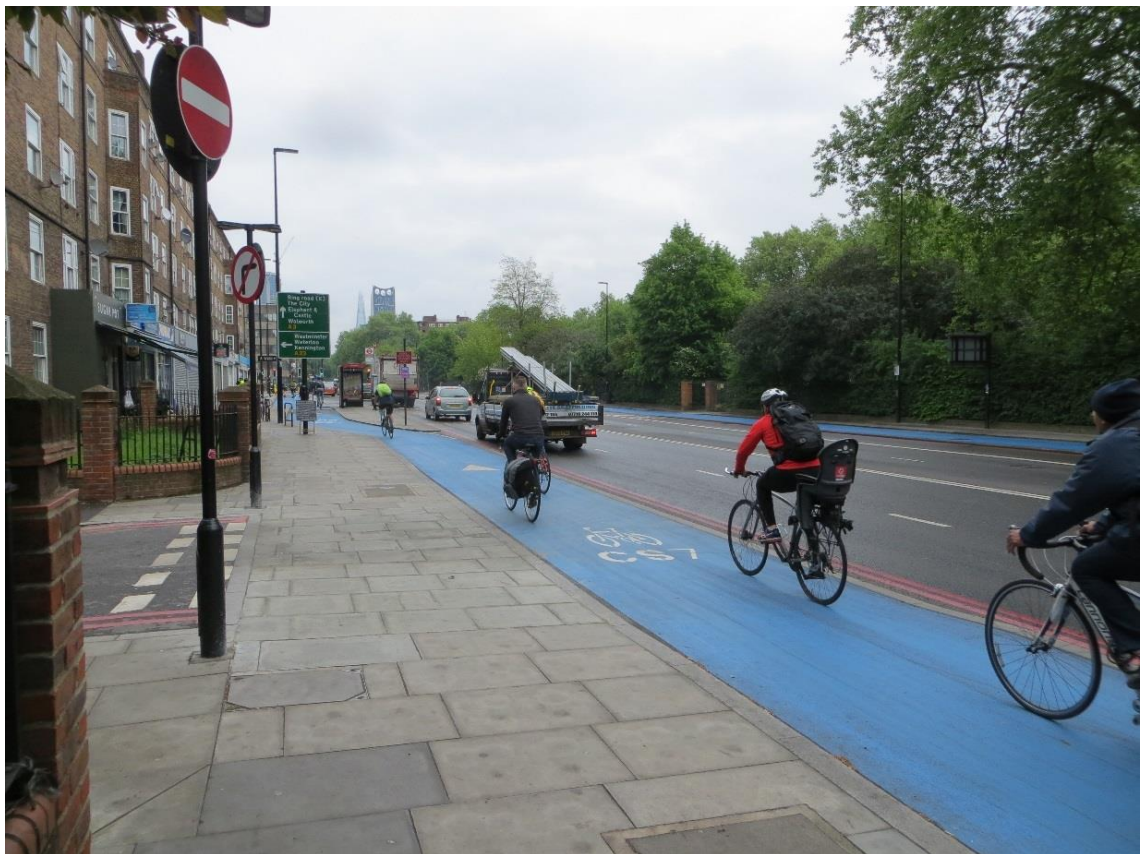
Figure 4.5: Cycle Superhighway 7 at Site 1: Kennington Park Road / Magee Street

- 4.8 As noted in the presentation of each case study junction, there were relatively few cyclist / driver interactions noted: only 154 in total across all seven case study junctions, compared to 3,537 pedestrian / driver interactions. This is because of the relatively small number of cyclists using the main roads and few vehicles using the side roads. In many cases, vehicles using the junction were interacting with pedestrians using the footway or vehicles using the main road rather than cyclists. This means that the data in this section should be treated with caution and any findings that can be drawn from this data are only indicative. Moreover, the majority of these interactions were observed at Site 1: Kennington Park Road / Magee Street where a stepped cycle track (part of Cycle Superhighway 7) runs adjacent to the continuous footway (Figure 4.5).

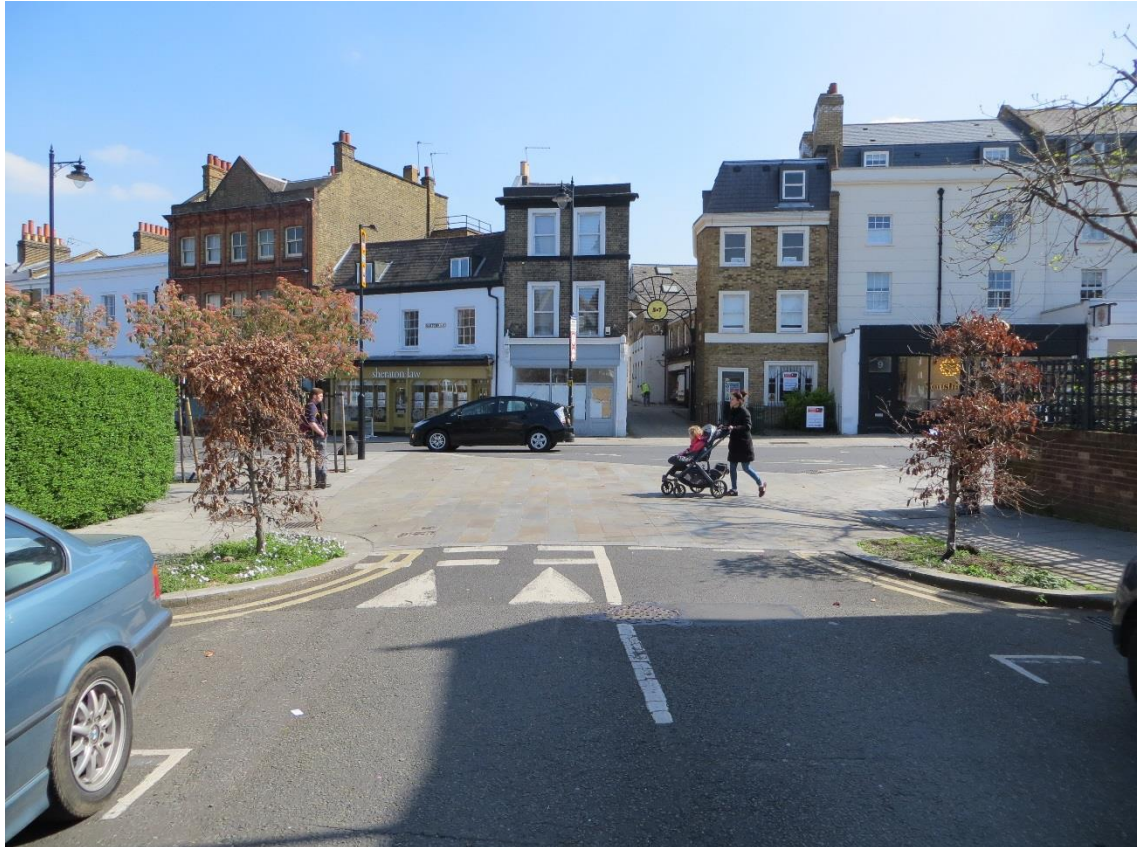
Figure 4.23: Deep continuous footway at Site 2: Clapham Old Town / Lydon Road

- 4.50 We observed that drivers were less likely to slow and stop at the dashed give way line at Sites 2 and 3 because it was set back a long way from the junction mouth. If drivers stopped at this give way point, they would be unable to see clearly on to the main road, and they are even several metres behind pedestrians crossing on the footway itself. Drivers therefore tended to proceed on to the footway and wait there (this behaviour is illustrated in Figure 3.19 in Objective 1).

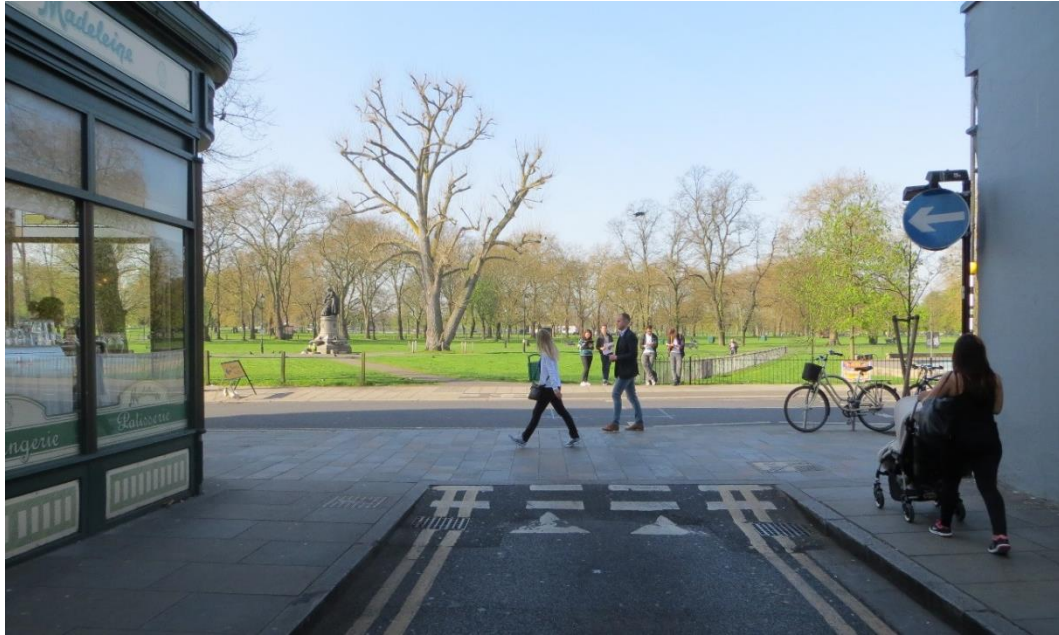
Figure 4.27: Restricted sightlines at Site 6: The Pavement / Bromell's Road

- 4.56 The data on driver behaviour supports this finding: 24% of drivers slow or stop when turning out of Site 4, compared to 7.9% at Site 6. Figure 4.29 and Figure 4.30 show this and the corresponding proportion of drivers who slow or stop, or who stop on the continuous footway. While this data supports the finding that restricted sightlines can make drivers more cautious when turning out, it should be noted that sightlines are but one of many different factors influencing driver behaviour at these sites so this finding may be due to confounding factors.
