# A10 KINGSLAND ROAD/STAMFORD ROAD HIGHWAYS IMPROVEMENTS

Stage 2 Road Safety Audit

Ref: 8126

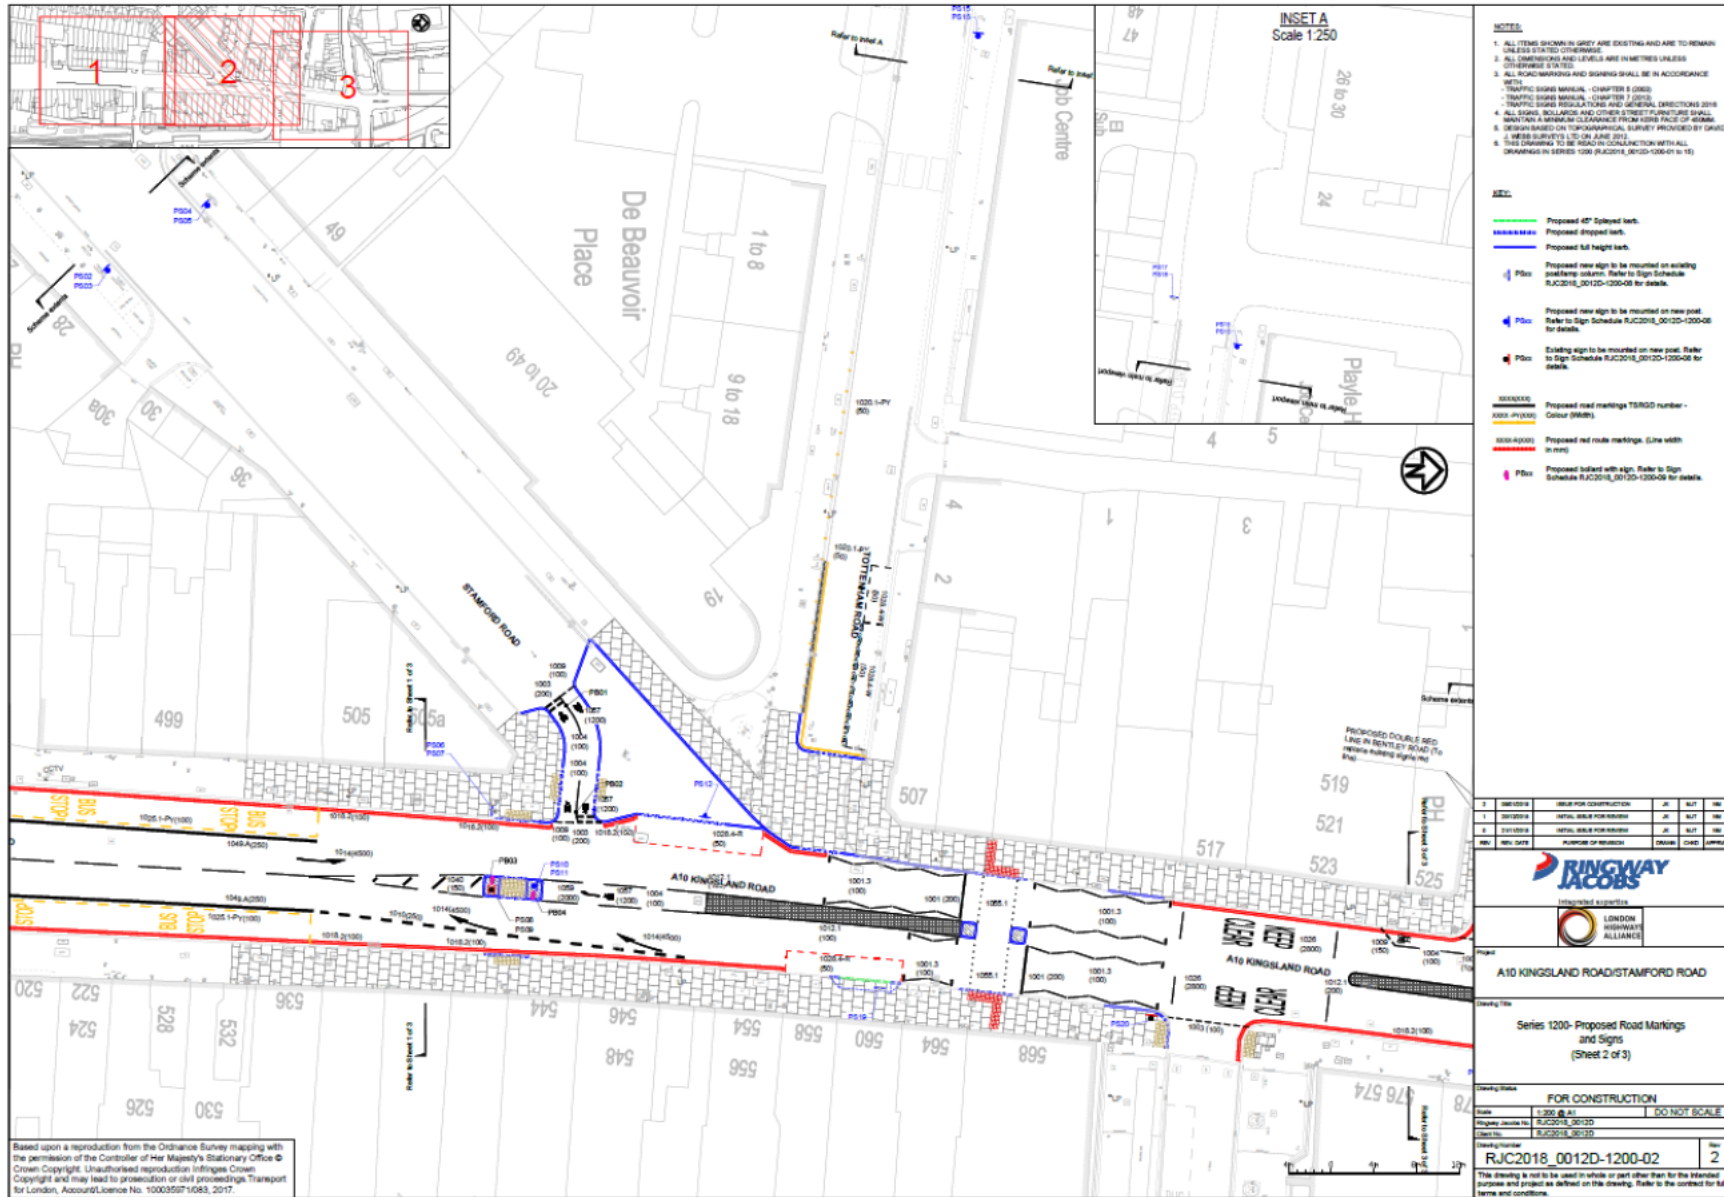
# APPENDIX B Problem Locations

**Location:** Stamford Road close to junction with Kingsland Road

**Summary:** Potential for collisions between cyclists and powered two wheeled vehicles.

It was noted at the time of the site visit that there is a motorcycle parking bay with close proximity to the proposed cycle lane. Whilst it is appreciated that bollards with a sign to Diag. 955 are to be installed, the Road Safety Audit Team are concerned that motorcyclists may choose to use the cycle lane to access Kingsland Road. This could lead to collisions between cycles and motorcyclists.

**Location:** Tottenham Road close to junction with Kingsland Road

**Summary:** Potential for collisions reversing vehicles and pedestrians.

It is proposed to close the junction of Tottenham Road and Kingsland Road as part of the works. It was noted at the time of the site visit that there is a car parking bay close to the junction in Tottenham Road. Vehicles using the parking bay will have to turn their vehicles to face westward or reverse into the private access several metres west in order to exit Tottenham Road. Both these manoeuvres could lead to conflicts between turning vehicles and pedestrians resulting in injury.

It is recommended that additional measures are used to deter motorcyclists from using the cycle lane.

It is recommended that the parking bay is removed as part of these works and that Waiting Restrictions including a Loading Ban are also introduced.
