Hazardous Material Asset Register - Detail for SharePoint

The purpose of this report is to detail the presence of any known (K), Presumed (P) or Strongly Presumed (SP) Asbestos Containing Materials (ACMs) within this location / asset. Any areas inaccessible during previous asbestos surveys are presumed (P) to contain ACMs until confirmed otherwise. All inaccessible areas will need to be surveyed prior to work being undertaken in these areas. Prior to any intrusive works commencing a Hazardous Materials Impact Assessment (F6048) must be submitted to [redacted]@tfl.gov.uk All staff / contractors working on this property must remain vigilant during their works and if any suspect material is encountered which is likely to be disturbed, contact the Hazardous Materials team prior to continuing the impacted works. Associated photographs can be found listed against the Maximo Reference number on the subsequent report.

Hazardous Materials - Photographs for SharePoint

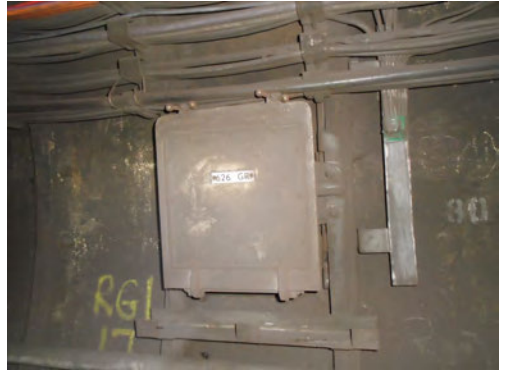
Reference:	31993	
Description:	Asbestos: Presumed N126-N-NBFA: Road NBFA - NOR - Old Street to Angel Start(m): 12 Finish(m): Not Specified	
Hazard Area:	Westinghouse Boxes	
Comments:	Westinghouse large	
Reference:	31658

Description:	Asbestos: Presumed N126-N-NBFA: Road NBFA - NOR - Old Street to Angel Start(m): 16 Finish(m): Not Specified	
Hazard Area:	Westinghouse Boxes	
Comments:	Trackside equipment Westinghouse large	
Reference:	31661

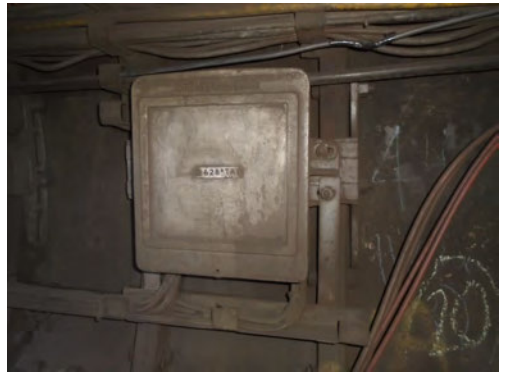
Description:	Asbestos: Presumed N126-N-NBFA: Road NBFA - NOR - Old Street to Angel Start(m): 23 Finish(m): Not Specified	
Hazard Area:	Westinghouse Boxes	
Comments:	Trackside equipment Westinghouse large	
Reference:	31662

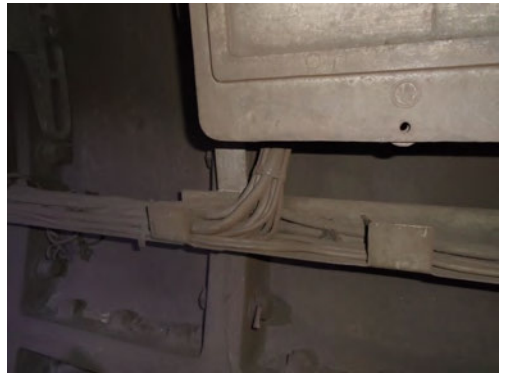
Description:	Asbestos: Known N126-N-NBFA: Road NBFA - NOR - Old Street to Angel Start(m): 24 Finish(m): Not Specified	
Hazard Area:	Cable Sheath	
Comments:	Woven cable sheath. Entry: JH, route: 1x5mmØ severed cables. 0.7x1 no

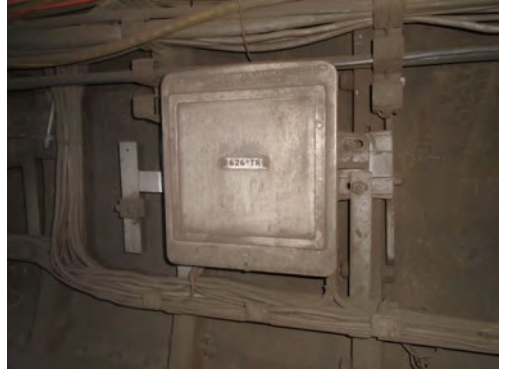
Reference:	46060

Description:	Asbestos: Presumed N126-N-NBFA: Road NBFA - NOR - Old Street to Angel Start(m): 24 Finish(m): Not Specified	
Hazard Area:	Westinghouse Boxes	
Comments:	Trackside equipment: Westinghouse large	
Reference:	31663

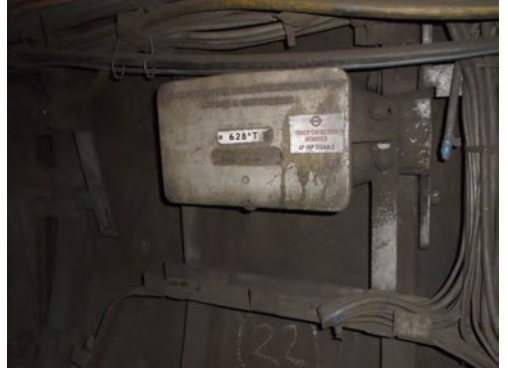
Description:	Asbestos: Presumed N126-N-NBFA: Road NBFA - NOR - Old Street to Angel Start(m): 25 Finish(m): Not Specified	
Hazard Area:	Westinghouse Boxes	
Comments:	Trackside equipment Westinghouse large	
Reference:	31664	 
Description:	Asbestos: Known N126-N-NBFA: Road NBFA - NOR - Old Street to Angel Start(m): 26 Finish(m): Not Specified	
Hazard Area:	Cable Sheath	
Comments:	Woven cable sheath. Entry: JH, route: 1x5mmØ severed cables. 0.7x1 no	
Reference:	35301

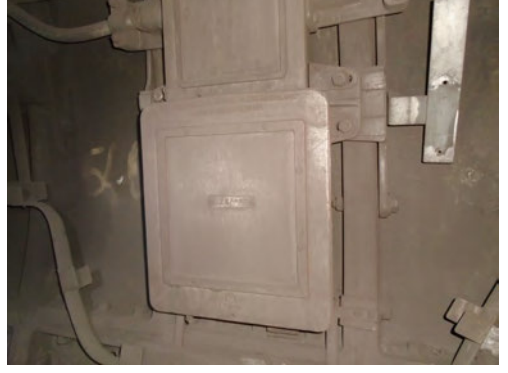
Description:	Asbestos: Presumed N126-N-NBFA: Road NBFA - NOR - Old Street to Angel Start(m): 26 Finish(m): Not Specified	
Hazard Area:	Westinghouse Boxes	
Comments:	Trackside equipment Westinghouse large

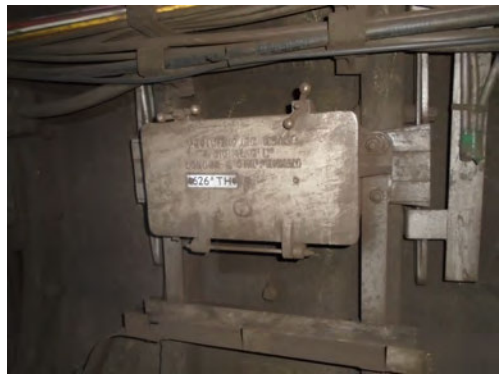
Reference:	31676

Description:	Asbestos: Presumed N126-N-NBFA: Road NBFA - NOR - Old Street to Angel Start(m): 160 Finish(m): Not Specified	
Hazard Area:	Westinghouse Boxes	
Comments:	Trackside equipment Westinghouse large	
Reference:	31759

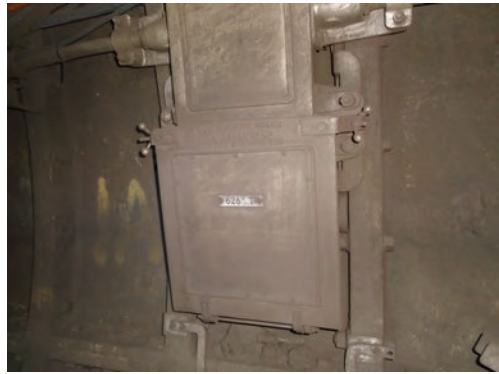
Description:	Asbestos: Presumed N126-N-NBFA: Road NBFA - NOR - Old Street to Angel Start(m): 161 Finish(m): Not Specified	
Hazard Area:	Westinghouse Boxes	
Comments:	Trackside equipment Westinghouse large	
Reference:	31758

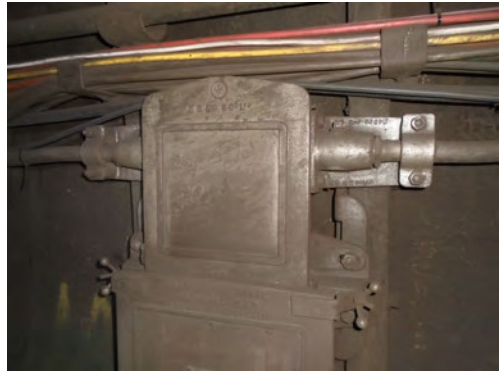
Description:	Asbestos: Presumed N126-N-NBFA: Road NBFA - NOR - Old Street to Angel Start(m): 161 Finish(m): Not Specified	
Hazard Area:	Westinghouse Boxes	
Comments:	Trackside equipment Westinghouse large	
Reference:	46061	
Description:	Asbestos: Known N126-N-NBFA: Road NBFA - NOR - Old Street to Angel Start(m): 210 Finish(m): Not Specified	
Hazard Area:	Cable Sheath	
Comments:	numerous woven cable sheath Entry: JH4, route: 2x15mmØ

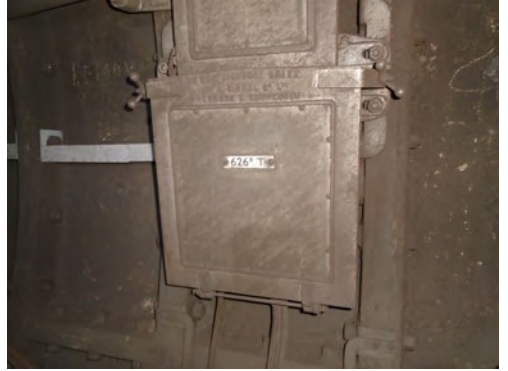
Reference:	31769

Description:	Asbestos: Presumed N126-N-NBFA: Road NBFA - NOR - Old Street to Angel Start(m): 236 Finish(m): Not Specified	
Hazard Area:	Westinghouse Boxes	
Comments:	Trackside equipment Westinghouse large	
Reference:	31767

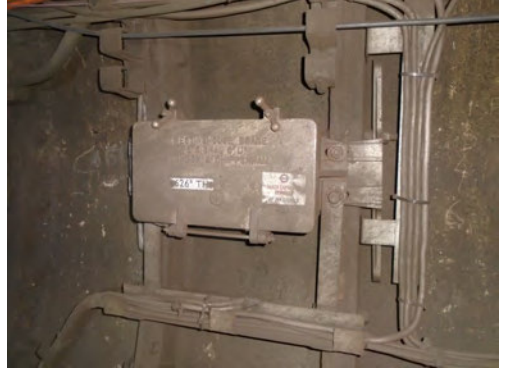
Description:	Asbestos: Presumed N126-N-NBFA: Road NBFA - NOR - Old Street to Angel Start(m): 236 Finish(m): Not Specified	
Hazard Area:	Westinghouse Boxes	
Comments:	Trackside equipment Westinghouse large	
Reference:	31774

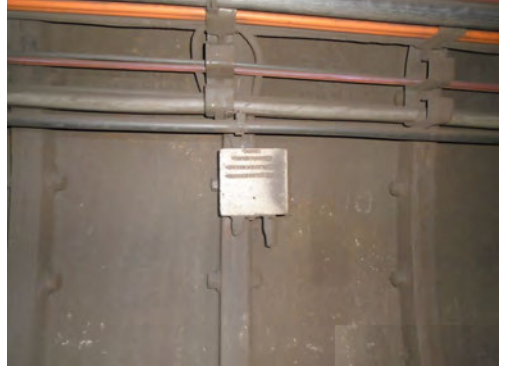
Description:	Asbestos: Presumed N126-N-NBFA: Road NBFA - NOR - Old Street to Angel Start(m): 392 Finish(m): Not Specified	
Hazard Area:	Westinghouse Boxes	
Comments:	Trackside equipment Westinghouse small	
Reference:	31777

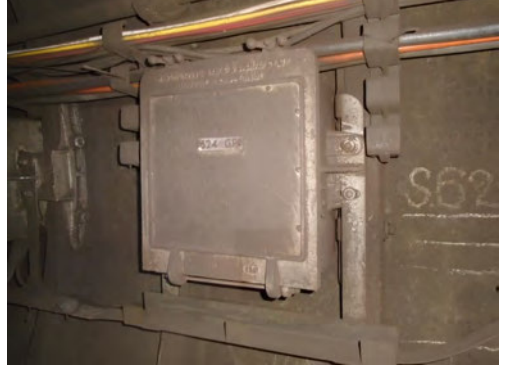
Description:	Asbestos: Presumed N126-N-NBFA: Road NBFA - NOR - Old Street to Angel Start(m): 465 Finish(m): Not Specified	
Hazard Area:	Westinghouse Boxes	
Comments:	Trackside equipment Westinghouse large

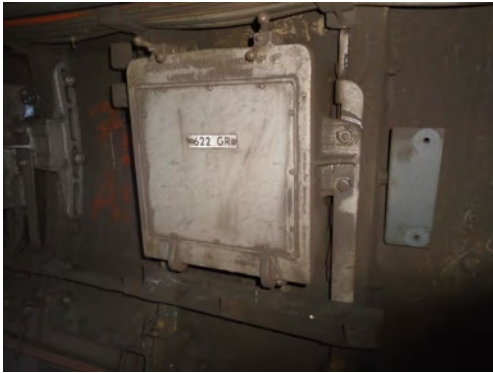
Description:	Asbestos: Presumed N126-N-NBFA: Road NBFA - NOR - Old Street to Angel Start(m): 788 Finish(m): Not Specified	
Hazard Area:	Westinghouse Boxes	
Comments:	Trackside equipment Westinghouse large

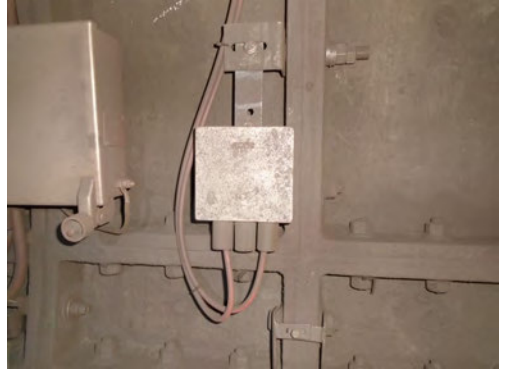
Reference:	31891

Description:	Asbestos: Presumed N126-N-NBFA: Road NBFA - NOR - Old Street to Angel Start(m): 1143 Finish(m): Not Specified	
Hazard Area:	Westinghouse Boxes	
Comments:	Trackside equipment Westinghouse small	
Reference:	35400

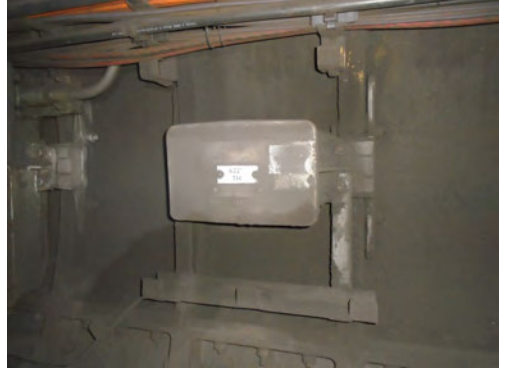
Description:	Asbestos: Presumed N126-N-NBFA: Road NBFA - NOR - Old Street to Angel Start(m): 1144 Finish(m): Not Specified	
Hazard Area:	Westinghouse Boxes	
Comments:	Trackside equipment Westinghouse large	
Reference:	31894

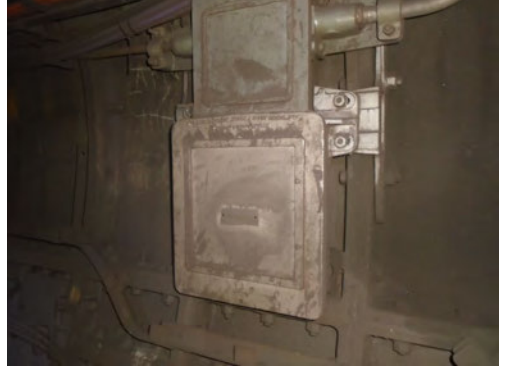
Description:	Asbestos: Presumed N126-N-NBFA: Road NBFA - NOR - Old Street to Angel Start(m): 1145 Finish(m): Not Specified	
Hazard Area:	Westinghouse Boxes	
Comments:	Trackside equipment Westinghouse large	
Reference:	31892

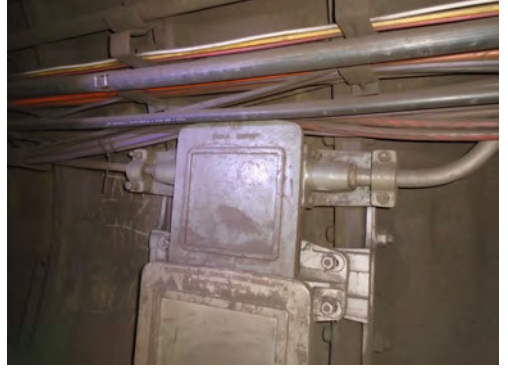
Description:	Asbestos: Presumed N126-N-NBFA: Road NBFA - NOR - Old Street to Angel Start(m): 1145 Finish(m): Not Specified	
Hazard Area:	Westinghouse Boxes	
Comments:	Trackside equipment Westinghouse large

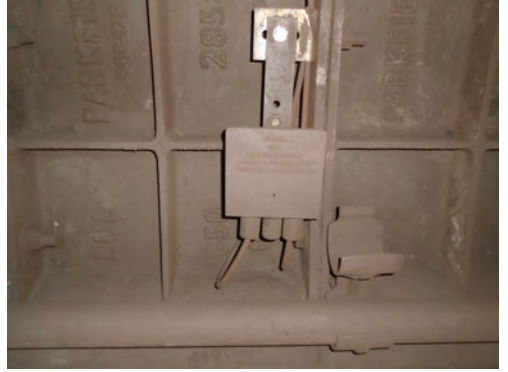
Reference:	31980

Description:	Asbestos: Presumed N126-N-NBFA: Road NBFA - NOR - Old Street to Angel Start(m): 1311 Finish(m): Not Specified	
Hazard Area:	Westinghouse Boxes	
Comments:	Trackside equipment Westinghouse small
