From: Kelly Darren
Sent: 02 June 2020 11:54
To: Storer Richard
Cc: Forrest Jim; Venn Daniel
Subject: Kempton Court CCTV Survey
Attachments: PJ00366135_Socotec UK Limited_51 Durward Street_New Install (1).pdf; drainage sketch - mark up.pdf

Project Name: PJ00366135_Socotec UK Limited_51 Durvward Street_New Install

Project Description: CCTV survey - New Installation

This report is issued as part of C512-BBM-A-ITP-D061_WS106-50227, inspection number 5.9, showing conditions of the existing drainage within BBMV construction site boundaries in Kempton Court private car park on the completion.

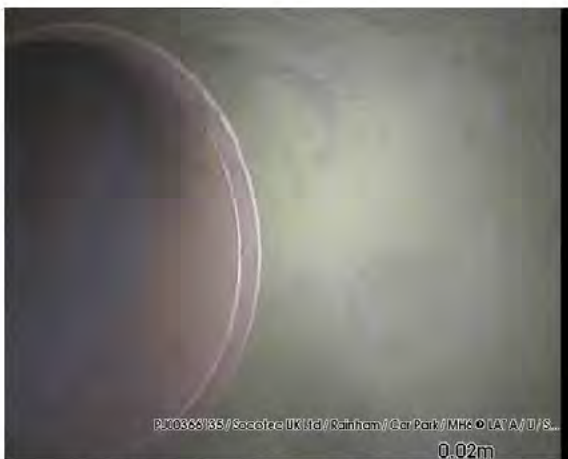
200317_1202E-Survey.jpg, 00:00:07, 0.02 m
Line deviates left

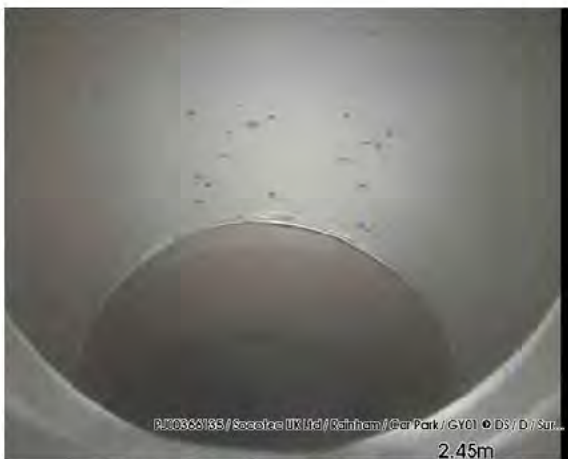
200317_1205E-Survey.jpg, 00:00:11, 2.45 m
Line deviates down

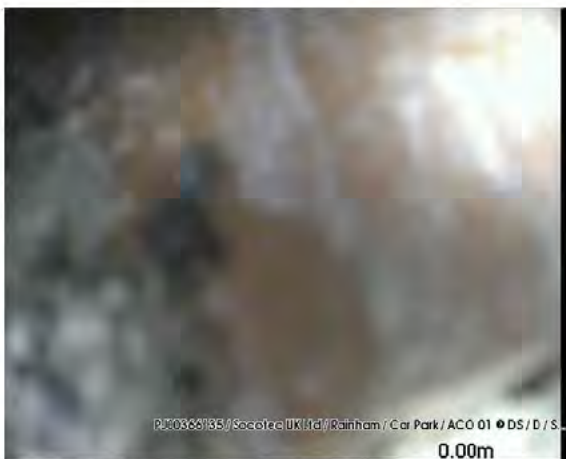
200317_1237E-Survey.jpg, 00:00:04, 0.00 m
Line deviates down

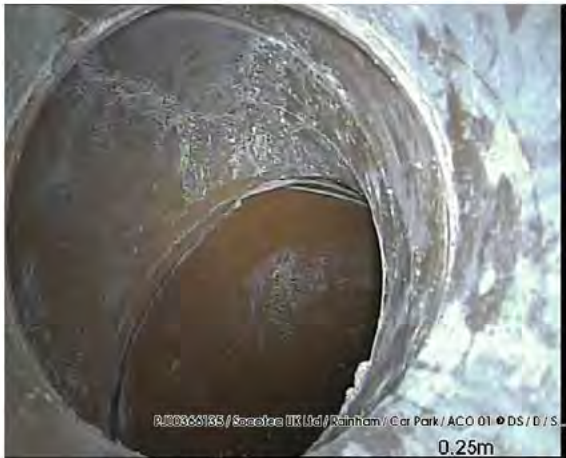
200317_1238B-Survey.jpg, 00:00:16, 0.25 m
Line deviates down

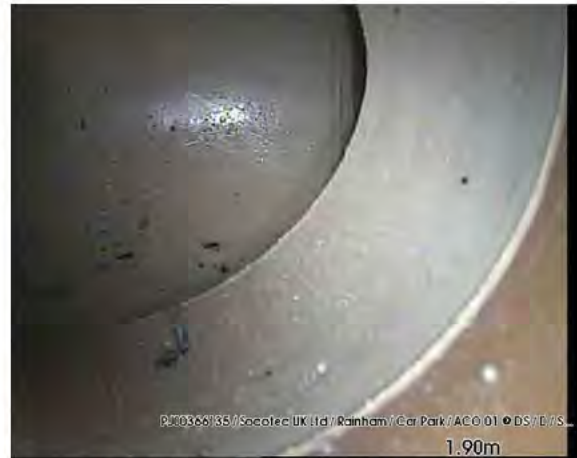
200317_1238C-Survey.jpg, 00:00:28, 1.90 m
Size changes, new size(s), 150 mm high

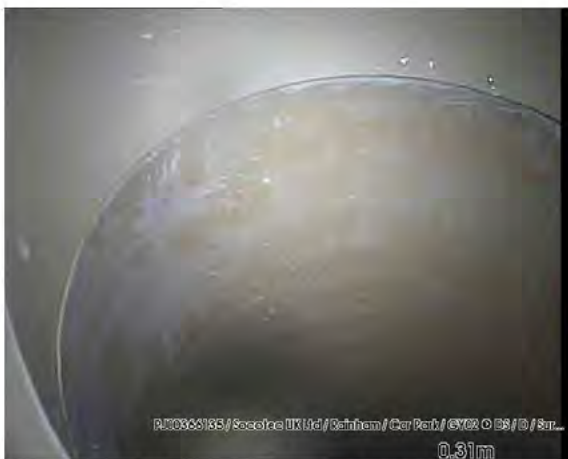
200317_1245C-Survey.jpg, 00:00:18, 0.31 m
 Line deviates down

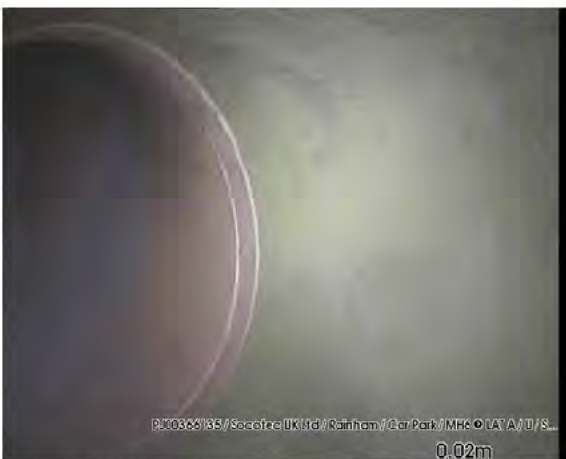
200317_1202E-Survey.jpg, 00:00:07, 0.02 m
 Line deviates left

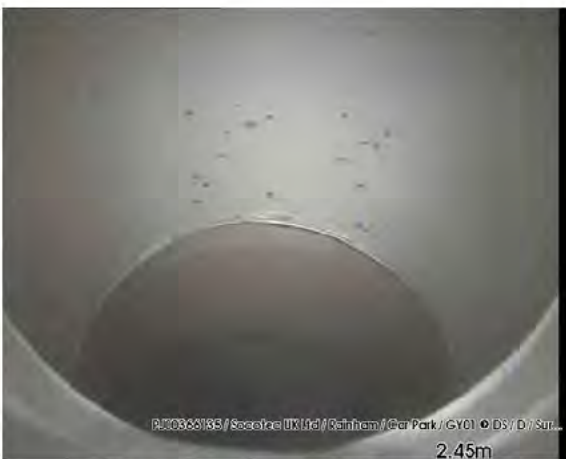
200317_1205E-Survey.jpg, 00:00:11, 2.45 m
 Line deviates down

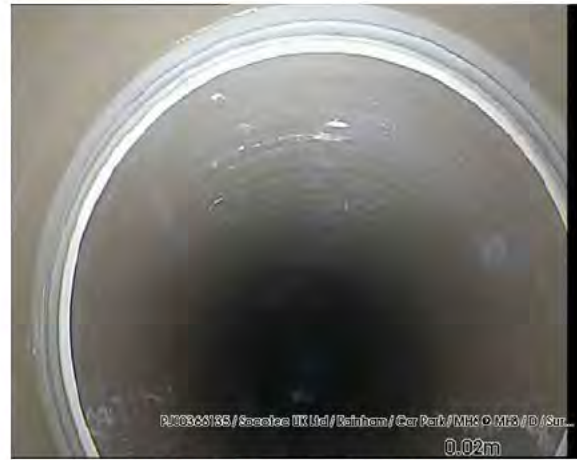
200317_1232A-Survey.jpg, 00:00:02, 0.04 m
 Water level, 5% % of the vertical dimension

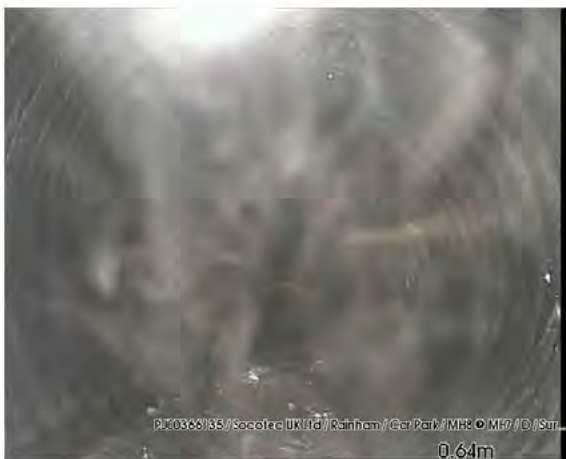
200317_1336B-Survey.jpg, 00:00:10, 0.64 m
 Material changes Polypropylene @REM

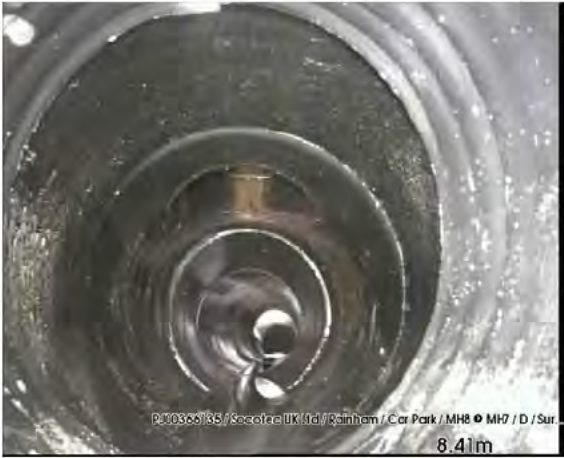
200317_1337D-Survey.jpg, 00:00:51, 8.41 m
 Size changes, new size(s), 225 mm high

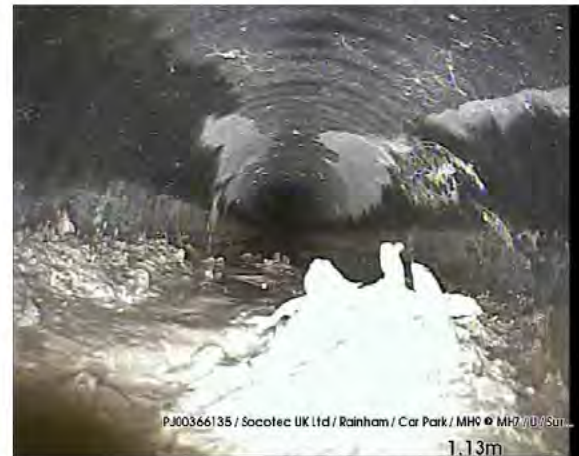
200317_1438A-Survey.jpg, 00:02:08, 1.13 m
 Survey abandoned, unable to pass

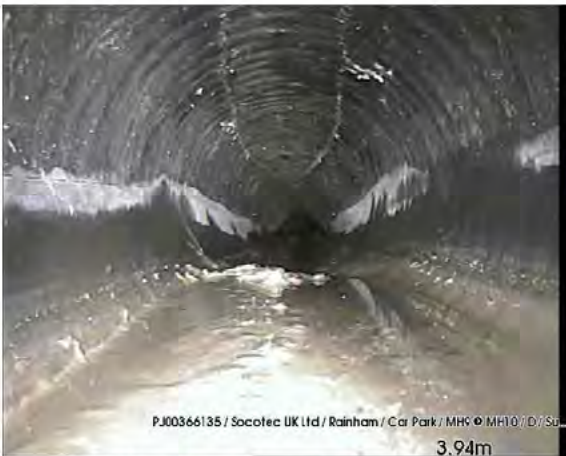
200317_1440E-Survey.jpg, 00:00:32, 3.94 m
 Settled deposits, fine, 10% % cross-sectional area loss

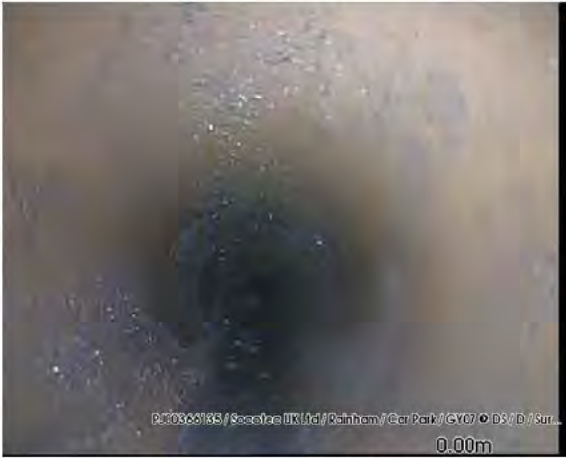
200318_1432C-Survey.jpg, 00:00:00, 0.00 m
 Start node type, gully, reference number: GY07

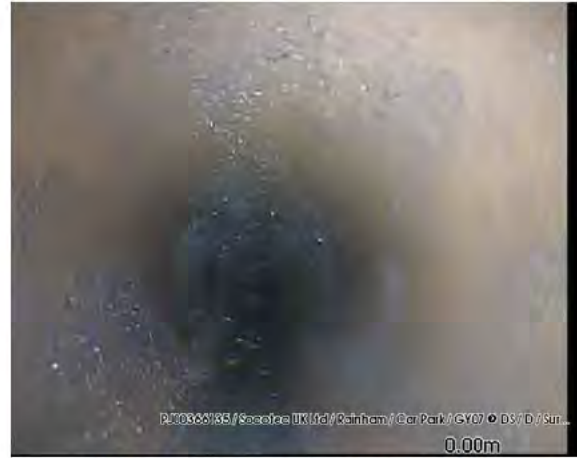
200318_1432D-Survey.jpg, 00:00:03, 0.00 m
 Water level, 5% % of the vertical dimension

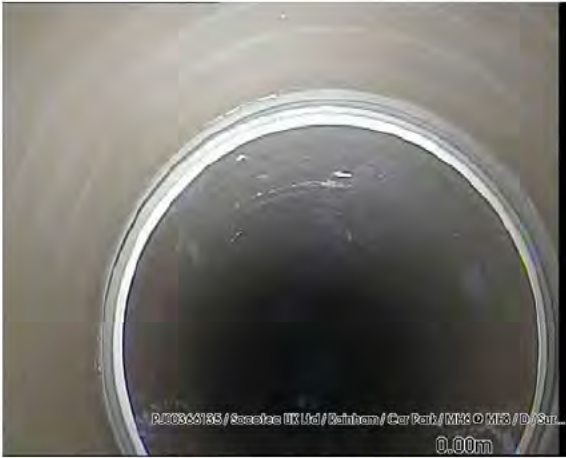
200317_1231C-Survey.jpg, 00:00:00, 0.00 m
 Start node type, manhole, reference number: MH6

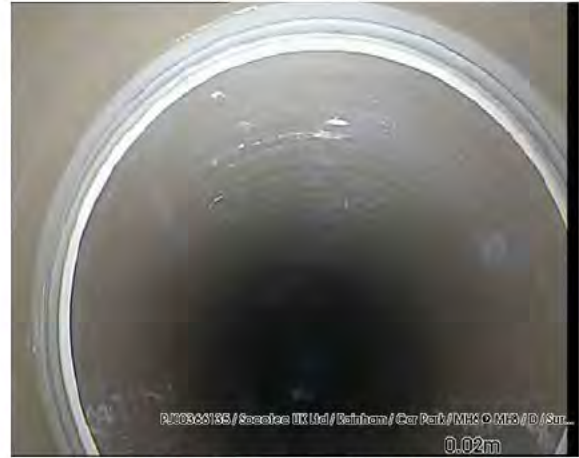
200317_1232A-Survey.jpg, 00:00:02, 0.04 m
 Water level, 5% % of the vertical dimension

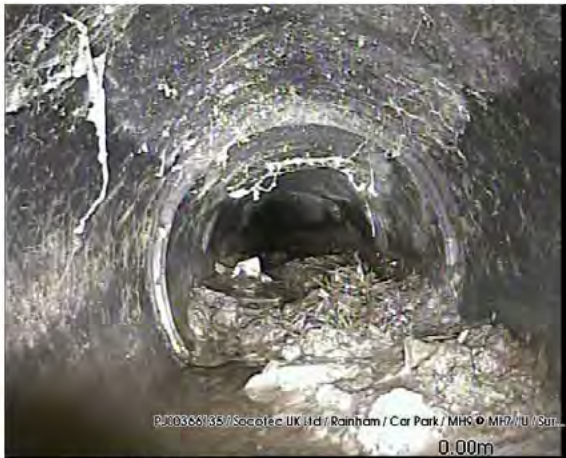
200317_1435C-Survey.jpg, 00:00:00, 0.00 m
 Start node type, manhole, reference number: MH9

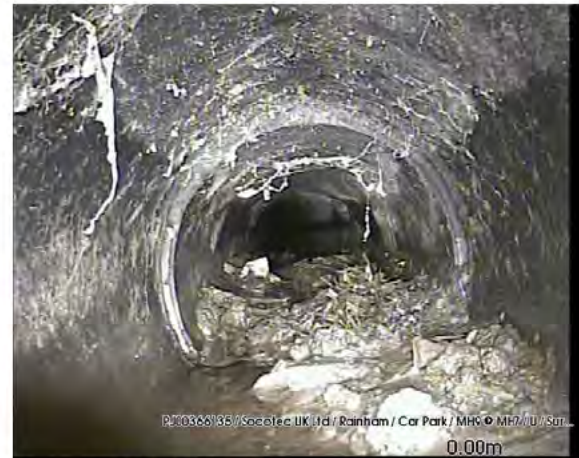
200317_1435D-Survey.jpg, 00:00:04, 0.00 m
 Water level, 5% % of the vertical dimension

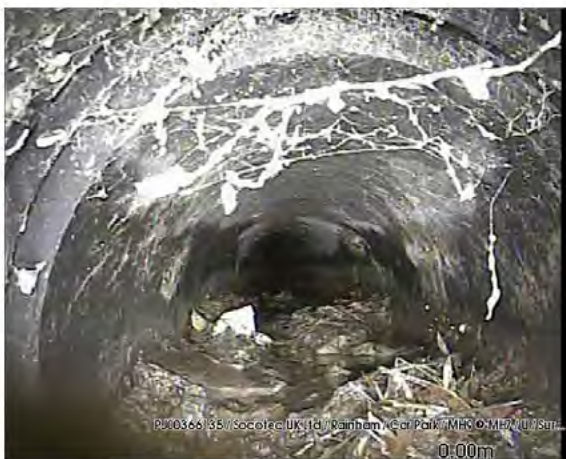
Section	PLR	Grade	Description
7	MH7X	4	Settled deposits, fine, 40% % cross-sectional area loss
8	MH9X	3	Multiple defects
13	GY06X	3	Settled deposits, fine, 10% % cross-sectional area loss
14	GY08X	3	Settled deposits, fine, 10% % cross-sectional area loss
16	GY07X	3	Settled deposits, fine, 10% % cross-sectional area loss

200317_1436A-Survey.jpg, 00:00:09, 0.00 m
 Settled deposits, fine, 40% % cross-sectional area loss

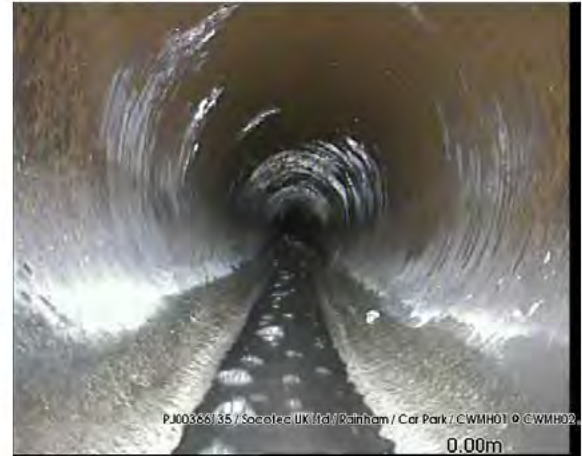
200317_1456D-Survey.jpg, 00:00:02, 0.00 m
 Water level, 5% % of the vertical dimension, Strong flow

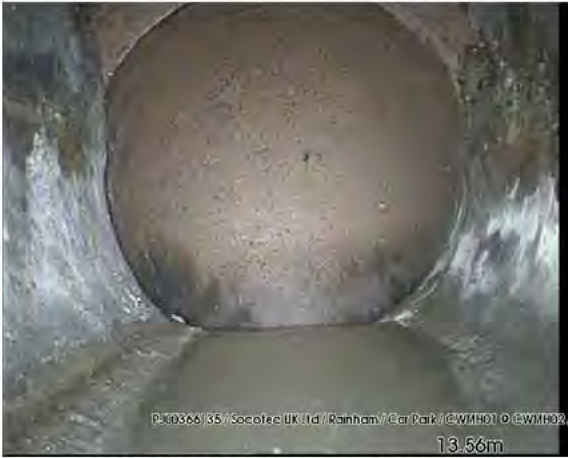
PJ00366135 / Socotec UK Ltd / Rainham / Car Park / CWMH01 O / CWMH02
13.56m

200317_1458A-Survey.jpg, 00:01:18, 13.56 m
Finish node type, manhole, reference number: CWMH02

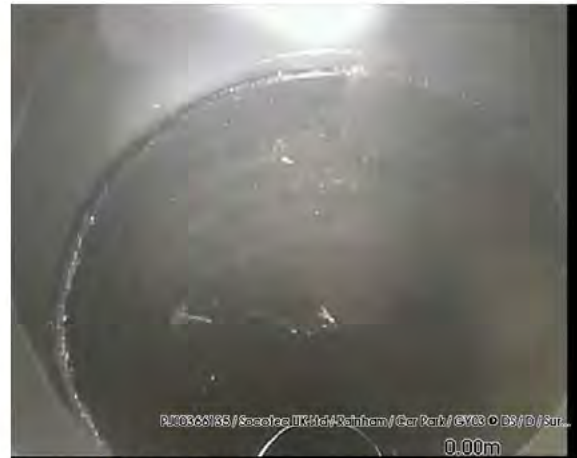
200318_1135D-Survey.jpg, 00:00:02, 0.00 m
 Water level, 5% % of the vertical dimension

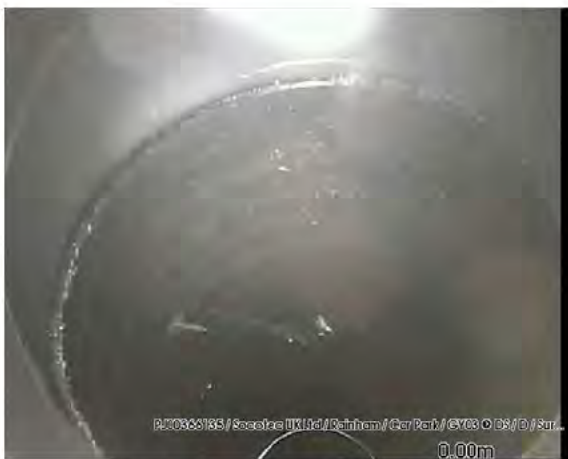
200318_1135E-Survey.jpg, 00:00:04, 0.00 m
 Line deviates down

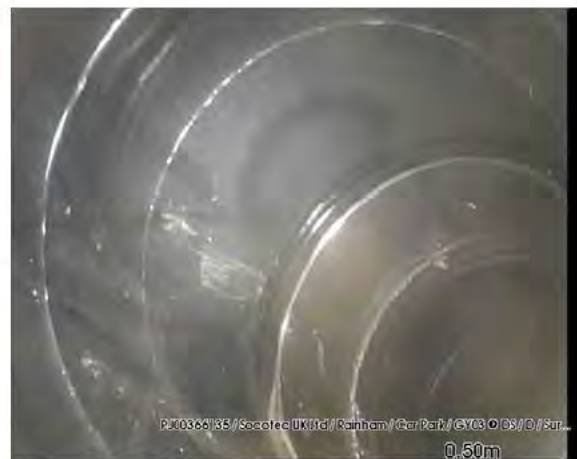
200318_1135F-Survey.jpg, 00:00:11, 0.50 m
 Line deviates right

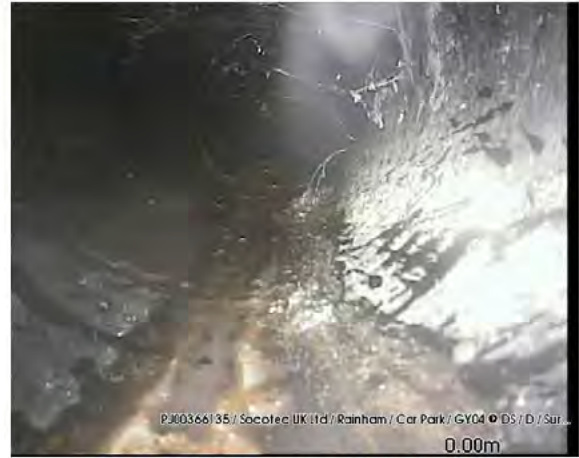
200318_1144D-Survey.jpg, 00:00:03, 0.00 m
 Water level, 5% % of the vertical dimension

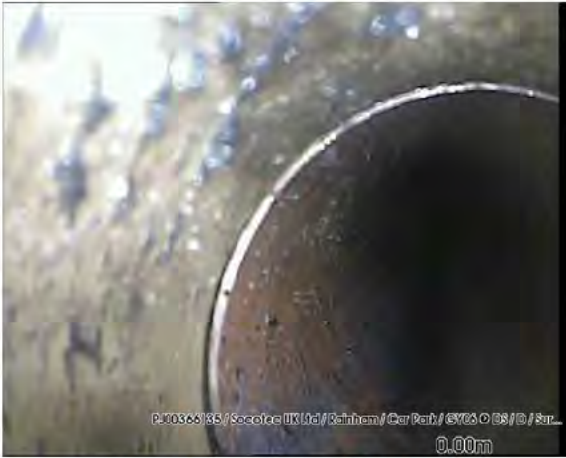
200318_1354C-Survey.jpg, 00:00:00, 0.00 m
 Start node type, gully, reference number: GY06

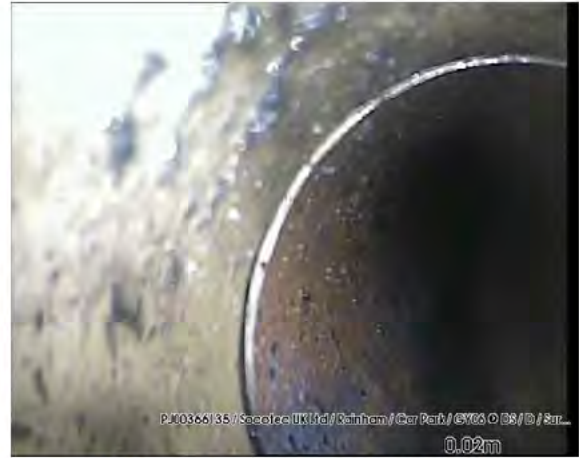
200318_1354D-Survey.jpg, 00:00:02, 0.02 m
 Water level, 5% % of the vertical dimension

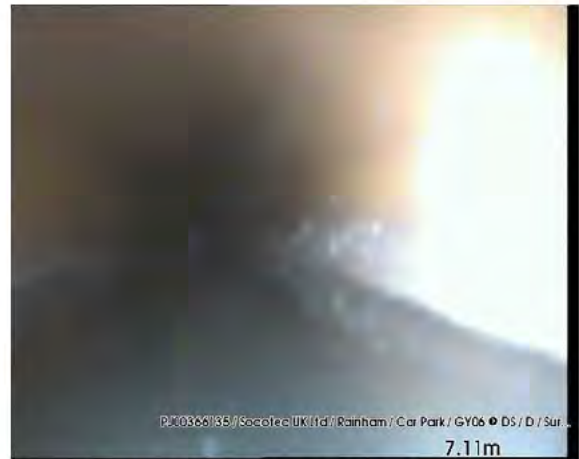
200318_1355A-Survey.jpg, 00:00:40, 7.11 m
 Water level, 10% % of the vertical dimension

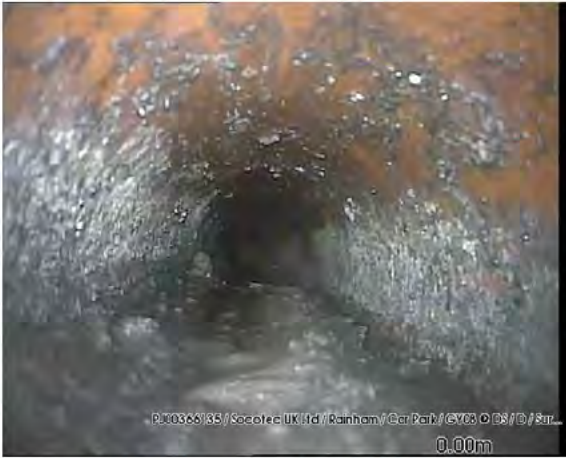
200318_1410C-Survey.jpg, 00:00:00, 0.00 m
 Start node type, gully, reference number: GY08

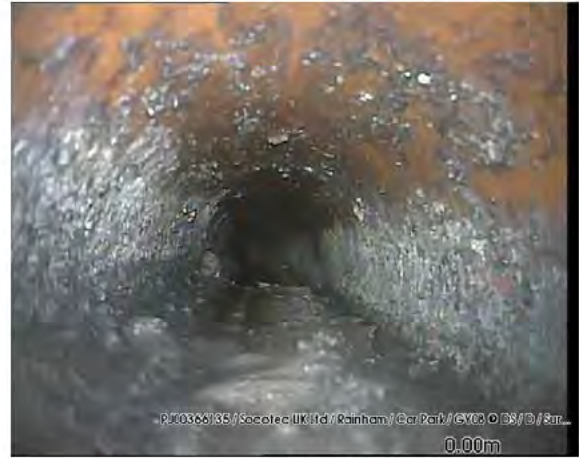
200318_1410D-Survey.jpg, 00:00:02, 0.00 m
 Water level, 10% % of the vertical dimension

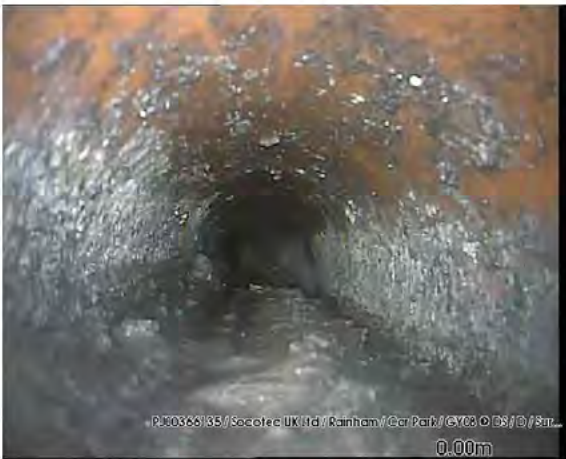
200318_1411A-Survey.jpg, 00:00:04, 0.00 m
 Settled deposits, fine, 10% % cross-sectional area loss

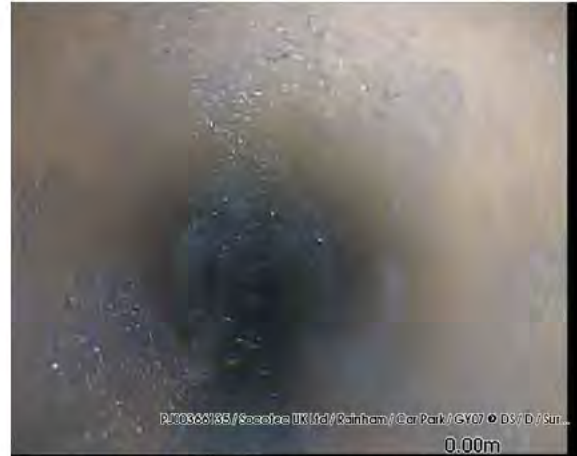
200318_1432D-Survey.jpg, 00:00:03, 0.00 m
 Water level, 5% % of the vertical dimension

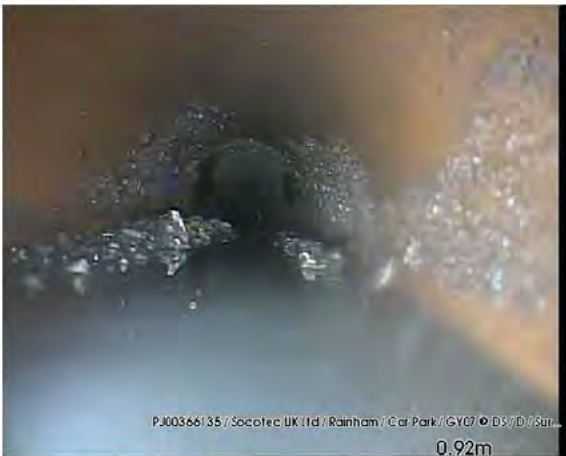
200318_1432E-Survey.jpg, 00:00:14, 0.92 m
 Settled deposits, fine, 10% % cross-sectional area loss
